Window W4 - C/G 1:5

**OSBORNES**CHARTEREDARCHITECTS  
The Balconies • Hanley Swan • Malvern • Worcestershire • WR8 0DN  
T: 01684 311303 E: architecture@osbornesarchitects.com F: 01684311255 W: osbornesarchitects.com  
CLIENT AMBASSADOR THEATRE GROUP  
PROJECT MANCHESTER OPERA HOUSE  
TITLE WINDOW REPAIR - W4-C/G  
SCALE 1:5; NTS @ A1  
DATE MAR 2020  
DRAWN AML  
DRAWING NUMBER 19-143- WR4

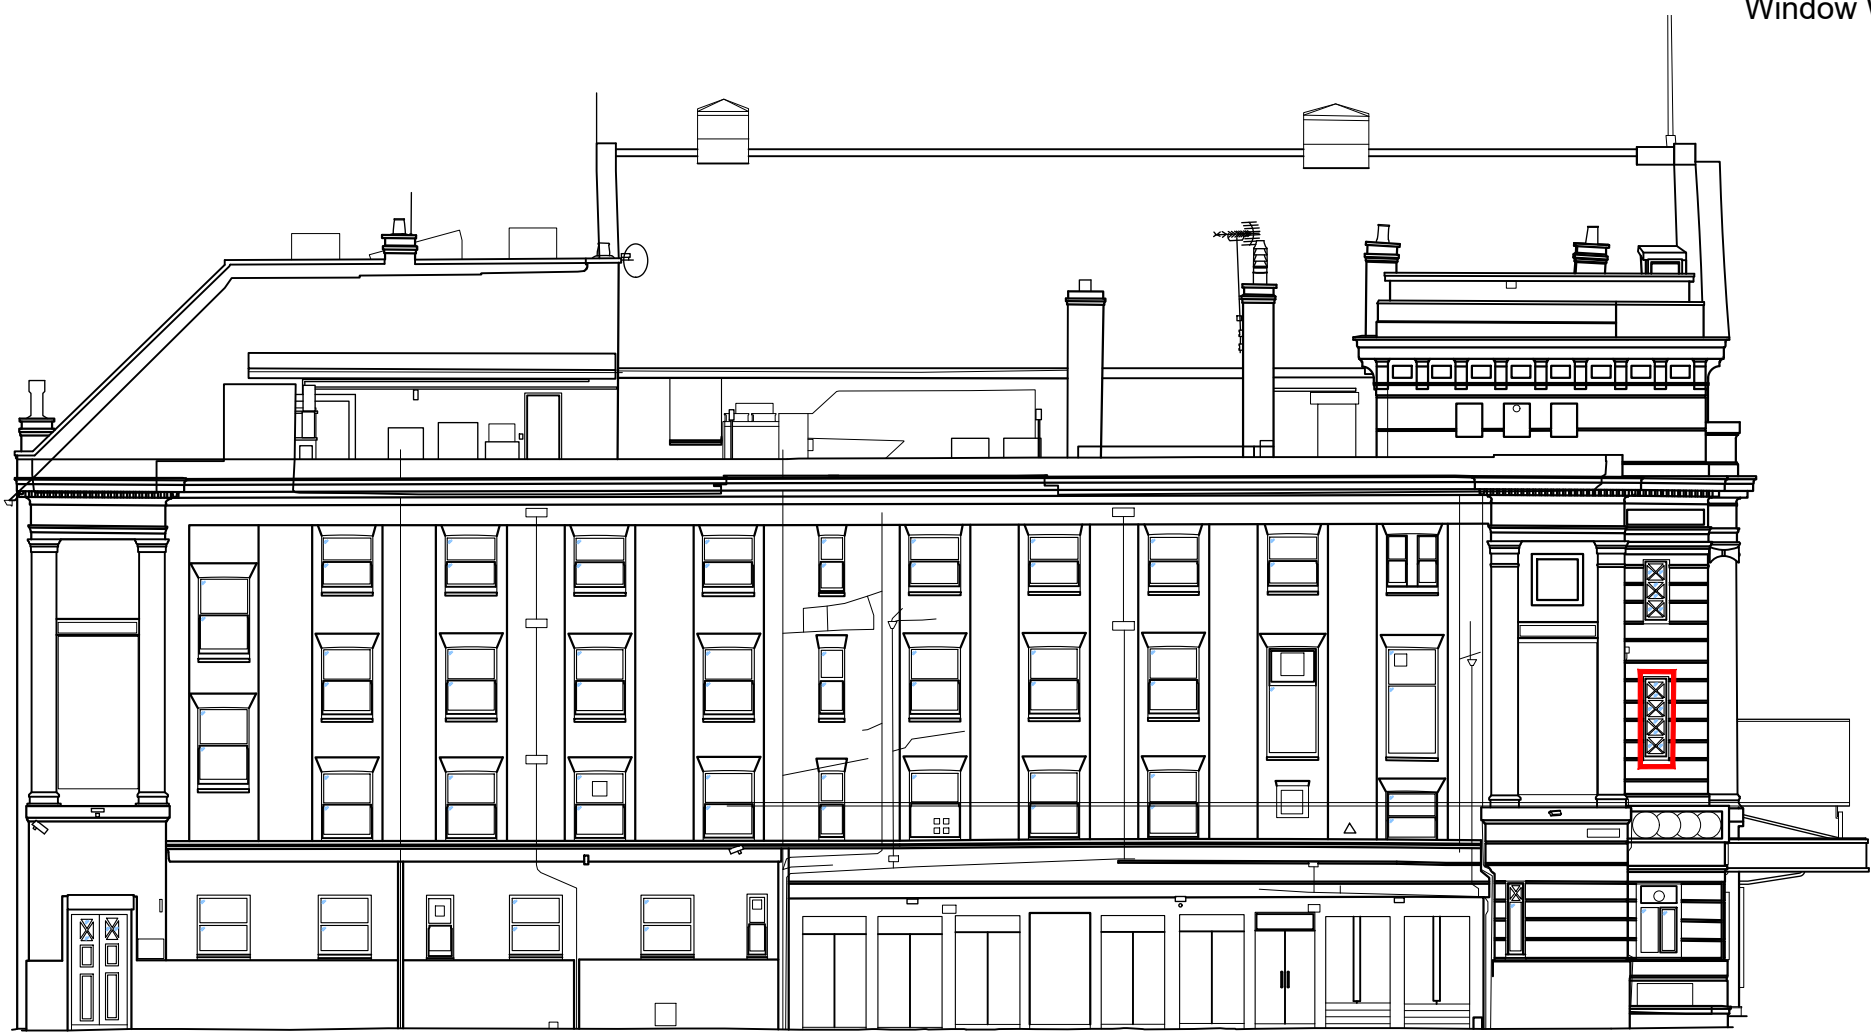
Landing in front of stair.

Due to limited access repairs to frame and beads will need assessing once window has been removed and is fully accessible for further investigation.

Carefully remove beads to allow for existing broken glass to be removed and new glass to be replaced. New glass to match existing. Ensure bead is labeled for replacement in original location.  
Also see general notes on glass replacement.

Replace bead to match existing bead detail in all areas indicated on window, where missing or damaged.  
To avoid damage to glass remove existing putty using non-caustic solvent paint stripper as manufacturers instructions and cover with polyethylene film to prevent drying out. Once putty is softened sufficiently, remove by careful scraping. Further applications may be required depending on thickness of putty.
