# WILSONS PARK, NEWTON HEATH

## Nocturnal Bat Survey Report

*May 2022*

*Project Name:*            *Wilsons Park, Newton Heath*  
*Project Reference:*    *CW20-286*  
*Report Title:*           *Nocturnal Bat Survey Report*  
*Report Reference:*    *CW20-286 RPT 002*  
*Printing Instructions:* *Print at A4 Portrait, Double Sided.*

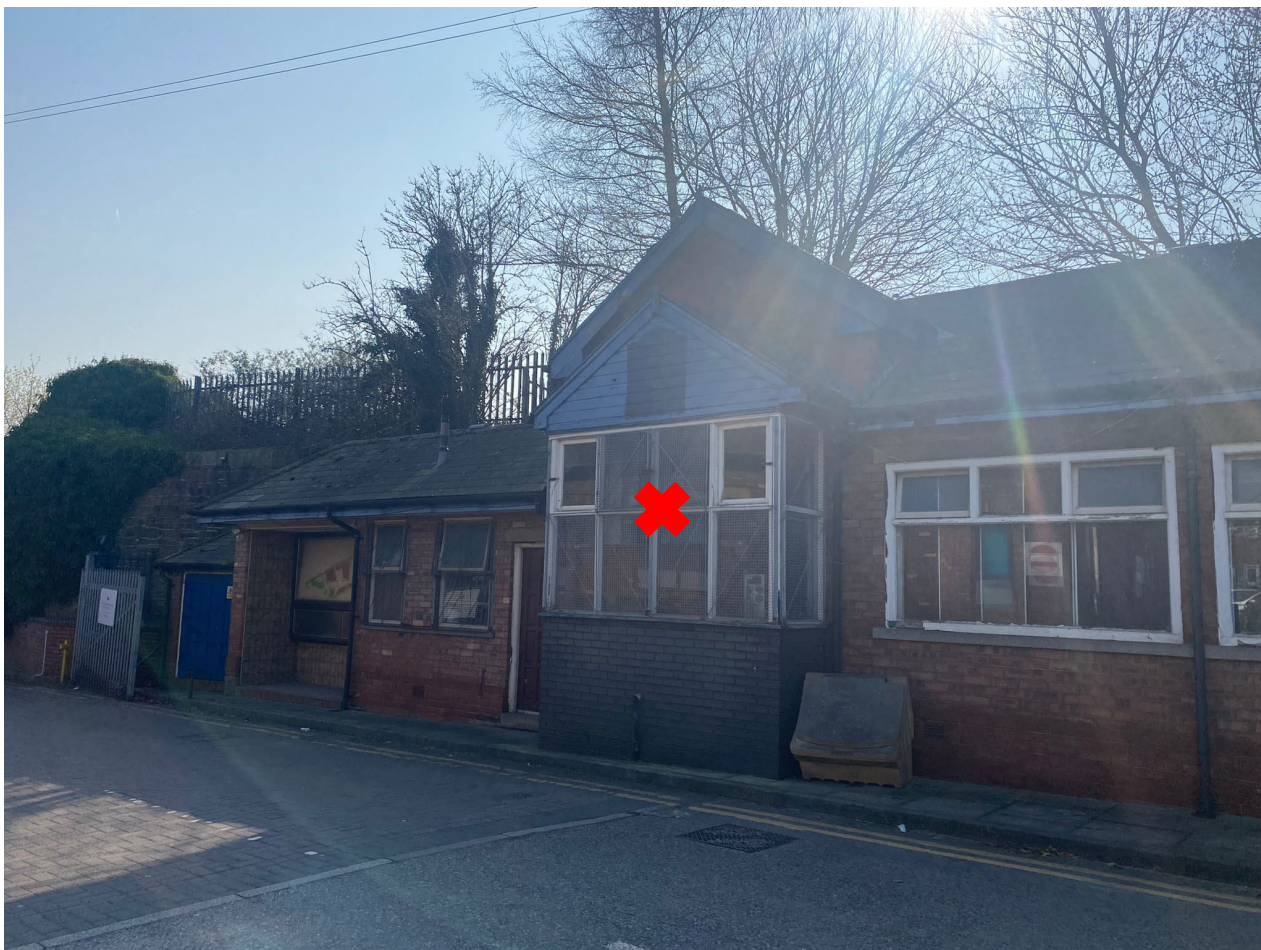
Figure 3.1 Approximate Location of Bat Roost

- 3.1.1. Bat activity was only recorded from VP1 during the survey, with the first bat observed at 21:29 and the last bat observed at 22:04. Both observed bats were common pipistrelles, with a peak count of 1 bat (*Pipistrellus pipistrellus*).
- 3.1.2. The second bat recorded at 22:04 was observed re-entering into The Gatehouse (demonstrated on Figure 3.1) and was heard inside. Please refer to Figure 3.1 for the location of the roost.

- 3.3.1. The Gatehouse showed signs of providing a roost for a single common pipistrelle and is anticipated to be relate to where the low number of bat droppings were observed during the PRA.
- 3.3.2. The single bat recorded during the nocturnal survey and low number of bat droppings, indicates it comprises a non-breeding summer roost for low numbers of common and widespread bat species.

- 4.5.1. The demolition of the buildings should not result in the overall loss of bat roosts. Therefore, a replacement roost site will need to be provided for each of the roost affected. In this case, the one roost identified in the Gatehouse and the inactive roost identified during the PRA in Building 5. The Bat Mitigation Guidelines (Mitchell-Jones, 2004) state that avoiding damage or loss of roosts is the preferred option. However, the works require the full demolition of the building, and this is not possible. As such, replacement roost provisions should be on a “like-for-like” basis to replace the existing conditions that will be lost.
