**FORMER GAMECOCK PUB,  
BOOTH STREET, MANCHESTER**

**PRELIMINARY BAT ROOST  
ASSESSMENT**

Report No: RT-MME-153624-02 Rev B

Date: March 2021  
Revised: May 2021

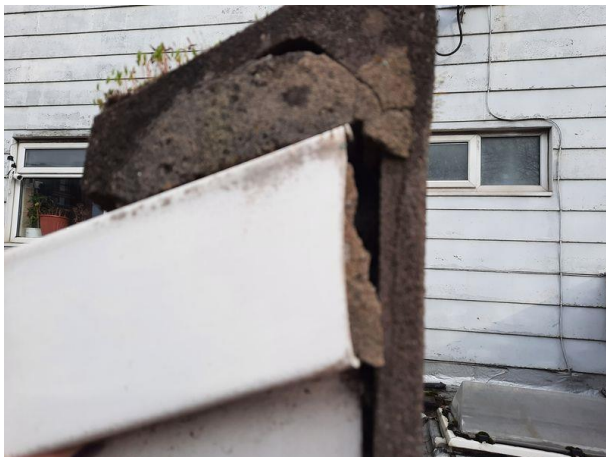
This was a single storey toilet block located to the west of the main building section, with rendered brick walls. This section had two single pitched tiled roofs to the north and south, with a flat felted section in between. The flat section of roof was approximately 1 m below the pitched roof sections with inward looking windows and a skylight present in the intermediate space. The sloping roofs had concrete interlocking profile tiles, with abundant moss growth. uPVC fascia boards were noted along the edges of the sloped roofs, and these were in good condition and well-sealed, with cobwebs recorded below. A line of clay tiles overhung the ridge on both sides, and resembled fascias above the flat-roofed section. These tiles were generally in good condition and the undersides were sealed with mortar below. However, a gap in the mortar was identified at the ridge of the northern pitched section (Plate 4.1). Although free of debris, this gap was inspected, and was found to be relatively superficial, only extending for approximately 2 cm. Small gaps were also noted under several of the roof tiles on both roof pitches, where they were slightly raised. These gaps may provide potential roosting locations for crevice dwelling bat species or could provide access to the interior of the building. Due to the shape of the interlocking tiles, gaps were also noted behind each of the tiles at eaves level. However, these had all been filled with mortar, meaning that no bat access/roosting opportunities were available at eaves level.

**Plate 4.1: Gap in Mortar Below Overhanging Ridge Tile**

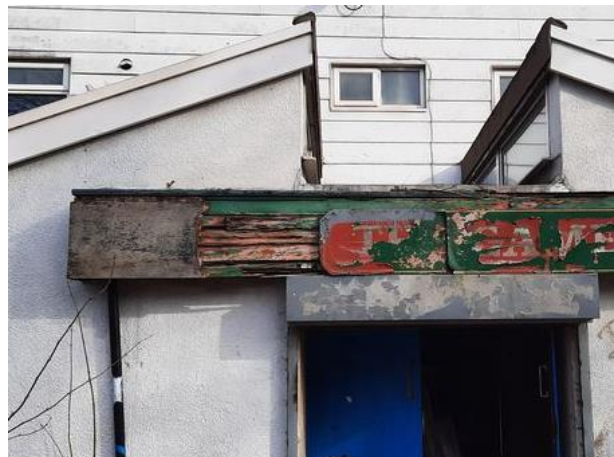
On the western elevation, a wooden pub sign was present above a metal shutter door. The sign was in poor condition, with damaged horizontal back panelling exposed (Plate 4.2). A minor gap was present between the wall and wooded boards (0.5 cm), however this was cobwebbed, indicating no recent use by fauna.

**Plate 4.2: Damage to Panelling of Pub Sign on West Elevation of Section 1.**

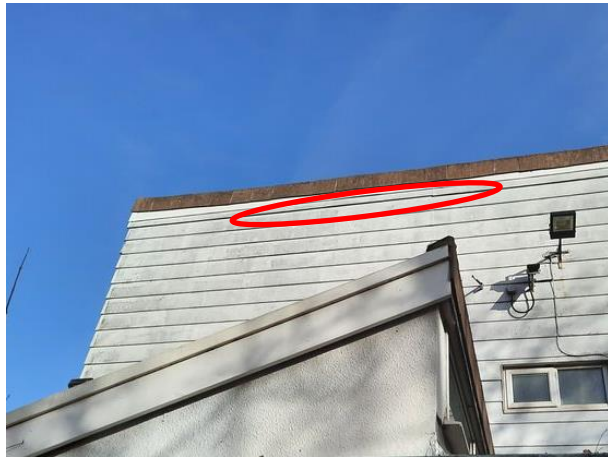
The main section of the building had brick walls with wooden horizontal cladding present on the top half of the building on all sides. The roof on the main section was sloped at a 45° angle with concrete interlocking tiles and a dormer window present to the east. The ground floor windows and doors were covered by metal sheeting that was intact and tight fitting. On the western elevation, the cladding near the eaves had lifted slightly (Plate 4.3), creating a small gap which could not be fully inspected due to its height and location. In addition, a small number of damaged cladding joints were present where the panels met on the south-west corner. These were lifted or dislodged, and the gaps below appeared to extend into cladding (Plate 4.4), thus providing potential bat roost/access features. A hole in cladding on the south-west elevation at 2.5 m high was fully inspected and did not extend sufficiently to support roosting bats.

Plate 4.3: Gap Between Cladding

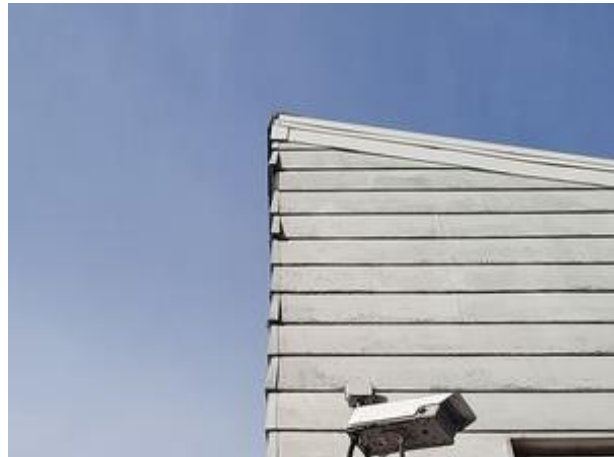
Plate 4.4: Lifted and Missing Cladding Joints

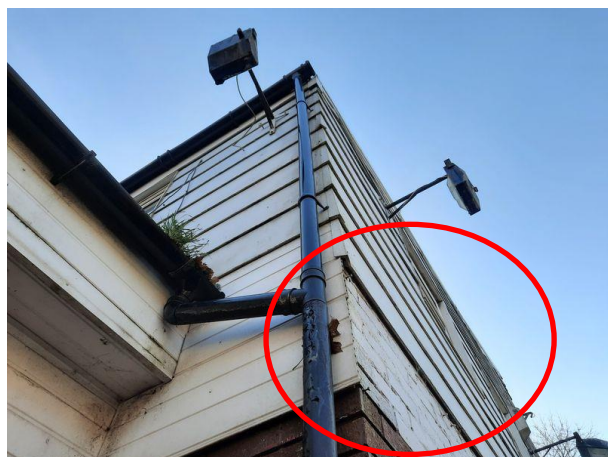
On the northern elevation, some of the cladding boards were missing from the wall, exposing the brickwork behind (Plate 4.5). Once again, gaps were noted on the underside of the remaining cladding, which may present roosting opportunities for bats.

Plate 4.5: Missing Cladding to North

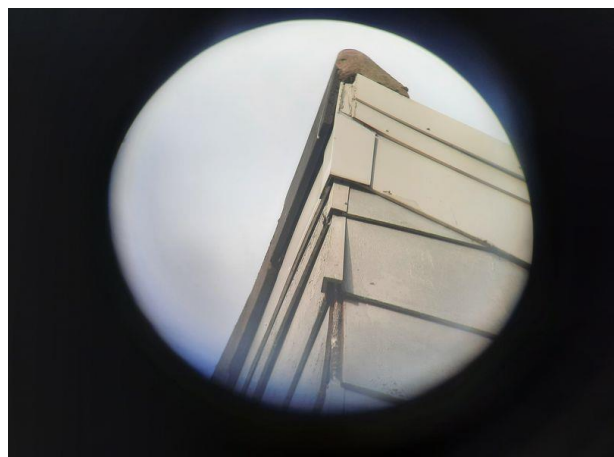
Similar to the roofs discussed within Section 1, gaps were noted below the interlocking tiles at the eastern eaves. However, these had all been filled with mortar, meaning that no bat access/roosting opportunities were available at eaves level. To the west, gaps were noted under overhanging ridge tiles, some of which appeared to be clear of cobwebs or debris (Plate 4.6). Some of these gaps appeared to extend 3-4 cm, and as such, may provide a suitable roosting crevice of bats. Due to their height and location, these features could not be fully inspected.

Plate 4.6: Gap Beneath Overhanging Tile

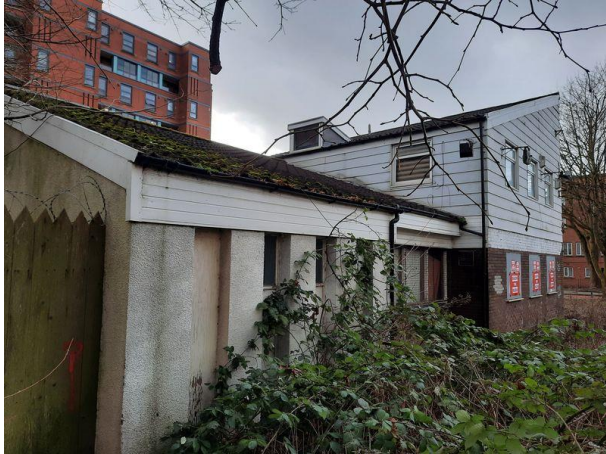
This was a single storey extension to the north-east of Section 2 (Plate 4.7). The north and east elevation were rendered with uPVC fascia boarding at the eaves which was in good condition and well-sealed. The northern elevation had wooden windows and section of this was meshed off. The roof was single pitched at a 45° angle with concrete interlocking profile tiles which had abundant moss growth on the eastern side. The tiles at the ridge once again hung over the side of the building on the southern side, approximately 1 m above the flat roof of Section 4. Some of these tiles to east appeared newer and tighter fitting than the rest. The interlocking tiles at the eaves on the north side once again had gaps behind them. However, no mortar was present behind these tiles, meaning that these could be a potential access/roosting feature. The gaps appeared to extend up to 15 cm (Plate 4.8).

**Plate 4.7: North-East extension**

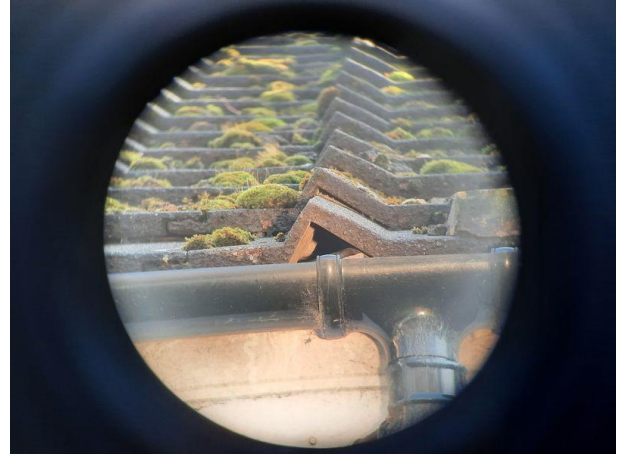
**Plate 4.8: Opening Under Overhanging Profile Roof Tiles**

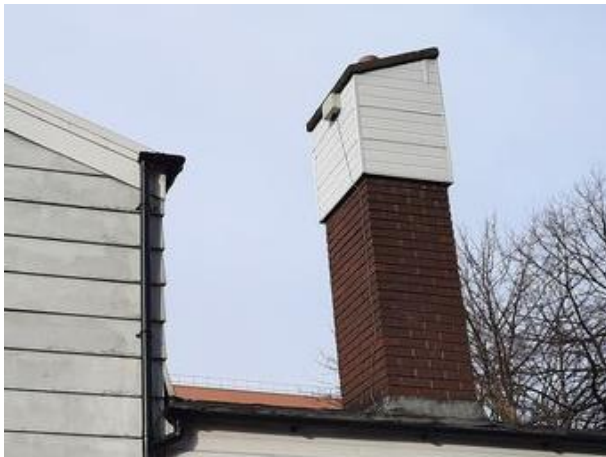
This was a flat roofed single storey brick extension to the south-east of the main section. The uPVC fascia boarding present on the southern and eastern elevations was in good condition and well-sealed. The felt roof was also in good condition with a tall brick chimney stack with uPVC cladding on the top and sides, to the south of the roof. The chimney had 2-3 cm gaps between the cladding and brickwork (Plate 4.9), which were considered to provide a potential crevice for roosting bats. Due to their height and location, these gaps could not be fully inspected, but light cobwebbing could be seen from ground level.

**Plate 4.9: Gap Under Chimney Cladding**

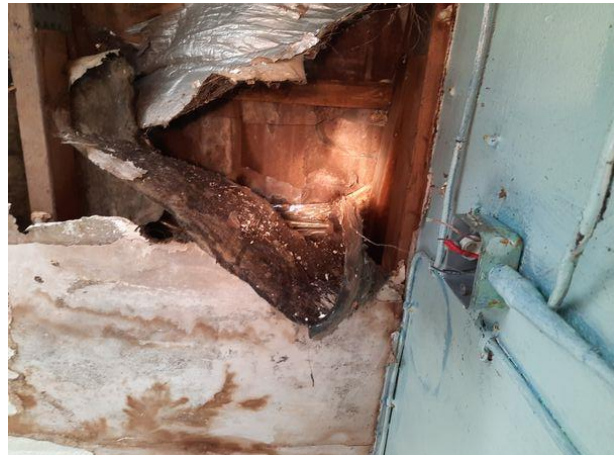
**Plate 4.11: Broken Ceiling Board in Southern  
Toilet Block (Section 1)**

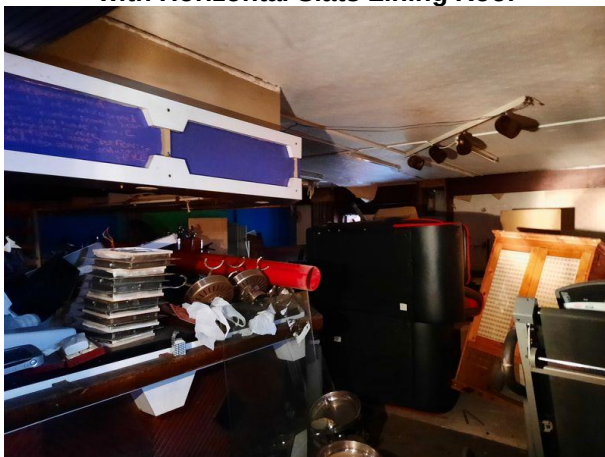
The main section was two storeys, however only the ground level could be inspected at the time of the survey. The ground floor ceiling had no loft hatches and at the time of the survey was very cluttered with furniture (Plate 4.11). The ceiling comprised horizontal wooden boarding to the east (Plate 4.12) and patterned wallpaper to the west. The room had brick walls with both rendered and wallpapered sections. A mixture of wooden and uPVC windows were present on the north and south facing walls, which were well sealed and covered with metal grills on the outside. Lighting was installed within the pub but had not been used for a long time, with numerous cobwebs noted on the ceiling and walls. The pub was generally well sealed internally due to previous security issues with the site.

**Plate 4.11: Cluttered Ground Floor of Main  
Section (Section 2)**
