# Television Baseline Survey Report

Mobility Hub, Ancoats, Manchester

May 2021

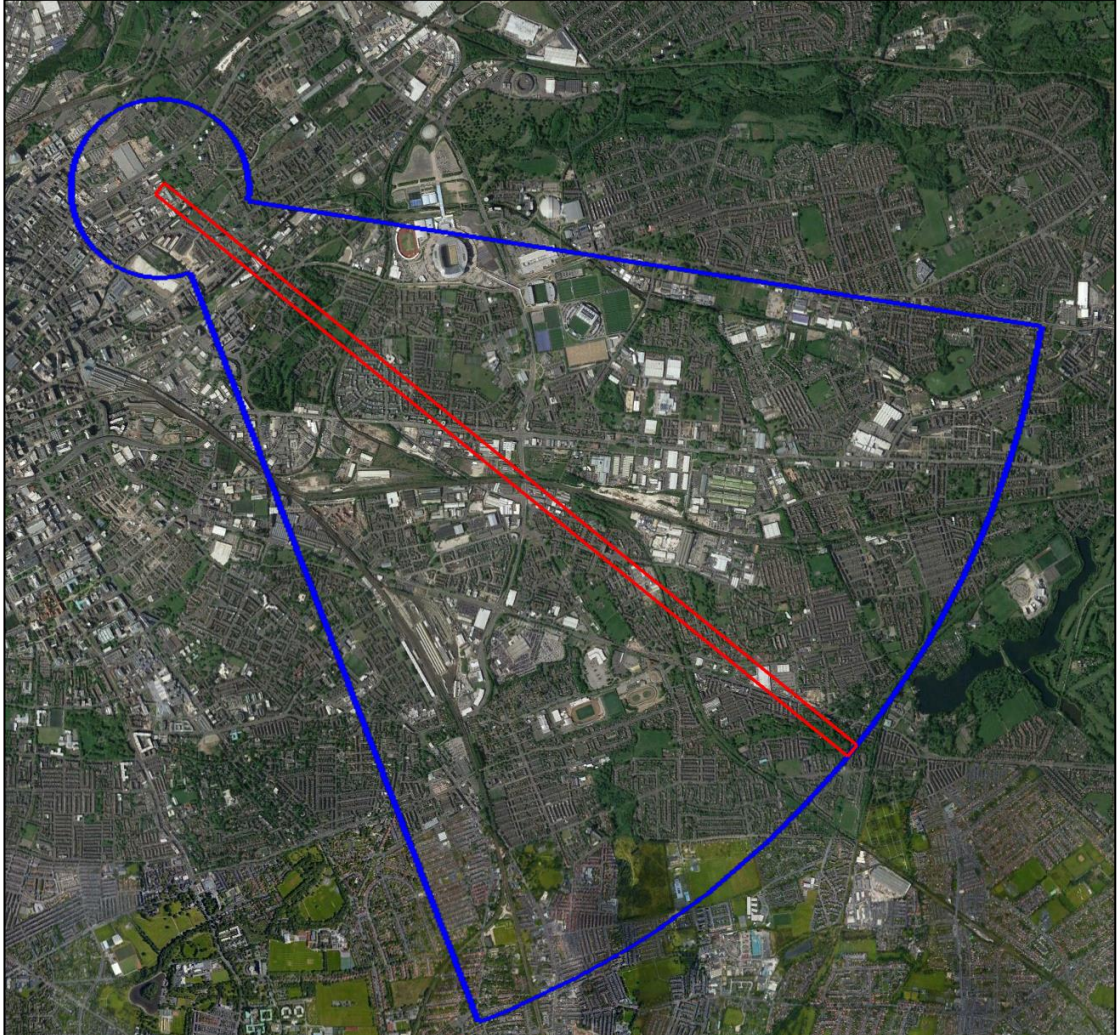
Figure 5 *Interference zones - aerial image*

Figure 5<sup>6</sup> below shows the interference areas overlaid onto aerial imagery.

The interference zones have been constructed in accordance with Ofcom guidance presented in Section 3, which gives fixed dimensions that do not vary with building size. The survey results and previous experience have informed the overall judgement of where effects are predicted.

It can be seen that the shadow zone passes over areas that are mostly urban containing high and low-rise residential developments. Areas closest to the proposed development are at the highest risk of experiencing television interference.

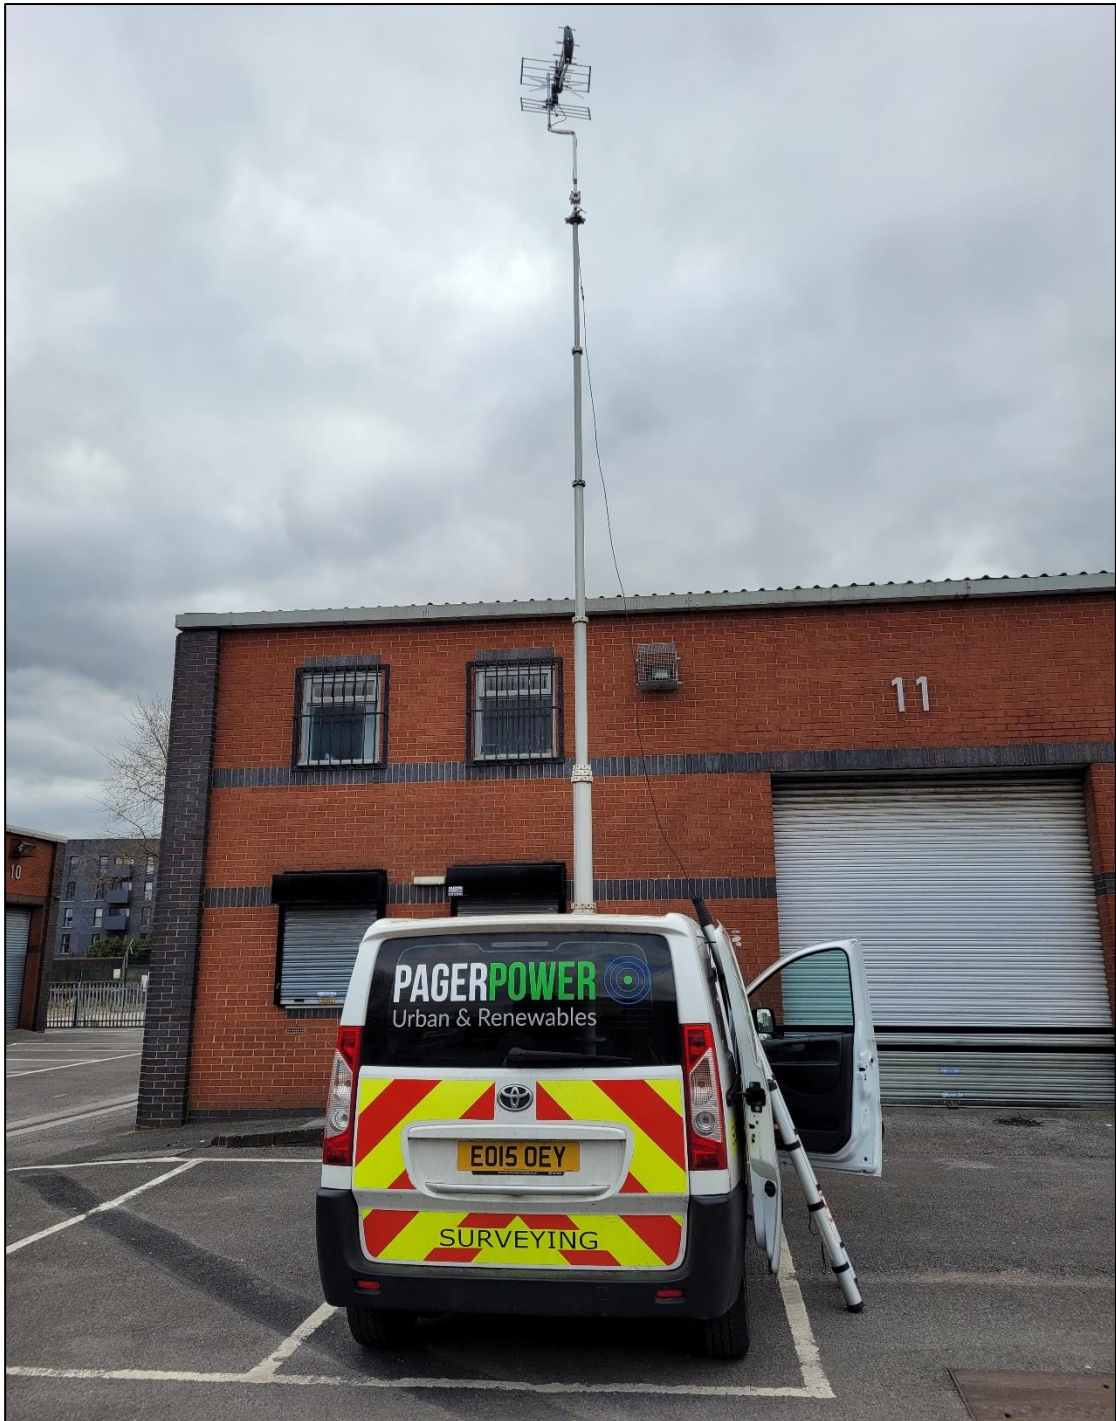
### Location 1

| Location | Measured Signal Strength (dB) | Remarks | High-Level Conclusion |
|---|---|---|---|
| 1 | <p>31 – 63</p> <p>The majority of multiplexes overall were of very good strength.</p> | <p>Aerials directed towards Winter Hill were observed.</p> <p>All multiplexes displayed fine picture and audio quality, with signal fluctuations of less than 1dB and no signs of interference.</p> | <p>The survey location is immediately adjacent to the proposed development location.</p> <p>A moderate impact upon signals at this location is possible based on the proximity to the proposed development (within 500m). The most significant effects are possible for the weaker local channels, but the majority of channels should retain good quality transmission.</p> <p>This could depend on the relative height of the building development and any receiving aerials.</p> |

Notes: Elevated Horizontally Polarised (HP) Ultra High Frequency (UHF) aerials directed towards the Winter Hill transmitter were observed.

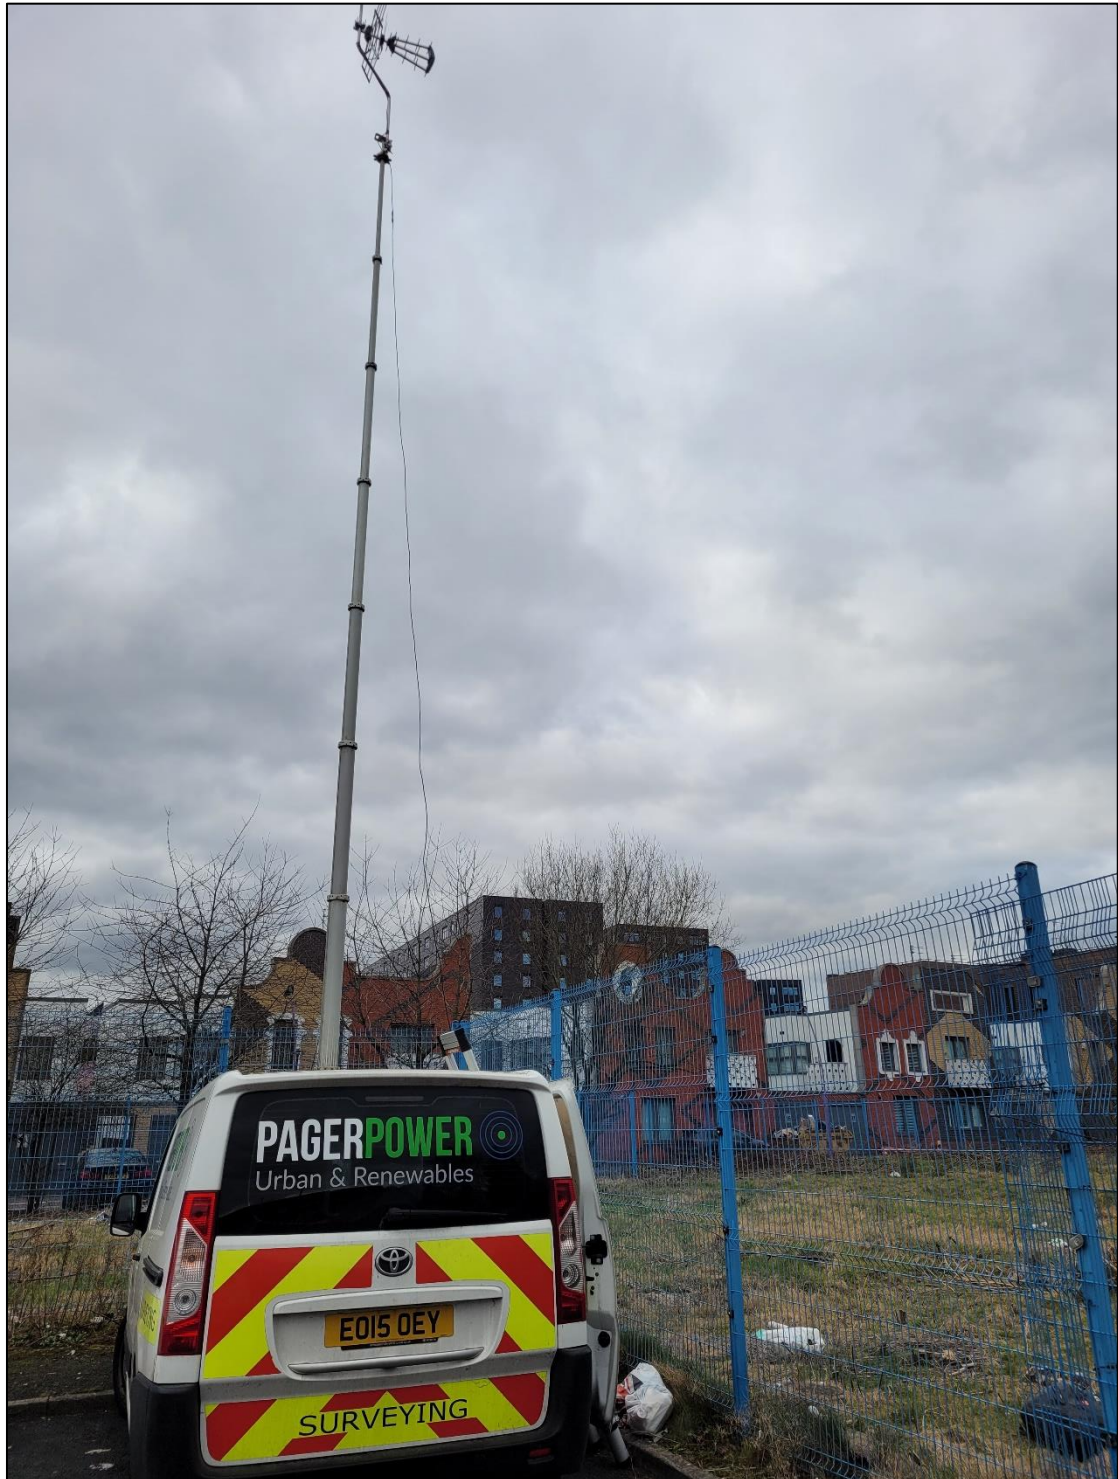
Location 2

| Location | Measured Signal Strength (dB) | Remarks | High-Level Conclusion |
|---|---|---|---|
| 2 | <p>32 – 67</p> <p>The majority of multiplexes overall were of good or very good strength.</p> | <p>Aerials directed towards Winter Hill and satellite dishes were observed.</p> <p>All multiplexes displayed fine picture and audio quality, with signal fluctuations of less than 1dB and no signs of interference.</p> | <p>The survey location is within 300m of the proposed development.</p> <p>A moderate impact upon signals at this location is possible based on the proximity to the proposed development (within 500m). The most significant effects are possible for the weaker local channels, but the majority of channels should retain good quality transmission. This could depend on the relative height of the building development and any receiving aerials.</p> |

Notes: Elevated Horizontally Polarised (HP) Ultra High Frequency (UHF) aerials directed towards the Winter Hill transmitter and satellite dishes were observed.

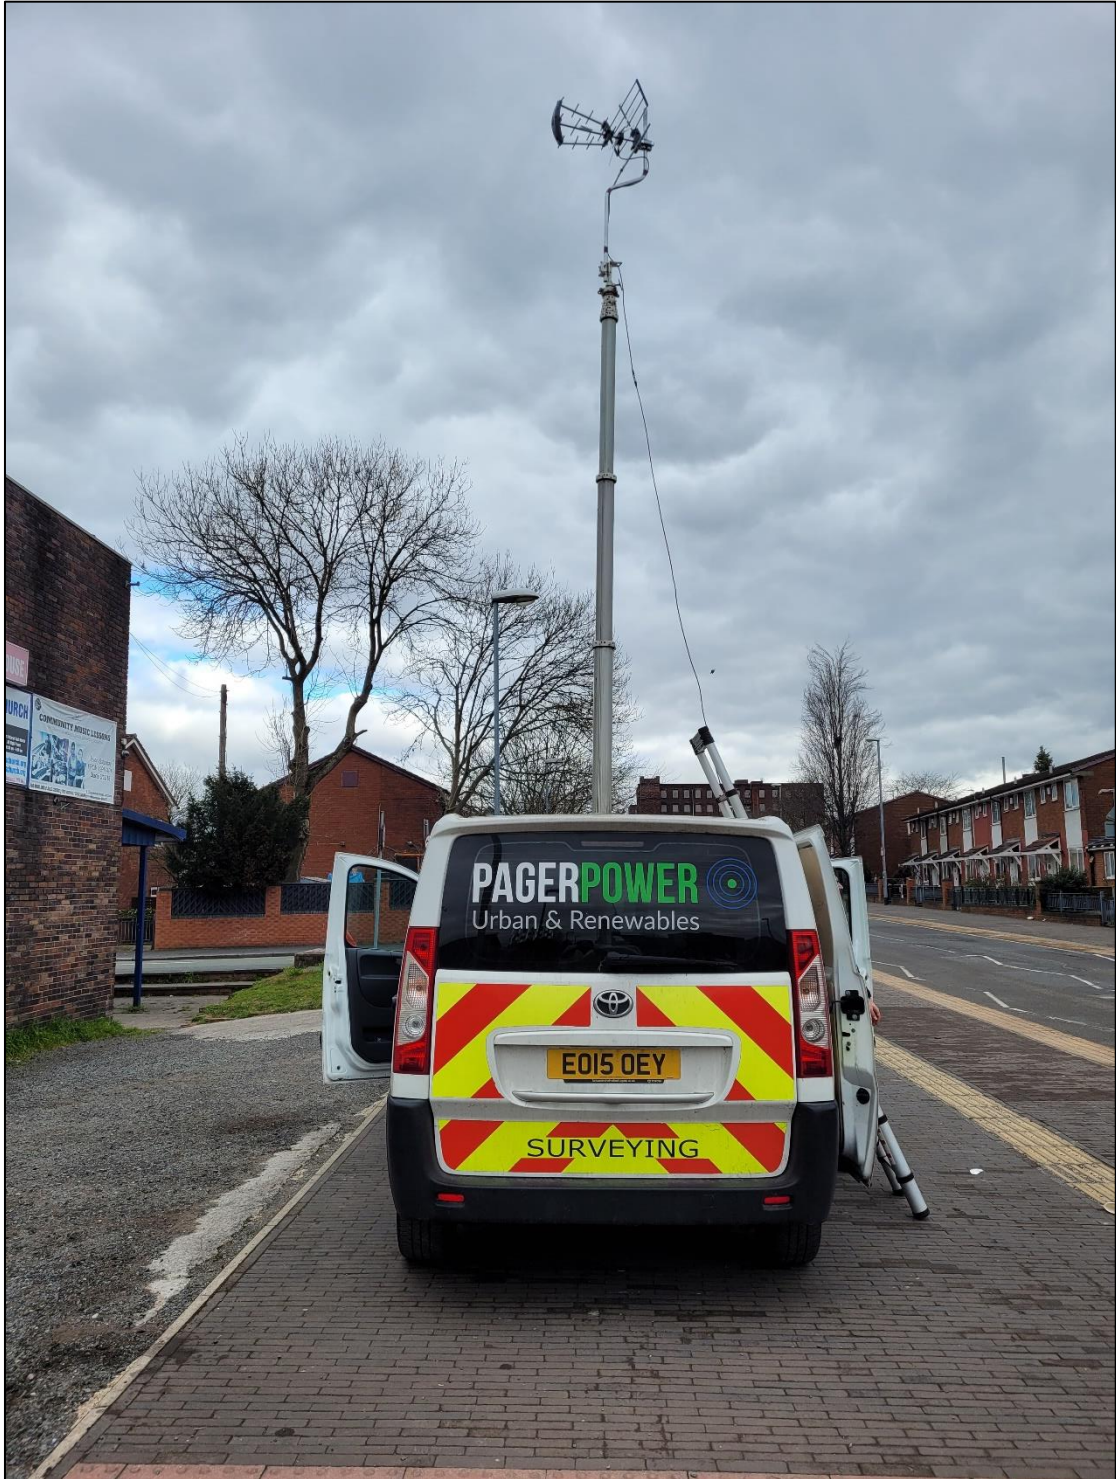
Location 3

| Location | Measured Signal Strength (dB) | Remarks | High-Level Conclusion |
|---|---|---|---|
| 3 | <p>42 – 72</p> <p>The majority of multiplexes overall were of very good strength.</p> | <p>Aerials directed towards Winter Hill and satellite dishes were observed.</p> <p>All multiplexes displayed fine picture and audio quality, with signal fluctuations of less than 1dB and no signs of interference.</p> | <p>The survey location is within 600 metres of the proposed development.</p> <p>A low impact upon signals at this location is possible based on the proximity to the proposed development (within 1 km). The most significant effects are possible for the weaker local channels, but the majority of channels should retain good quality transmission. This could depend on the relative height of the building development and any receiving aerials.</p> |

Notes: Elevated Horizontally Polarised (HP) Ultra High Frequency (UHF) aerials directed towards the Winter Hill transmitter and satellite dishes were observed.

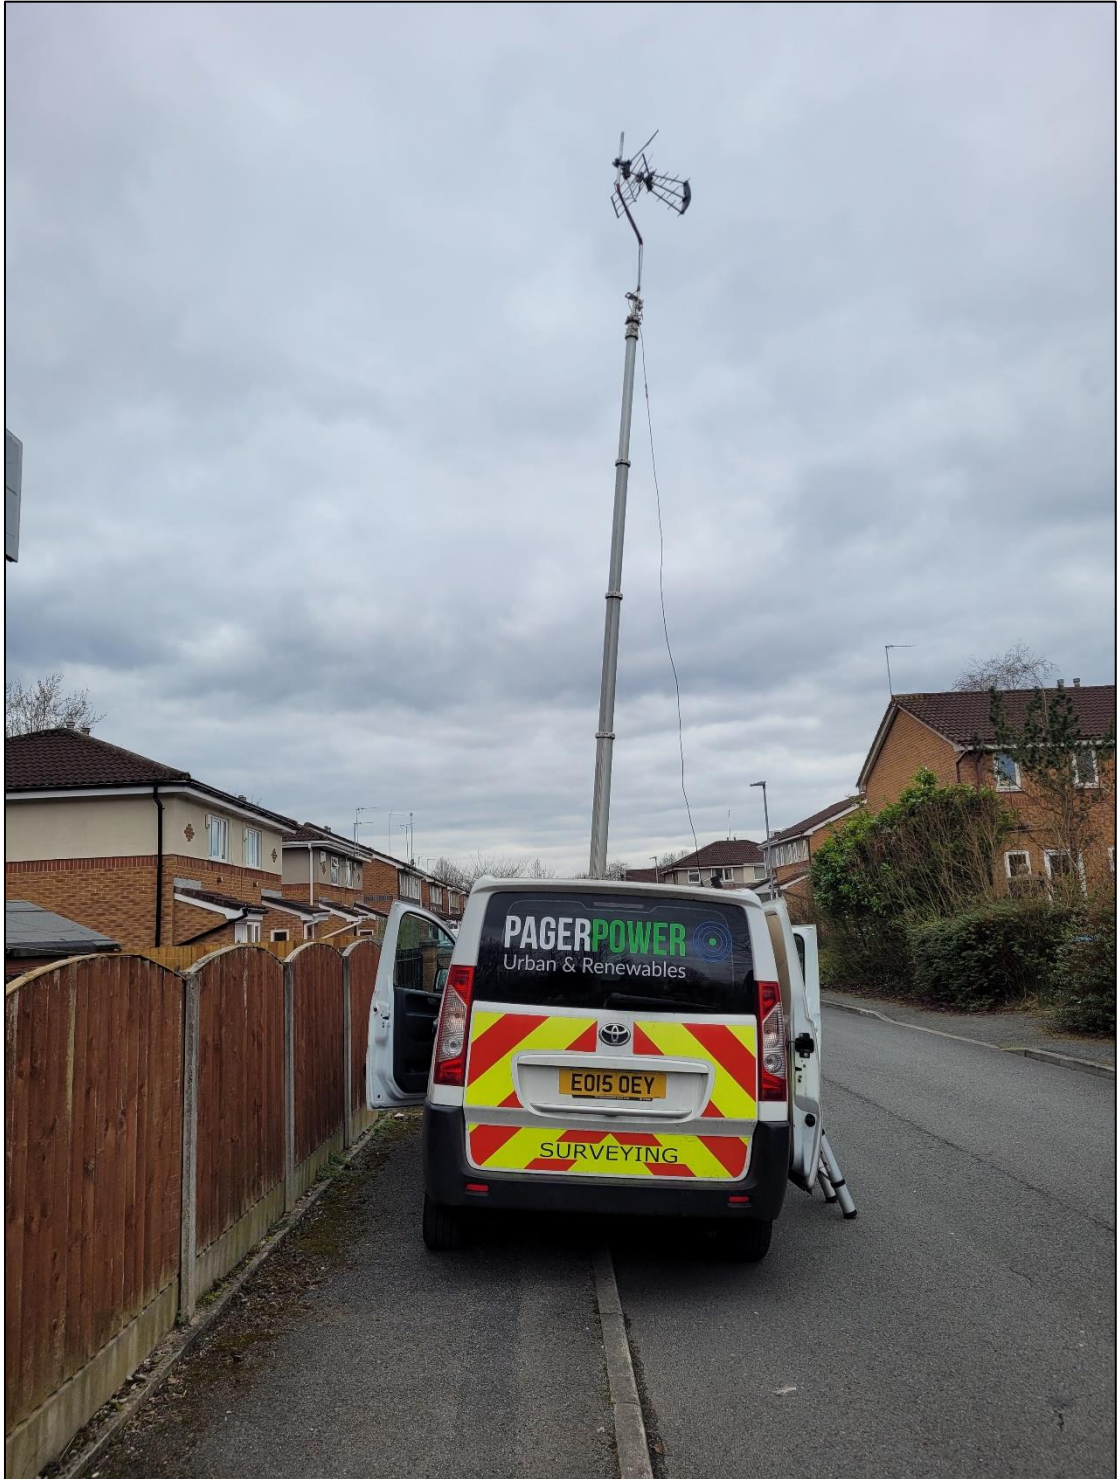
Location 4

| Location | Measured Signal Strength (dB) | Remarks | High-Level Conclusion |
|---|---|---|---|
| 4 | <p>27 – 50</p> <p>The majority of multiplexes overall were of good or very good strength.</p> | <p>Aerials directed towards Winter Hill and satellite dishes were observed.</p> <p>The weakest local channel was not received at this location. All remaining multiplexes displayed fine picture and audio quality, with signal fluctuations of less than 1dB and no signs of interference.</p> | <p>The survey location is within 1 kilometre of the proposed development.</p> <p>A low impact upon signals at this location is possible based on the proximity to the proposed development (within 1 km). The most significant effects are possible for the weaker local channels, but the majority of channels should retain good quality transmission. This could depend on the relative height of the building development and any receiving aerials.</p> |

Notes: Elevated Horizontally Polarised (HP) Ultra High Frequency (UHF) aerials directed towards the Winter Hill transmitter and satellite dishes were observed.

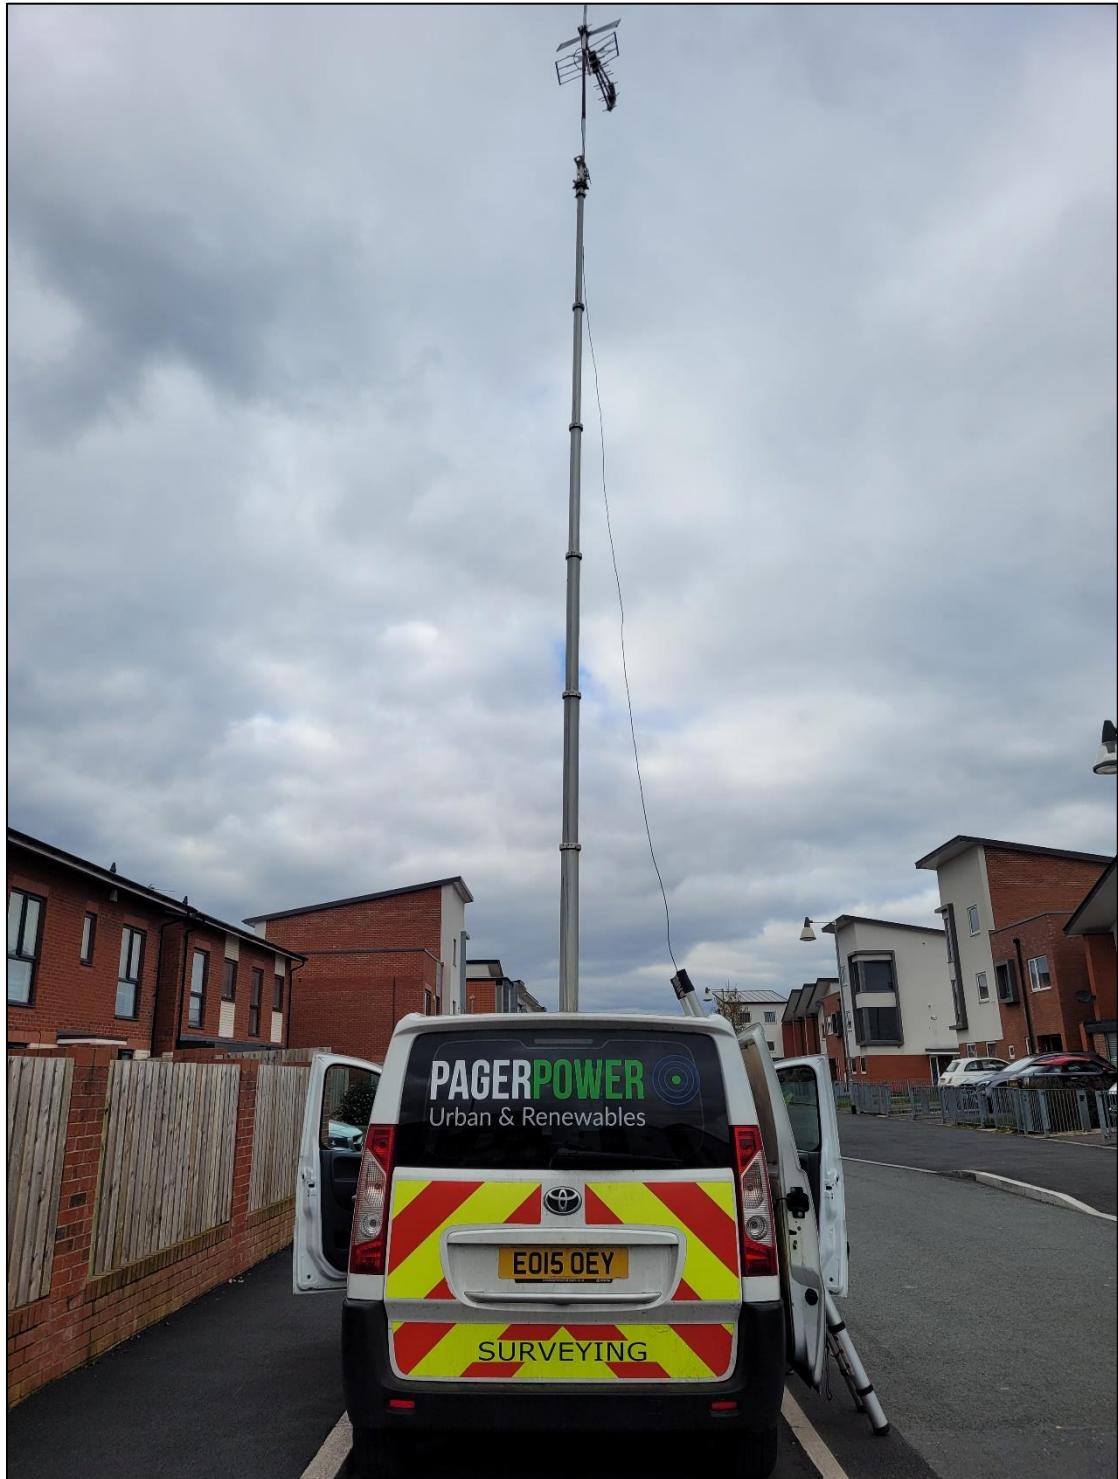
Location 5

| Location | Measured Signal Strength (dB) | Remarks | High-Level Conclusion |
|---|---|---|---|
| 5 | <p>32 – 63</p> <p>The majority of multiplexes overall were of very good strength.</p> | <p>Aerials directed towards Winter Hill and satellite dishes were observed.</p> <p>All multiplexes displayed fine picture and audio quality, with signal fluctuations of less than 1dB and no signs of interference.</p> | <p>The survey location is approximately 1.7 km from the proposed development.</p> <p>A minimal impact upon signals at this location is expected based on the distance to the proposed development. It is unusual for significant signal degradation to manifest itself at ranges of more than 1 km.</p> <p>Significant interference is therefore unlikely, however the possibility cannot be ruled out, particularly for the weakest multiplexes that are currently receivable.</p> |

Notes: Elevated Horizontally Polarised (HP) Ultra High Frequency (UHF) aerials directed towards the Winter Hill transmitter and satellite dishes were observed.

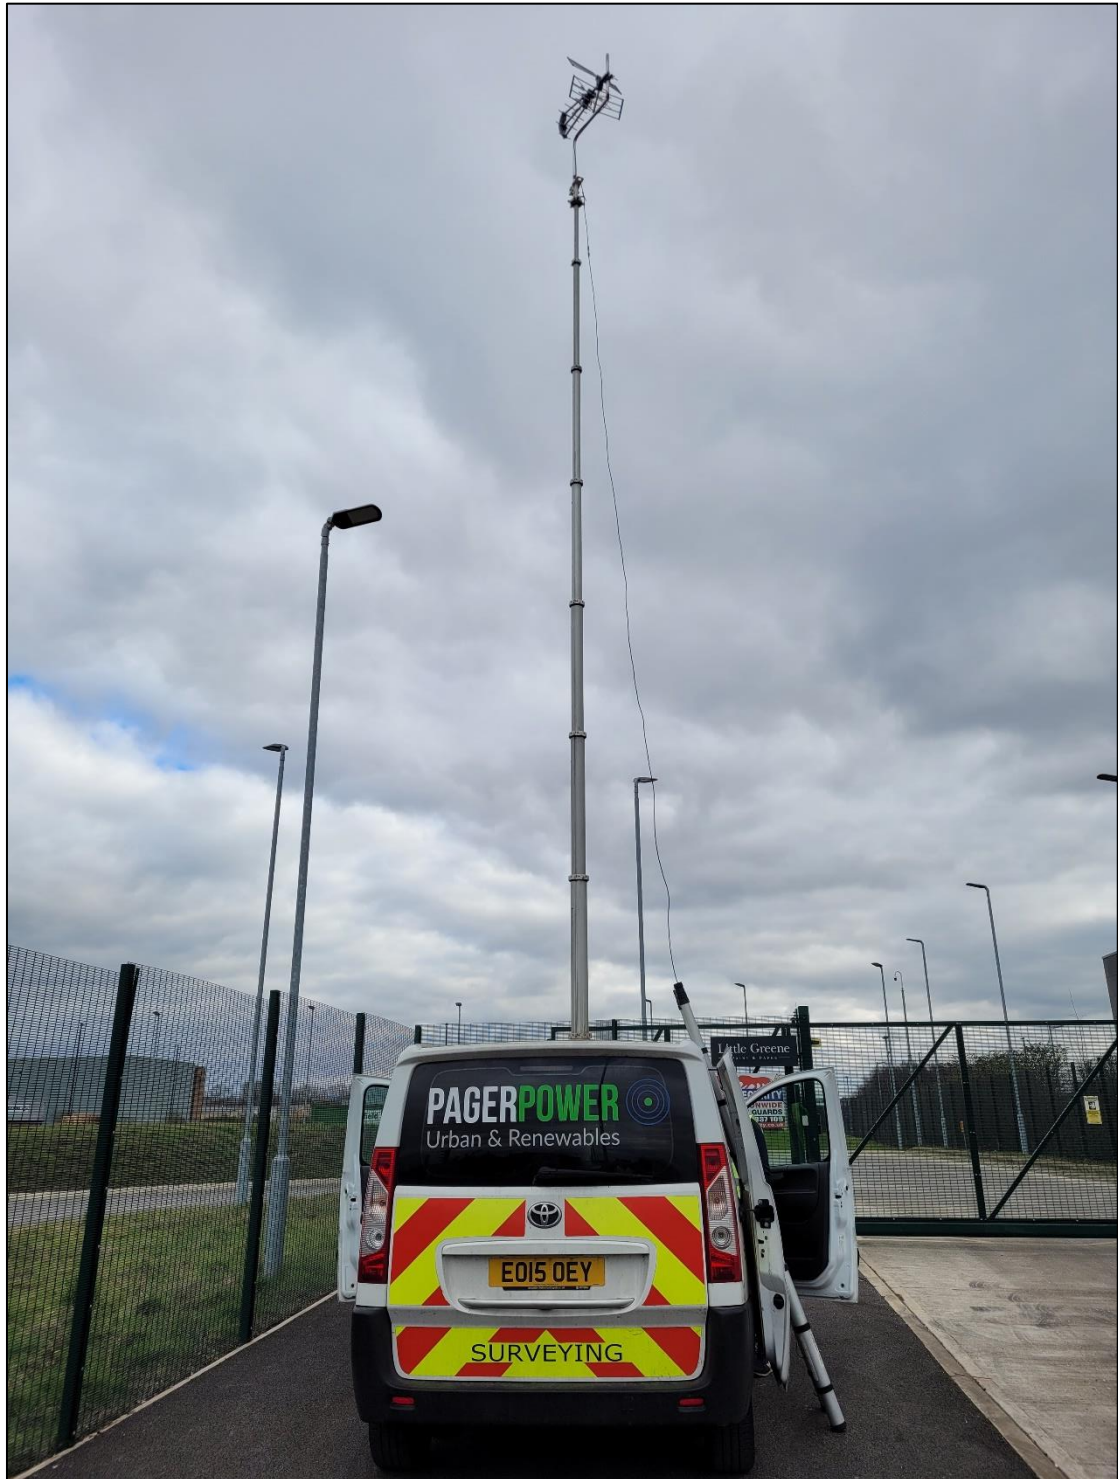
Location 6

| Location | Measured Signal Strength (dB) | Remarks | High-Level Conclusion |
|---|---|---|---|
| 6 | <p>31 – 61</p> <p>The majority of multiplexes overall were of very good strength.</p> | <p>No aerials or satellite dishes were observed.</p> <p>All multiplexes displayed fine picture and audio quality, with signal fluctuations of less than 1dB and no signs of interference.</p> | <p>The survey location is approximately 2.5 km from the proposed development.</p> <p>A minimal impact upon signals at this location is expected based on the distance to the proposed development. It is unusual for significant signal degradation to manifest itself at ranges of more than 1 km.</p> <p>Significant interference is therefore unlikely, however the possibility cannot be ruled out, particularly for the weakest multiplexes that are currently receivable.</p> |

Notes: No aerials or satellite dishes were observed at this location.

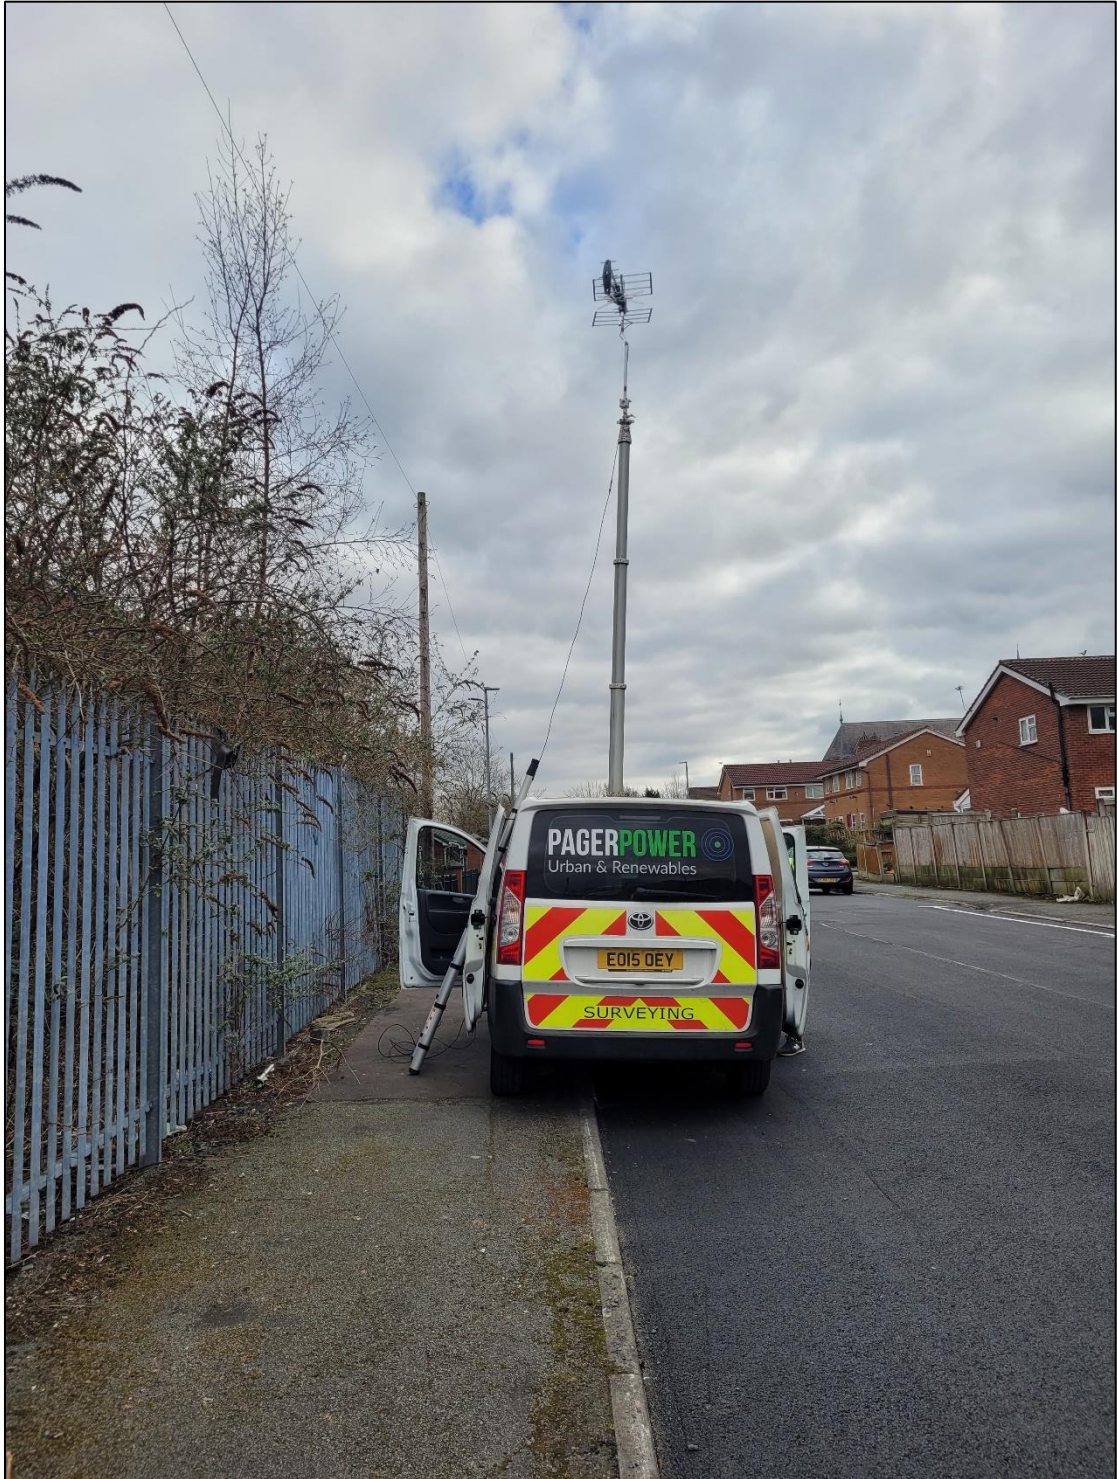
Location 7

| Location | Measured Signal Strength (dB) | Remarks | High-Level Conclusion |
|---|---|---|---|
| 7 | <p>38 – 71</p> <p>The majority of multiplexes overall were of very good strength.</p> | <p>Aerials directed towards Winter Hill and satellite dishes were observed.</p> <p>All multiplexes displayed fine picture and audio quality, with signal fluctuations of less than 1dB and no signs of interference.</p> | <p>The survey location is approximately 3 km from the proposed development.</p> <p>A minimal impact upon signals at this location is expected based on the distance to the proposed development. It is unusual for significant signal degradation to manifest itself at ranges of more than 1 km.</p> <p>Significant interference is therefore unlikely, however the possibility cannot be ruled out, particularly for the weakest multiplexes that are currently receivable.</p> |

Notes: Elevated Horizontally Polarised (HP) Ultra High Frequency (UHF) aerials directed towards the Winter Hill transmitter and satellite dishes were observed.

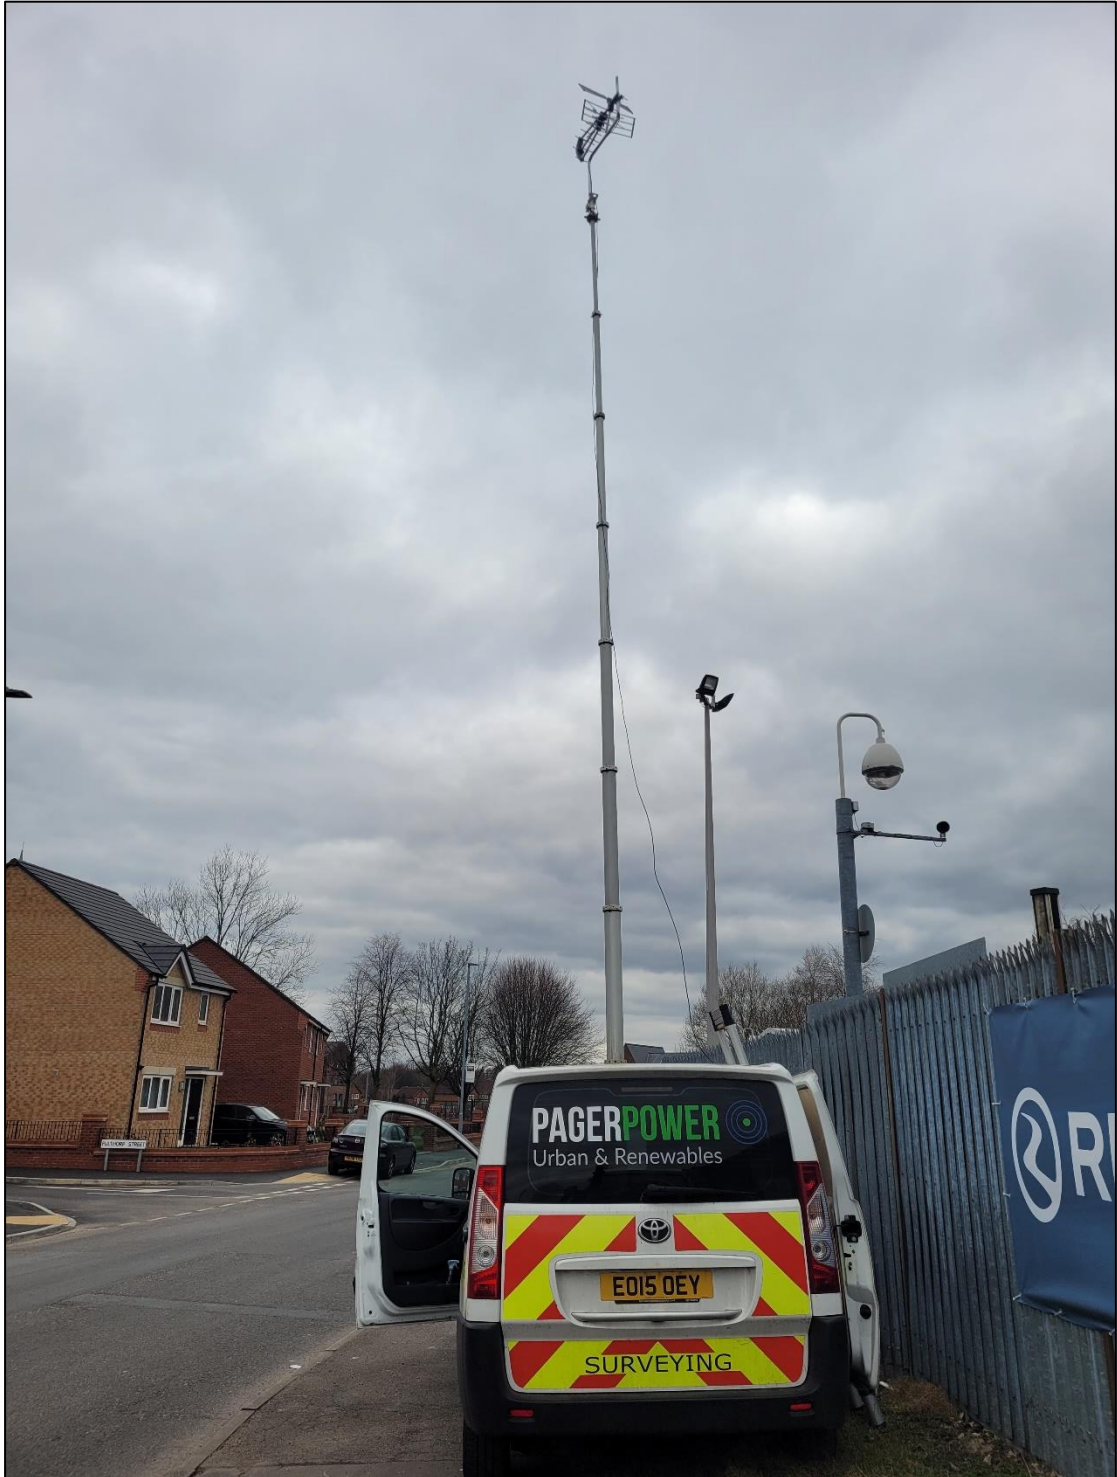
Location 8

| Location | Measured Signal Strength (dB) | Remarks | High-Level Conclusion |
|---|---|---|---|
| 8 | <p>40 – 73</p> <p>The majority of multiplexes overall were of very good strength.</p> | <p>Satellite dishes were observed.</p> <p>All multiplexes displayed fine picture and audio quality, with signal fluctuations of less than 1dB and no signs of interference.</p> | <p>The survey location is approximately 3.5 km from the proposed development.</p> <p>A minimal impact upon signals at this location is expected based on the distance to the proposed development. It is unusual for significant signal degradation to manifest itself at ranges of more than 1 km.</p> <p>Significant interference is therefore unlikely, however the possibility cannot be ruled out, particularly for the weakest multiplexes that are currently receivable.</p> |

Notes: Satellite dishes were observed.

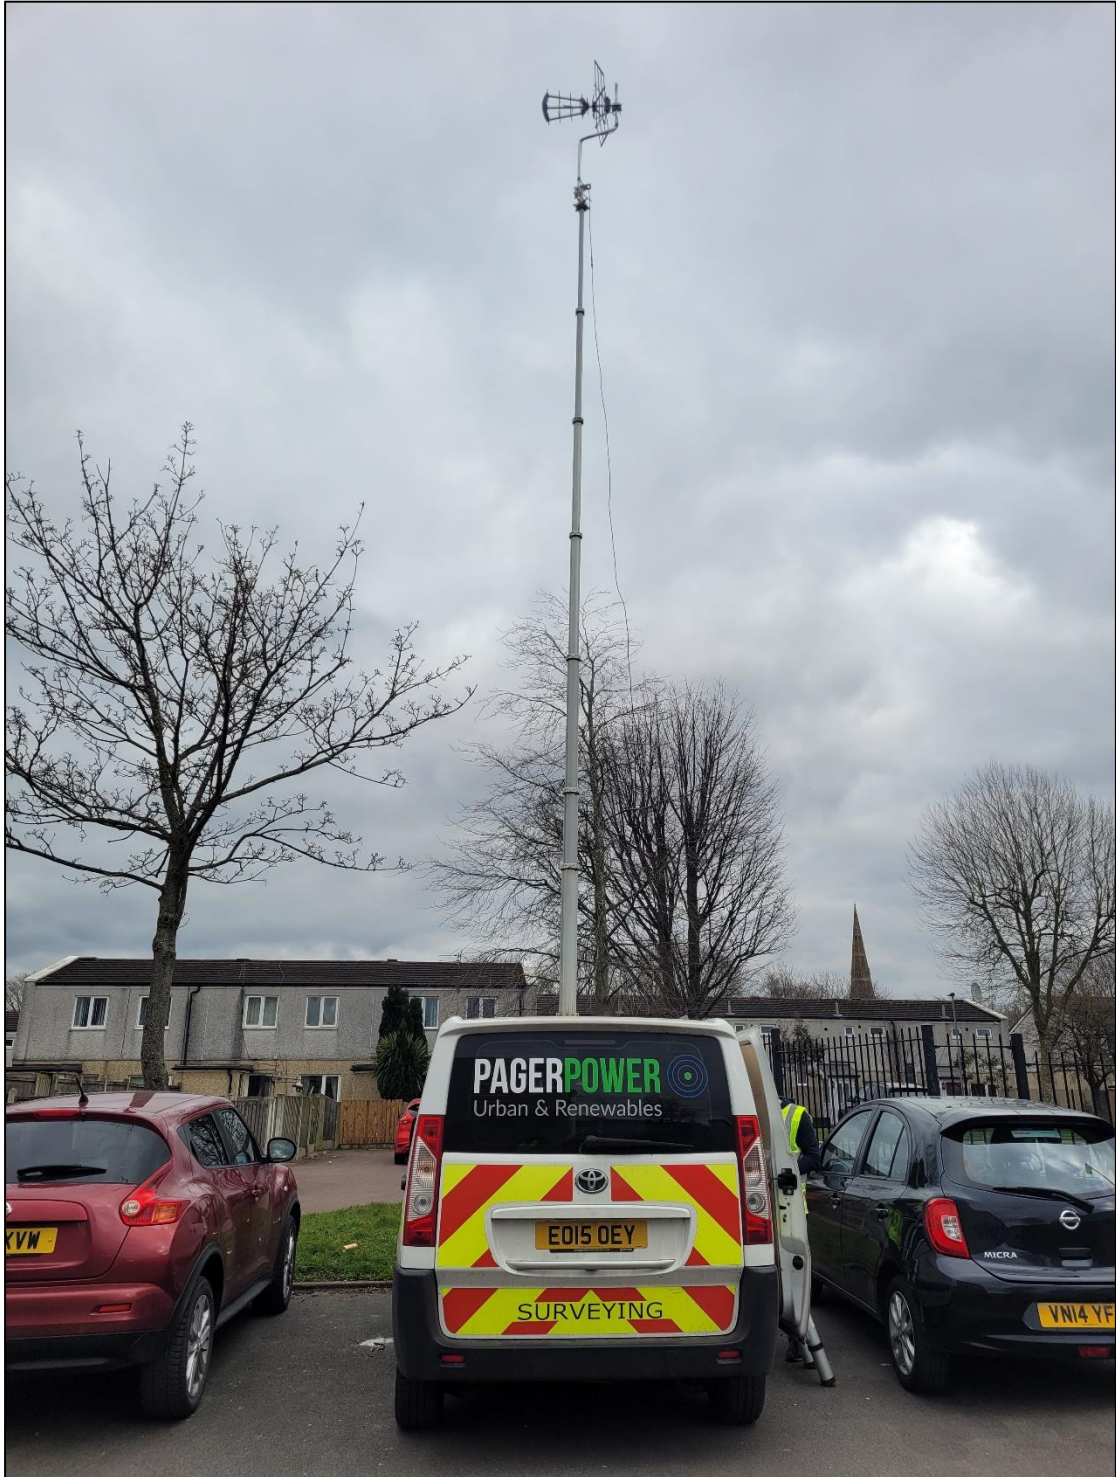
Location 9

| Location | Measured Signal Strength (dB) | Remarks | High-Level Conclusion |
|---|---|---|---|
| 9 | <p>34 – 67</p> <p>The majority of multiplexes overall were of very good strength.</p> | <p>Aerials directed towards Winter Hill and satellite dishes were observed.</p> <p>All multiplexes displayed fine picture and audio quality, with signal fluctuations of less than 1dB and no signs of interference.</p> | <p>The survey location is approximately 4.2 km from the proposed development.</p> <p>A minimal impact upon signals at this location is expected based on the distance to the proposed development. It is unusual for significant signal degradation to manifest itself at ranges of more than 1 km.</p> <p>Significant interference is therefore unlikely, however the possibility cannot be ruled out, particularly for the weakest multiplexes that are currently receivable.</p> |

Notes: Elevated Horizontally Polarised (HP) Ultra High Frequency (UHF) aerials directed towards the Winter Hill transmitter and satellite dishes were observed.

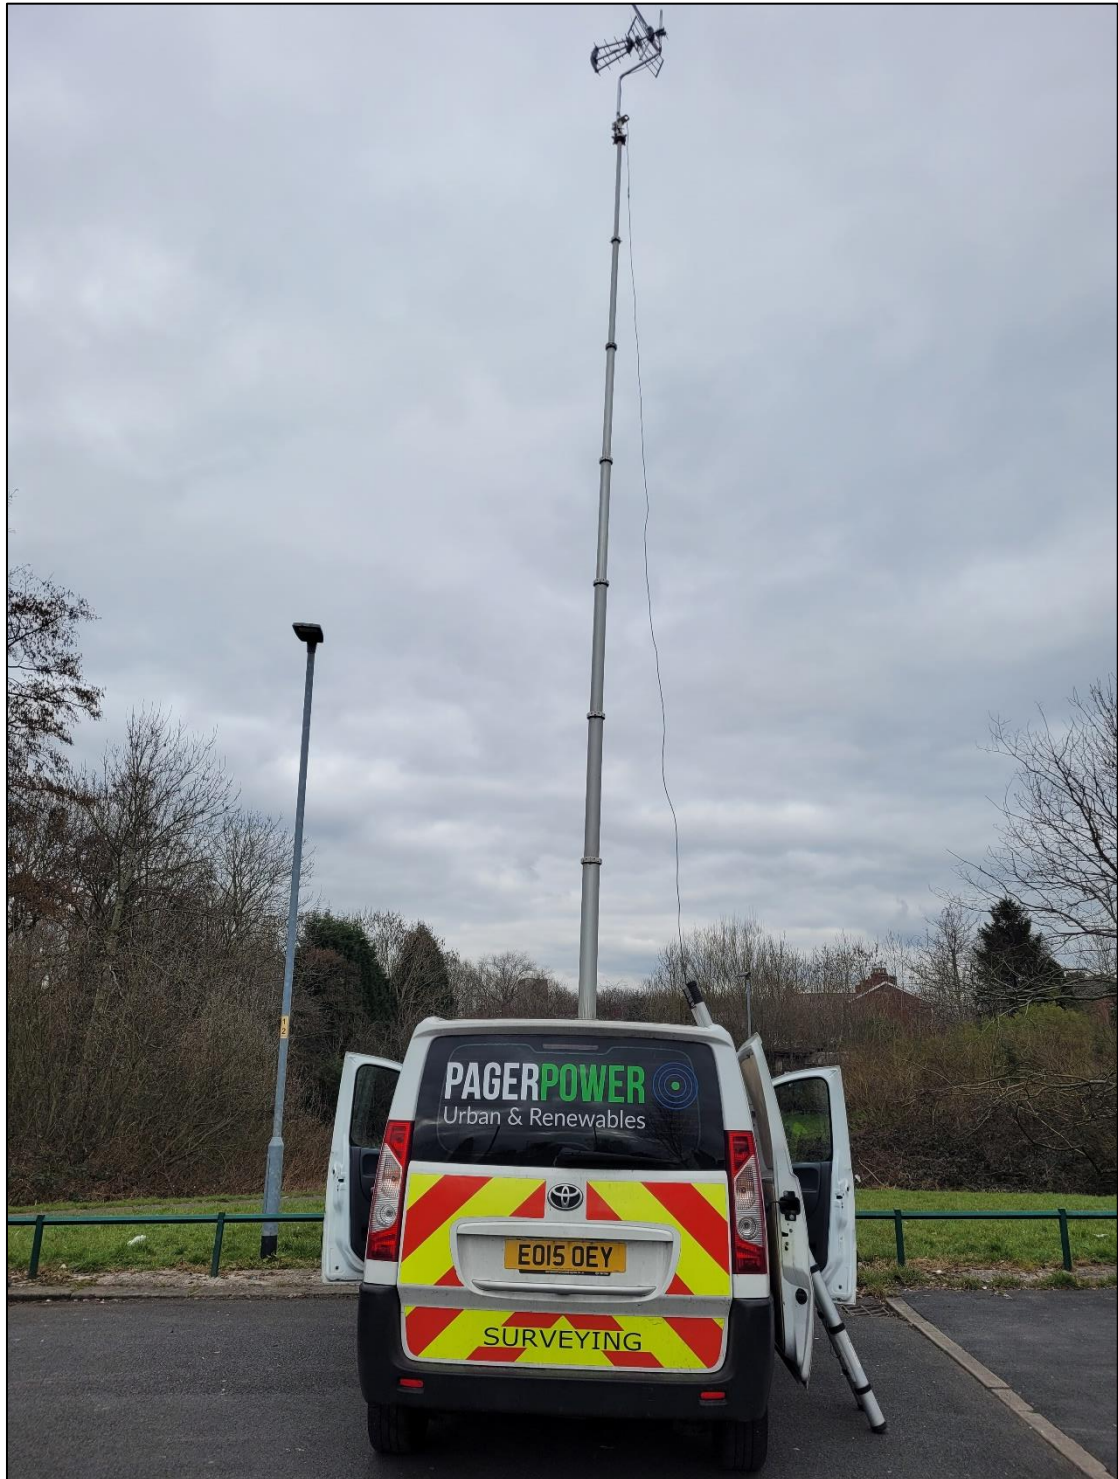
Location 10

| Location | Measured Signal Strength (dB) | Remarks | High-Level Conclusion |
|---|---|---|---|
| 10 | <p>32 – 65</p> <p>The majority of multiplexes overall were of very good strength.</p> | <p>Aerials directed towards Winter Hill and satellite dishes were observed.</p> <p>All multiplexes displayed fine picture and audio quality, with signal fluctuations of less than 1dB and no signs of interference.</p> | <p>The survey location is approximately 5 km from the proposed development.</p> <p>A minimal impact upon signals at this location is expected based on the distance to the proposed development. It is unusual for significant signal degradation to manifest itself at ranges of more than 1 km.</p> <p>Significant interference is therefore unlikely, however the possibility cannot be ruled out, particularly for the weakest multiplexes that are currently receivable.</p> |

Notes: Elevated Horizontally Polarised (HP) Ultra High Frequency (UHF) aerials directed towards the Winter Hill transmitter and satellite dishes were observed.
