**Citylabs 4.0**

## Ground Investigation Report

GEO-REP-002

Issue 2 | 13 April 2022

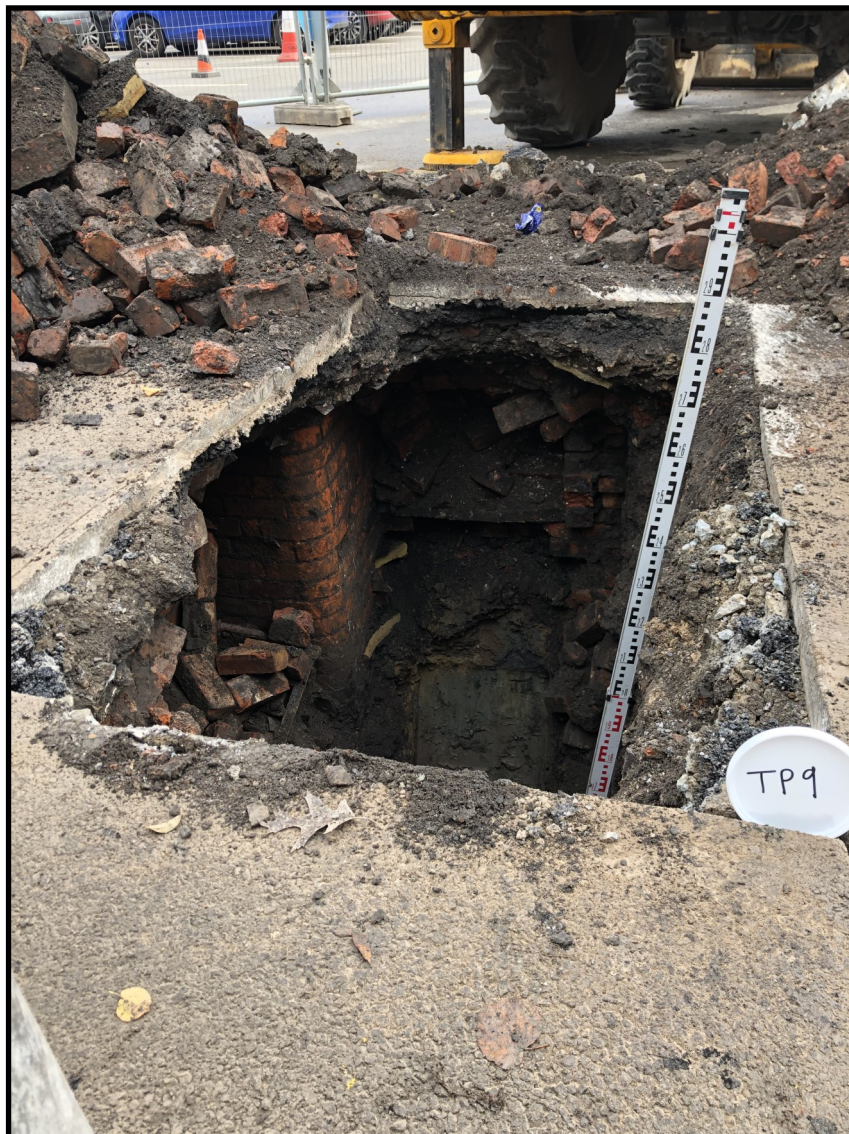
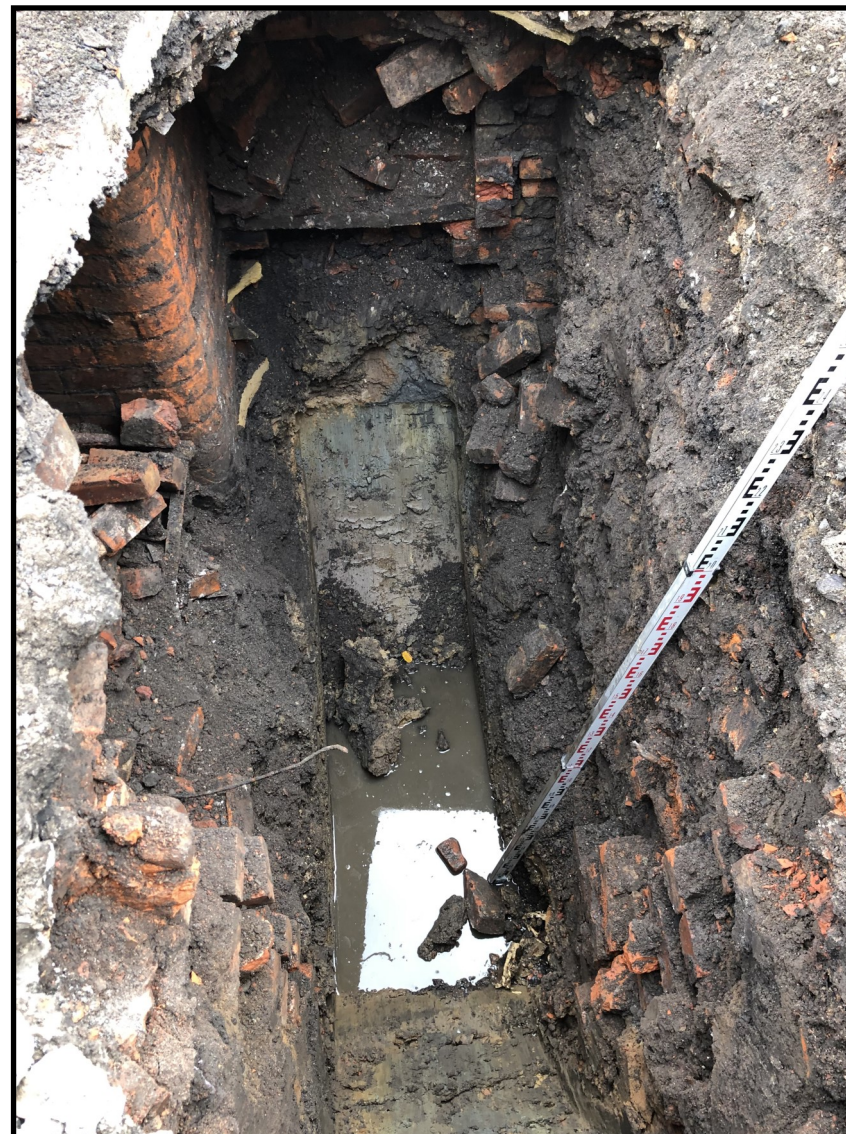
| <b>Dimensions:</b><br><br>Final Depth:    3.00m<br><br> <p style="text-align: center;">Length (m)<br/>2.20m</p> <p style="position: absolute; left: 50px; top: 150px; transform: rotate(-90deg);">Width (m)<br/>0.80m</p> <p style="text-align: center;">Orientation: 90°</p> | <b>General Remarks:</b><br><br>HVP value average (set of 3)<br>Mexe Cone Test at 0.20mbgl = CBR 2-5%<br>Intact Wall and buttress on western elevation of pit. Unstable at northern elevation.<br><br><br><br><br><br><br><br><br><br> |

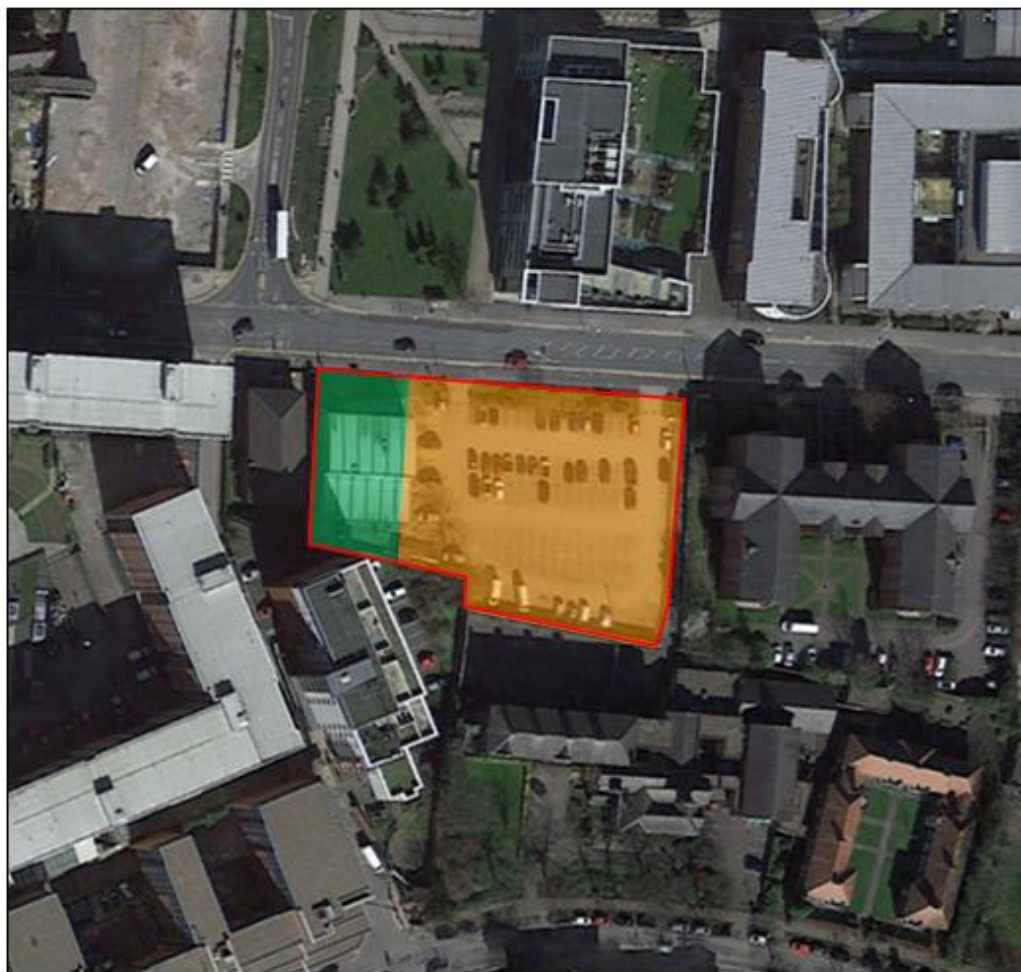
Risk Map

For indicative purposes – not to scale.

Please note that this assessed risk map may not take into account all post-war redevelopment/excavations on site.

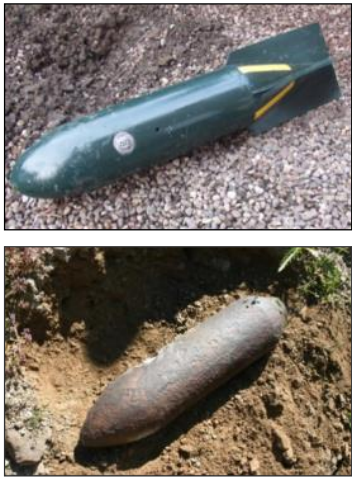
SC 250kg High Explosive Bomb

| Bomb Weight | 245-256kg (540-564lb) |
| Use | Against railway installations, embankments, flyovers, underpasses, large buildings and below-ground installations. |
| Remarks | It could be carried by almost all German bomber aircraft, and was used to notable effect by the Junkers Ju-87 Stuka (Sturzkampfflugzeug or dive-bomber). |

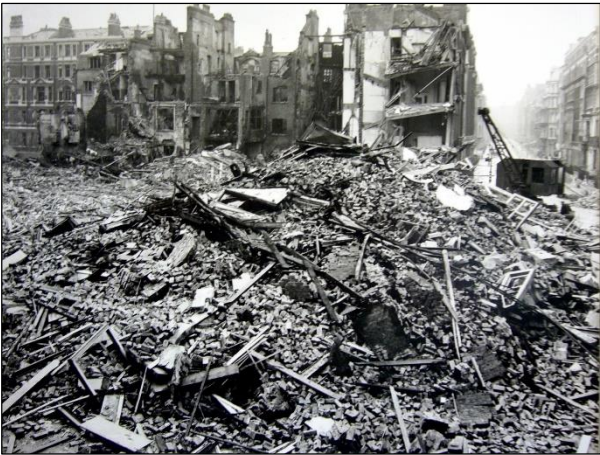
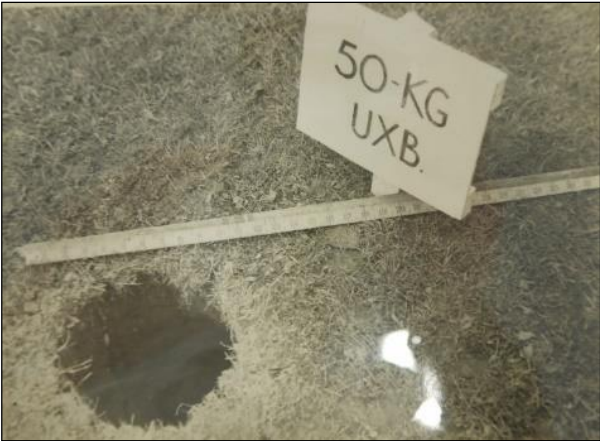
**Top:** J-curve Effect - Due to angle of entry, unexploded bombs would often end their trajectory at a lateral offset from point of entry, often ending up beneath adjacent extant structures/sites. The photograph above shows 250kg bomb found in Bermondsey pointing upwards, demonstrating 'J-curve'

One of the most common scenarios for UXO going unnoticed was when a UXB fell into a 'bomb site' (such as the area shown **Top Left**), the entry hole of the bomb obscured by any debris and rubble present. Note that the entry hole of a 50kg UXB could be as little as 20cm in diameter (**Left**).

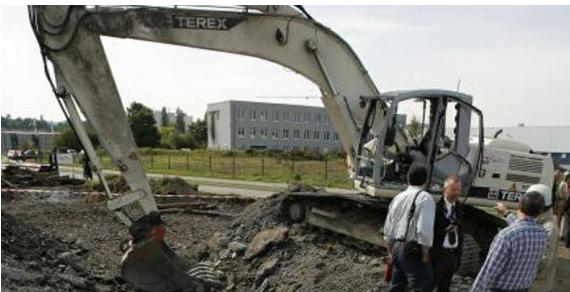
WWII bomb injures 17 at Hattingen construction site

Seventeen people were injured on Friday when a construction crew unwittingly detonated a buried World War II-era bomb in Hattingen.

An excavator apparently drove over a 250-kilogramme (550 pound) American bomb, damaging surrounding buildings. Most of the injured suffered auditory trauma from the blast, and the excavator operator suffered injuries to his hands, police in the German state of North Rhine-Westphalia said.

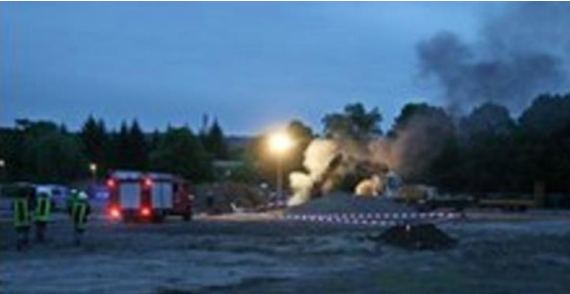
World War II bomb kills three in Germany

A special commission is investigating the causes of the explosion, while prosecutors are considering whether the team leader should face charges of manslaughter through culpable negligence, the BBC's Oana Lungescu reports from Berlin.

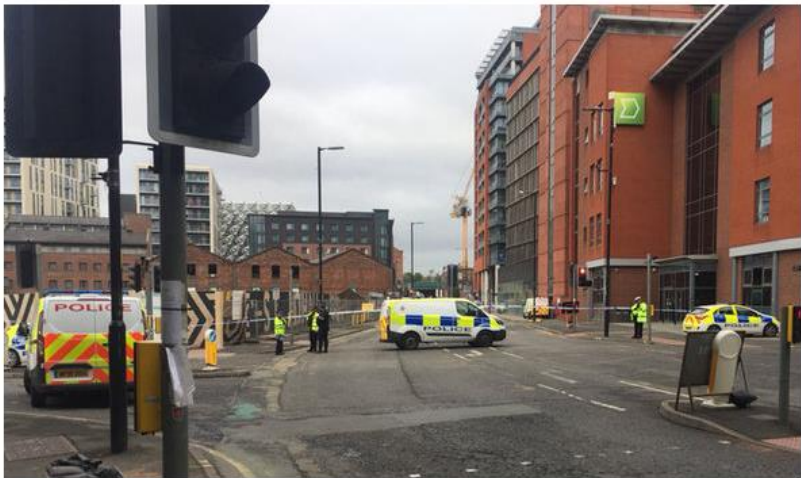
MANCHESTER city centre was in lock down after an “unexploded cartridge” was found on a building site.

A nearby block of flats was evacuated due to the unexploded device.

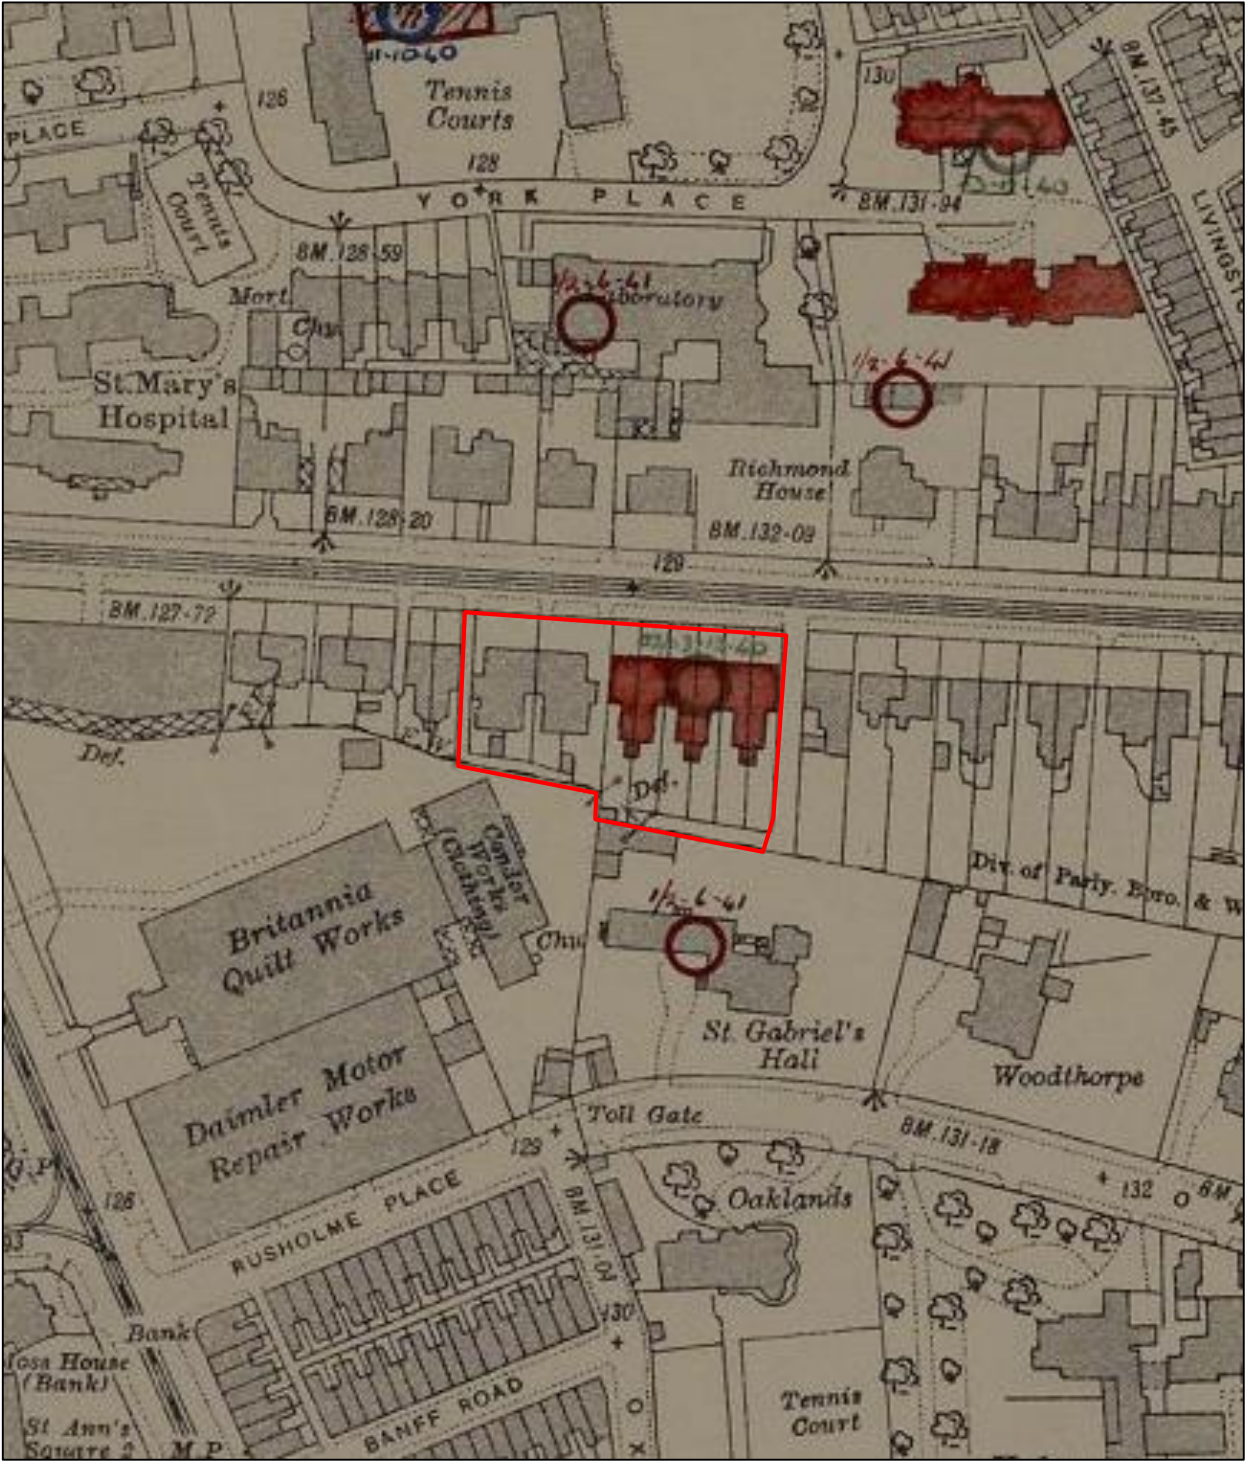
Red circle: fire bomb  
Blue circle: high explosive bomb  
Green: line mine  
Solid red shading: demolished building  
Hatched red shading: partially damaged structure
