## PHASE I GEO-ENVIRONMENTAL SITE ASSESSMENT

Land at Ashton Old Road,  
Manchester,  
M11 2NJ

Report Ref: 22-1146-PI  
Date Issued: April 2022

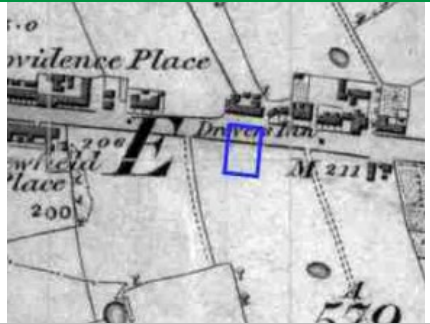
| MAP EDITION | HISTORICAL LAND USE | HISTORICAL MAP EXCERPT |
|---|---|---|
| Pre 1848-<br>Pre 1892 | The site appears to be undeveloped farmland with a road running along the northern boundary. | |

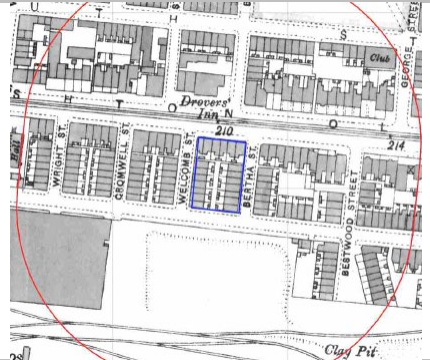
| MAP EDITION | HISTORICAL LAND USE | HISTORICAL MAP EXCERPT |
|---|---|---|
| Pre 1892-<br>Pre 1967 | The site is shown to be occupied by 3no. terraced streets comprising c.20no. properties with associated yards and access streets. | |

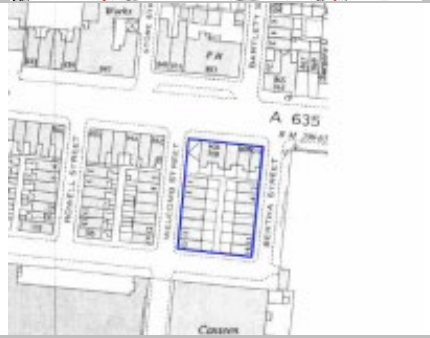
| MAP EDITION | HISTORICAL LAND USE | HISTORICAL MAP EXCERPT |
|---|---|---|
| Pre 1967-<br>Pre 1981 | 1no. property in the north west of the site has been demolished. The remainder of the site remains unchanged. | |

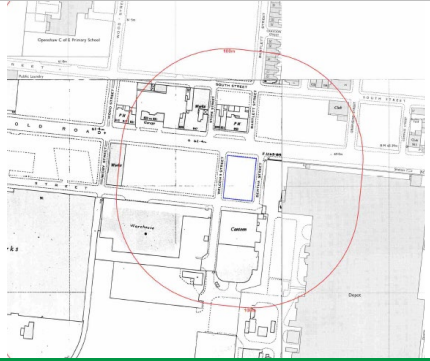
| MAP EDITION | HISTORICAL LAND USE | HISTORICAL MAP EXCERPT |
|---|---|---|
| Pre 1981-<br>Present | The terraced properties are no longer recorded onsite.<br>The site remains unchanged to date. | |

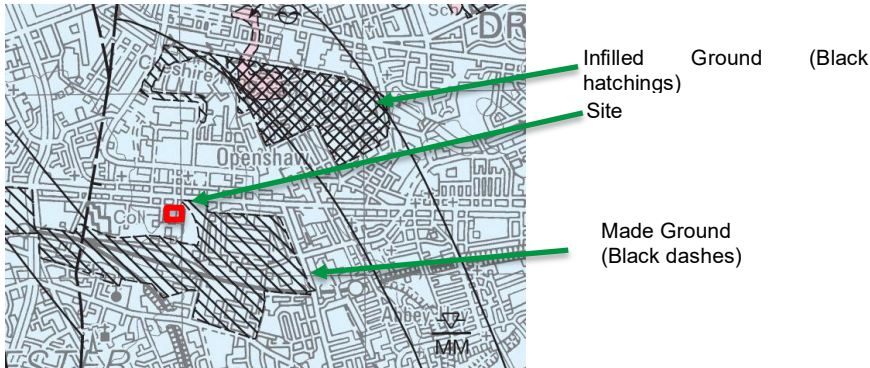
| SOURCES OF INFORMATION | SUMMARY |
|---|---|
| British Geological Survey Mapping | <p>The 1:10,000 geological mapping for the area notes Made ground is present to the east and south of the site with a significant area of infilled ground c.500m north of the site.</p> <p>An unnamed inferred normal fault is indicated c. 475m west of the site dipping to the east.</p> <p>No evidence of mining features are noted onsite or within the vicinity of the site.</p> |

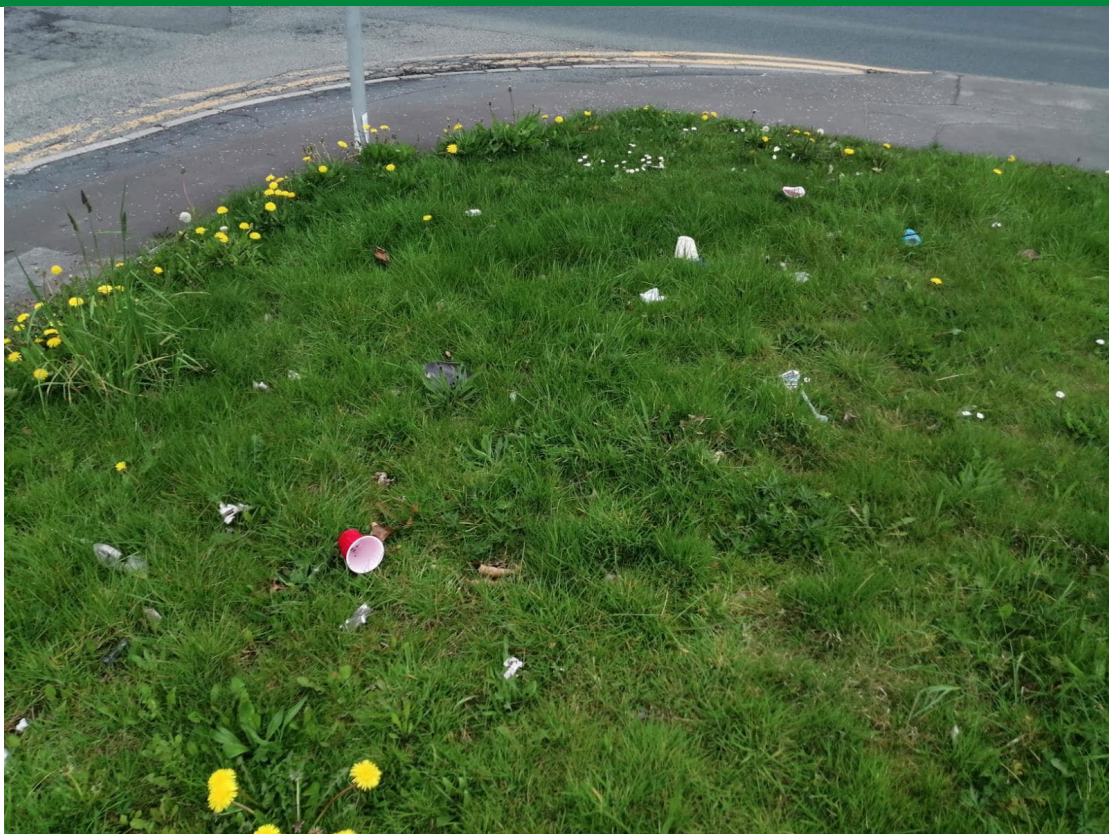
**PLATE 4 – EVIDENCE OF LITTERING ON SITE**

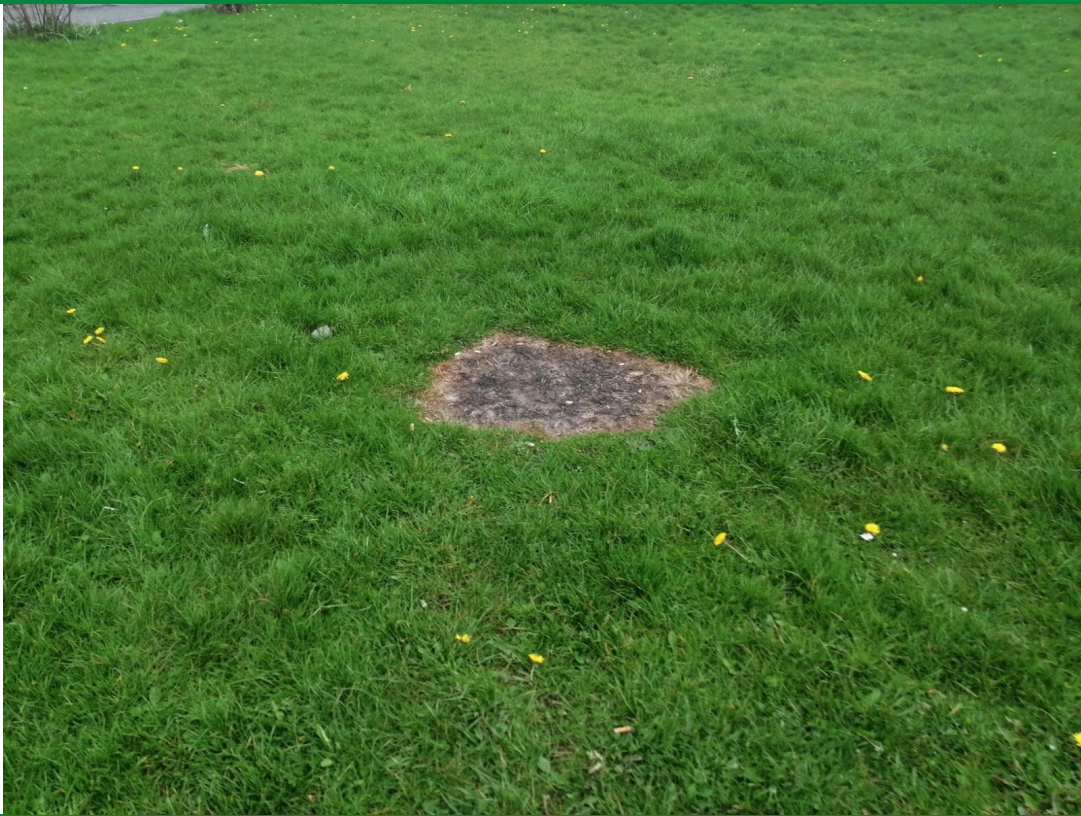
**PLATE 5 – EVIDENCE OF SMALL FIRE ON SITE**

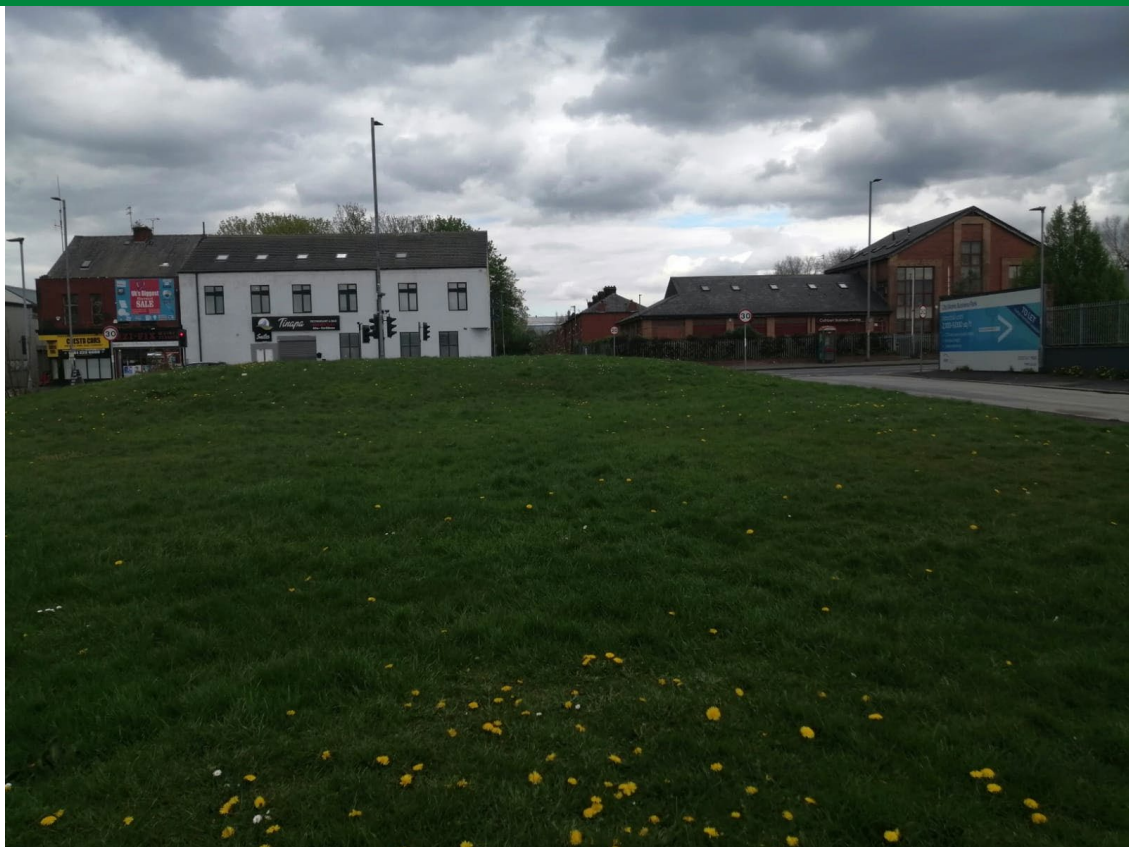
| <b>Slope</b> | The site is relatively flat though a c.1-2m raised bunded area is noted in the northern site area. | |

**PLATE 6 – VIEW OF SITE LOOKING NORTH, NOTE BUND AT NORTHERN BOUNDARY**
