# Television Baseline Survey Report

Faithful+Gould

Silk Street

May, 2019

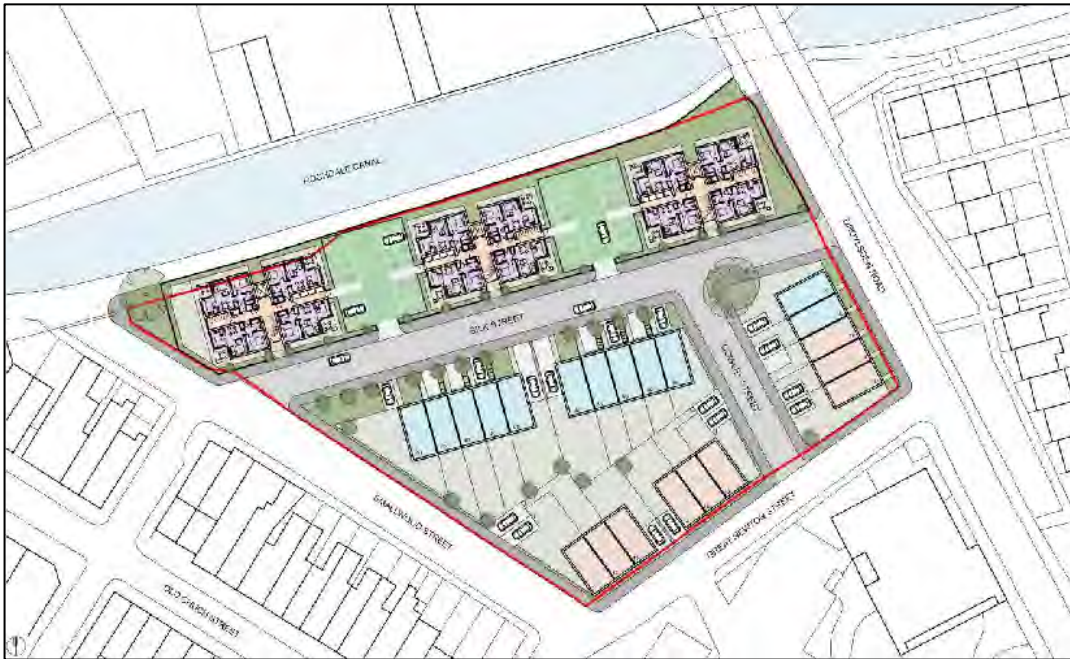
Figure 1 Proposed development site

The available plans show the apartment blocks will reach four storeys. Figure 1 below<sup>1</sup> shows the development site.

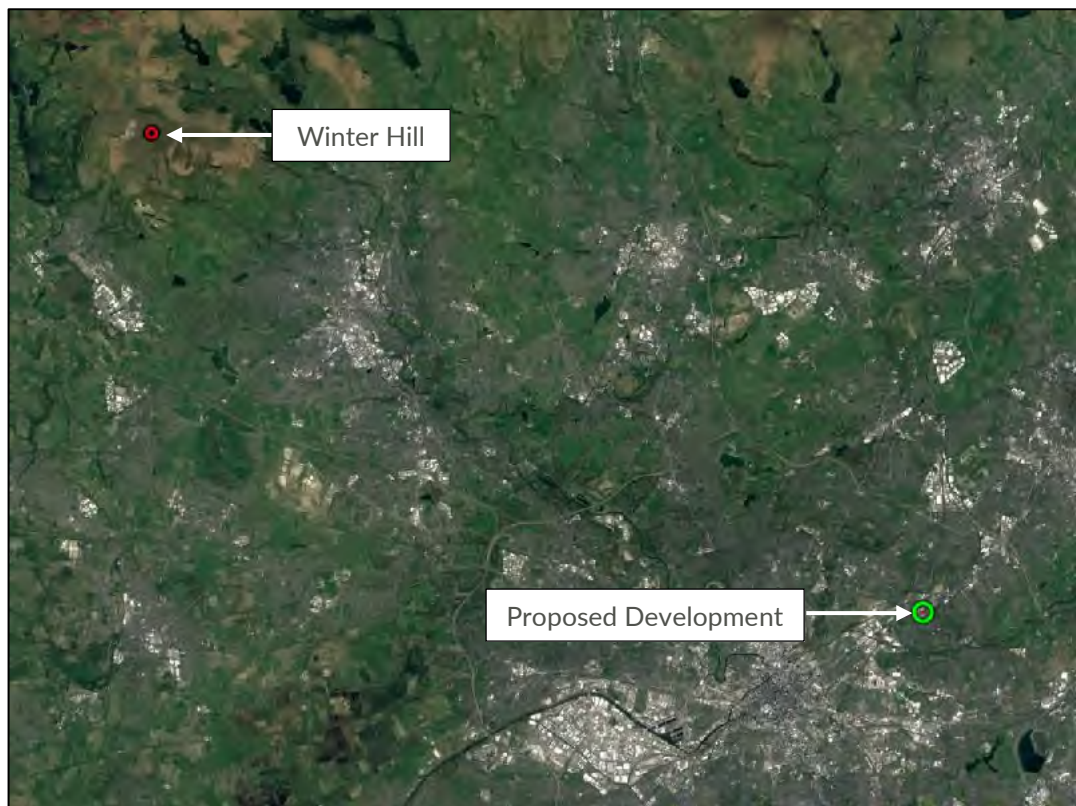
Figure 2 *Television transmitter and proposed development relative location*

Winter Hill is one of the UK's main television transmitters located approximately 26 km northwest of the proposed development (published coordinates SD66051446). The main digital services provided are shown in Table 1 below.

Figure 2 below<sup>3</sup> shows the relative location of the transmitter and the proposed development.

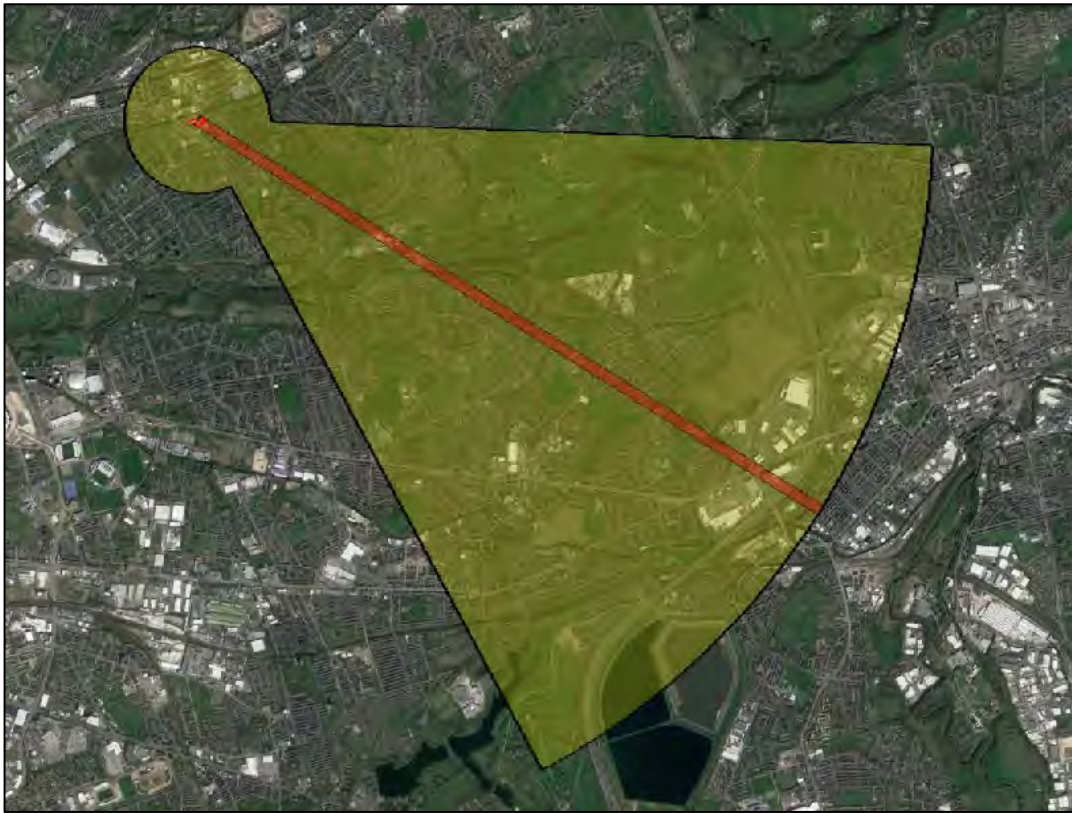
Figure 6 Interference zones map

Figure 6 below<sup>7</sup> shows the interference zones overlaid onto an aerial image of the area.

It can be seen that the shadow zone passes over urban areas that containing dwellings. Areas closest to the proposed development at the highest risk of experiencing television interference.

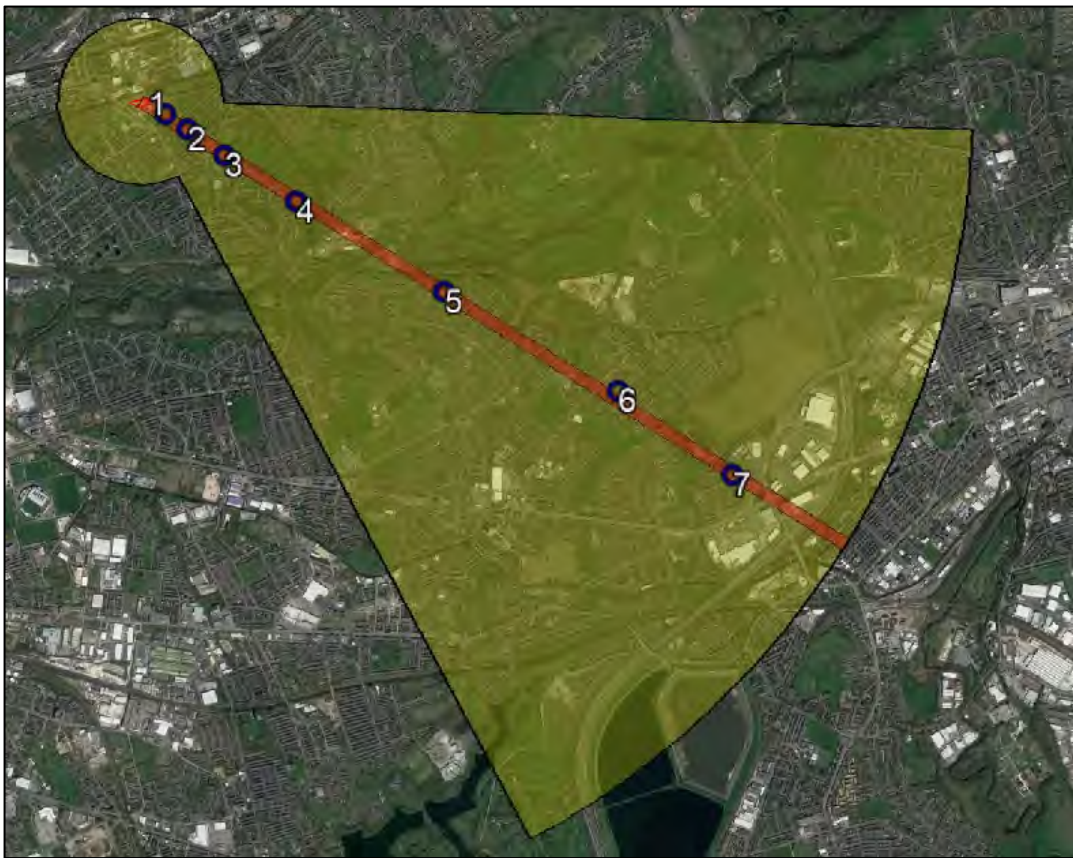
Figure 7 Survey locations

Figure 7 below<sup>8</sup> shows the survey locations overlaid onto aerial photography. The proposed development location and the shadow zone are also shown. Survey locations were chosen pre-survey (within the shadow zone) however safe and available access influenced the specific position on the day. The locations below show the actual survey locations. The locations are deliberately closer together in the proposed development's immediate vicinity. This is because interference is generally more likely the closer the location is to the obstruction.

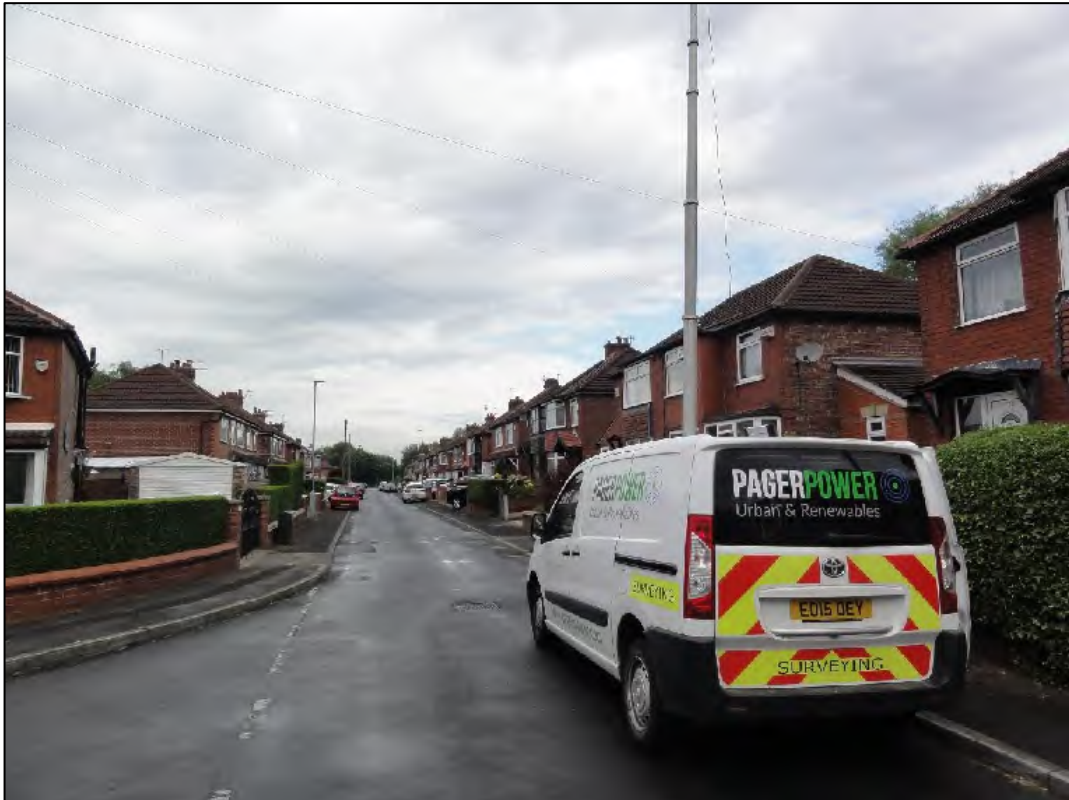
### Location 7

| Location | Average Measured Signal Strength (dB) | Remarks | High Level Conclusion |
|---|---|---|---|
| 7 | <p>Main TV MUX:<br/>59 (Very Good)</p> <p>Local TV MUX:<br/>53 (Good)</p> | <p>Aerials directed towards the Winter Hill transmitter were observed at this location, along with many satellite dishes.</p> <p>All multiplexes displayed fine picture and audio quality, with signal fluctuations of less than 0.5dB and no signs of interference.</p> | <p>It is highly unlikely that noticeable losses would occur at this range.</p> <p>No interference is predicted.</p> |

Notes: Located in the outer city suburbs. HP aerials orientated towards Winter Hill were observed. Many satellite dishes were observed.

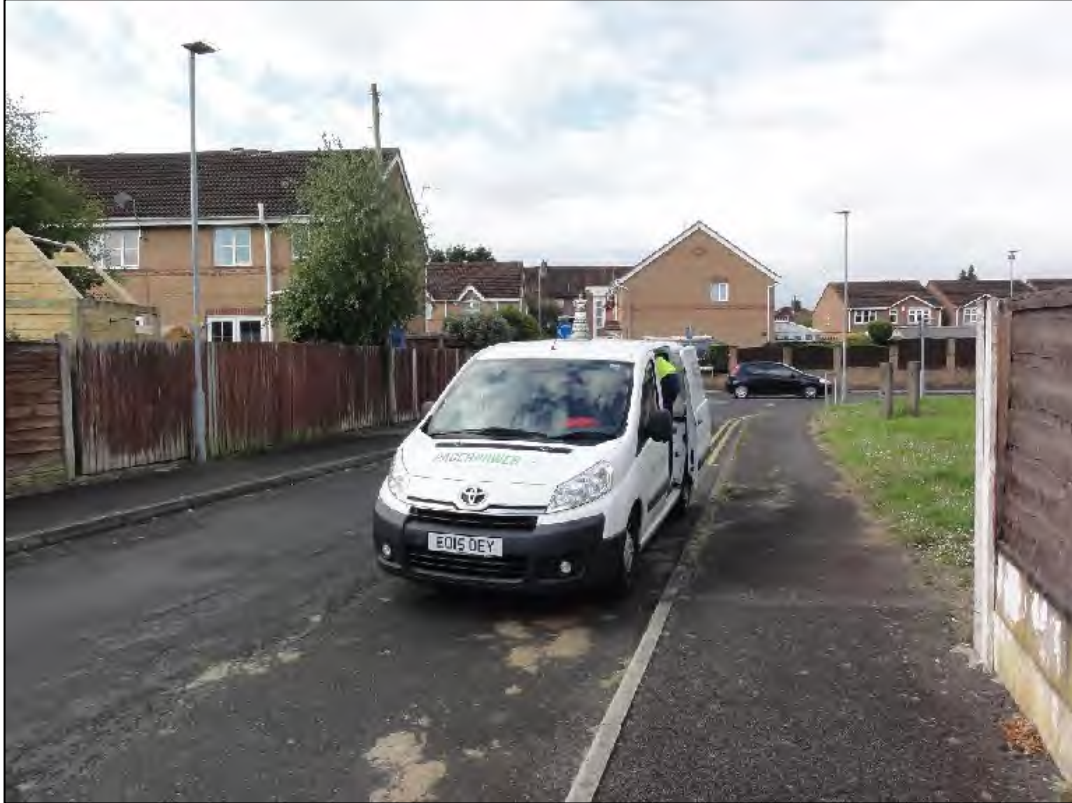
Location 6

| Location | Average Measured Signal Strength (dB) | Remarks | High Level Conclusion |
|---|---|---|---|
| 6 | <p>Main TV MUX: 66 (Very Good)</p> <p>Local TV MUX: 59 (Very Good)</p> | <p>Aerials directed towards the Winter Hill transmitter were observed at this location, along with some satellite dishes.</p> <p>All multiplexes displayed fine picture and audio quality, with signal fluctuations of less than 0.5dB and no signs of interference.</p> | <p>It is highly unlikely that noticeable losses would occur at this range.</p> <p>No interference is predicted.</p> |

Notes: Located in the outer city suburbs. HP aerials orientated towards Winter Hill were observed. Satellite dishes were observed.

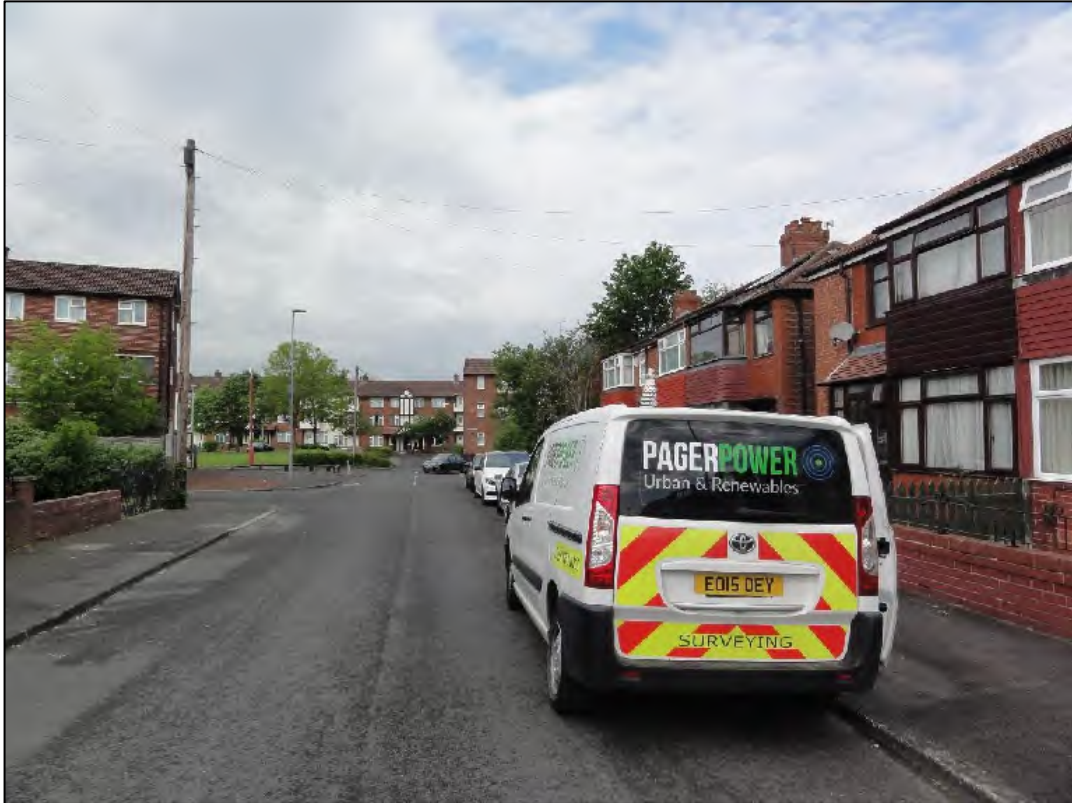
Location 5

| Location | Average Measured Signal Strength (dB) | Remarks | High Level Conclusion |
|---|---|---|---|
| 5 | <p>Main TV MUX: 65 (Very Good)</p> <p>Local TV MUX: 59 (Very Good)</p> | <p>Aerials directed towards the Winter Hill transmitter were observed at this location, along with some satellite dishes.</p> <p>All multiplexes displayed fine picture and audio quality, with signal fluctuations of less than 0.5dB and no signs of interference.</p> | <p>It is highly unlikely that noticeable losses would occur at this range.</p> <p>No interference is predicted.</p> |

Notes: Located in the outer city suburbs. HP aerials orientated towards Winter Hill were observed. Satellite dishes were observed.

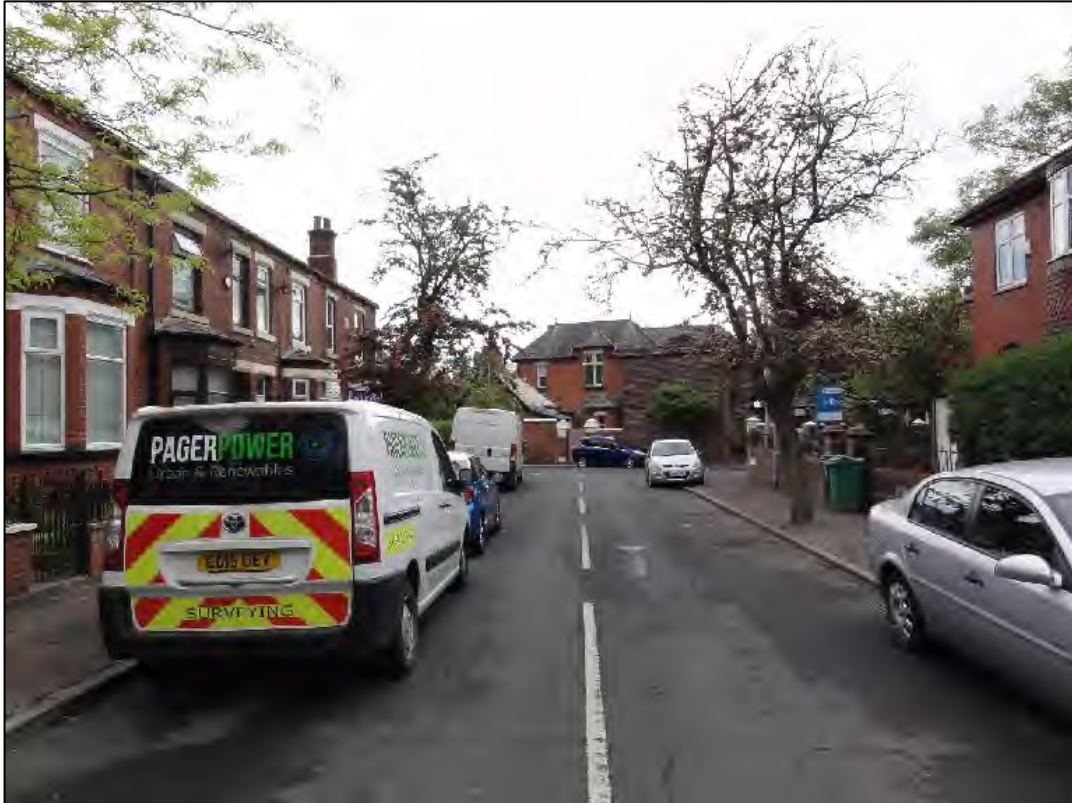
Location 4

| Location | Average Measured Signal Strength (dB) | Remarks | High Level Conclusion |
|---|---|---|---|
| 4 | <p>Main TV MUX: 57 (Very Good)</p> <p>Local TV MUX: 49 (Good)</p> | <p>Aerials directed towards the Winter Hill transmitter were observed at this location, along with many satellite dishes.</p> <p>All multiplexes displayed fine picture and audio quality, with signal fluctuations of less than 0.5dB and no signs of interference.</p> | <p>This location is approximately 1 km from the proposed development. Based on the scale of the proposed development and the quality of the existing signal, noticeable impacts are unlikely in practice.</p> <p>Interference is unlikely.</p> |

Notes: Located in the outer city suburbs. HP aerials orientated towards Winter Hill were observed. Many satellite dishes were observed:

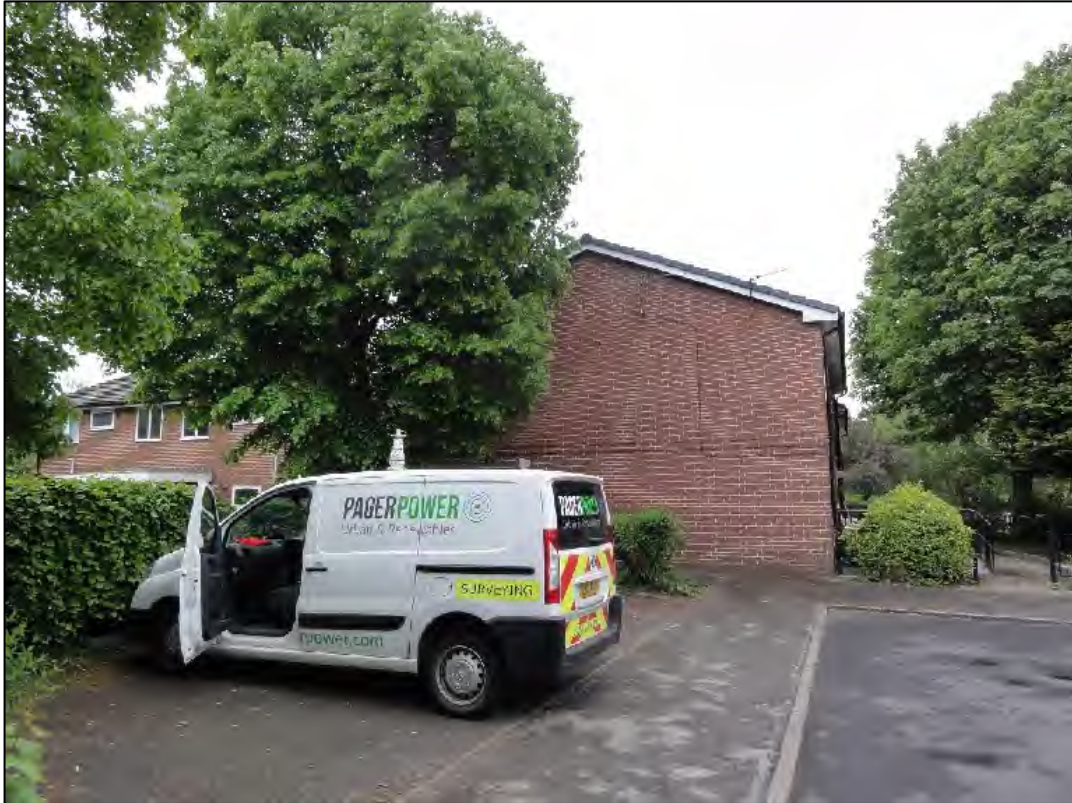
Location 3

| Location | Average Measured Signal Strength (dB) | Remarks | High Level Conclusion |
|---|---|---|---|
| 3 | <p>Main TV MUX: 63 (Very Good)</p> <p>Local TV MUX: 57 (Very Good)</p> | <p>Aerials directed towards the Winter Hill transmitter were observed at this location, along with some satellite dishes.</p> <p>All multiplexes displayed fine picture and audio quality, with signal fluctuations of less than 0.5dB and no signs of interference.</p> | <p>This location is approximately 500 metres from the proposed development. Based on the scale of the proposed development and the quality of the existing signal, noticeable impacts are unlikely in practice.</p> <p>Interference is unlikely.</p> |

Notes: Located in the outer city suburbs. HP aerials orientated towards Winter Hill were observed. Satellite dishes were observed.

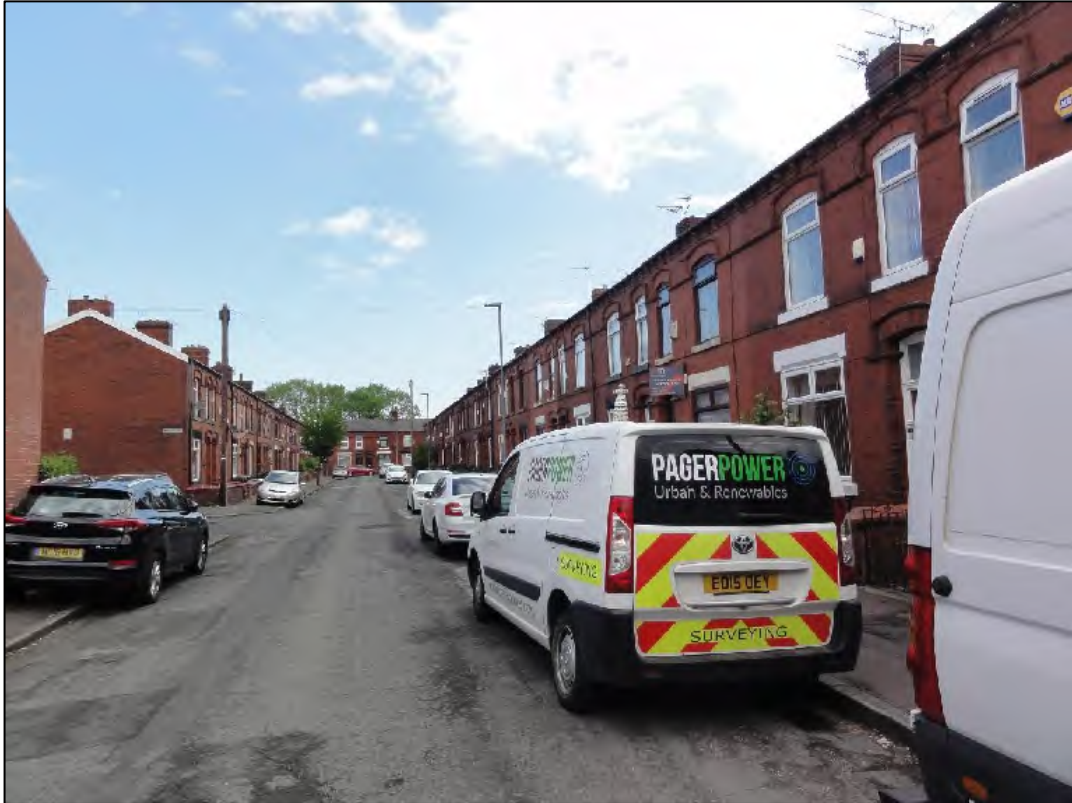
Location 2

| Location | Average Measured Signal Strength (dB) | Remarks | High Level Conclusion |
|---|---|---|---|
| 2 | Main TV MUX:<br>67 (Very Good)<br><br>Local TV MUX:<br>59 (Very Good) | Aerials directed towards the Winter Hill transmitter were observed at this location, along with many satellite dishes.<br><br>All multiplexes displayed fine picture and audio quality, with signal fluctuations of less than 0.5dB and no signs of interference. | This location is approximately 300 metres from the proposed development. It is probable that the signal will be partially weakened by the proposed development. It is possible that the losses would not be noticeable in practice due to the current signal strength, however interference at this range cannot be ruled out.<br><br>Interference is possible. |

Notes: Located in the outer city suburbs. HP aerials orientated towards Winter Hill were observed. Many satellite dishes were observed.

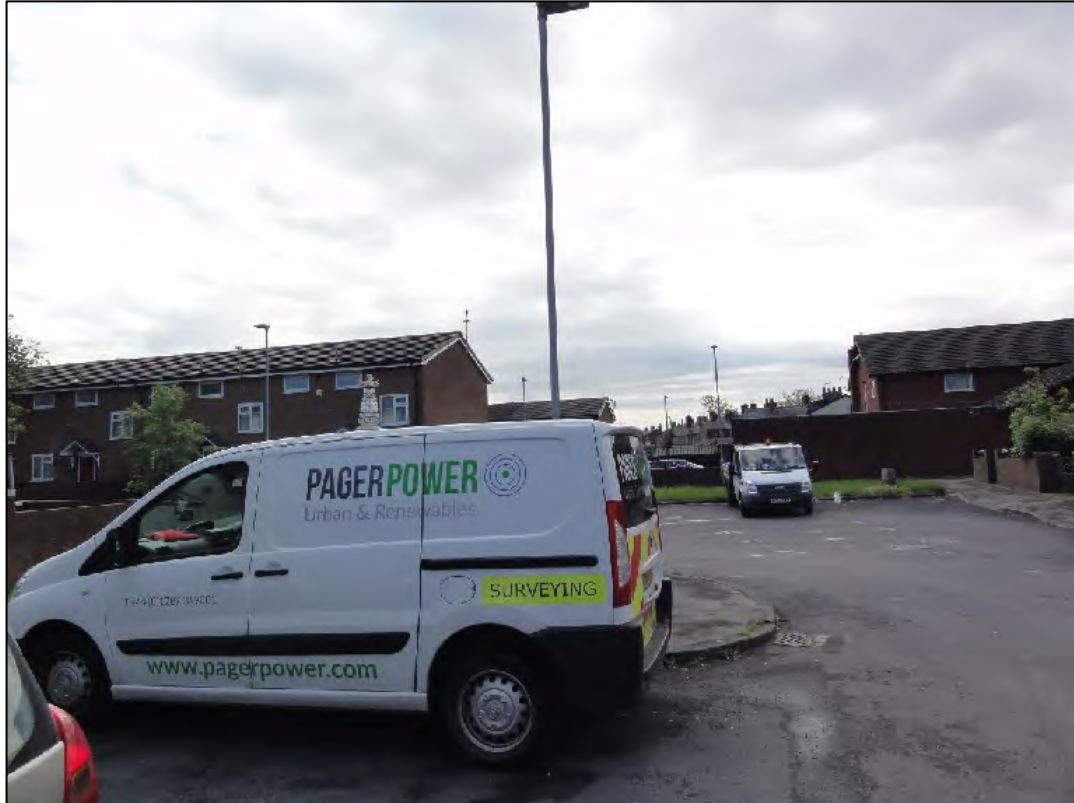
## Location 1

| Location | Average Measured Signal Strength (dB) | Remarks | High Level Conclusion |
|---|---|---|---|
| 1 | Main TV MUX:<br>61 (Very Good)<br><br>Local TV MUX:<br>52 (Good) | Aerials directed towards the Winter Hill transmitter were observed at this location, along with many satellite dishes.<br><br>All multiplexes displayed fine picture and audio quality, with signal fluctuations of less than 0.5dB and no signs of interference. | This location is within 150 metres of the proposed development. It is likely that the signal will be partially weakened by the proposed development. It is possible that the losses would not be noticeable in practice due to the current signal strength, however interference at this range cannot be ruled out.<br><br>Interference is possible. |

Notes: Located in the outer city suburbs. Horizontally polarised (HP) aerials orientated towards Winter Hill were observed. Many satellite dishes observed.
