## PHASE I AND PHASE II GEO-ENVIRONMENTAL SITE ASSESSMENT

**Blackley Mere  
Blackley  
Manchester  
M8 4LL**

Report Ref: 11-164-R1  
Date Issued: October 2016

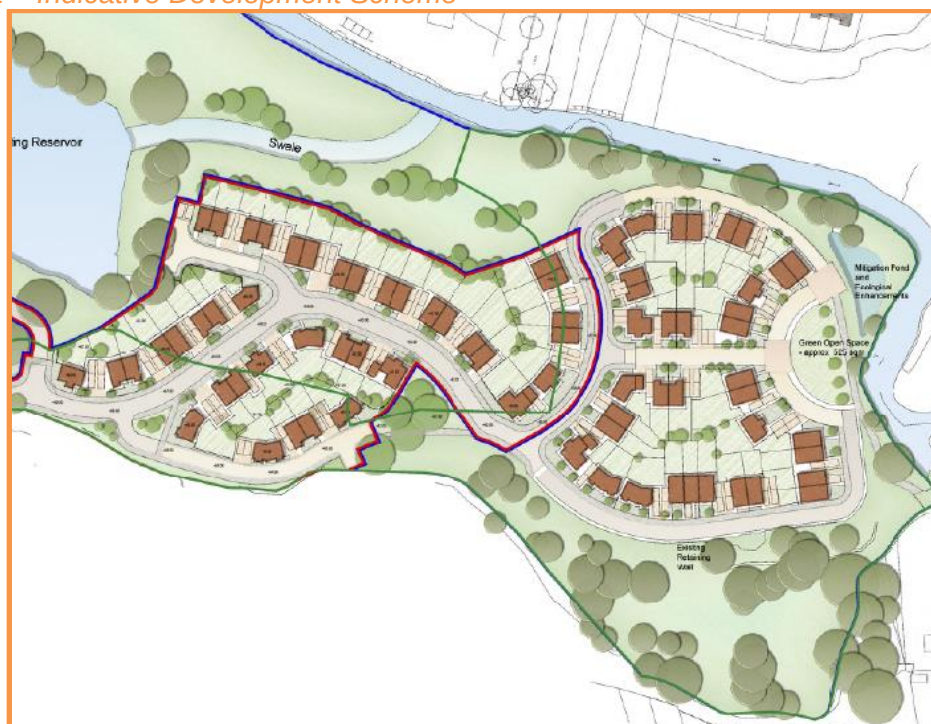
*Figure 1.1 – Indicative Development Scheme*

The Indicative Development Scheme is presented in the excerpt Figure 1.1 below and presented in Drawing No 11-164-004 (Appendix II).
