# Phase 2 Geo-Environmental Investigation & Assessment

Glendene, Wythenshawe

Garden City Design and Build Ltd

| <b>Report Reference:</b> | <b>9003G-WML-00-XX RP-G-0002</b> |

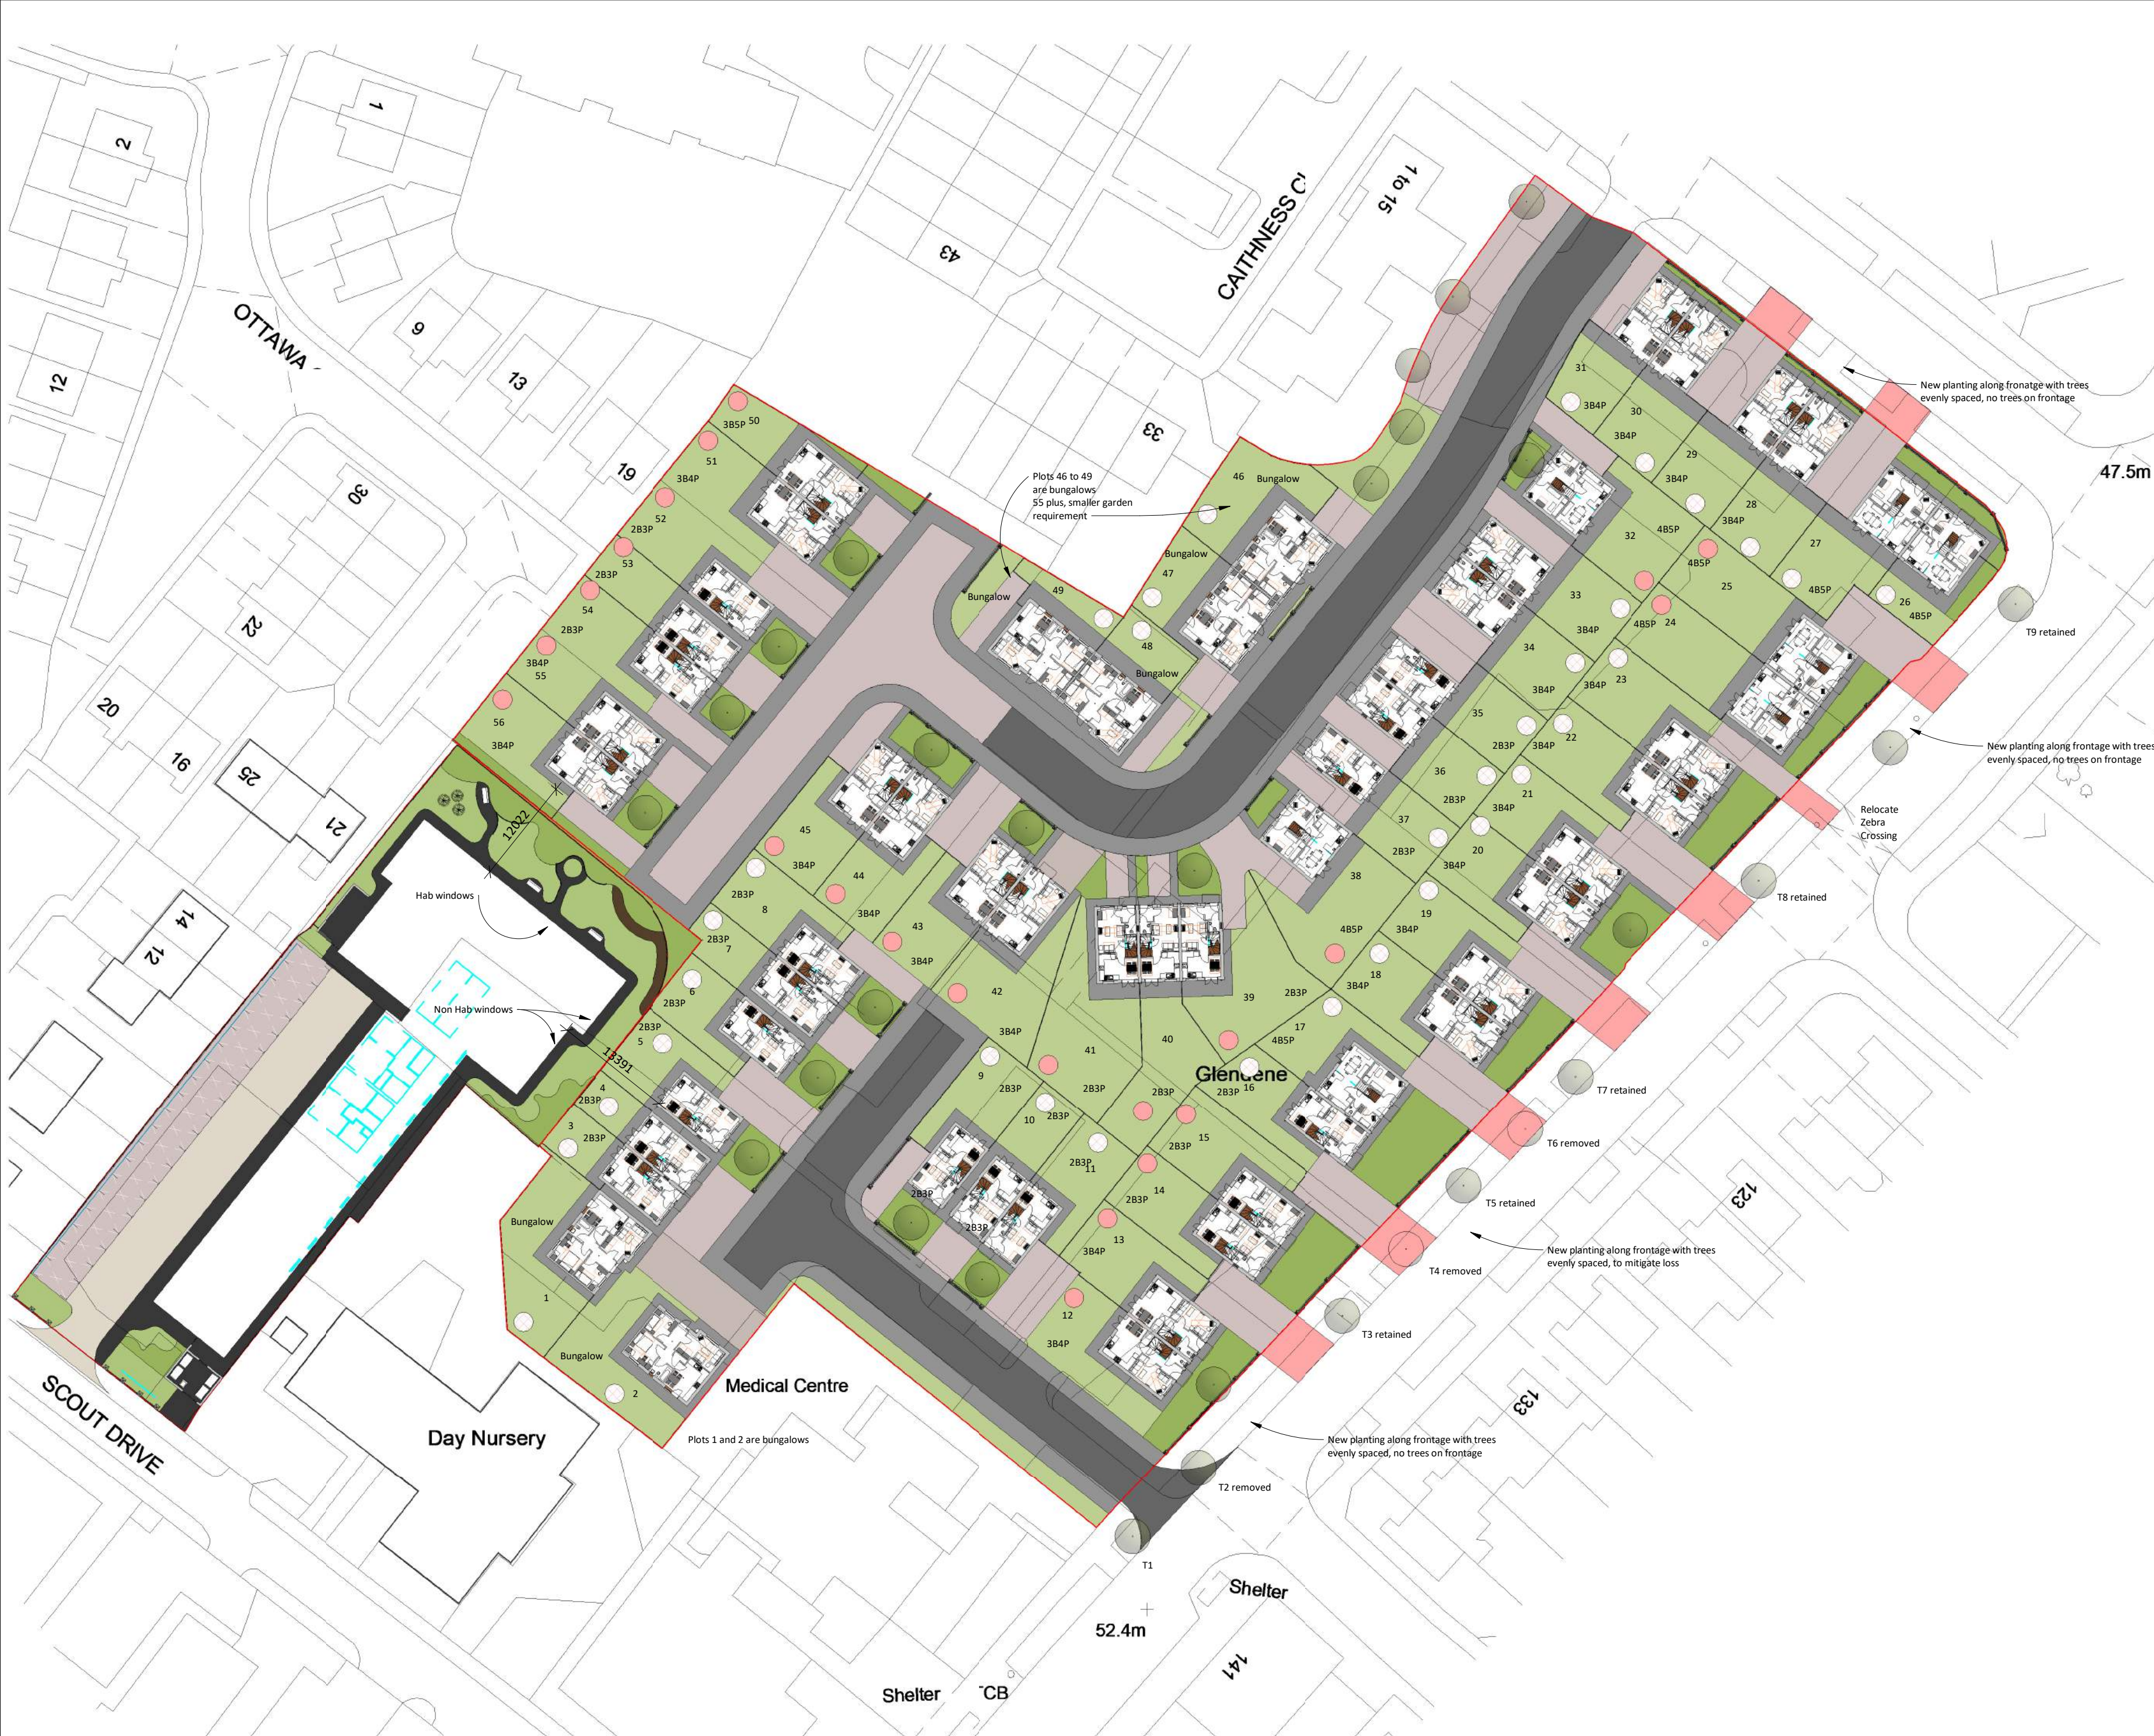
File Identifier:  
**CF-BTP-00-LP-DR-A-3333\_100**

- SHARED OWNERSHIP**
- 8 2B3P Houses
  - 10 3B4P Houses
  - 4 4B5P Houses

- AFFORDABLE RENT**
- 6 2B3P Bungalows
  - 13 2B3P Houses
  - 12 3B4P Houses
  - 3 4B5P Houses

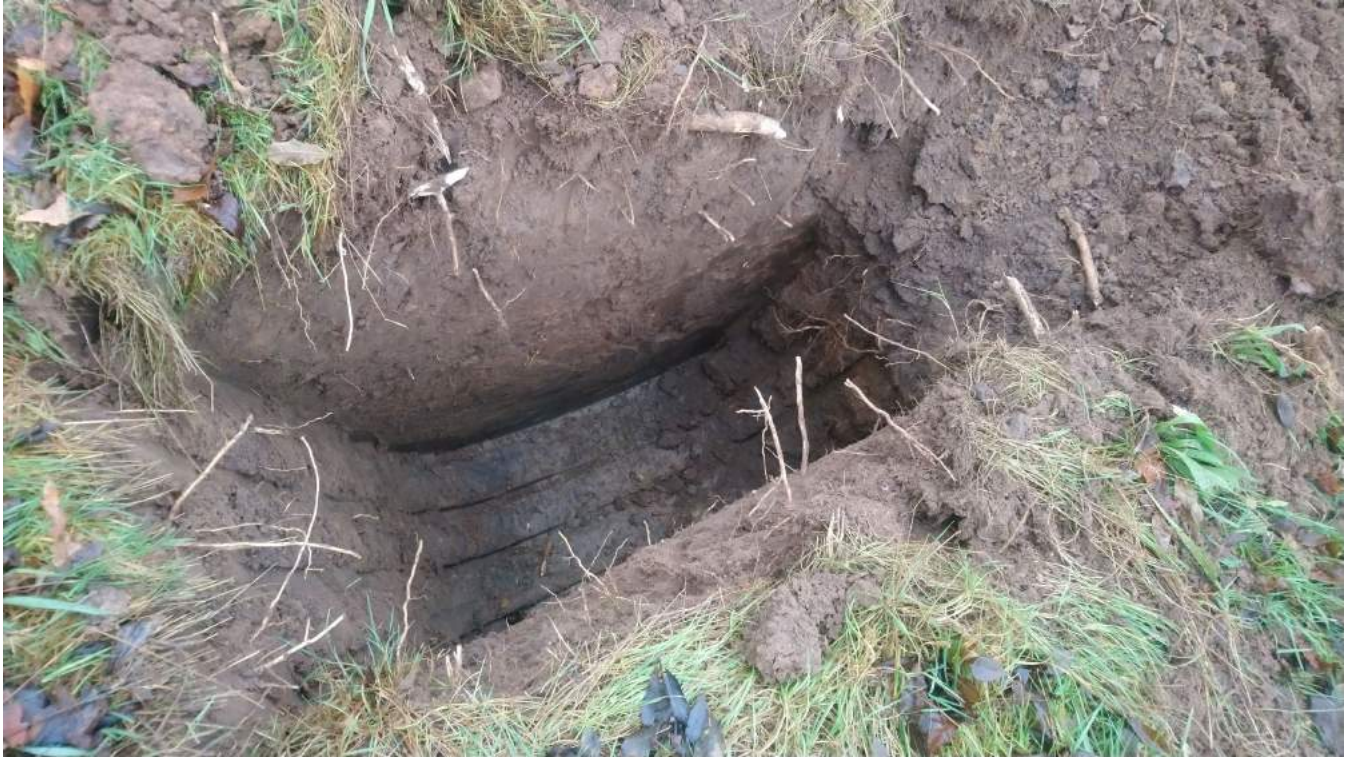
| Depth (m) | Type | Test Result | Level | Legend | Depth (m) | Description | Water |
| 0.40 | E | | | | | Turf over brown, slightly silty, clayey SAND with roots and rootlets. Rare subrounded gravel of sandstone. (MADE GROUND) | |

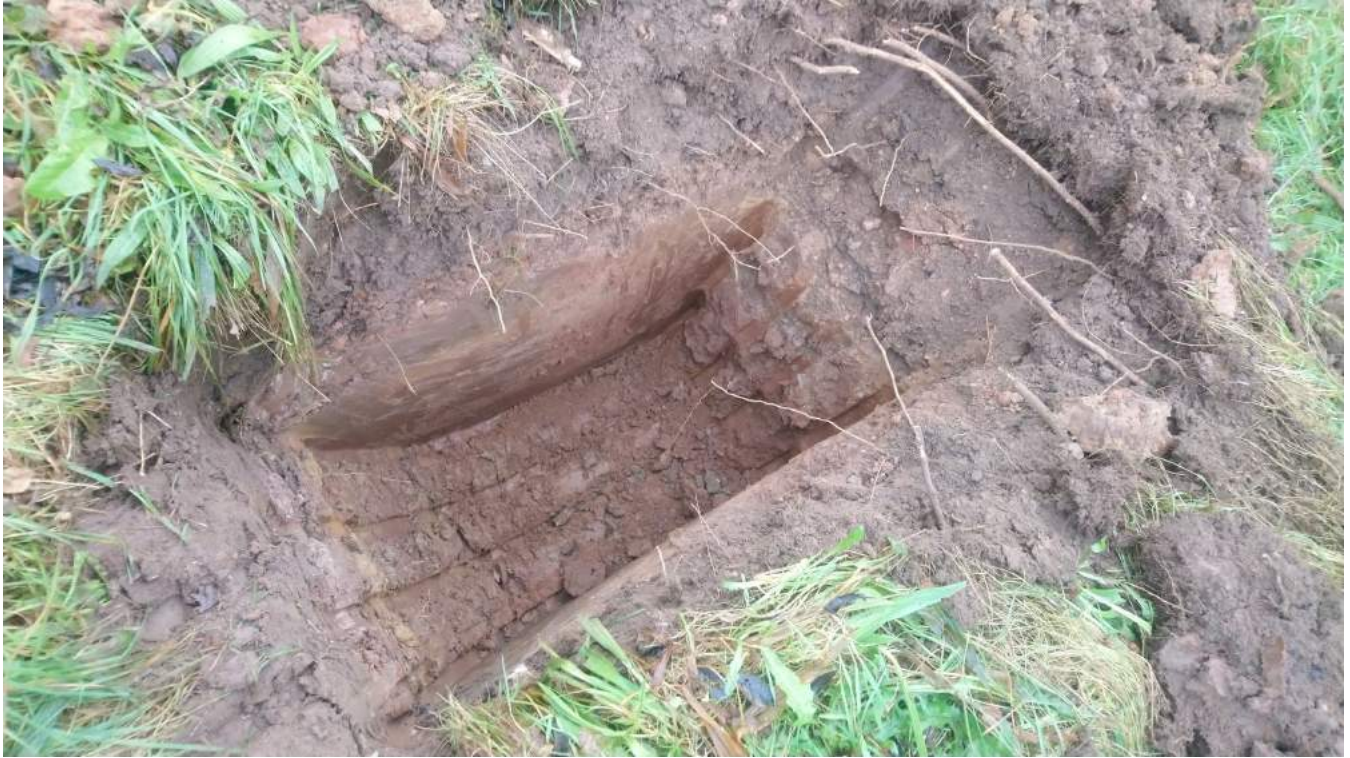
| Depth (m) | Type | Test Result | Level | Legend | Depth (m) | Description | Water |
| 0.30 | E | V=105,108,110 | | | 0.15 | Turf over dark brown, slightly silty, slightly sandy CLAY with roots and rootlets.<br>(TOPSOIL) | |

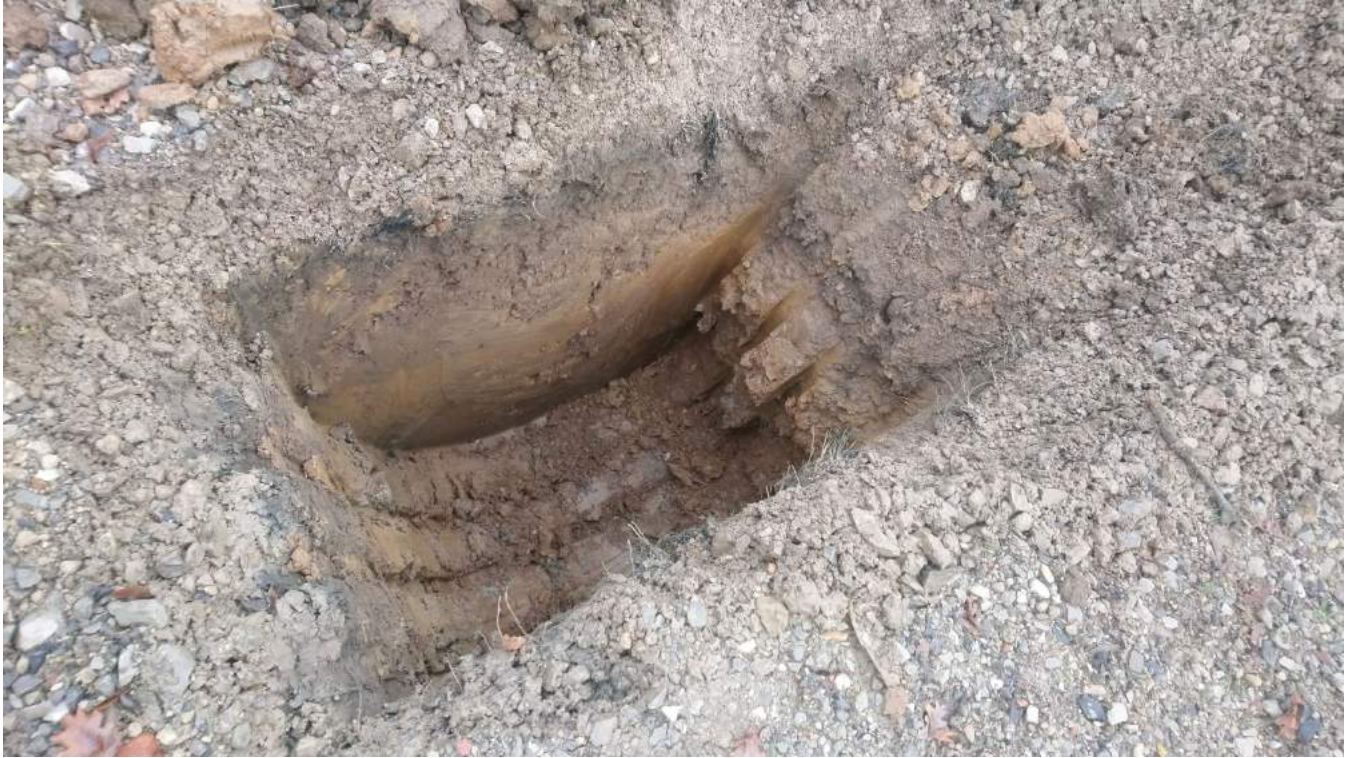
| Depth (m) | Type | Test Result | Level | Legend | Depth (m) | Description | Water |
| 0.10 | E | V=120,122,102 | | | 0.15 | Grey, subangular, fine to coarse GRAVEL including limestone, brick, sandstone and wood.<br>(MADE GROUND) | |

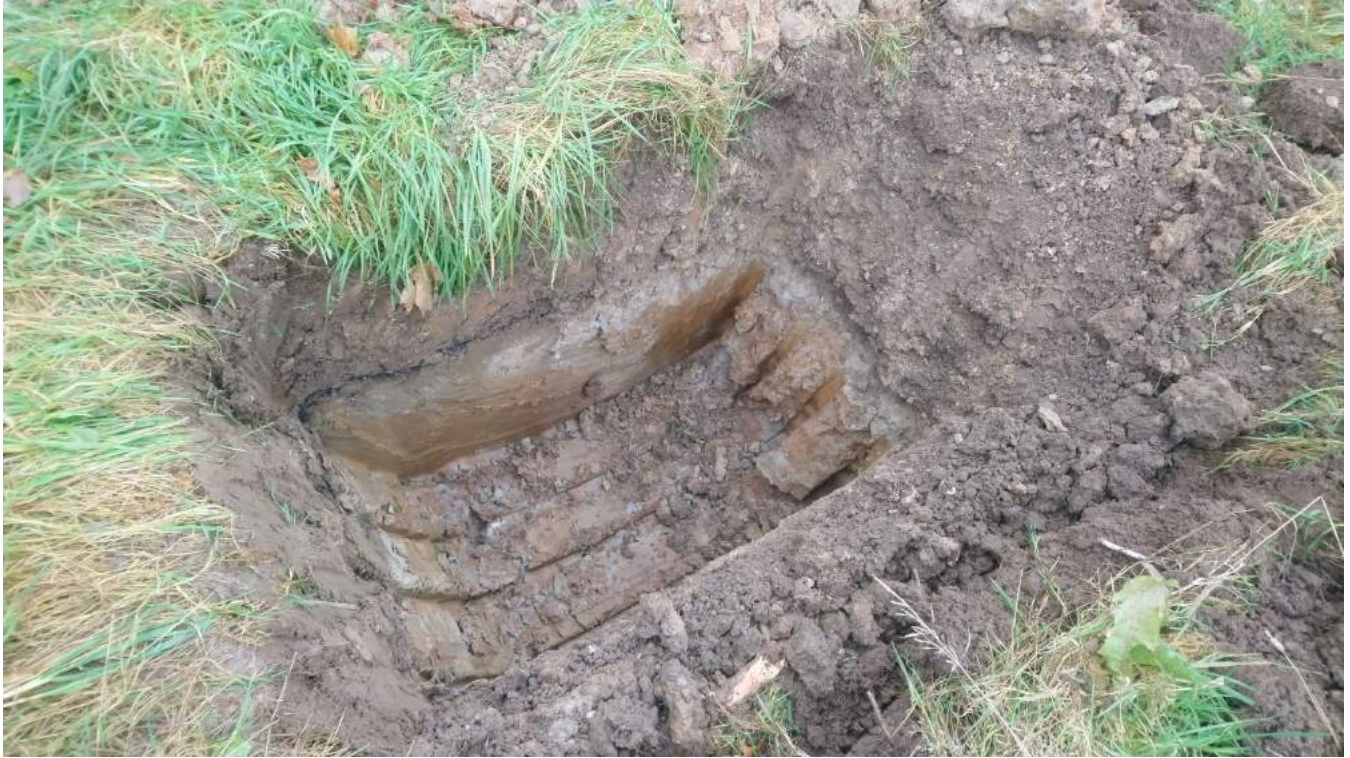
| Depth (m) | Type | Test Result | Level | Legend | Depth (m) | Description | Water |
| 0.20 | E | V=128,122,112 | | | 0.45 | Turf over dark brown, slightly silty, slightly sandy CLAY with rootlets.<br>(TOPSOIL) | |

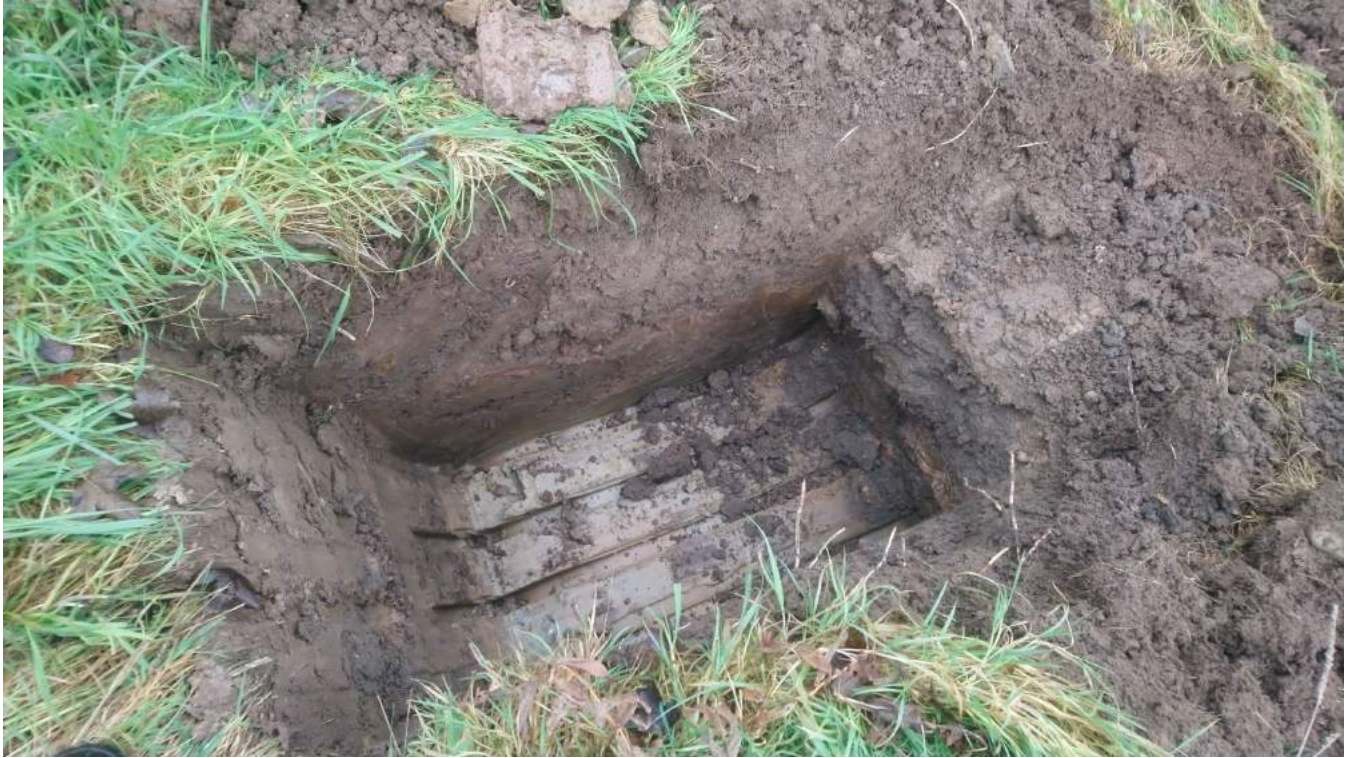
| Depth (m) | Type | Test Result | Level | Legend | Depth (m) | Description | Water |
| 0.10 | E | V=84,78,76 | | | 0.30 | Turf over dark brown, slightly silty, slightly sandy CLAY with rootlets.<br>(TOPSOIL) | |

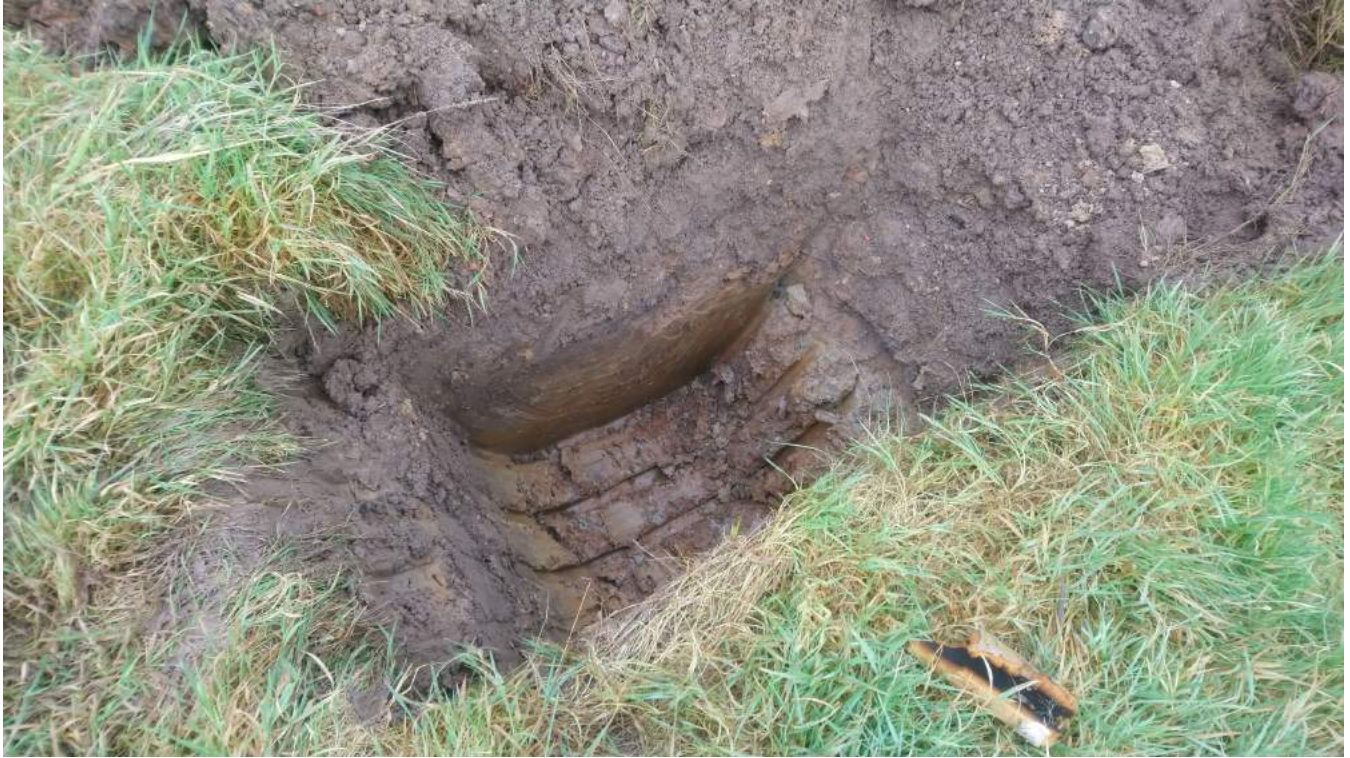
| Depth (m) | Type | Test Result | Level | Legend | Depth (m) | Description | Water |
| 0.40 | E | V=90,100,90 | | | 0.70 | Turf over dark brown, slightly silty, slightly gravelly, sandy CLAY with roots. Gravel is subangular, fine to coarse, including brick. (MADE GROUND) | |

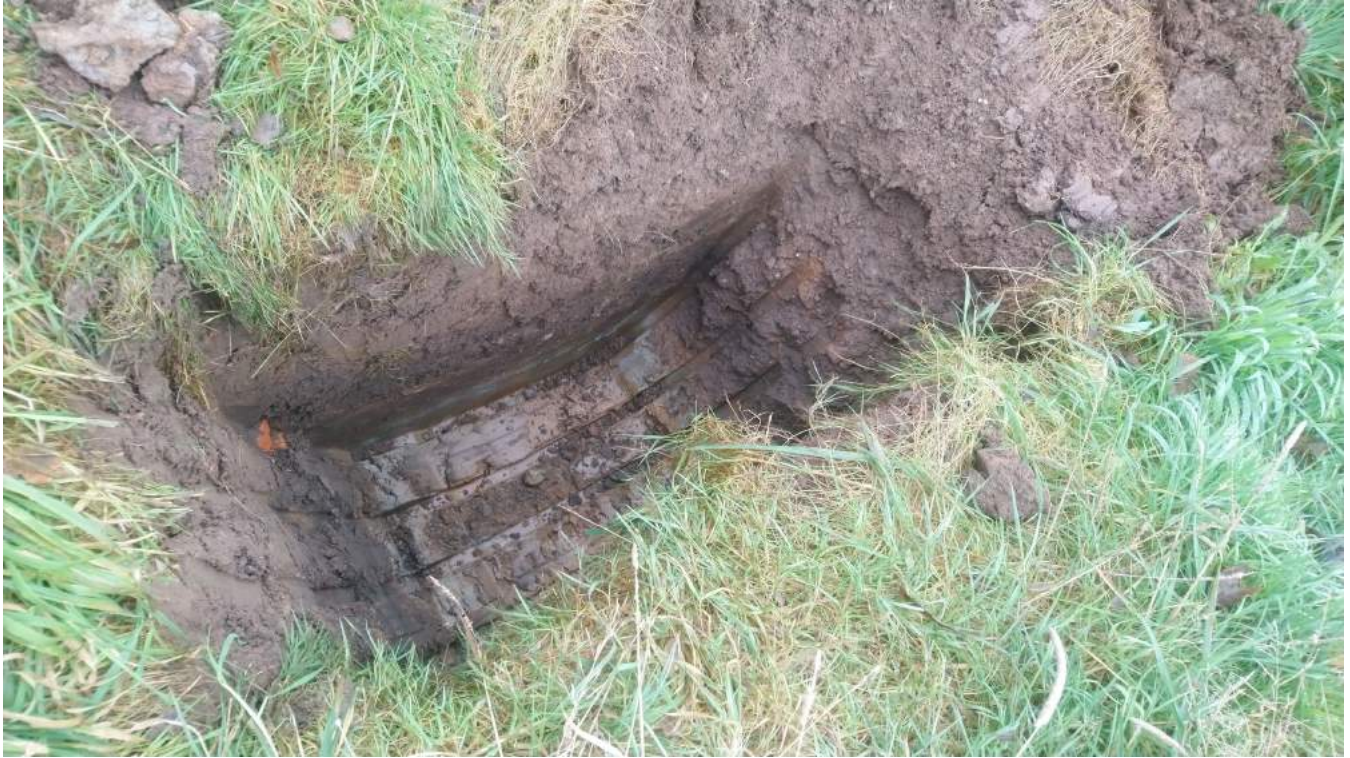
| Depth (m) | Type | Test Result | Level | Legend | Depth (m) | Description | Water |
| 0.50 | E | | | | | Turf over dark brown, slightly silty, slightly sandy, slightly gravelly CLAY. Gravel is subangular fine to coarse, including brick and concrete. (MADE GROUND) | |

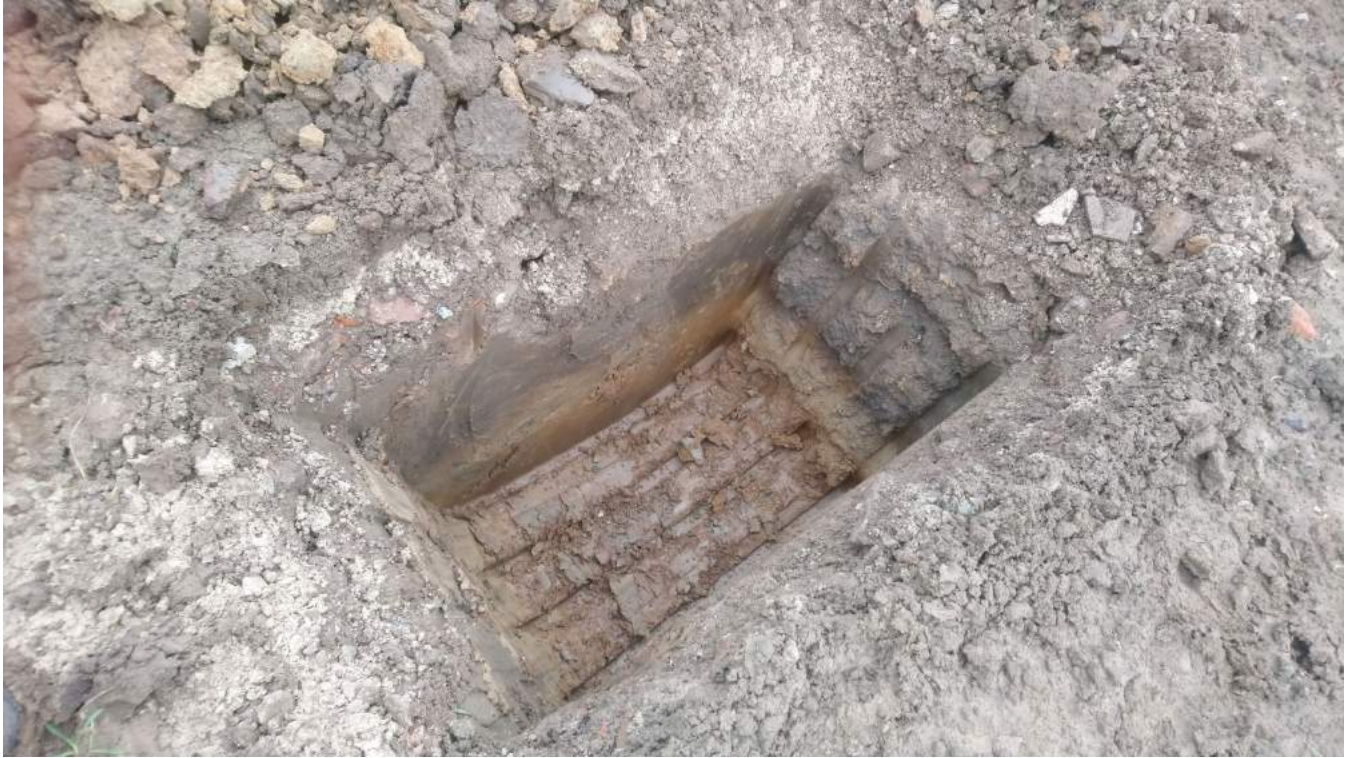
| Depth (m) | Type | Test Result | Level | Legend | Depth (m) | Description | Water |
| 0.10 | E | V=108,122,100 | | | | Brownish grey, slightly clayey, sandy, subangular, fine to coarse GRAVEL including limestone, sandstone and brick. (MADE GROUND) | |

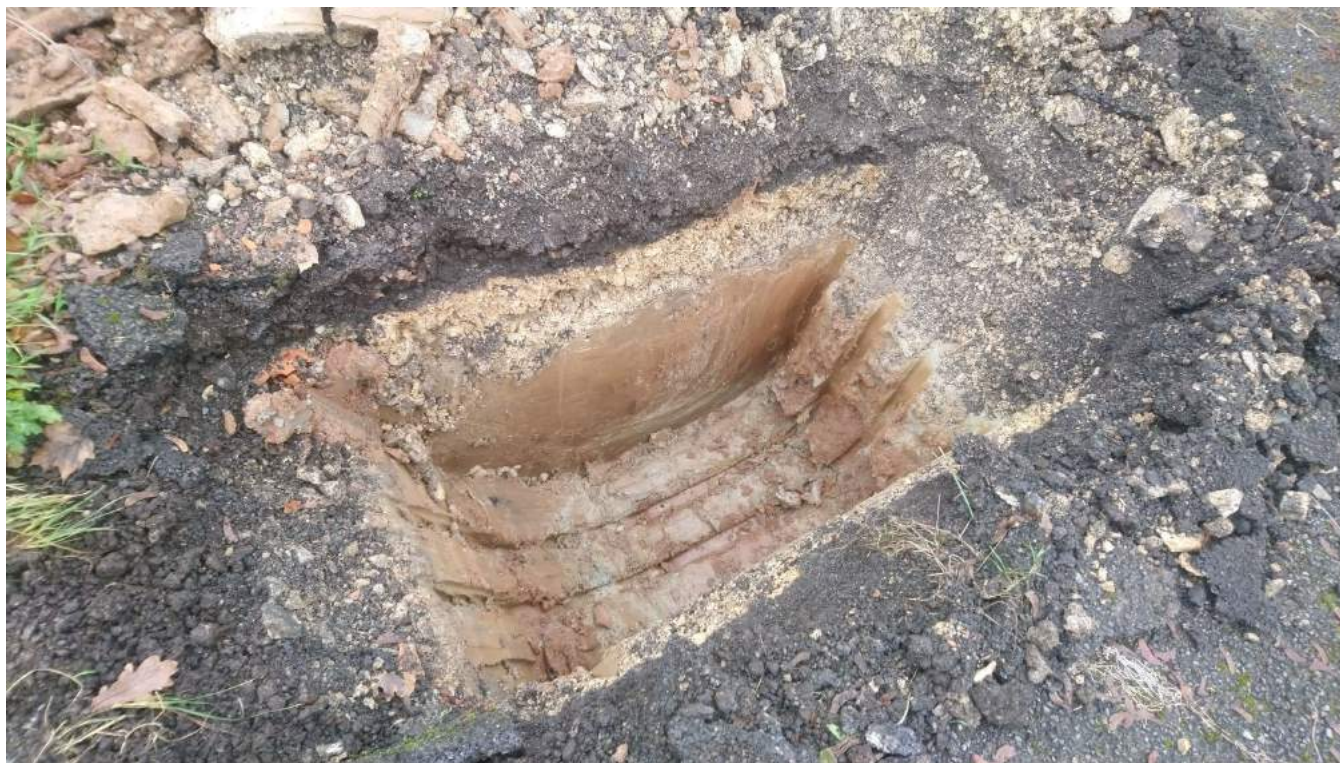
| Depth (m) | Type | Test Result | Level | Legend | Depth (m) | Description | Water |
| 0.02 | J | V=120,122,124 | | | 0.10 | Asphalt.<br>(MADE GROUND) | |

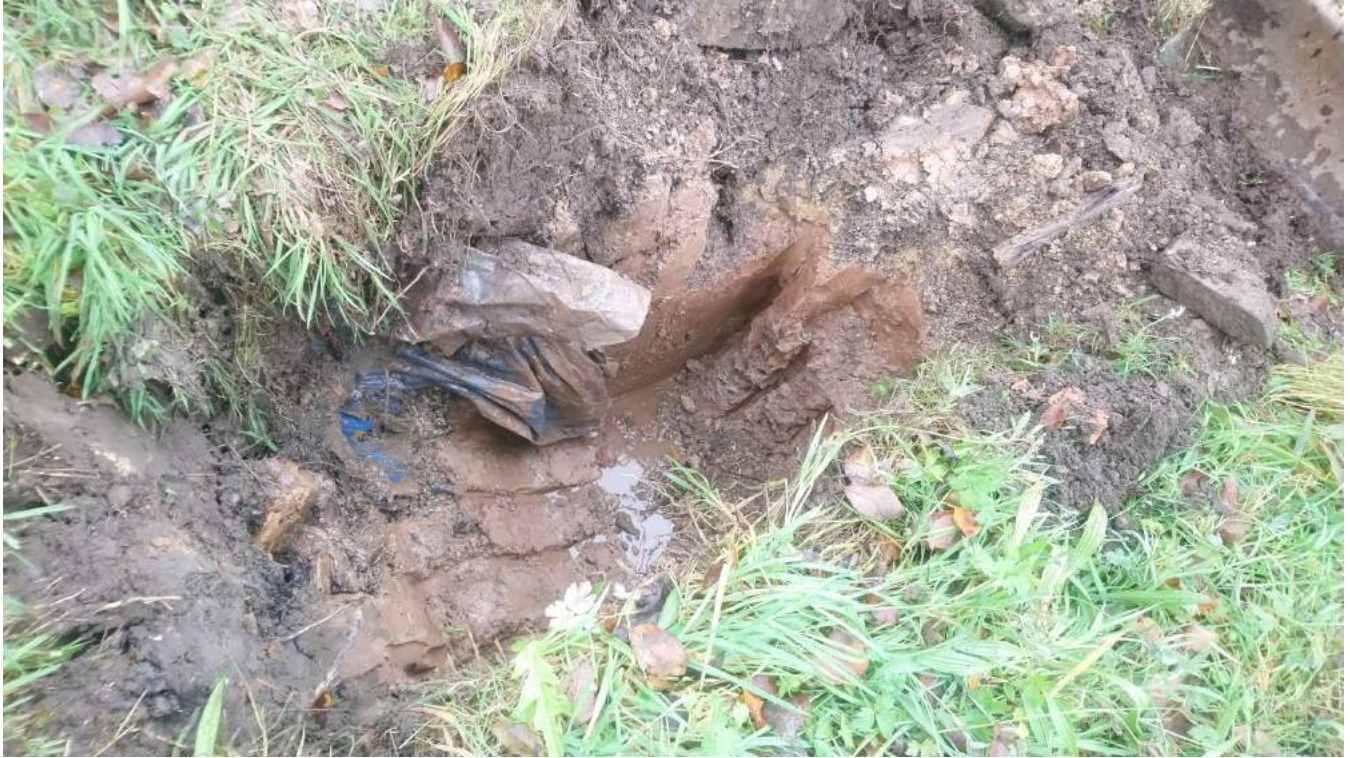
| Depth (m) | Type | Test Result | Level | Legend | Depth (m) | Description | Water |
| 0.10 | E | | | | 0.20 | Turf over dark brown, slightly clayey, gravelly SAND with rootlets. Gravel is subangular, fine to coarse, including sandstone, brick and concrete.<br>(MADE GROUND) | |

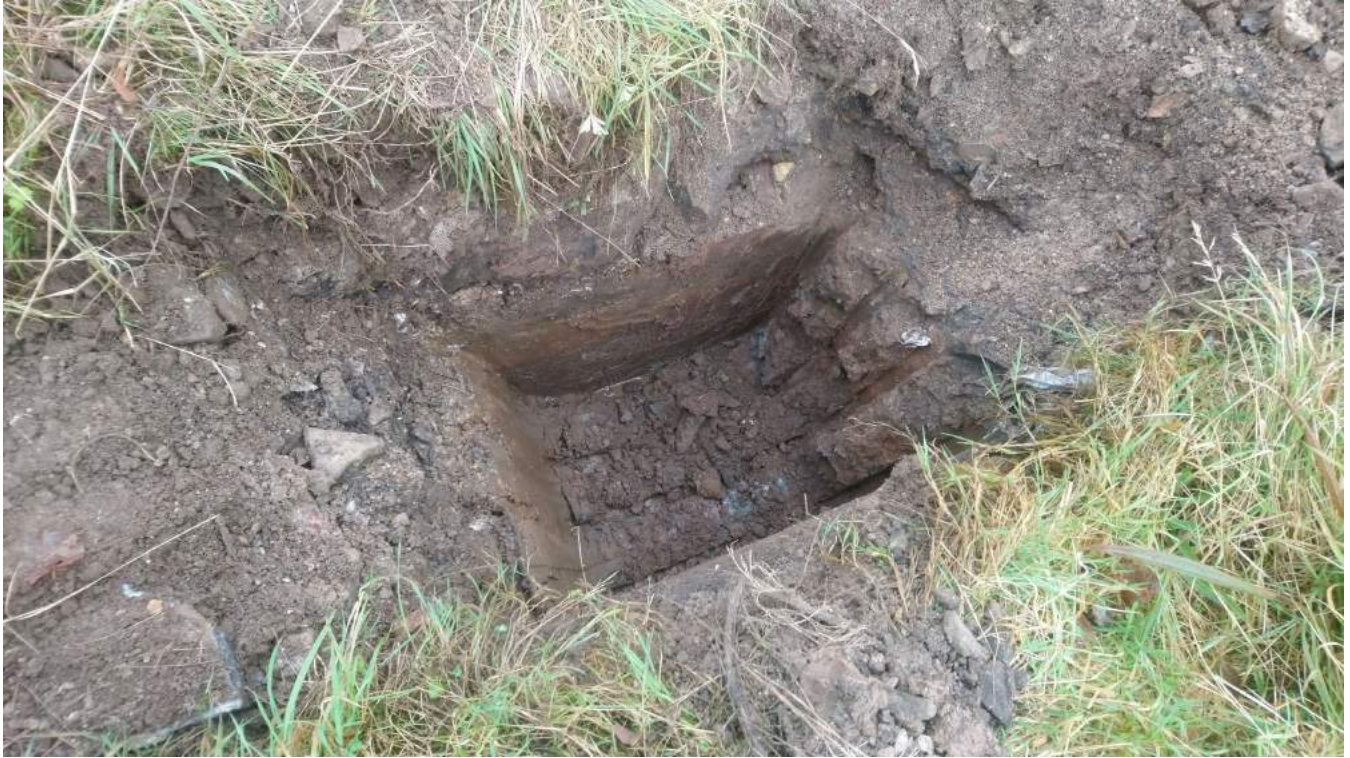
| Depth (m) | Type | Test Result | Level | Legend | Depth (m) | Description | Water |
| 0.10 | E | V=84,96,100 | | | 0.30 | Greyish brown, slightly silty, sandy, subangular, fine to coarse GRAVEL including limestone, brick, sandstone, concrete and plastic.<br>(MADE GROUND) | |
