# EXTENDED PHASE 1 HABITAT SURVEY & DAYTIME BAT SURVEY

## THE GREENFINCH PUBLIC HOUSE, DIDSBURY, MANCHESTER

JANUARY 2021

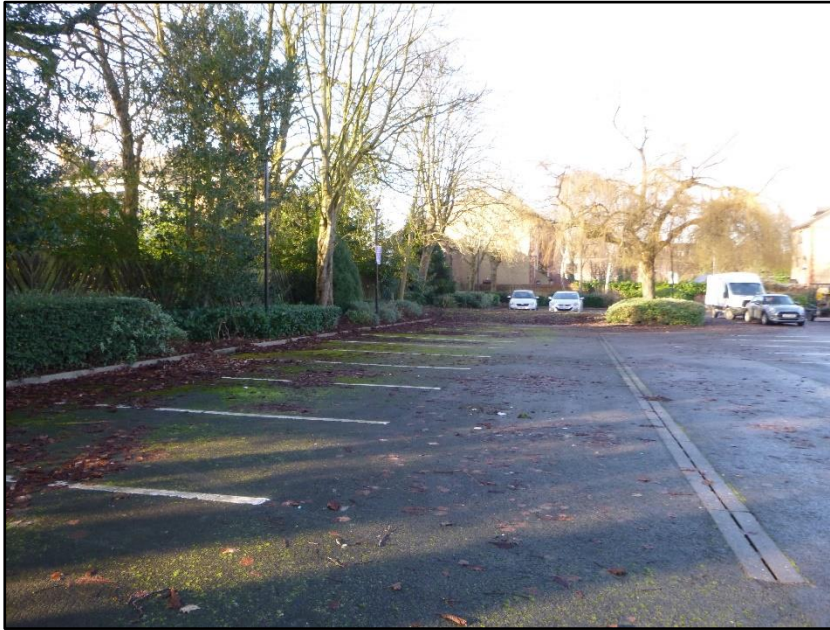
- 3.2 The majority of the site comprises hardstanding used as carparking and access (see Photograph 1). This is mapped as bare ground.

*Photograph 1 showing the bare ground*

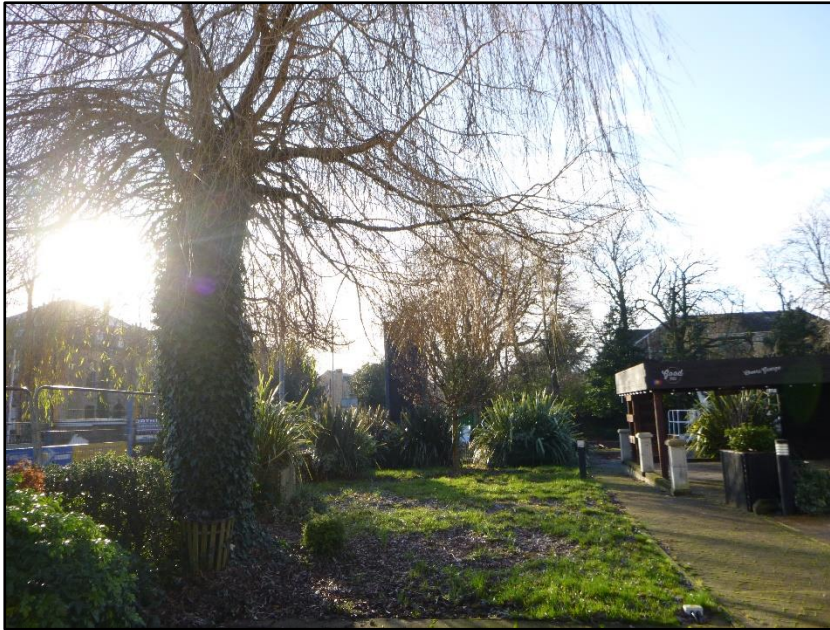
- 3.3 Areas of amenity grassland are present at the edges of the site and around the carpark (see Photograph 2). The grassland is short-mown and species-poor. Species present include Perennial Rye-grass *Lolium perenne*, Red Fescue *Festuca rubra*, Annual Meadow-grass *Poa annua*, Selfheal *Prunella vulgaris* and moss.

Photograph 2 showing the amenity grassland

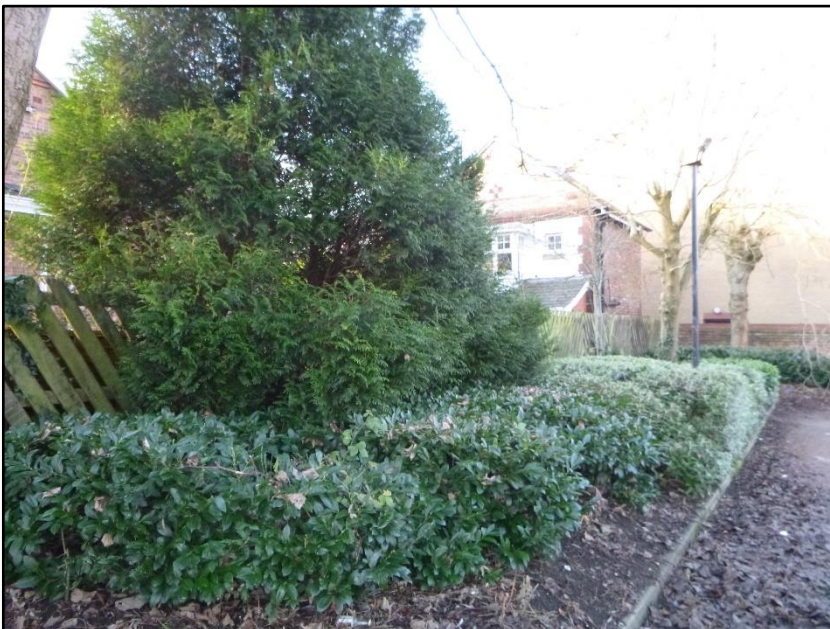
- 3.4 Introduced shrub beds line the majority of the site boundaries and are present in the carpark (see Photograph 3). Species in this habitat include Cherry Laurel *Prunus laurocerasus*, Wilson's Honeysuckle *Lonicera nitida*, Oregon-grape *Mahonia aquifolium*, Garden Privet *Ligustrum ovalifolium* and Holly *Ilex aquifolium*.

Photograph 3 showing the introduced shrub

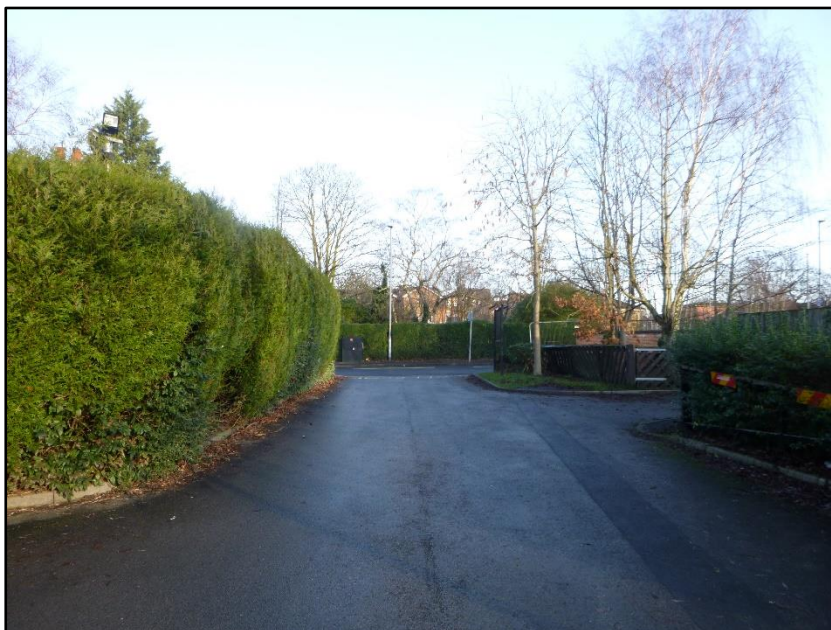
- 3.5 Two single-species hedgerows are present on site (see Photograph 4). A Leyland Cypress *Cupressus leylandii* hedgerow lines part of the western site boundary and a Garden Privet *Ligustrum ovalifolium* Hedgerow lines an internal fence. The north-

western and eastern site boundaries are marked by brick walls and the remainder of the site boundaries and some internal boundaries are marked by fencing.

*Photograph 4 showing the hedgerows*

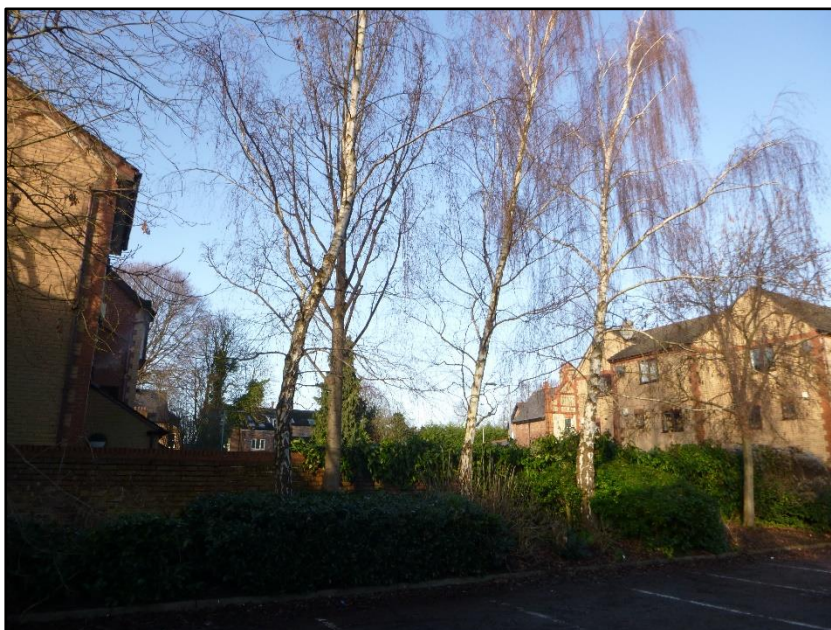
- 3.6 Trees are scattered along the site boundaries and on the amenity grassland on site (see Photograph 5). These are mainly semi-mature and tree species include Ash *Fraxinus excelsior*, Lime *Tilia x europaea*, Silver Birch *Betula pendula*, Rowan *Sorbus aucuparia* and Horse Chestnut *Aesculus hippocastanum*.

*Photograph 5 showing the scattered trees*

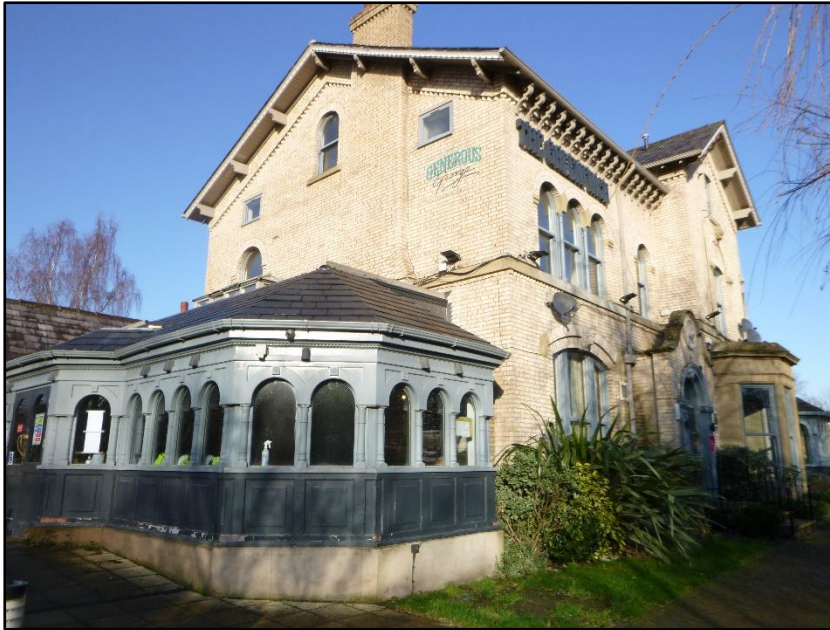
- 3.10 The buildings on site were the subject of a daytime bat survey and the results are detailed here. The buildings could be easily surveyed.
- 3.11 The three-storey public house is of brick construction with a pitched tiled roof (see Photograph 6). The external brick walls are in good condition, with no missing bricks or mortar, and do not support suitable cavities for roosting bats. The windows and door frames are well-sealed to the brickwork. The eaves overhang on the three-storey section of the building and a slit is present at the roof plate which could provide internal access for bats. Single-story conservatory extensions are present on the east and south-western elevations. These are clad with wooden panels which are in good condition and provide no roosting features for bats. A one-storey extension is present on the northern elevation (see Photograph 7). This is brick built and holds a hipped roof. The brickwork is in excellent condition, with all mortar intact. Wooden soffits are present on this extension which are in excellent condition and flush to the brickwork.

*Photograph 6 showing the exterior of the building*

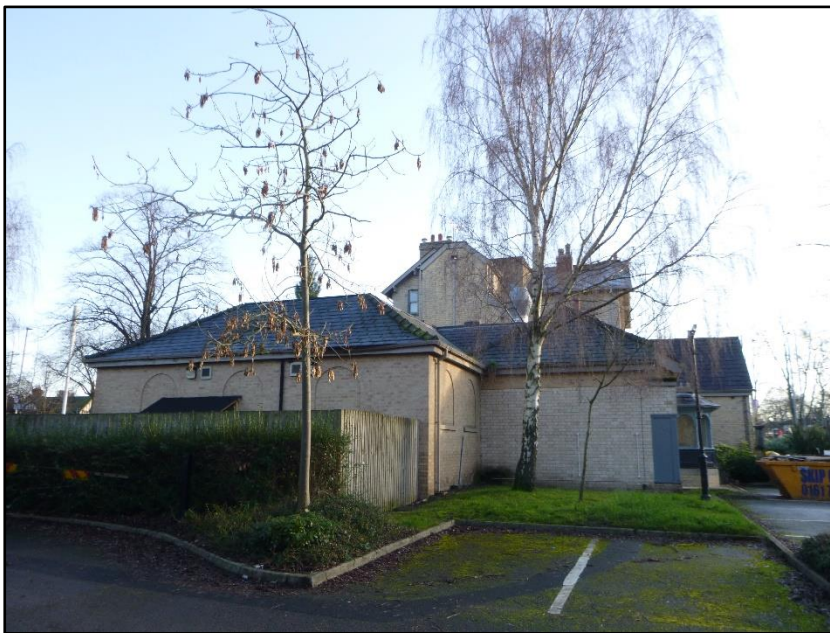
*Photograph 7 showing the one-storey extensions*

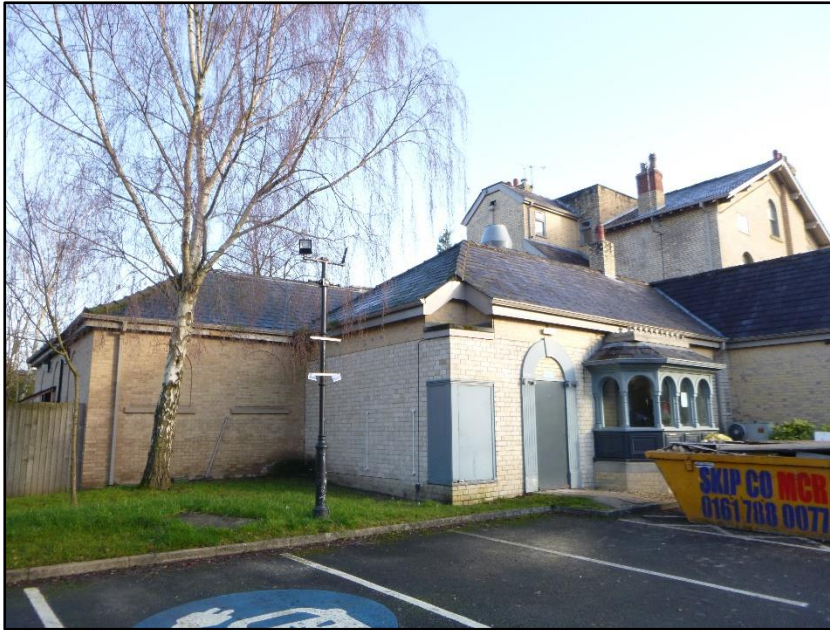
- 3.12 The building has a tiled roof (see Photograph 8). The tiles are all place and intact across the main building. The ridge tiles are intact and in good condition. Two tiles are missing on the conservatory roof. This area was inspected, and no evidence of bat use was found. Lead flashing exists around the chimneys and where the extensions meet the main building. This is flush to the tiles and brickwork.

*Photograph 8 showing the roof of the property*

- 4.5 All buildings on site have been the subject of a daytime bat survey. No evidence of bat use was found across the site. The public house building is in good condition externally apart from two missing tiles on an extension. No evidence of bat use was found associated with this damage and the room under the missing tiles is well-lit with no roof void present. The main roof void is well-sealed apart from a small gap at the roof plate. No crevices are present in the roof void and no evidence of bat use was found in the building; therefore, the building is concluded to hold *negligible* suitability for a bat roost. The structure to the south of the public house is open on all sides and the roof composition allows light into the structure, providing no cover for bats. No crevices are present; therefore, it is concluded to hold *negligible* suitability for a bat roost.

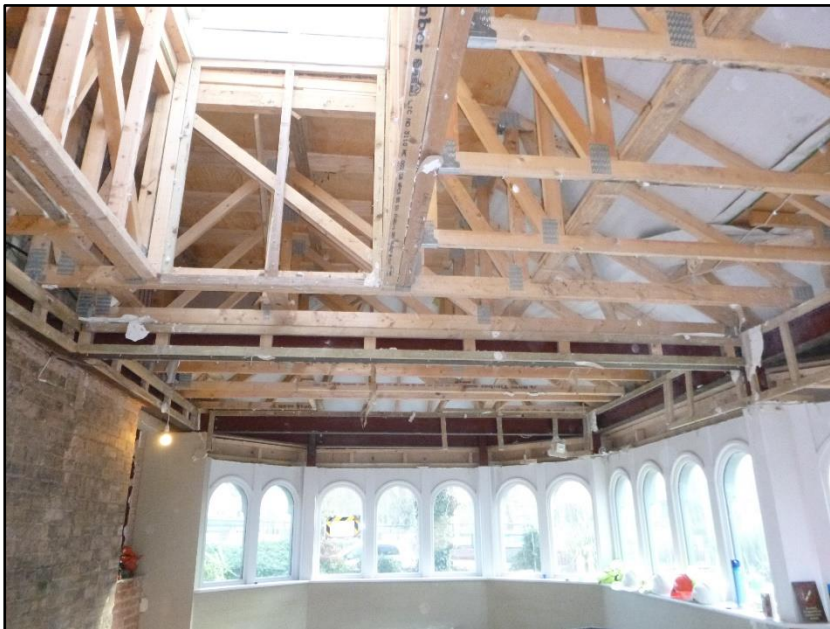
- 3.13 The ground, first and second floor rooms are well-finished and well-lit by daylight through the windows. No potential access points for bats are present. The roof voids in extensions on the south-west and eastern elevations are open to the ground floor. The underside of the roof is lined by a combination of roofing membrane and wooden boards (see Photograph 9). Both types of lining are intact and no access points for bats or cavities that could be used by bats are present.

*Photograph 9 showing the roof of the conservatory extension*

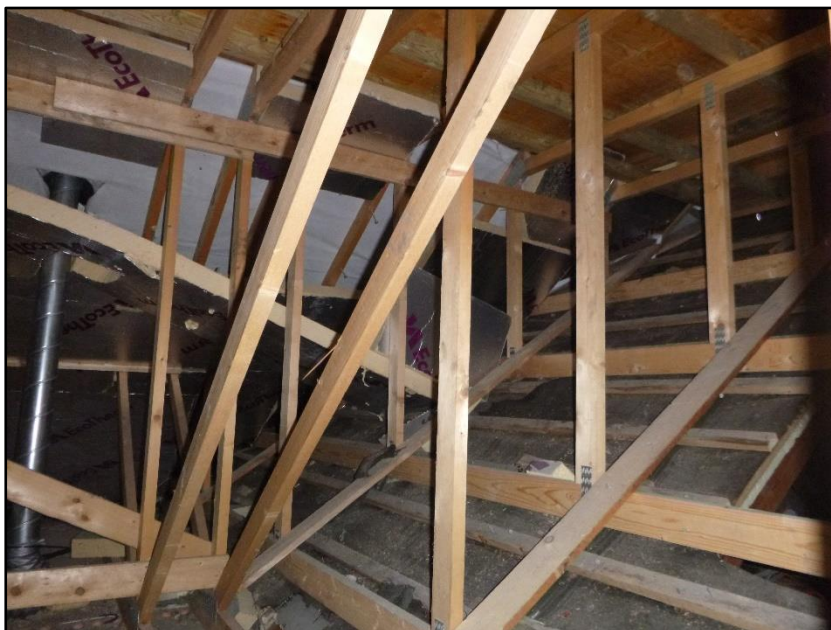
- 3.14 Roof voids are present above the main section of the building and above the extension on the north-western elevation. The loft space in the hipped roof is well-sealed (see Photograph 10). The wooden roof timbers are complete and do not provide crevices

for roosting bats. The roof is lined by insulation boards. This is partly missing, revealing the roofing membrane. This is in good condition, with no tears.

*Photograph 10 showing the roof void above north-western extension*

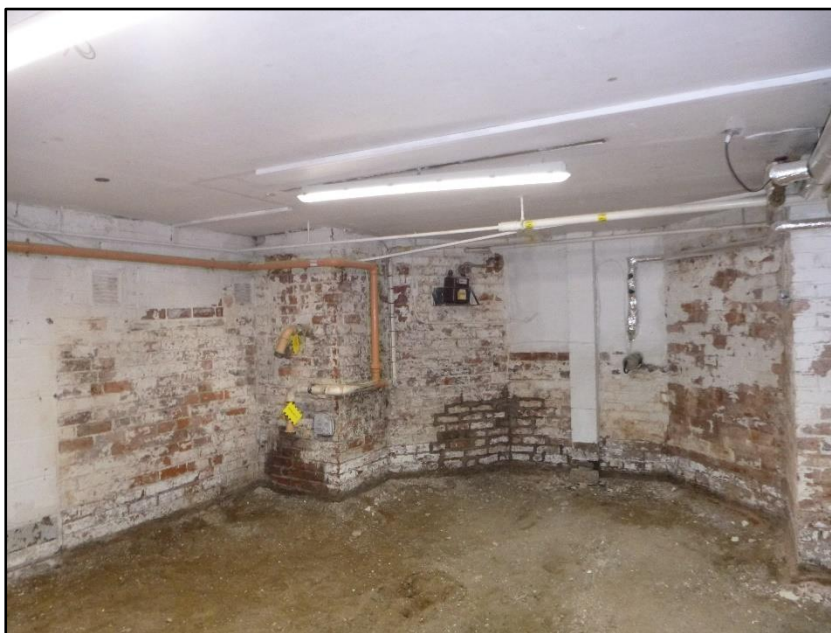
- 3.16 A basement is present under the main building (see Photograph 12). The basement is well-sealed, damp in parts and no access points for bats were found. No evidence of bat use was found in the basement.

*Photograph 12 showing the basement in the main building*

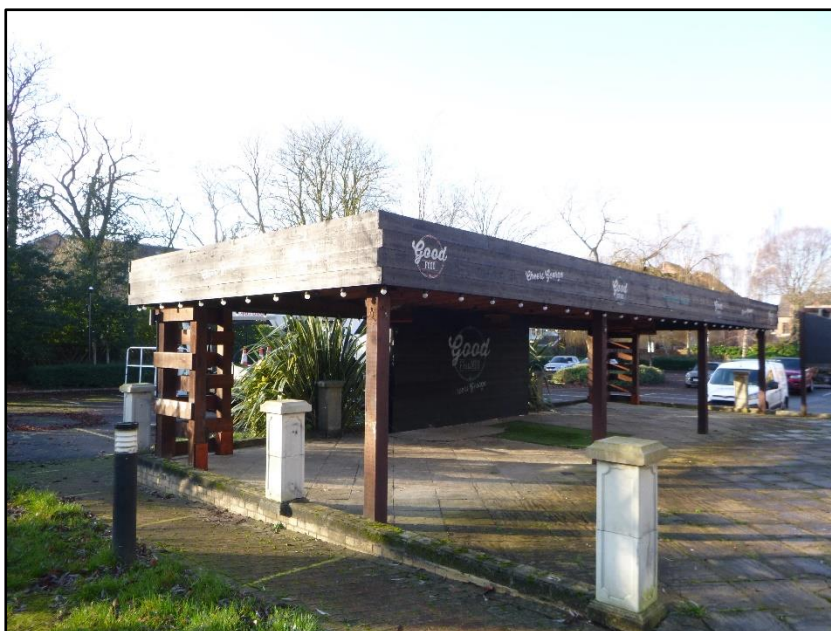
- 3.17 A shelter is present to the south of the building (see Photograph 13). This is an open structure constructed from wood with a sheet plastic roof. The structural beams and wooden cladding are in good condition, providing no crevices for roosting bats.

*Photograph 13 showing the shelter*

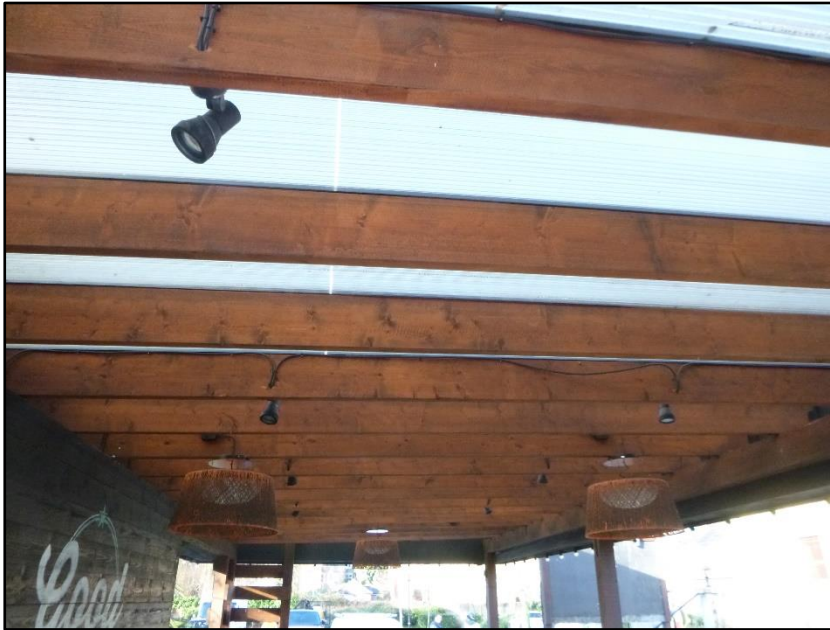
- 3.18 The interior of the shelter provides no cover for bats due to the open construction (see Photograph 14). The plastic roof is in good condition and allows light into the space. No

crevices are present internally and no evidence of bat activity was found within the structure.

Photograph 14 showing the interior of the shelter

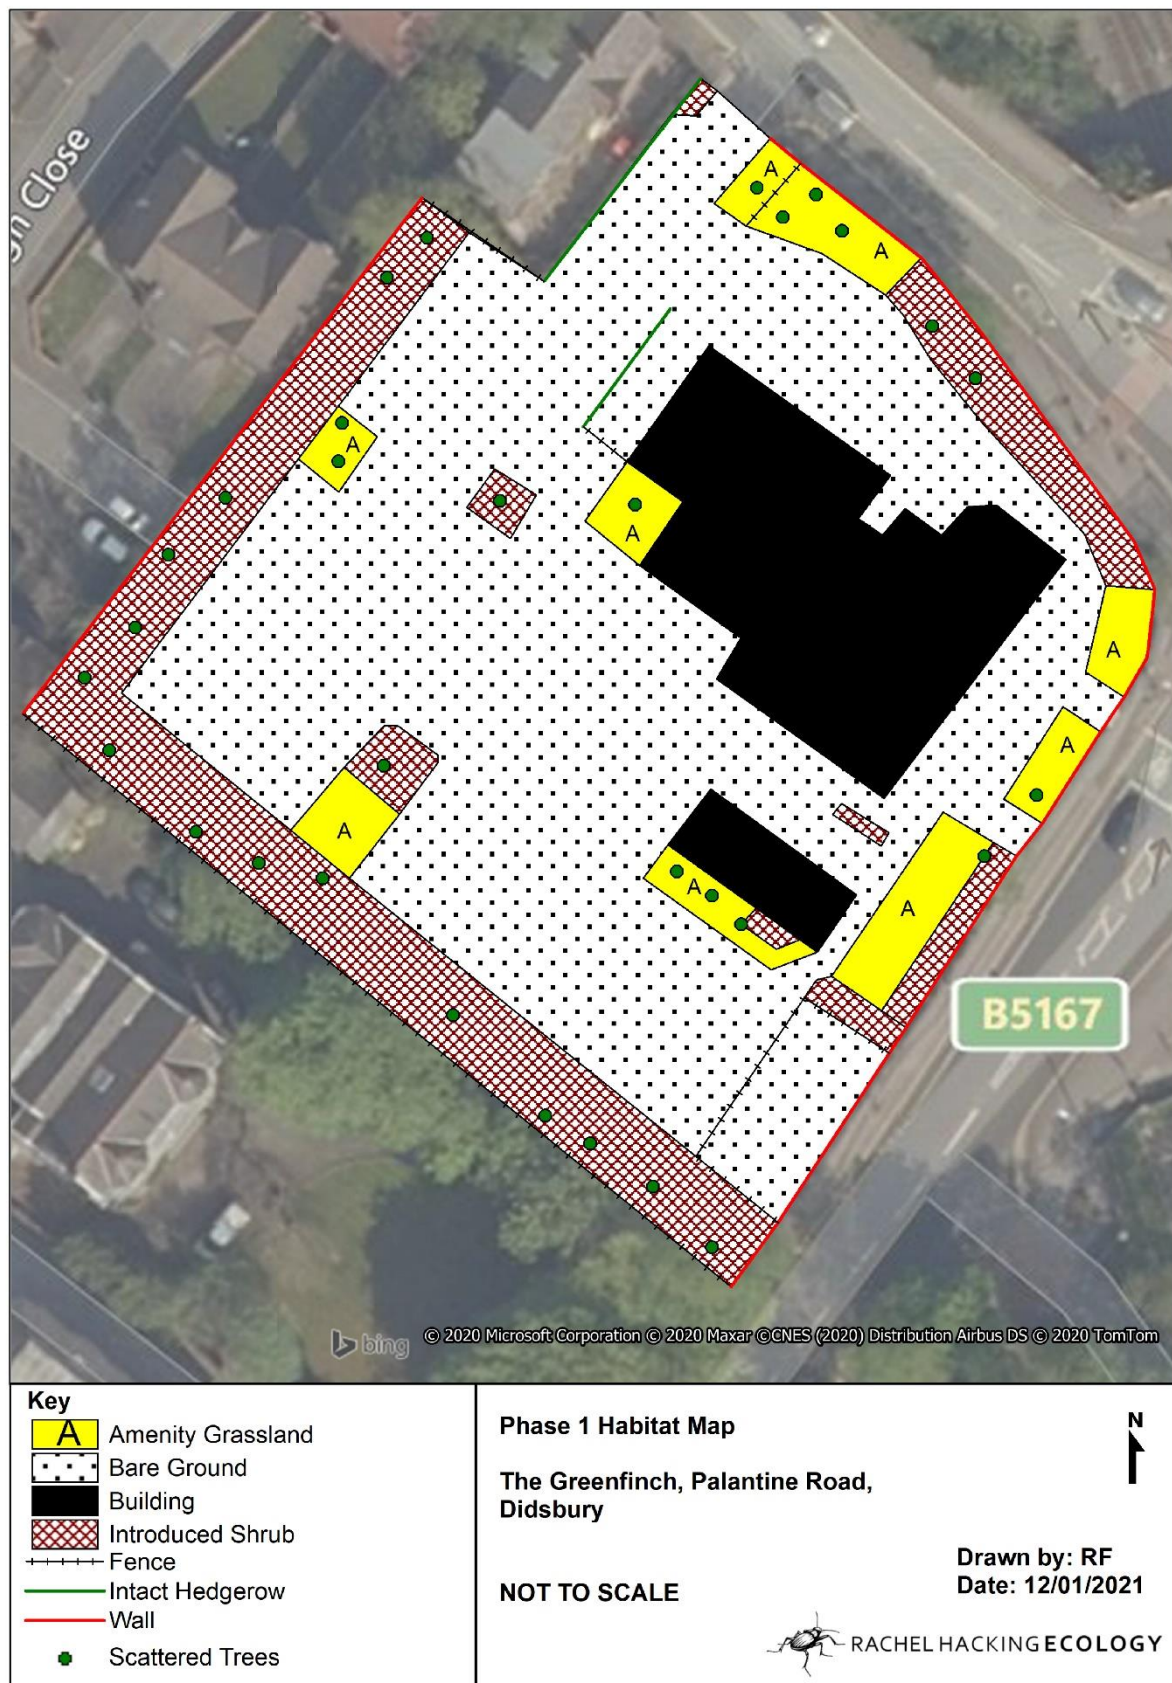
## APPENDIX A PHASE 1 HABITAT MAP

- 3.1 The Phase 1 Habitat Map can be found at the back of the report. The habitats on the proposed development site are described below.
