## COMPLETION AND GUARANTEE CERTIFICATE

THIS CERTIFICATE GUARANTEES THE CLIENT THAT THE IMPACTED SOILS ASSOCIATED WITH JAPANESE KNOTWEED AREA HAVE BEEN EXCAVATED AND DISPOSED OF AT AN APPROPRIATE LICENCED FACILITY, APPROXIMATE EXTENTS OF COMPLETED EXCAVATION AS PART OF THE PHASE 1 WORKS, AS SHOWN ON DRAWING JK20-6266-02. SHOULD ANY RE-GROWTH OCCUR WITHIN THE COMPLETED EXXCAVATION AREA, THEN THIS CERTIFICATE COVERS ADDITIONAL CHEMICAL TREATMENT UNTIL JULY 2035.

**SITE ADDRESS:** Moston Campus, Princedom Street, Manchester, W9 4WU

**JOB NUMBER:** JK20-6266

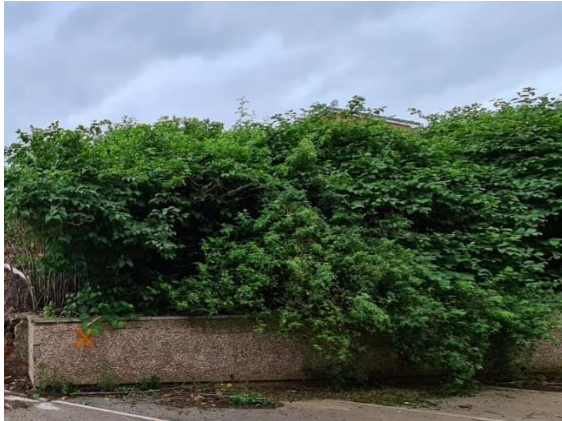
Vegetation within southern section of embankment area left in-situ due to the presence of nesting birds.

Due to the presence of nesting birds situated within the southern section of the original proposed working area of the embankment, only the northern section was remediated (as part of the above Phase 1 excavation works). JKSL will be returning to site, as part of Phase 2 excavation works to complete the remediation of the southern area of the embankment area. At this stage, it is anticipated that JKSL will complete the Phase 2 excavation works in September 2020.

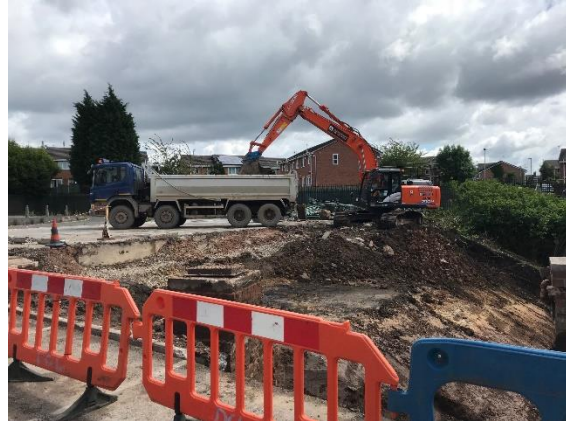
Excavation and loading of tipper wagons with materials containing Japanese knotweed.

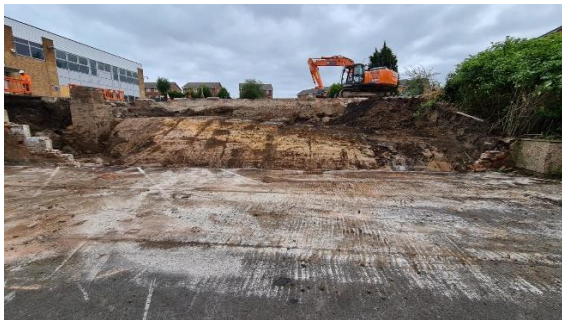
Completed excavation area as shown on drawing JK20-6266-03.

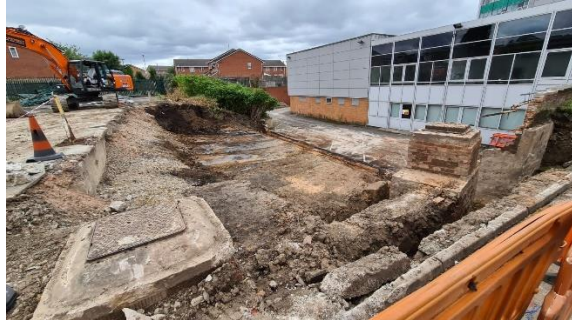
Completed excavation area as shown on drawing JK20-6266-03. Manhole structures and associated pipes left in-situ.

**Excavation restrictions.** Due to the presence of two manholes and associated drain pipes, not all of the materials containing Japanese knotweed situated within these structures and/or within material supporting these structures were excavated/removed. These structures/areas containing Japanese knotweed will be removed during the general site strip/demolition works. It is recommended that during these future works, JKSL are in attendance to implement a watching brief.

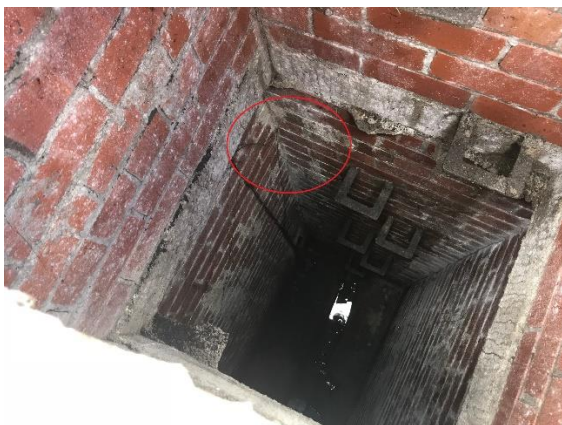
Evidence of rhizome being present within manhole structure.

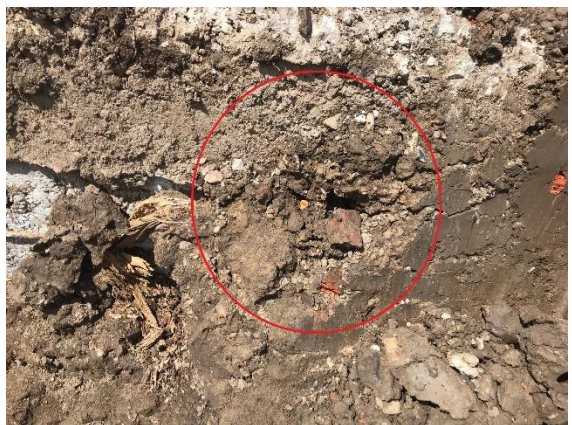
Evidence of rhizome being present in ground that is currently supporting the existing manhole/associated pipe structures.

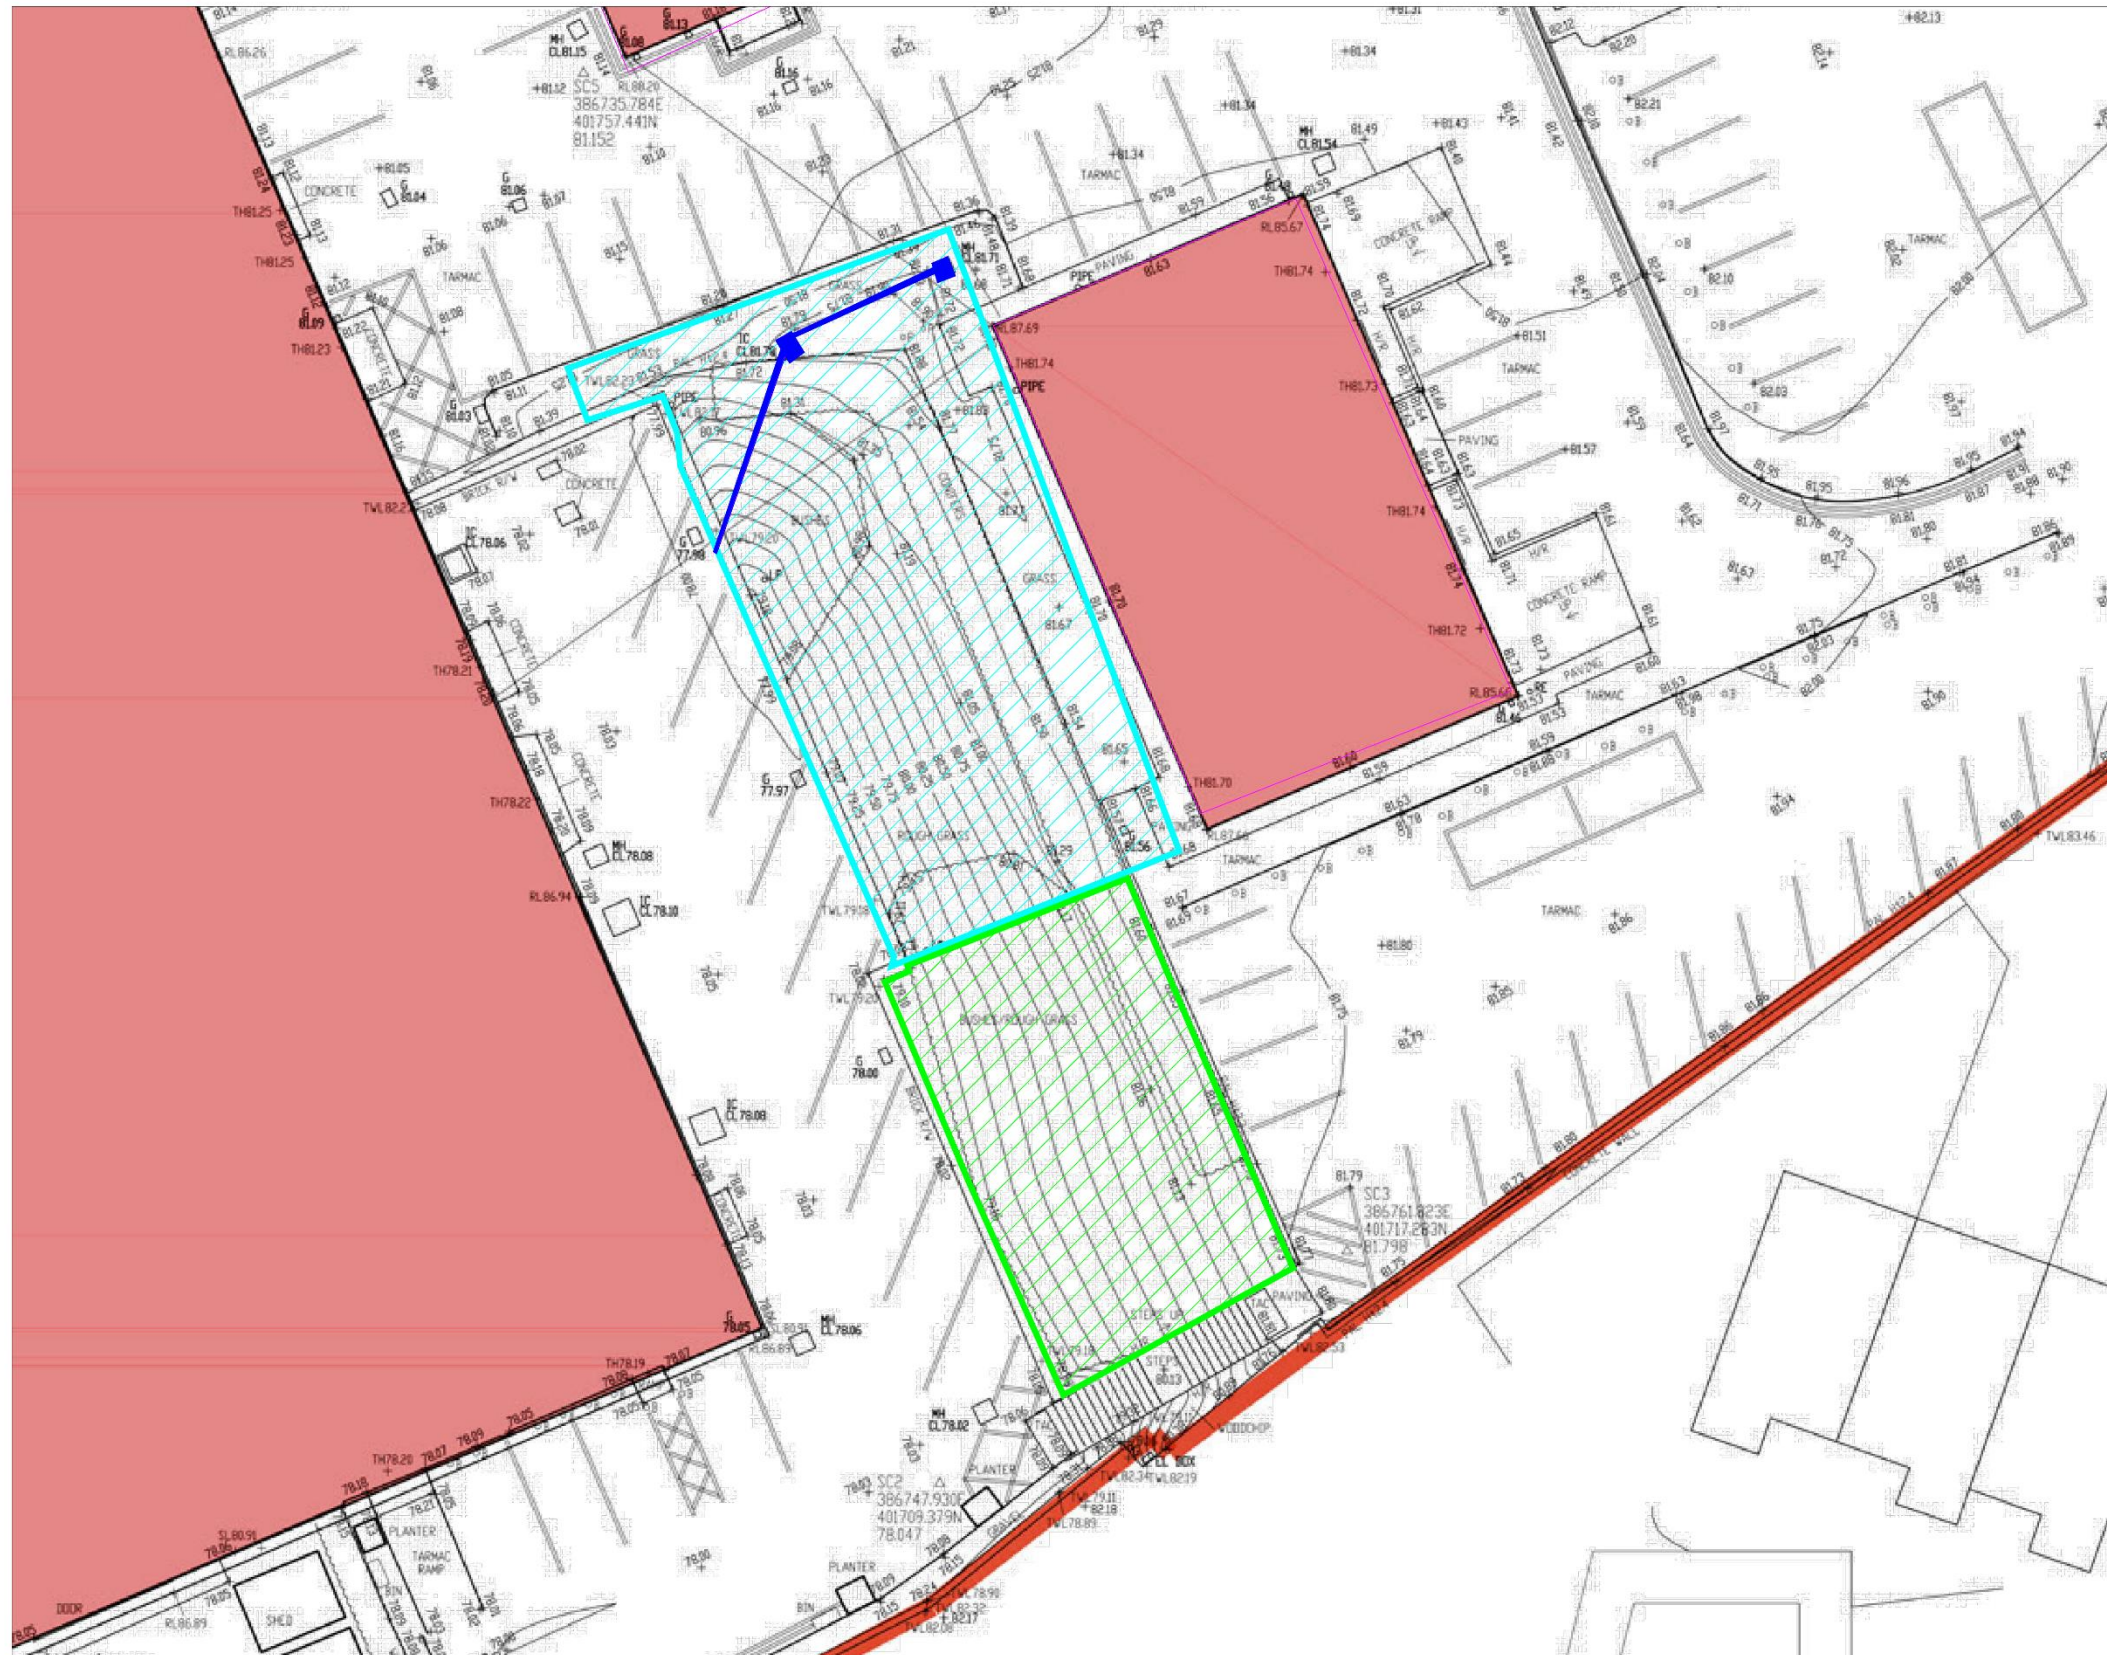
| Drawing No. JK20-6266-03 | Revision / |

- APPROXIMATE DEVELOPMENT BOUNDARY
- APPROXIMATE EXTENT OF COMPLETED EXCAVATION
- EXISTING MANHOLE LIFT IN SITU
- EXISTING PIPE LIFT IN-SITU ASSOCIATED WITH THE EXISTING MANHOLES
- APPROXIMATE EXTENT OF EXISTING VEGETATION / JAPANESE KNOTWEED SURFACE GROWTH LIFT IN SITU

| Rev/Description | Date | By | CHK |
|---|---|---|---|
| Approximate extents of completed excavation | | | |
