# Completion Report

Kingsway, Manchester

Cube Great Places

| <b>Report Reference:</b> | <b>8003G-WML-00-XX RP-G-0003</b> |

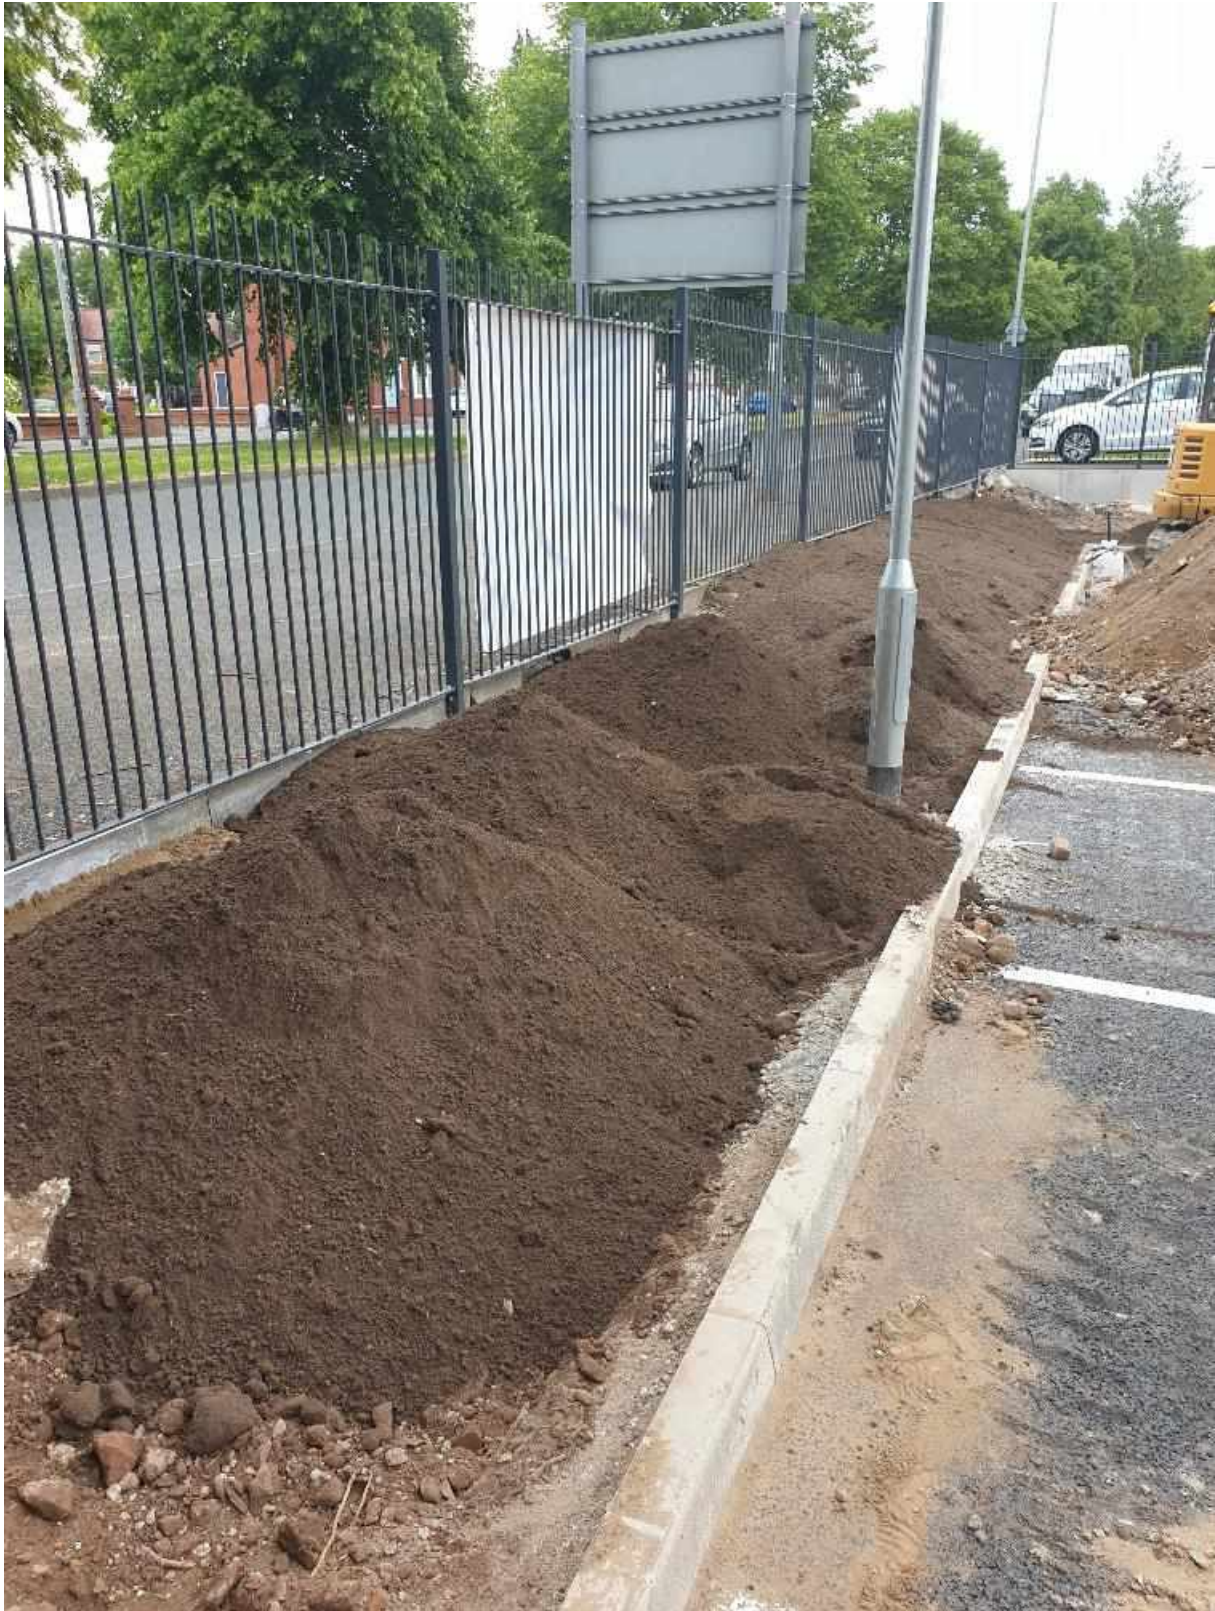
**Photograph 6**  
**Reduced area of thickness to the north-west of the car parking on Kingsway due to linear strip, changes in elevation and street furniture.**

- 3.11 The soft landscaping to the apartments forms a total area of approximately 250m<sup>2</sup> which based on the estimated thicknesses equates to 135m<sup>3</sup> of topsoil. Therefore, the 4no samples (obtained after import) equate to a testing regime of approximately 1 sample per 34m<sup>3</sup>.
- 3.12 A drawing showing the locations of the validation pits is presented in Appendix 01 with photographs from the groundworker presented within Appendix 02.

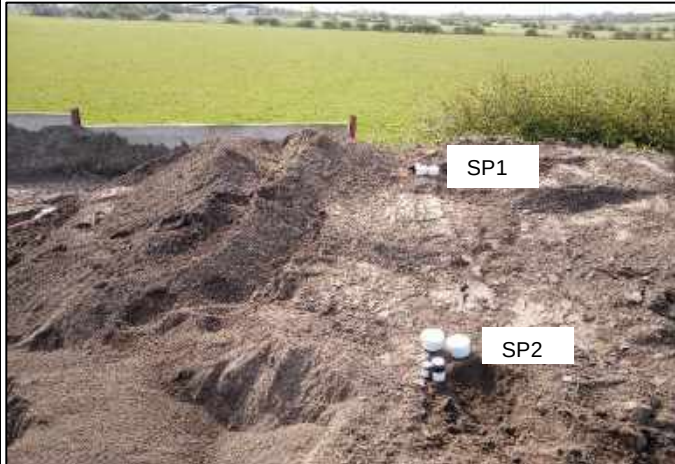
1 SP1 AND 2

Six near surface samples were taken at the positions determined and set out by Sub Surface, as shown on Figure 2 and were logged in accordance with BS EN ISO 14688-1: 2002 and BS EN ISO 14689-1: 2003 and samples were taken for contamination analysis. The log of the sample and photographs of the spoil mound sample locations are appended.
