# **LAND AT BLACKLEY MERE, CRUMPSALL, MANCHESTER**

## **SUPPLEMENTARY GROUNDWATER RISK ASSESSMENT REPORT**

**Report Title:** Land at Blackley Mere, Crumpsall, Manchester:  
Supplementary Groundwater Risk Assessment  
Report

**Report Reference:** 182.02.03

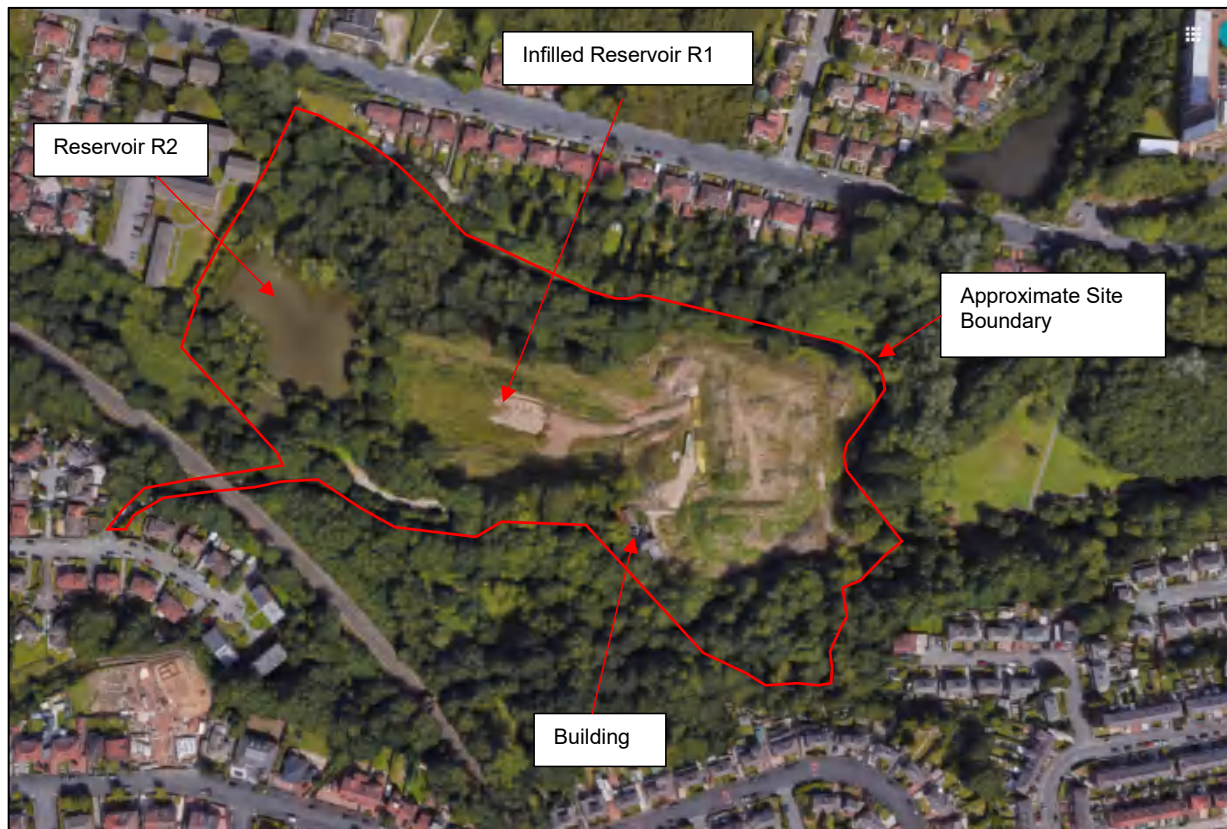
Figure 3: Site Aerial Photograph

Figure 3 depicts the current site status. A reservoir (R2) is present in the western sector of the site. The central sector comprises an infilled reservoir (R1). The eastern sector is partially covered with imported materials. A derelict building is present on the southern boundary. The immediate surrounding areas are predominantly residential but there is a cemetery on the far bank of the River Irk to the east of the site.

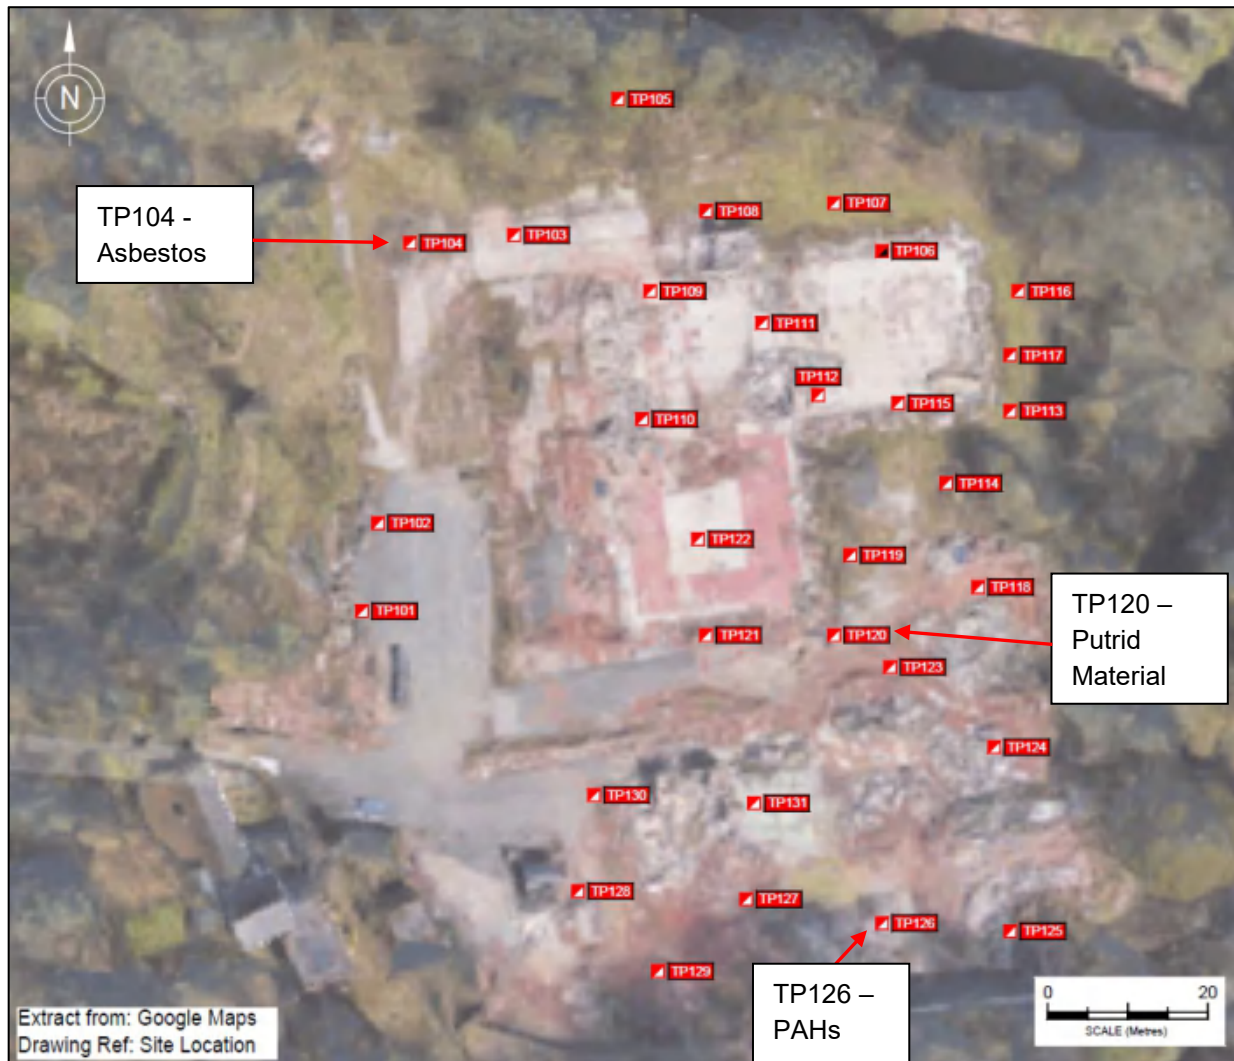
**Figure 6 Investigation Locations LKC (Eastern Area) Report (Taken from LKC Drawing no LKC 17 1257 Apr 2018)**

The area sampled is shown in Figure 6.

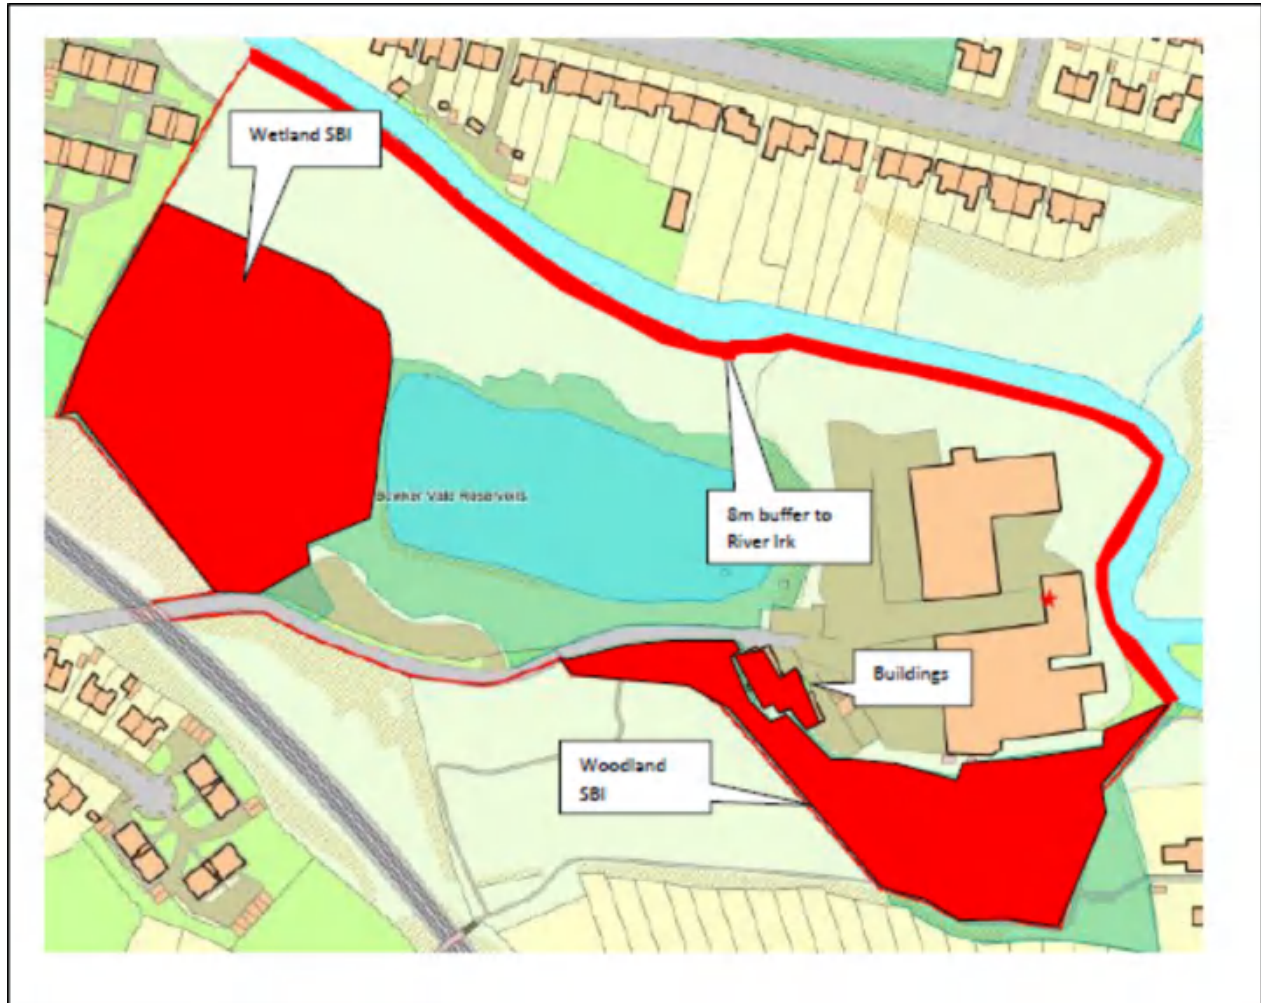
**Figure 8: Areas Which Require Habitat Protection**

Proposed control measures include programme constraints to avoid works within some months of the year, and an Ecological Mitigation Scheme comprising:

- A Wetland Management Scheme
- A Woodland Management Scheme
- An Invasive Non-Native Species (INNS) Management Scheme
