**City Labs 4.0**

## Geotechnical & Geoenvironmental Desk Study Report

GEO-REP-001

Issue | 7 May 2019

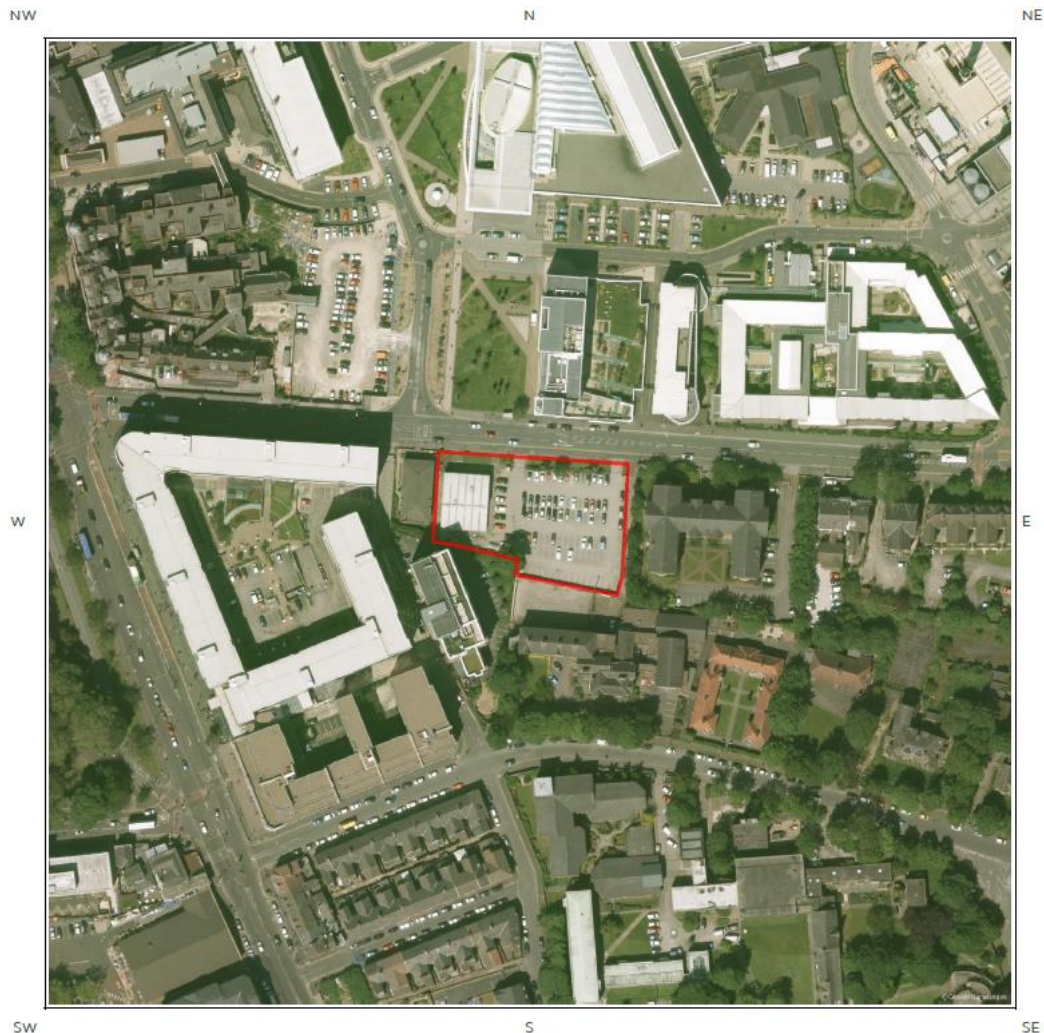
The site is located to the south of Manchester City Centre approximately 1.5km south of the A57(M) Mancunian Way. The site area is approximately 0.3ha and centred on National Grid Reference SJ851958 (385166 , 395814). A recent aerial photograph of the site is shown in Figure 1 below.

Figure 1: Site satellite image © Groundsure Report [1].

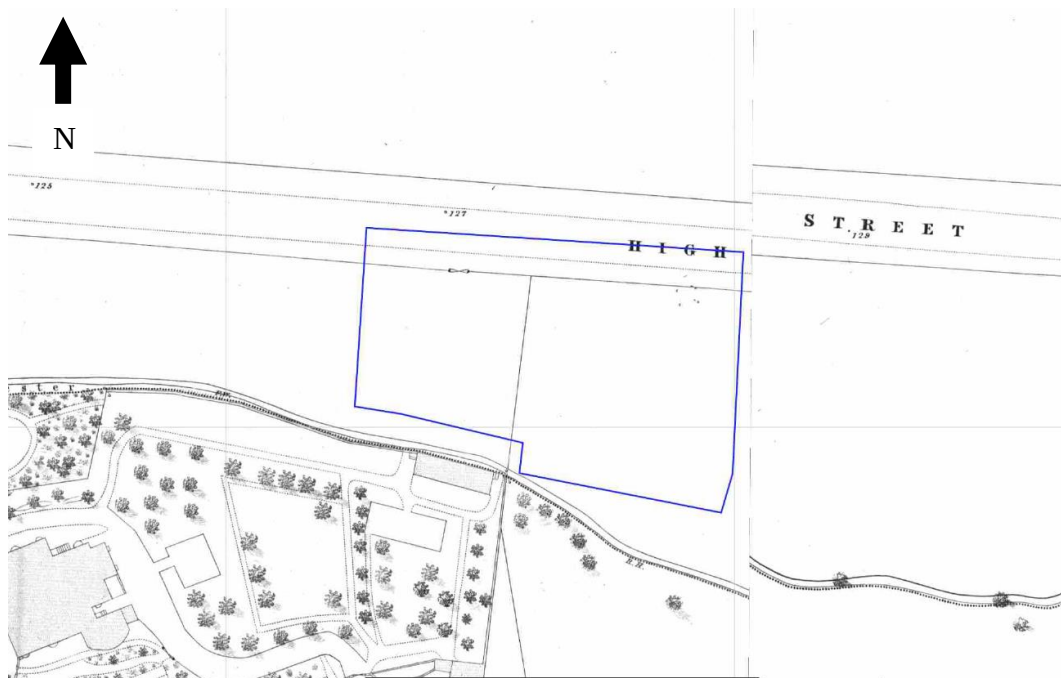
Figure 2 Historical OS mapping extract, 1848 to 1850, scale 1:1,056 [3].

The site history has been assessed through examination of a range of historical mapping held in the Arup Manchester archive, supplemented by the Groundsure report [3], and Google Earth Pro aerial imagery. A sequence of historical mapping and aerial image extracts are presented below. Table 1 summarises the historical development both on the site and on neighbouring sites.

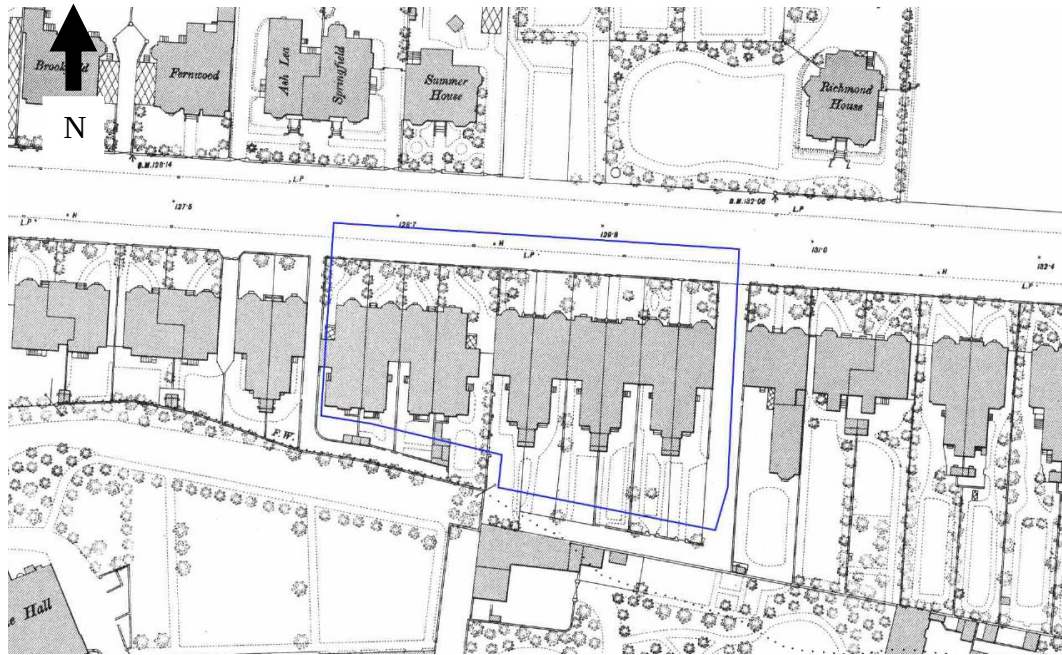
Figure 3 Historical OS mapping extract, 1891 scale 1:500 [3].
