Piccadilly elevation

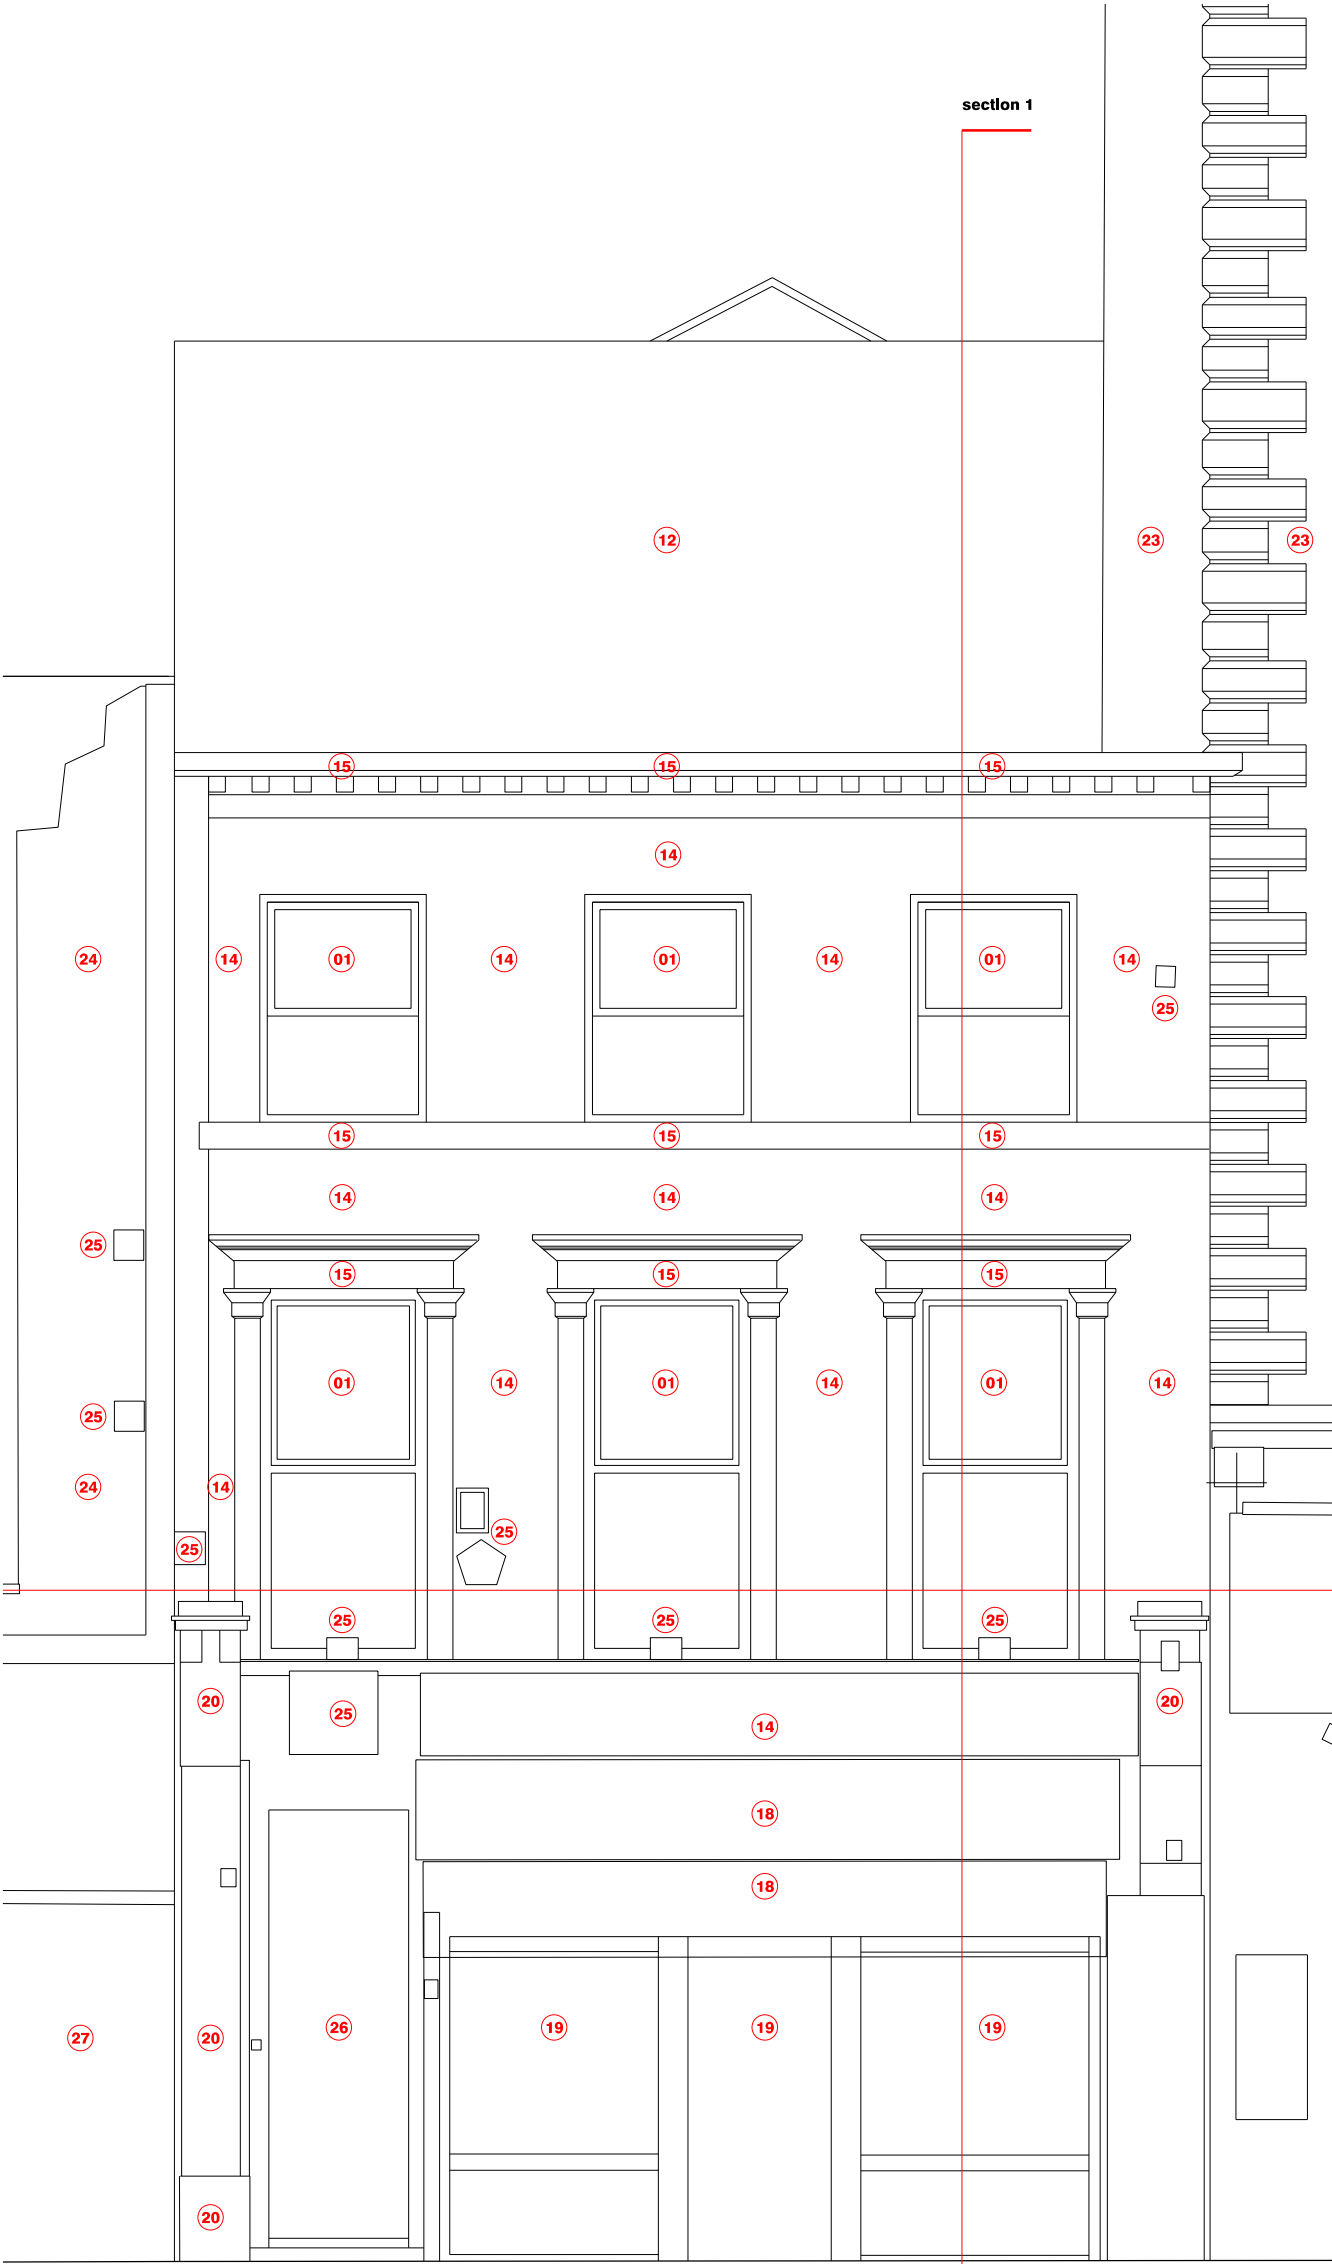
- 01 existing timber window, internal architraves, and cill  
02 existing dado rail  
03 existing skirting  
04 existing painted plaster wall  
05 existing painted plaster ceiling  
06 existing plasterboard ceiling concealing existing ceiling with possible cornice above  
07 existing chipboard raised floor  
08 existing cornices (others may be revealed following soft-strip)  
09 existing stone slab floor  
10 existing timber ceiling and beams  
11 existing floor tiles and skirtings  
12 existing slate roof  
13 existing timber door  
14 existing painted facade  
15 existing cornice  
16 existing lay-in ceiling tiles concealing existing ceiling with possible cornice above  
17 existing timber floor  
18 existing shop signage and roller shutter  
19 existing shop front door and glazed screens  
20 existing timber plasters  
21 existing shop fit-out  
22 existing painted brickwork  
23 gable and chimney of 49 Piccadilly

24 remnant of former TSB facade  
25 lights, alarms and other non-original items fixed to facade  
26 roller shutters concealing timber door  
27 hoarding  
28 existing brickwork  
29 existing stone cill
