## Detailed Unexploded Ordnance (UXO) Risk Assessment

| <b>Project Name</b> | 193 Hathersage Road, Manchester |
| <b>Report Reference</b> | DA8680-00 |

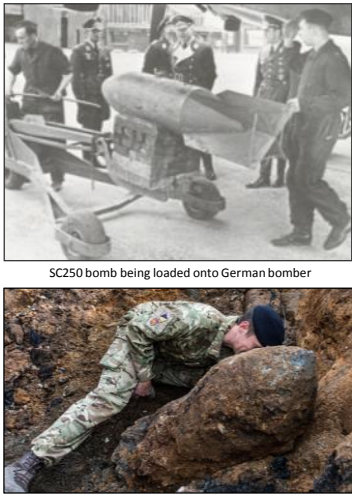
SC 250kg High Explosive Bomb

| Use | Against railway installations, embankments, flyovers, underpasses, large buildings and below-ground installations. |

SC250 bomb being loaded onto German bomber

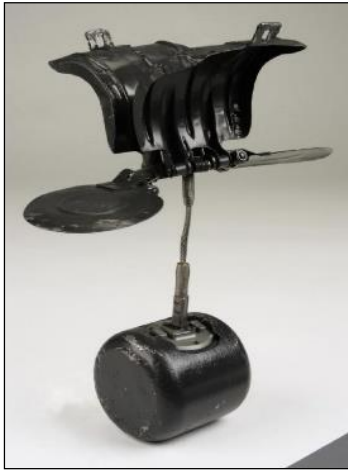
Parachute Mine (Luftmine B / LMB)

| Bomb Weight | Approx. 990kg (2176lb) |
| Use | Against civilian, military and industrial targets. Used as blast bombs and designed to detonate above ground level to maximise damage to a wider area. |
| Remarks | Deployed a parachute when dropped in order to control its descent. Had the potential to cause extensive damage in a 100m radius. |

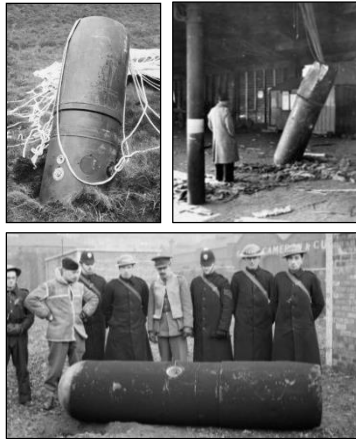
SC 1000kg

| Bomb Weight | Approx. 993-1027kg (2,189-2,264lb) |

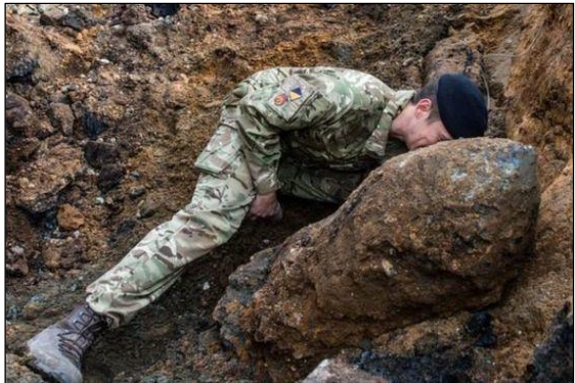
**Top:** J-curve Effect - Due to angle of entry, unexploded bombs would often end their trajectory at a lateral offset from point of entry, often ending up beneath adjacent extant structures/sites. The photograph above shows 250kg bomb found in Bermondsey pointing upwards, demonstrating 'J-curve'

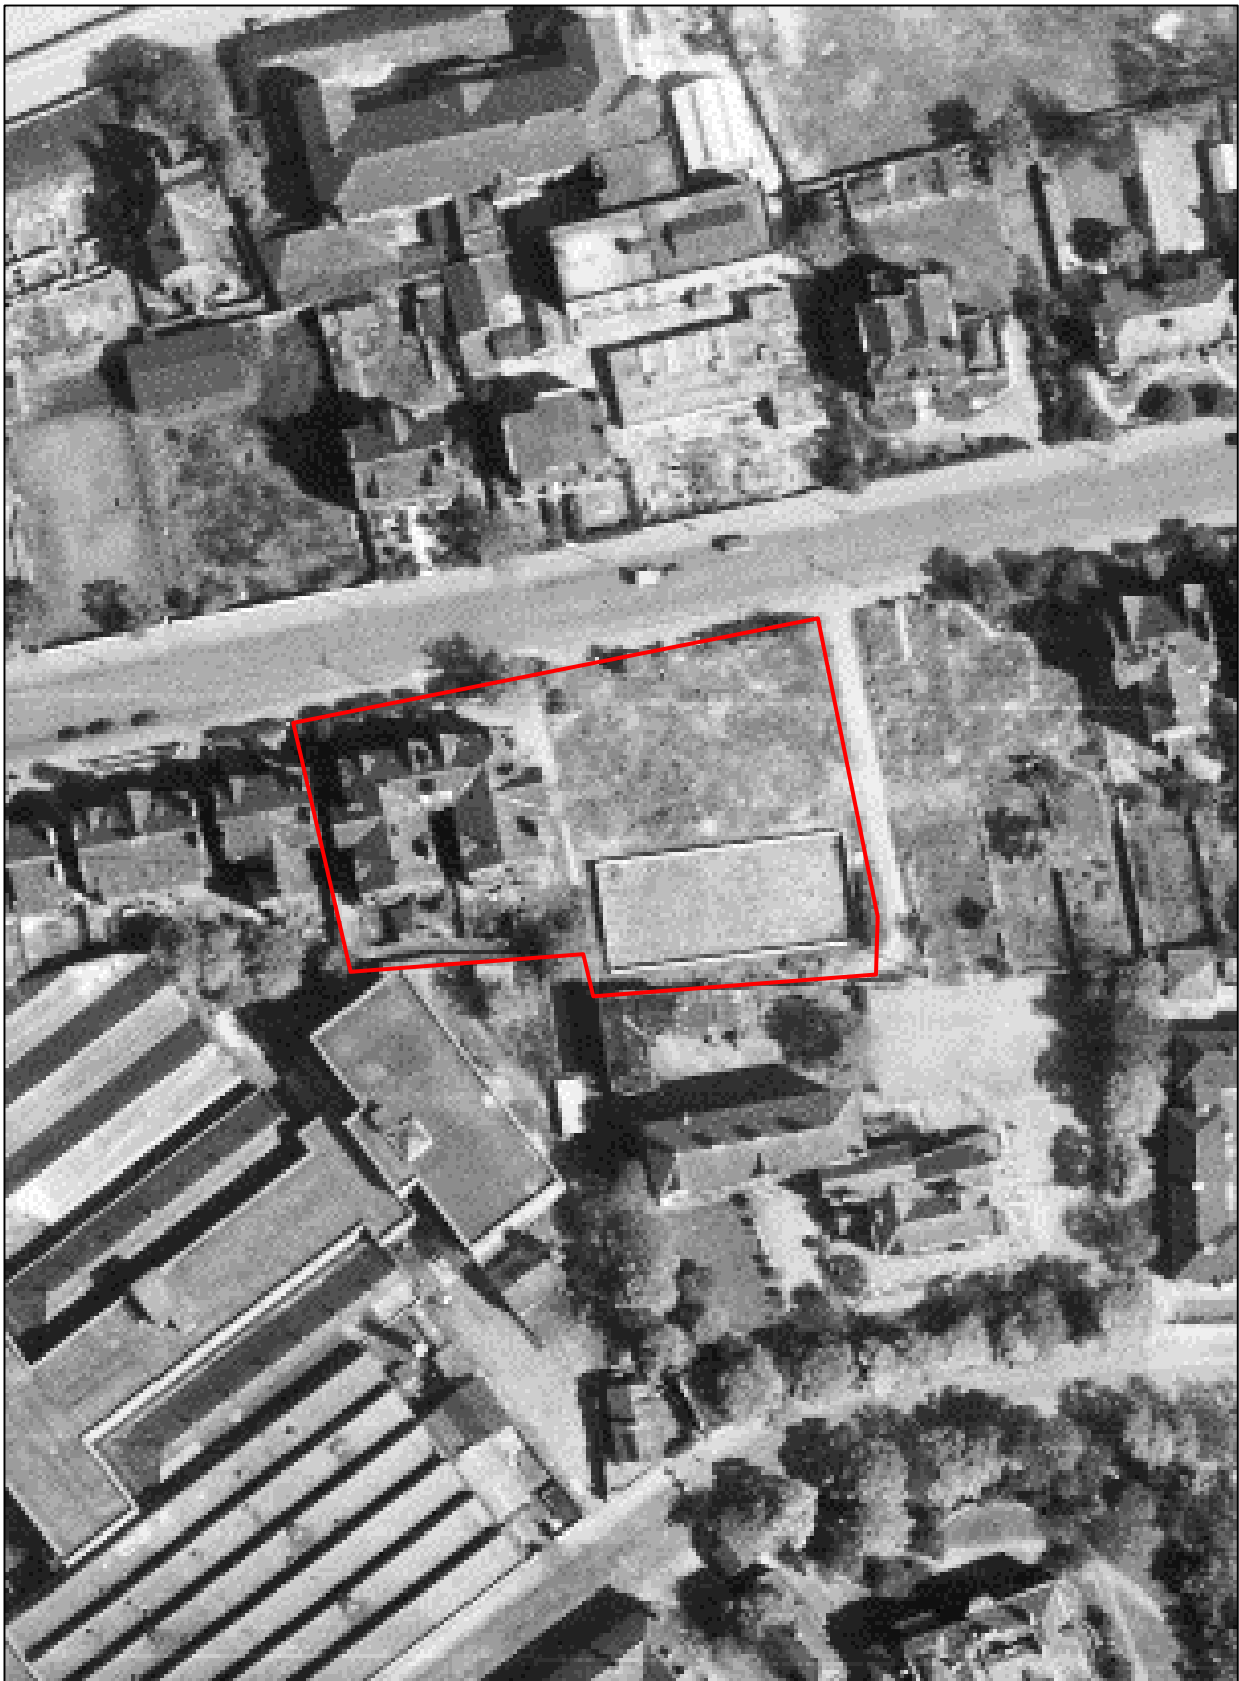
Source: Manchester Central Library

- Damage cards for Manchester were also obtained from the Manchester Central Library. This source records a number of properties on High Street to have been demolished owing to significant bomb damage. This includes property number 173, which historical OS mapping indicates was located within the very east of the proposed boundary, and number 171 which was located adjacent to the eastern boundary.

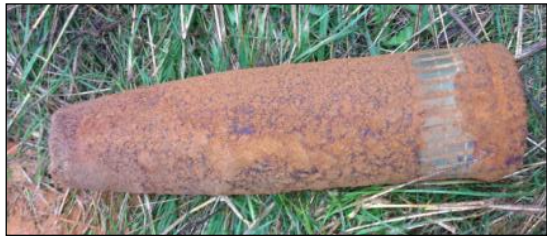
| Use | The 3.7in AA Mks 1-3 were the standard Heavy Anti-Aircraft guns of the British Army. |
| Ceiling | 30,000ft to 59,000ft |

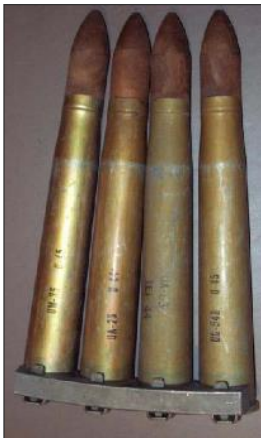
| Remarks | Light quick fire high explosive anti-aircraft projectile. Each projectile fitted with small tracer element. If no target hit, shell would explode when tracer burnt out. Designed to engage aircraft flying below 2,000ft |

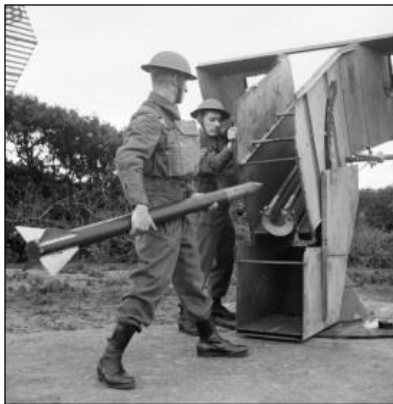
| Remarks | As a short range rocket-firing anti-aircraft weapon developed for the Royal Navy. It was used extensively by British ships during the early days of World War II. The UP was also used in ground-based single and 128-round launchers known as Z Batteries. Shell consists of a steel cylinder reduced in diameter at the base and threaded externally to screw into the shell ring of the rocket motor |
