Natural Stone Review  
Piccadilly Warehouse Project  
Manchester

The following document was prepared on 1<sup>st</sup> April 2021 with the intention of providing information to support the stone proposed for the restoration of the Piccadilly Warehouse Project, Manchester M1 3EF (11 Bloom Street and Mindel House, 10 Minshull Street).

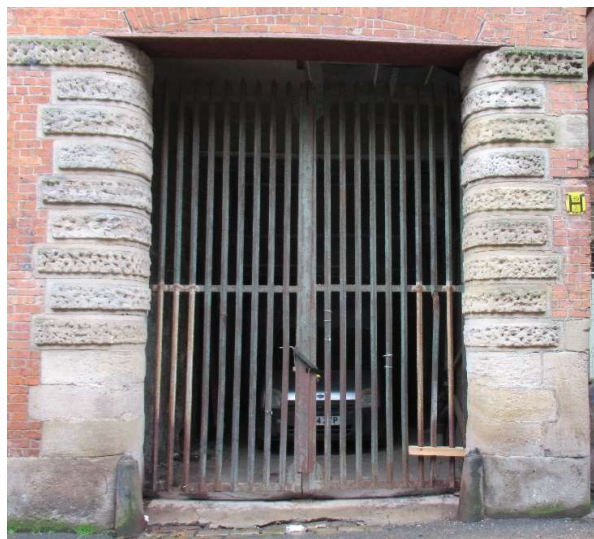
**Fig 1**

Elements holding a primary visual location or those containing a moderate degree of masonry detail are generally cut from stone that is more consistent in terms of colour and tend to exhibit a finer, medium to course grained texture. Elements of a more robust aesthetic have been produced from a less consistent material and contain a wider degree of bedding striation and granular size. For example, the loading bay to the rear of 11 Bloom Street (Fig 1) is produced from a course grained stone containing much larger quartz pebbles.

**Fig 1 – 4** Images taken at rear including ultra-close up showing granular structure.

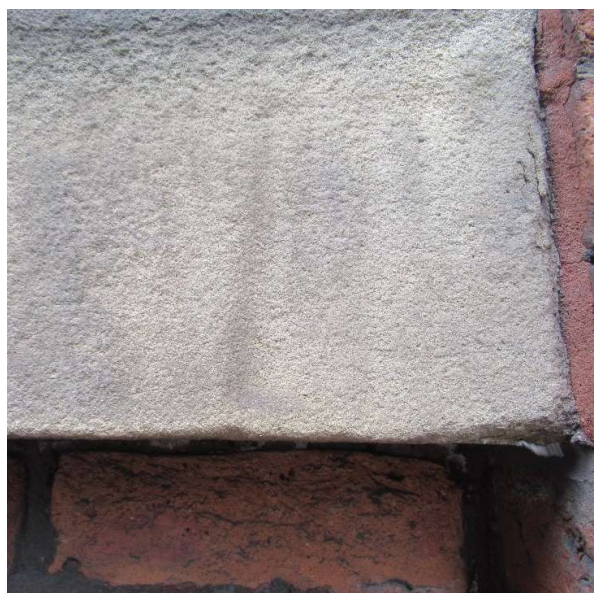
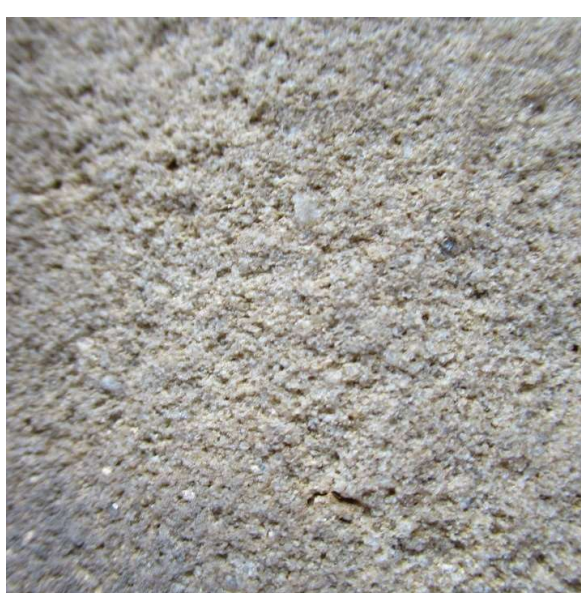
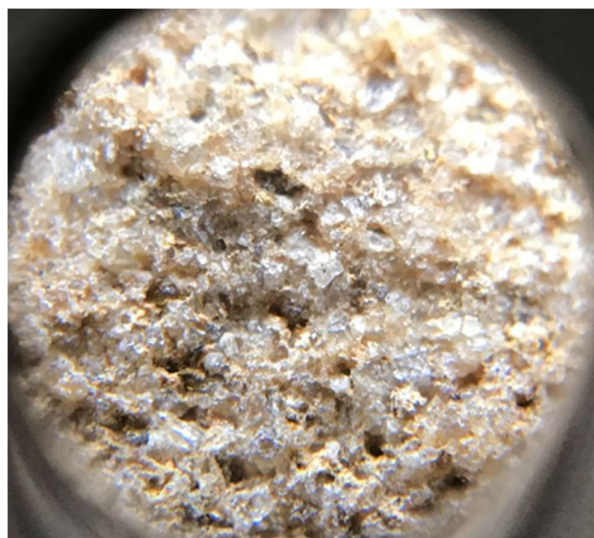
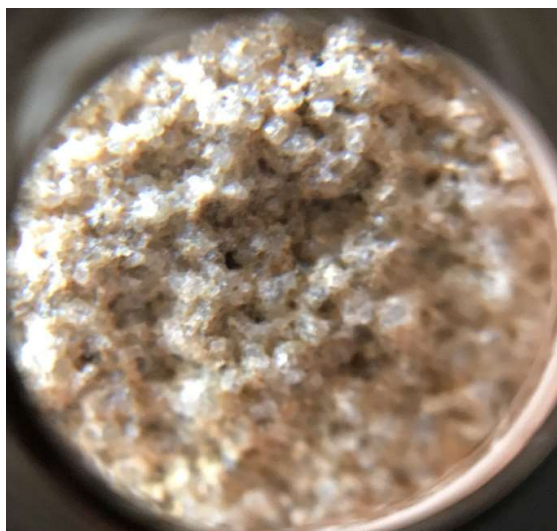
**Fig 5**

**Fig 5 –** Images taken at front including 2 ultra-close ups showing granular structure.

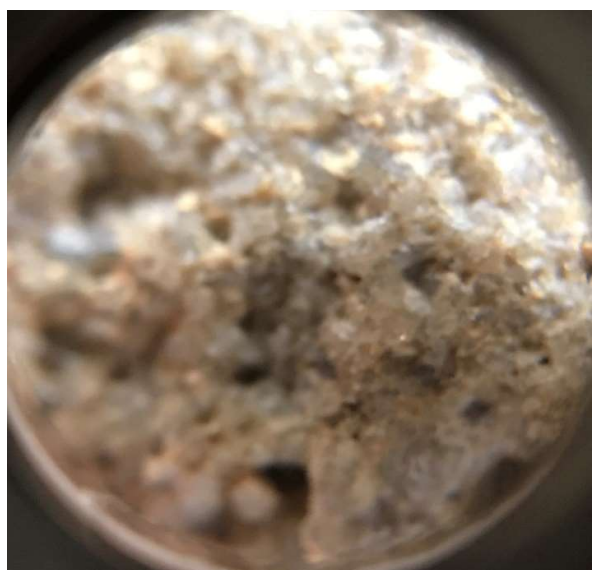
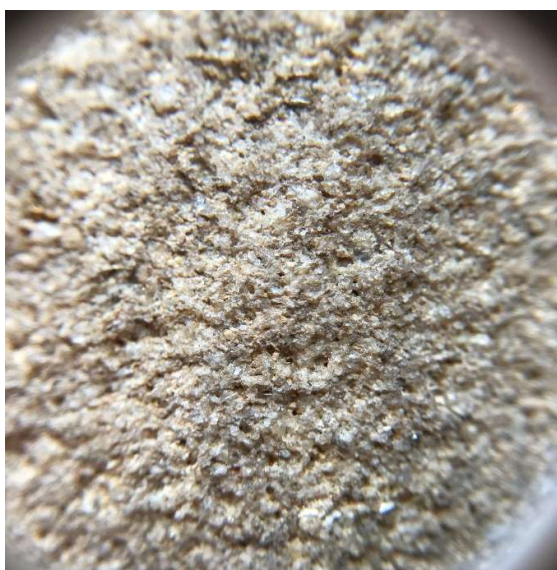
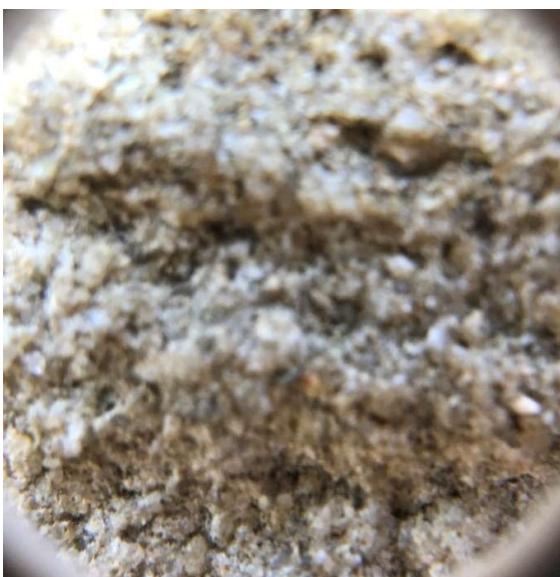
**Fig 9 – 12** Images showing ultra-close ups of granular structure at various locations round the buildings.

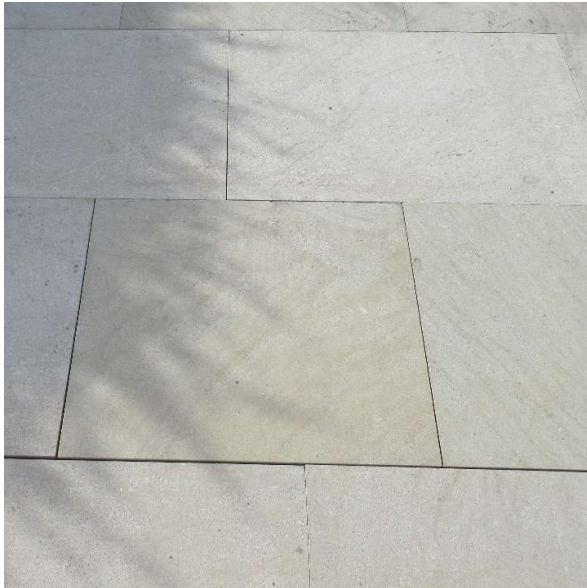
**Fig 13 – 16** Images of Crosland Hill including ultra-close ups of granular structure.

Crosland Hill Hard Yorkstone. The quarry is located approximately 22-miles North East of the site. The stone matches the assumed geological classification identified by site investigation and is similar in both colour and texture to that used on both buildings. The quarry can provide block stone of sufficient dimensional to accommodate full unit replacement of any components required should the need arise. Johnsons Wellfield have sufficient resources in terms of mineral deposit and manufacturing capability to produce any masonry work required. Crosland Hill quarry is extracting mineral that can be selected to accommodate both consistent or variant colour and granular size.
