| project | kampus • listed buildings |
| drawing number | AW(00)232e |

**minto proposed short elevations**

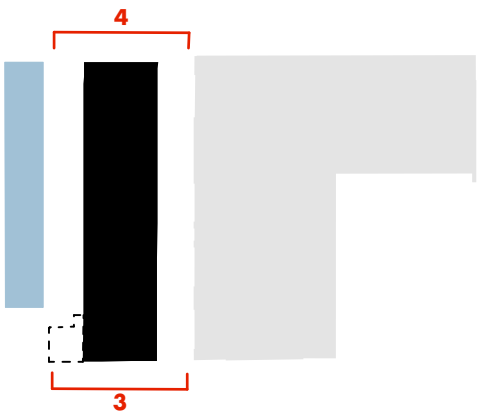
- 1 existing stonework to be cleaned (method tbc)
- 2 existing brickwork to be cleaned (method tbc)
- 3 existing timber door repaired and re-instated
- 4 slate roof re-laid with reclaimed tiles
- 5 existing stone copings to be repaired/replaced where necessary
- 6 new rooflights on central pivot
- 7 new PPC aluminium windows
- 8 existing stone cills to be cleaned (method tbc)
- 9 existing screens repaired and re-instated
- 10 existing steps repaired
- 11 existing fire escape to be retained and repaired (inaccessible)
- 12 new timber door - opening dimension to be confirmed following additional survey work
- 13 existing sign to be lightly cleaned and retained
