Our reference: 20200-CUR-XX-EX-RP-G-0001-P02

**Re: Phase 2 Ground Investigation Environmental Letter Report  
Temporary Car Parks at North Manchester General Hospital**

TCP05 Northern Temporary Carpark  
Option 2 - Standard Paving

PROJECT  
**MSCP ENABLING WORKS**

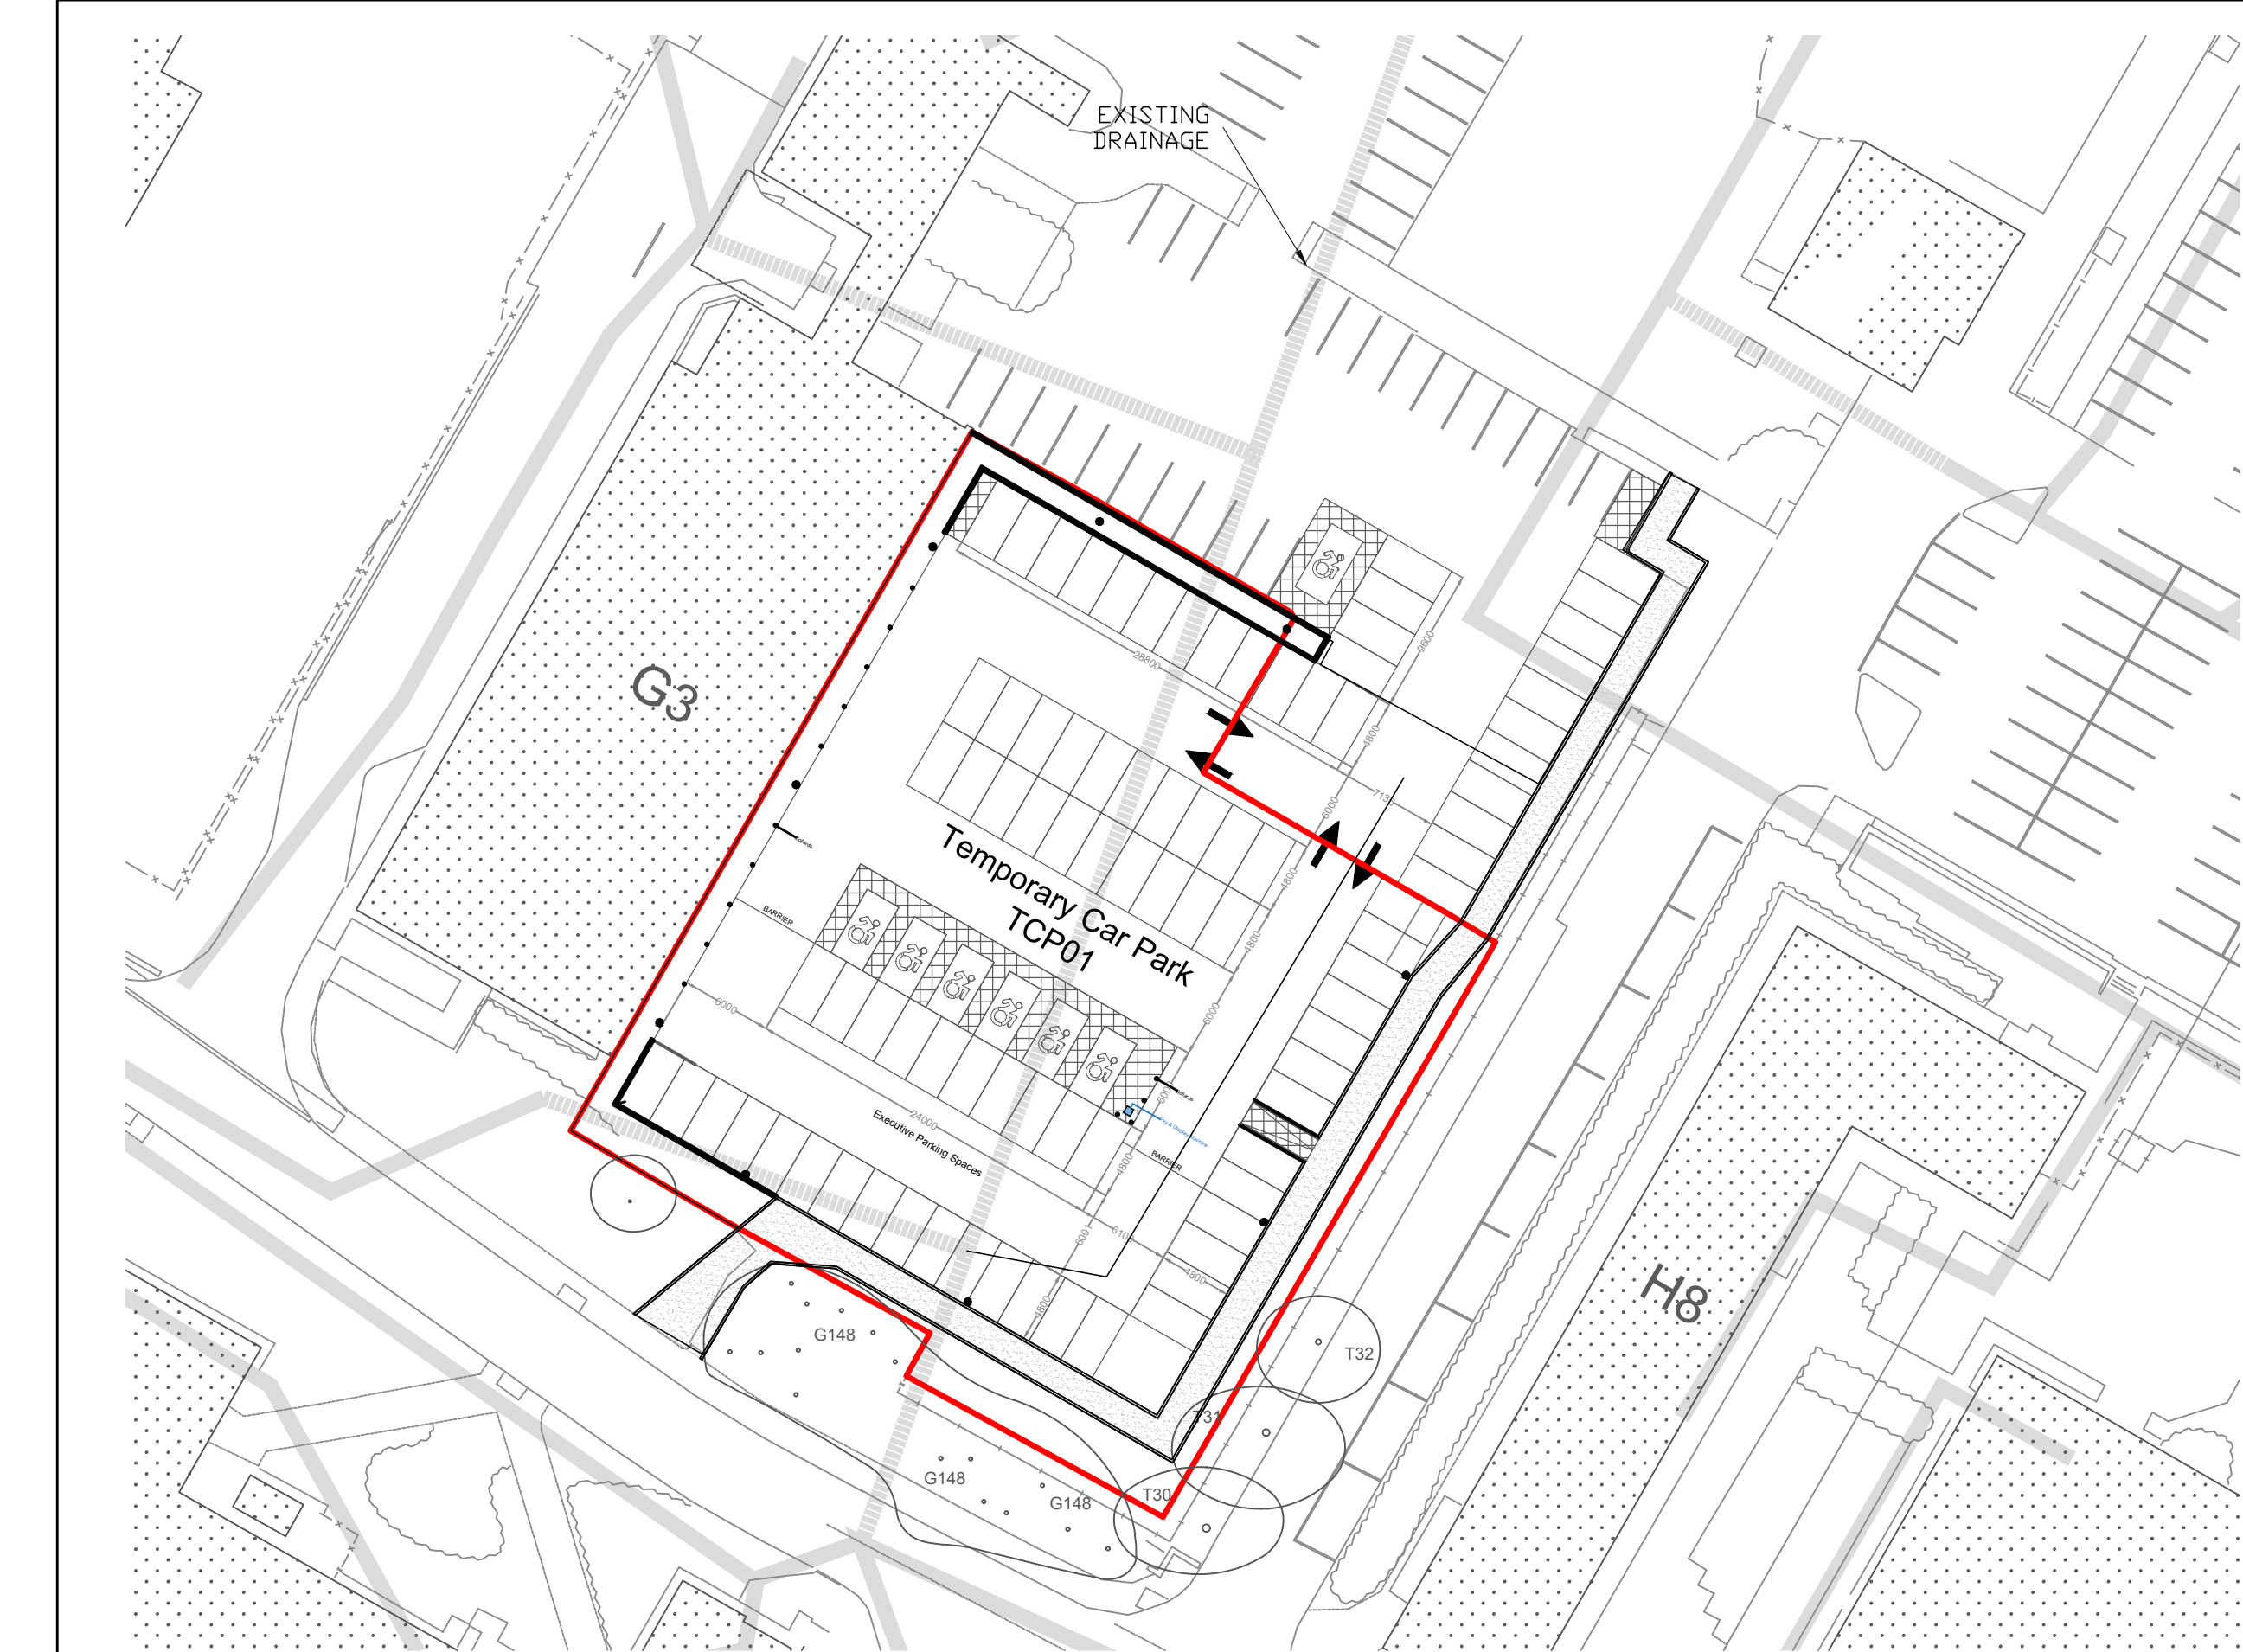
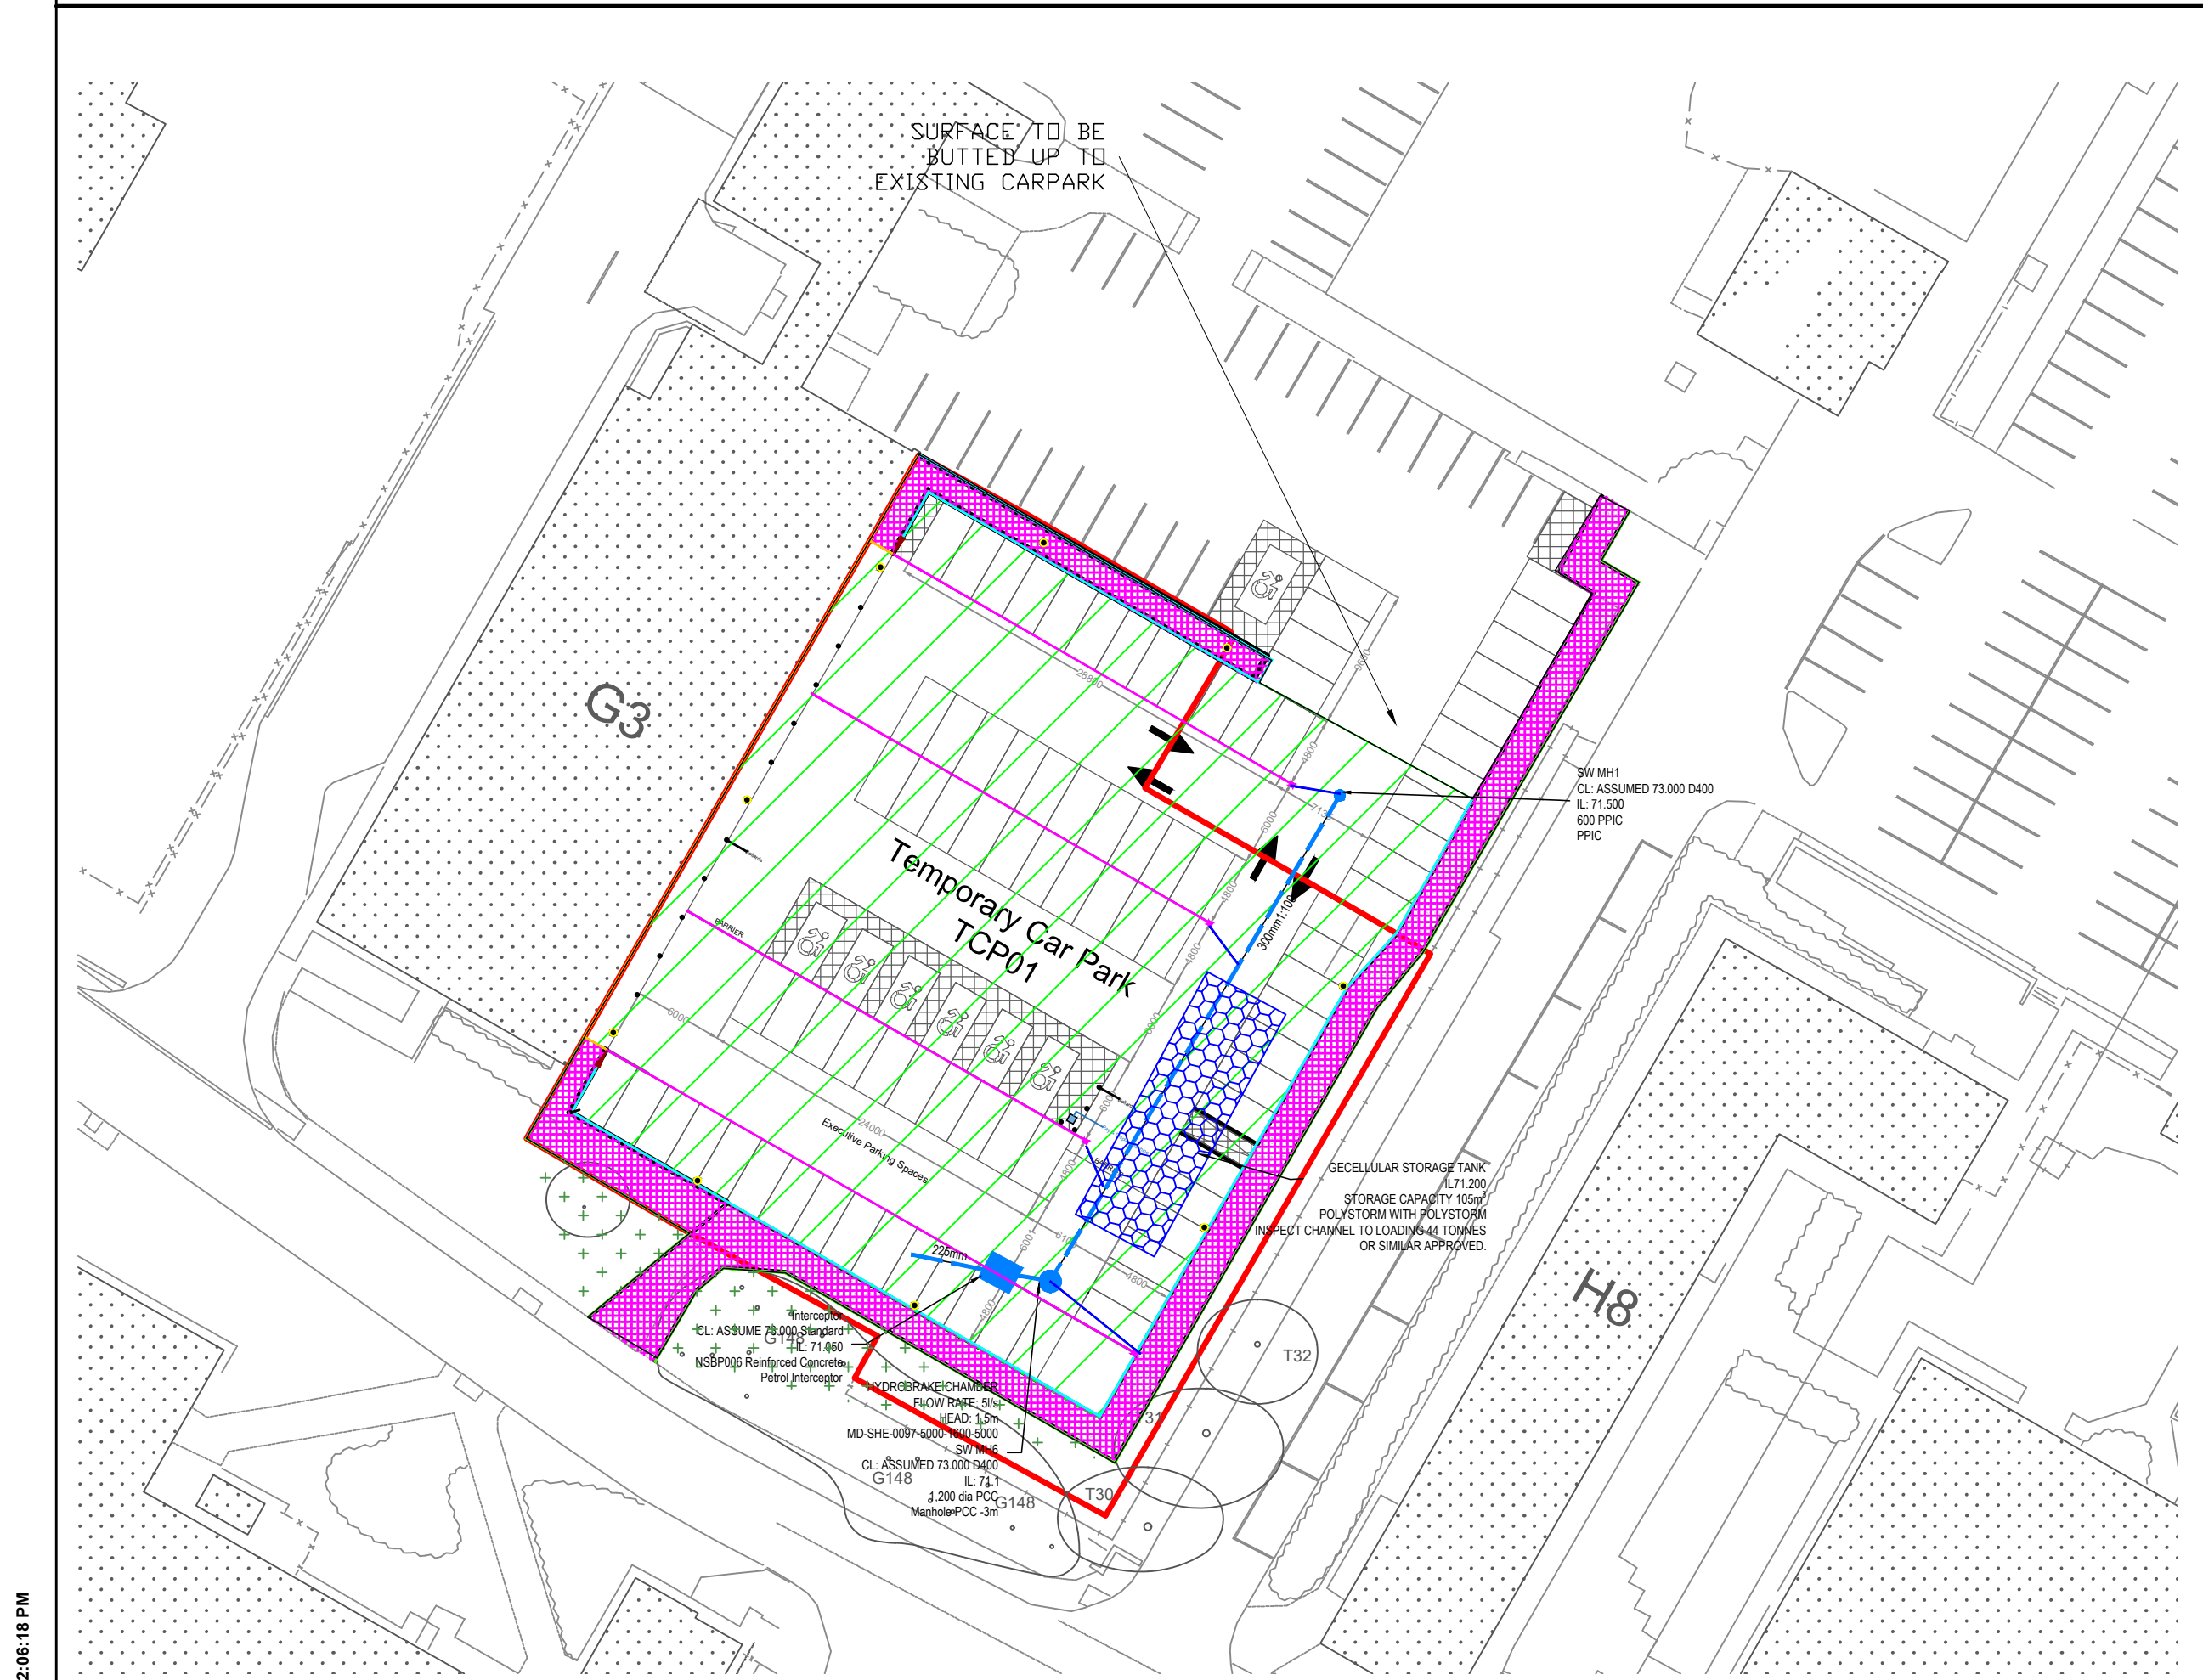
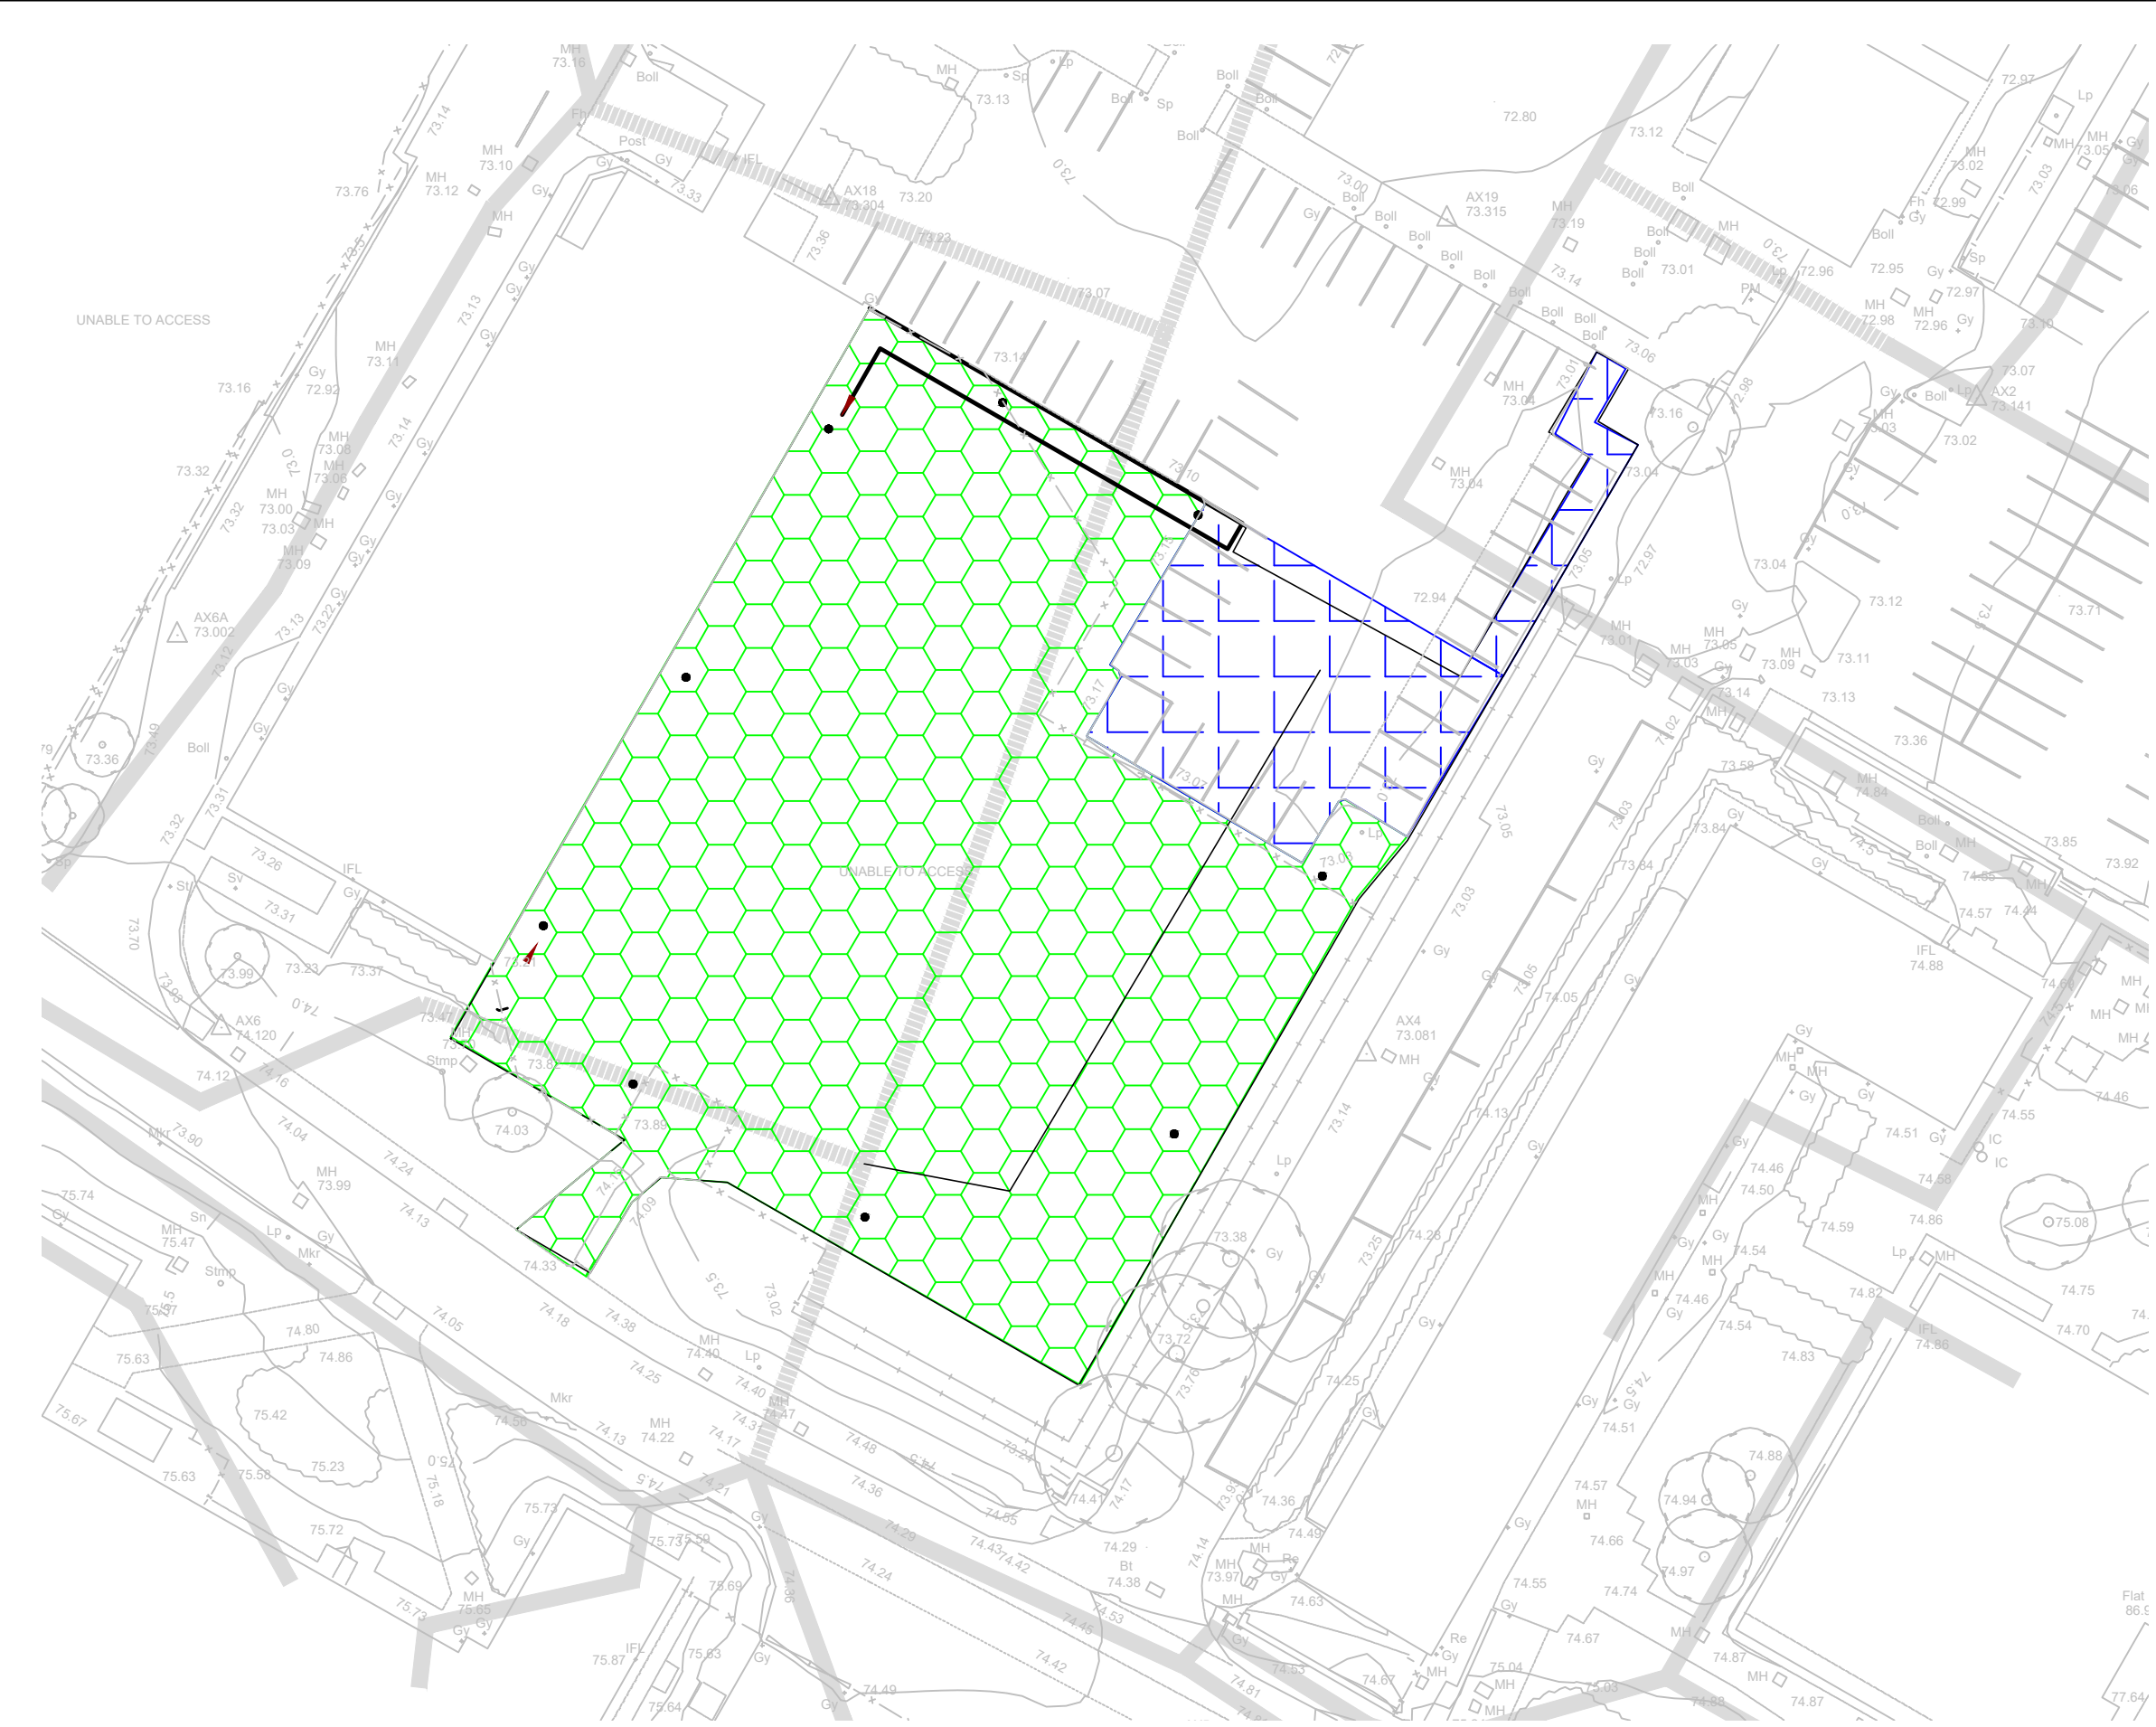
GENERAL ARRANGEMENT

SITE CLEARANCE

- Curtins drawing ref. 20200-CUR-MSCP-EXDR-D-9511 P01
- Curtins drawing ref. 20200-CUR-MSCP-EX-DR-D-9521 P02
