Phase II Geoenvironmental Site Assessment  
Land at Jersey Street, Ancoats, Manchester

Reference:13-350-R3  
Date: February 2020

## PHASE II GEOENVIRONMENTAL SITE ASSESSMENT

Parcel C  
Manchester Life Phase 3  
Land to the north and south of Jersey Street,  
Manchester,  
M4 6JW

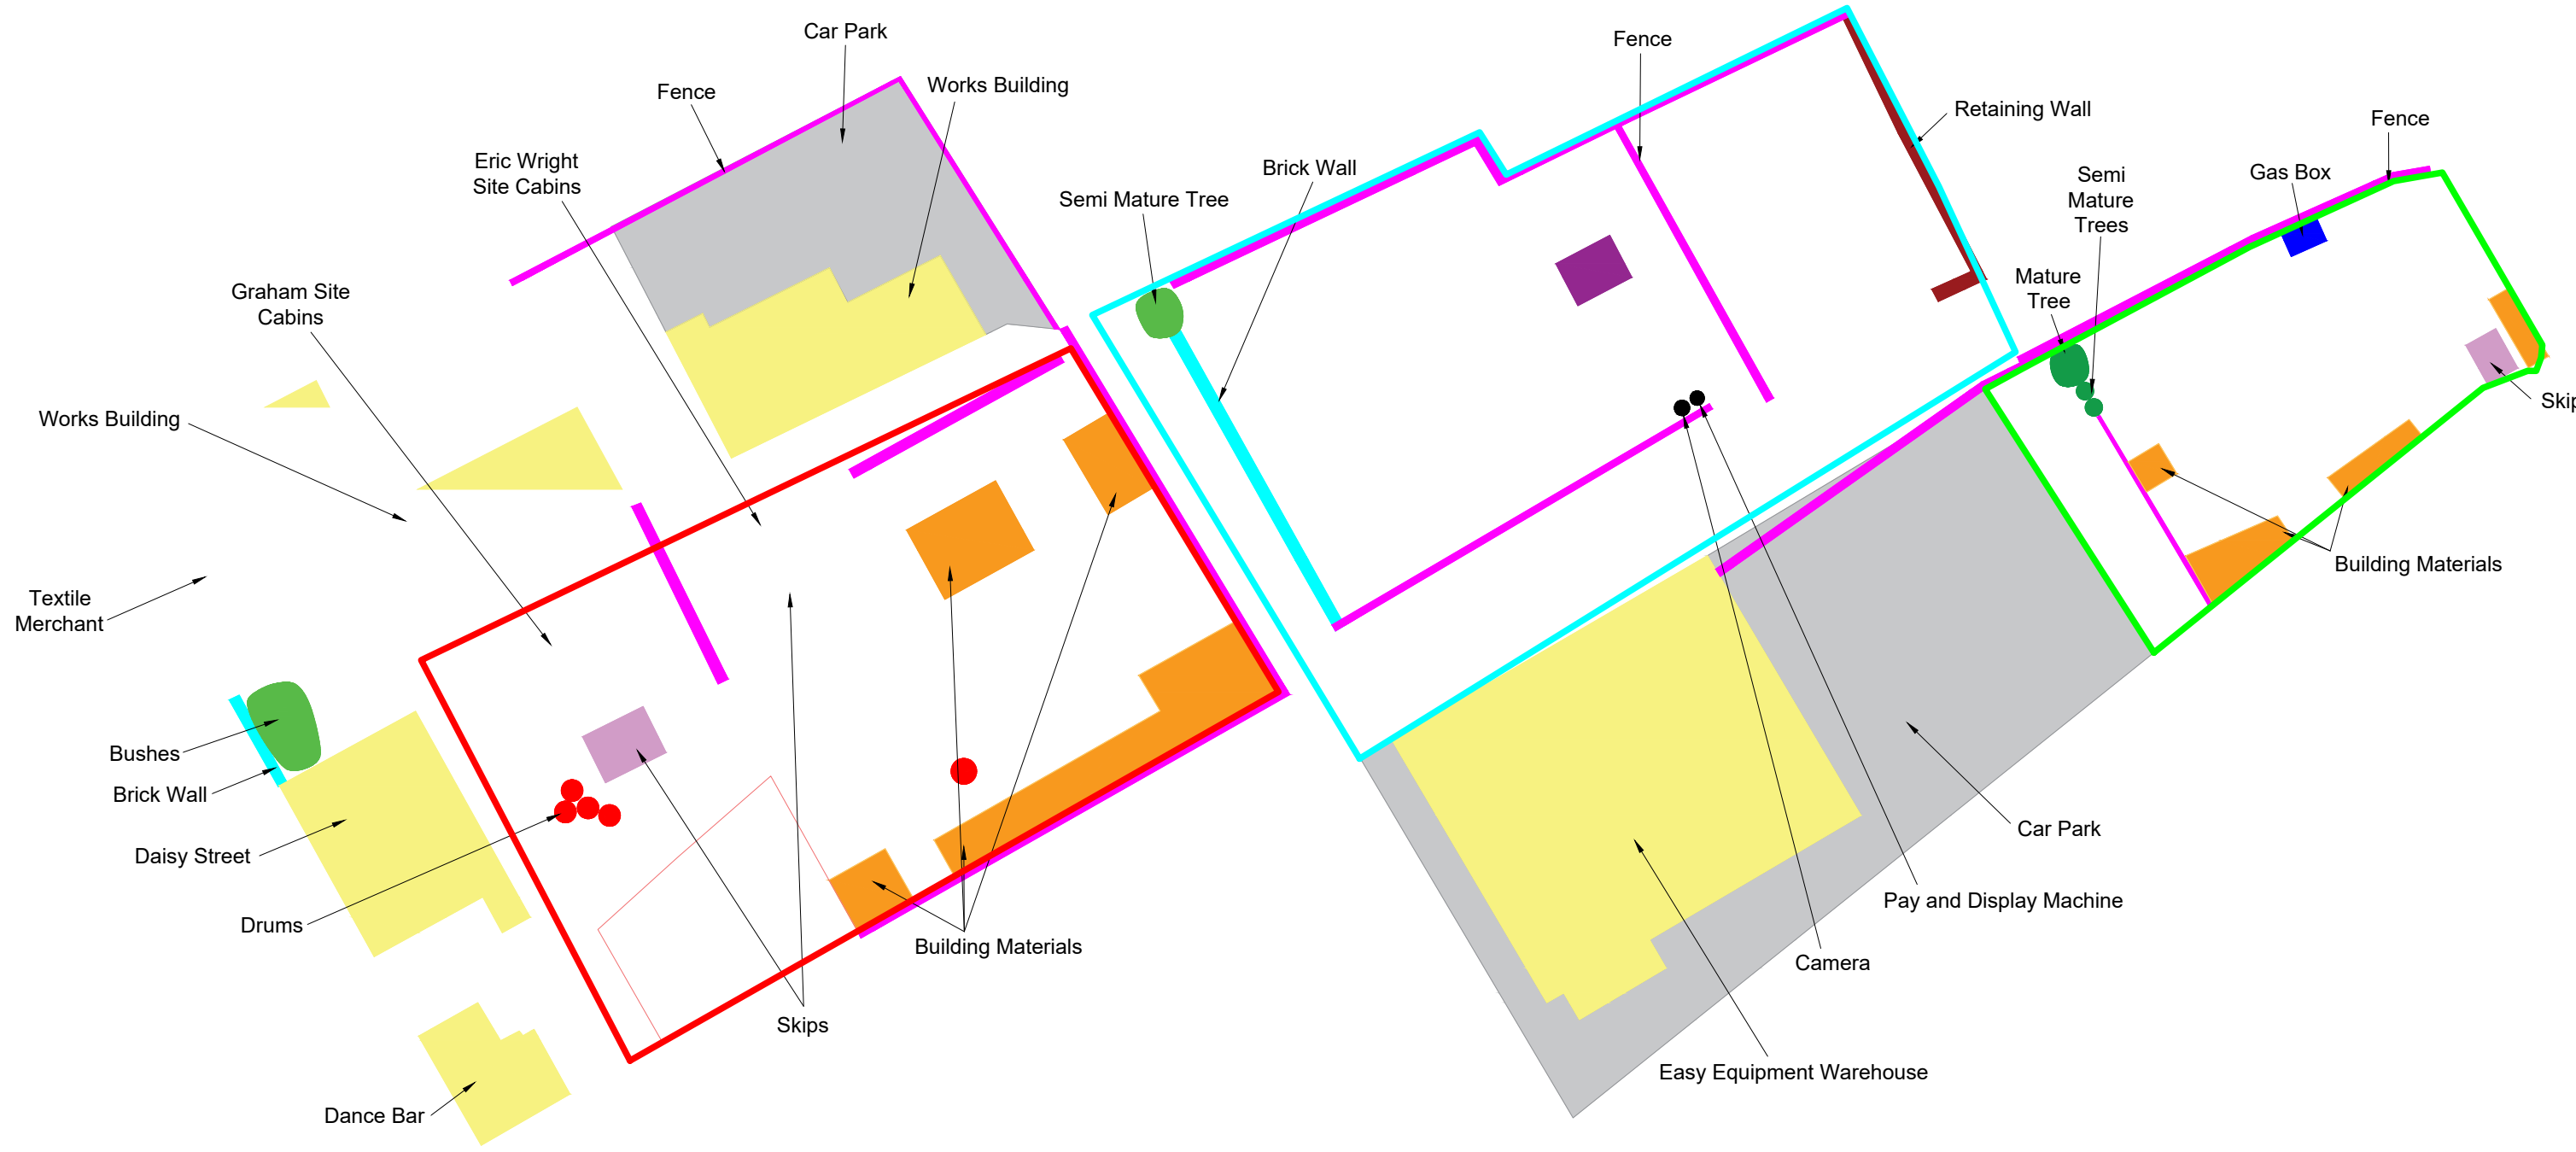
- Current Site Features**
- Skips
  - Existing Commercial Buildings
  - Trees/Bushes
  - Site Cabins
  - Gas Box
  - Building Materials
  - Retaining Wall
  - Car Park
  - Drums
  - Brick Wall
  - Fence
  - Camera/Pay and Display Machine
  - Parcel A
  - Parcel B
  - Parcel C

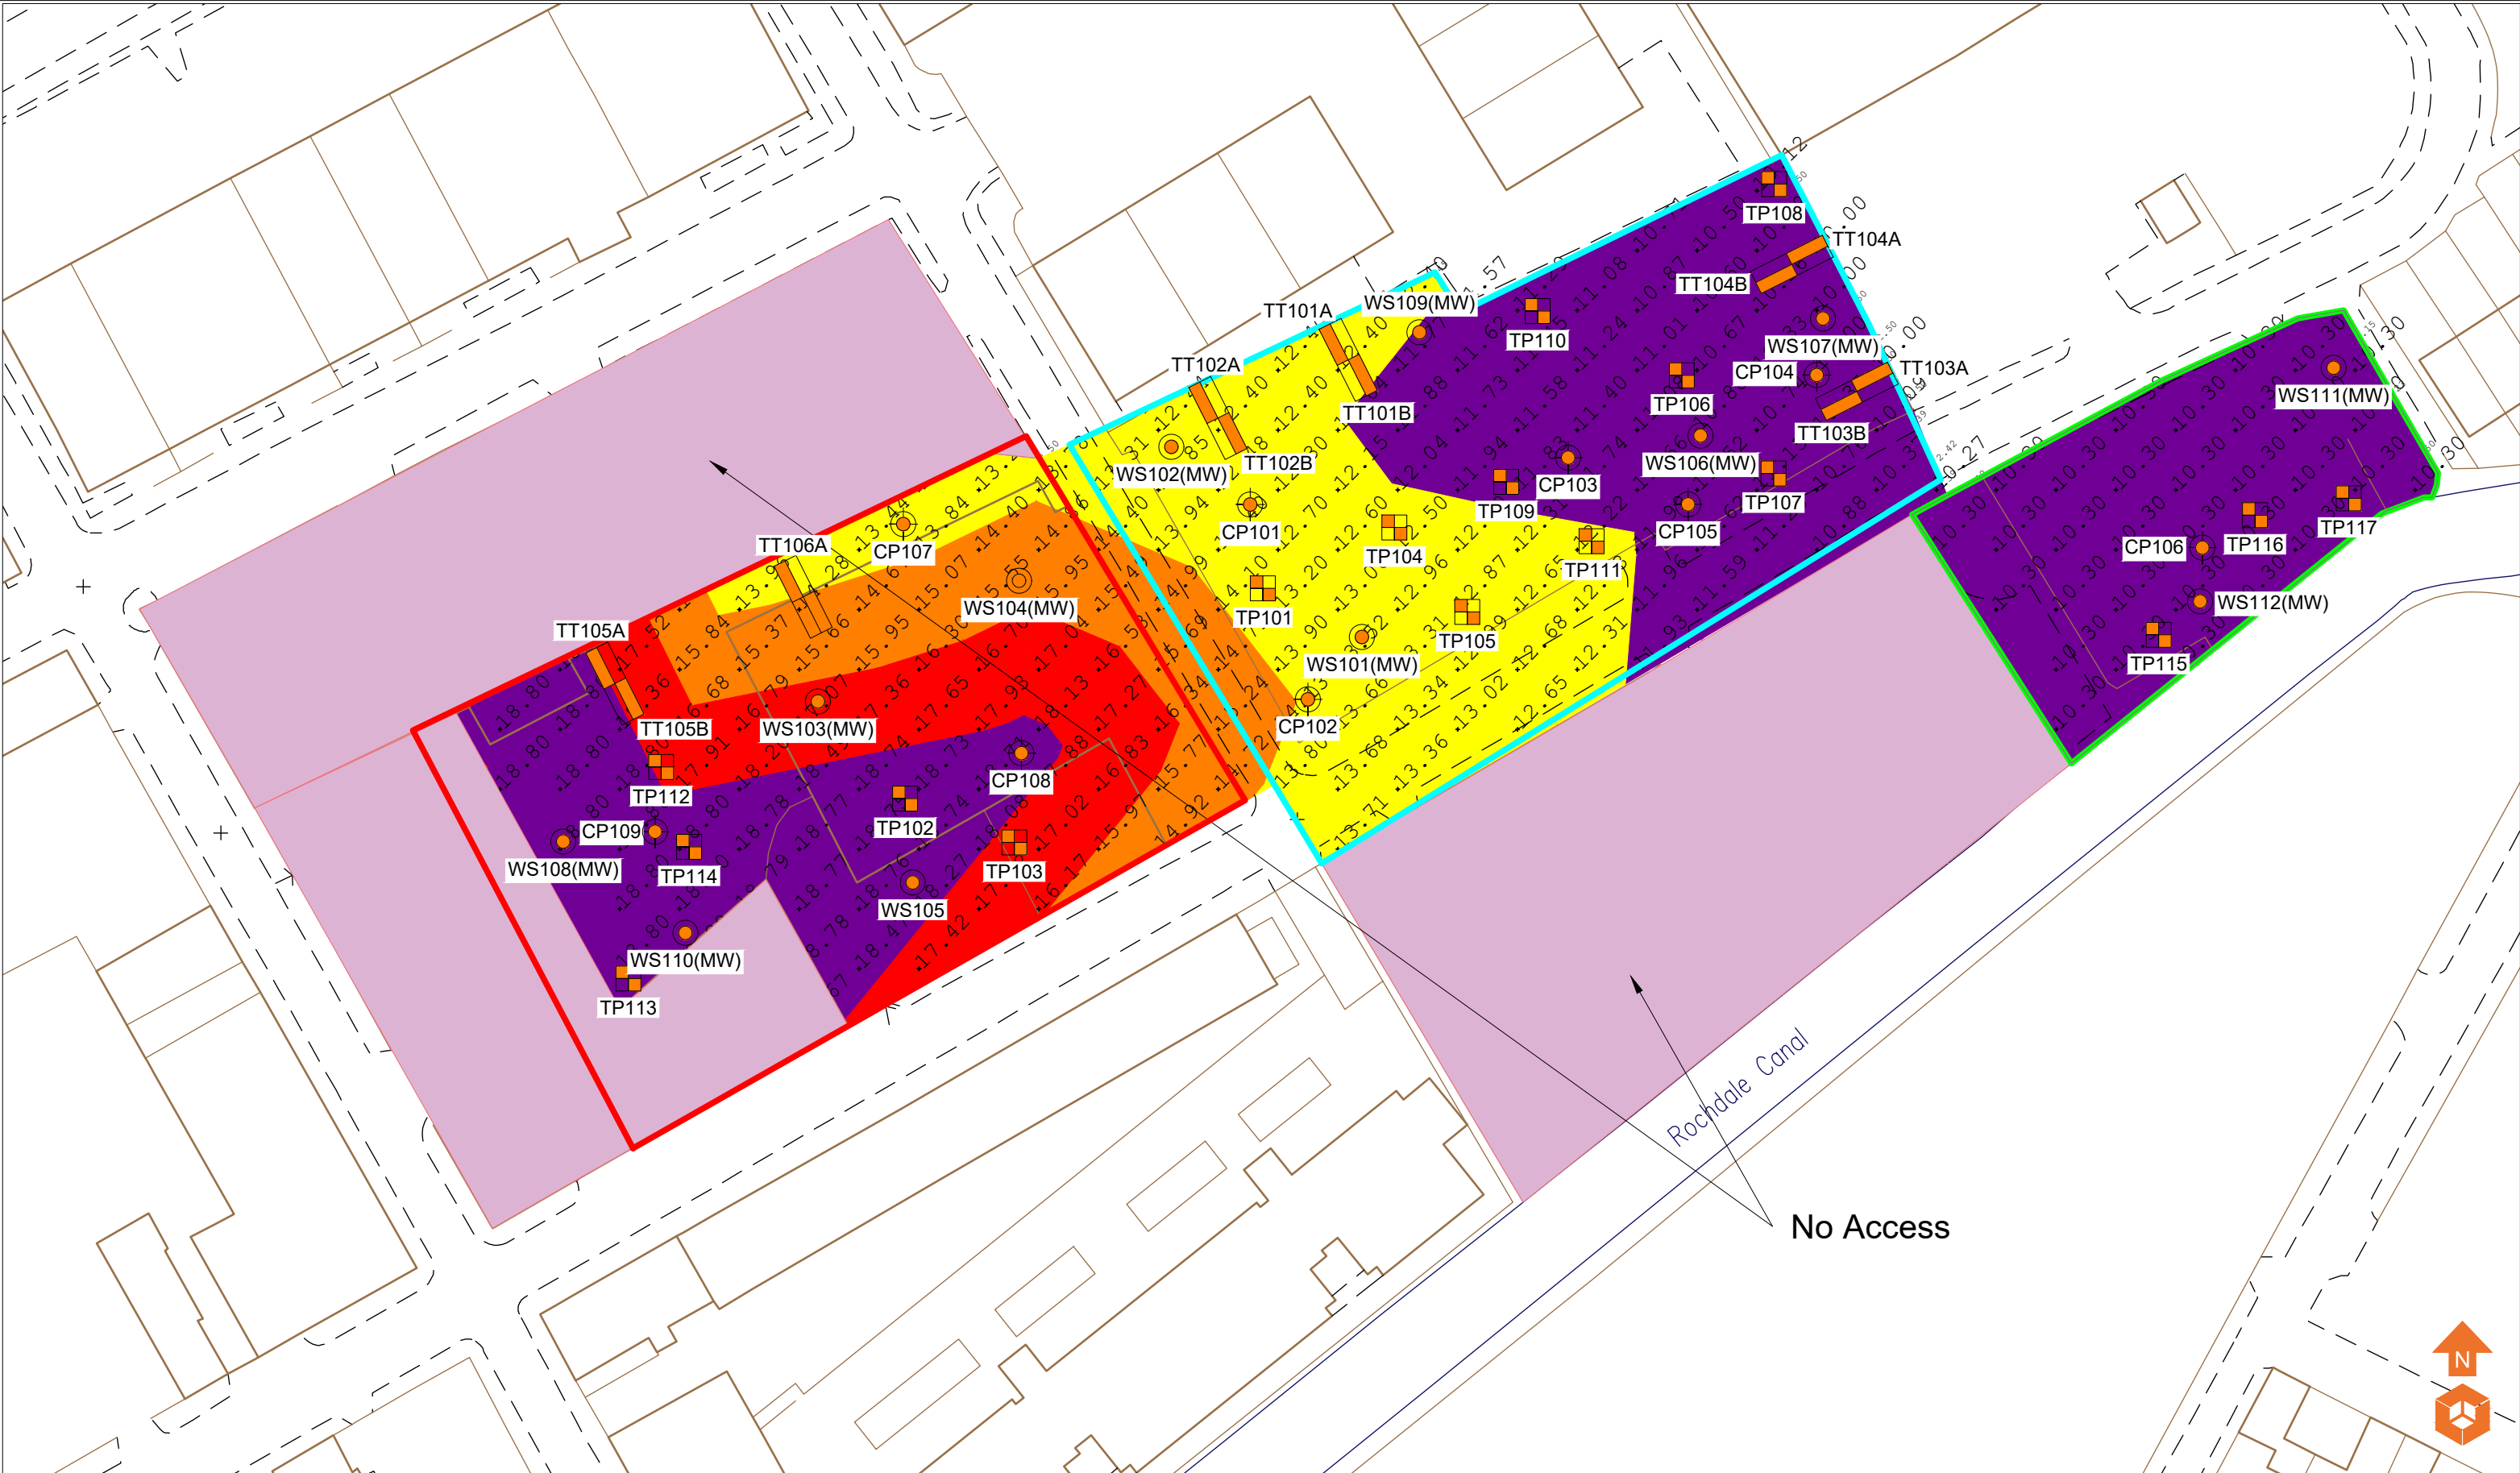
| <div>Location Symbols</div> <div><div><div><div></div><div>Approximate Window Sample Probehole Location</div></div><div><div></div><div>Approximate Trial Pit Location</div></div><div><div></div><div>Approximate Silt Trench Location</div></div><div><div></div><div>No Access</div></div><div><div></div><div>Full Extent of Made Ground Not Identified</div></div><div><div></div><div>Parcel A</div></div><div><div></div><div>Parcel B</div></div><div><div></div><div>Parcel C</div></div></div><div>Depth to Bedrock (m)</div><div><div><div></div><div>Depth to Bedrock 0.00 - 1.99m</div></div><div><div></div><div>Depth to Bedrock 2.00 - 3.99m</div></div><div><div></div><div>Depth to Bedrock 4.00 - 5.99m</div></div><div><div></div><div>Depth to Bedrock 6.00 - 7.99m</div></div><div><div></div><div>Depth to Bedrock 8.00 - 9.99m</div></div><div><div></div><div>Depth to Bedrock 10.00 - 11.99m</div></div><div><div></div><div>Depth to Bedrock 12.00 - 13.99m</div></div><div><div></div><div>Depth to Bedrock 14.00 - 15.99m</div></div><div><div></div><div>Depth to Bedrock &gt;16.00m</div></div></div></div> | | <div>Notes:</div> | | | | | | <div>Client:</div> <div>Manchester Life</div> | | <div>Job No:</div> <div>13-729</div> | <div>Date:</div> <div>17.02.2020</div> | <div><div><div><div></div><div>e3p</div></div><div>Environmental Engineering Partnerships Ltd<br/>City Heliport &amp; Business Centre<br/>Eccles, Manchester, M30 7RU<br/>Tel: 0161 707 9612<br/>E-mail: info@e3p.co.uk<br/>Website: www.e3p.co.uk</div></div></div> | | | |

The sampling locations are illustrated in Drawing 13-729-004 (Appendix III). The ground conditions encountered are indicated on the logs, which are provided in Appendix V.

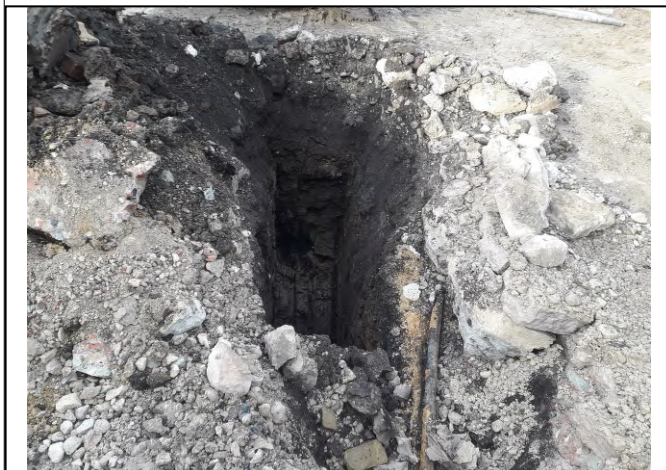
Trial Pit 115

Remarks: 1. Complete. 2. Moved west due to services at 0.60m bgl.

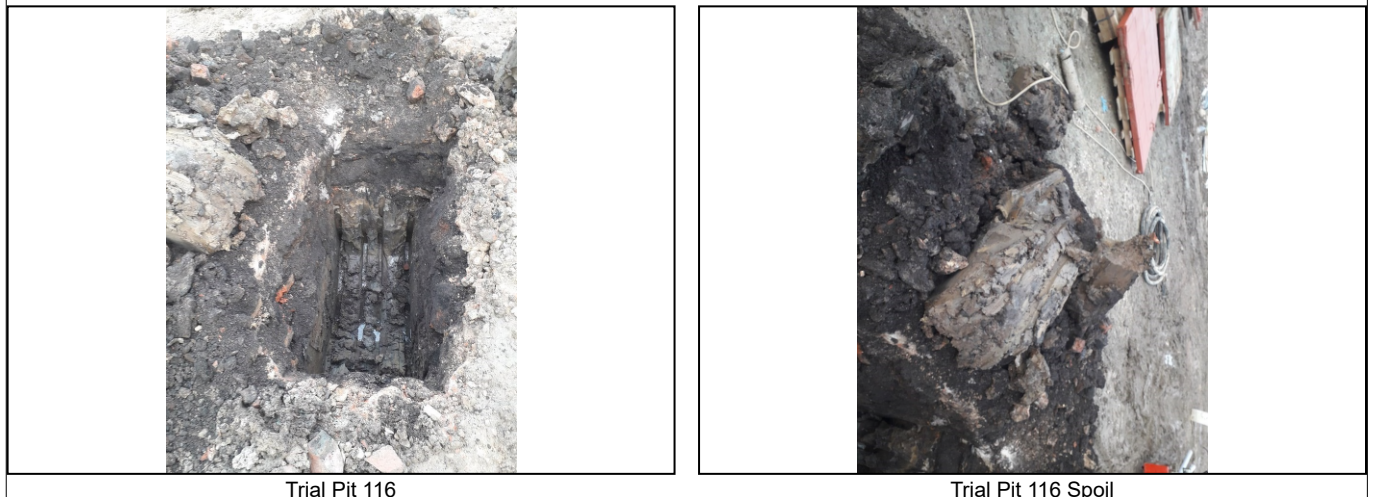
Trial Pit 116 Spoil
