**DOWNLEY DRIVE  
MANCHESTER  
M4 7JU**

## **PHASE 2 GEO-ENVIRONMENTAL INVESTIGATION AND ASSESSMENT**

**GREAT PLACES HOUSING ASSOCIATION**

**Ref: 19-B-12490/Downley Drive**

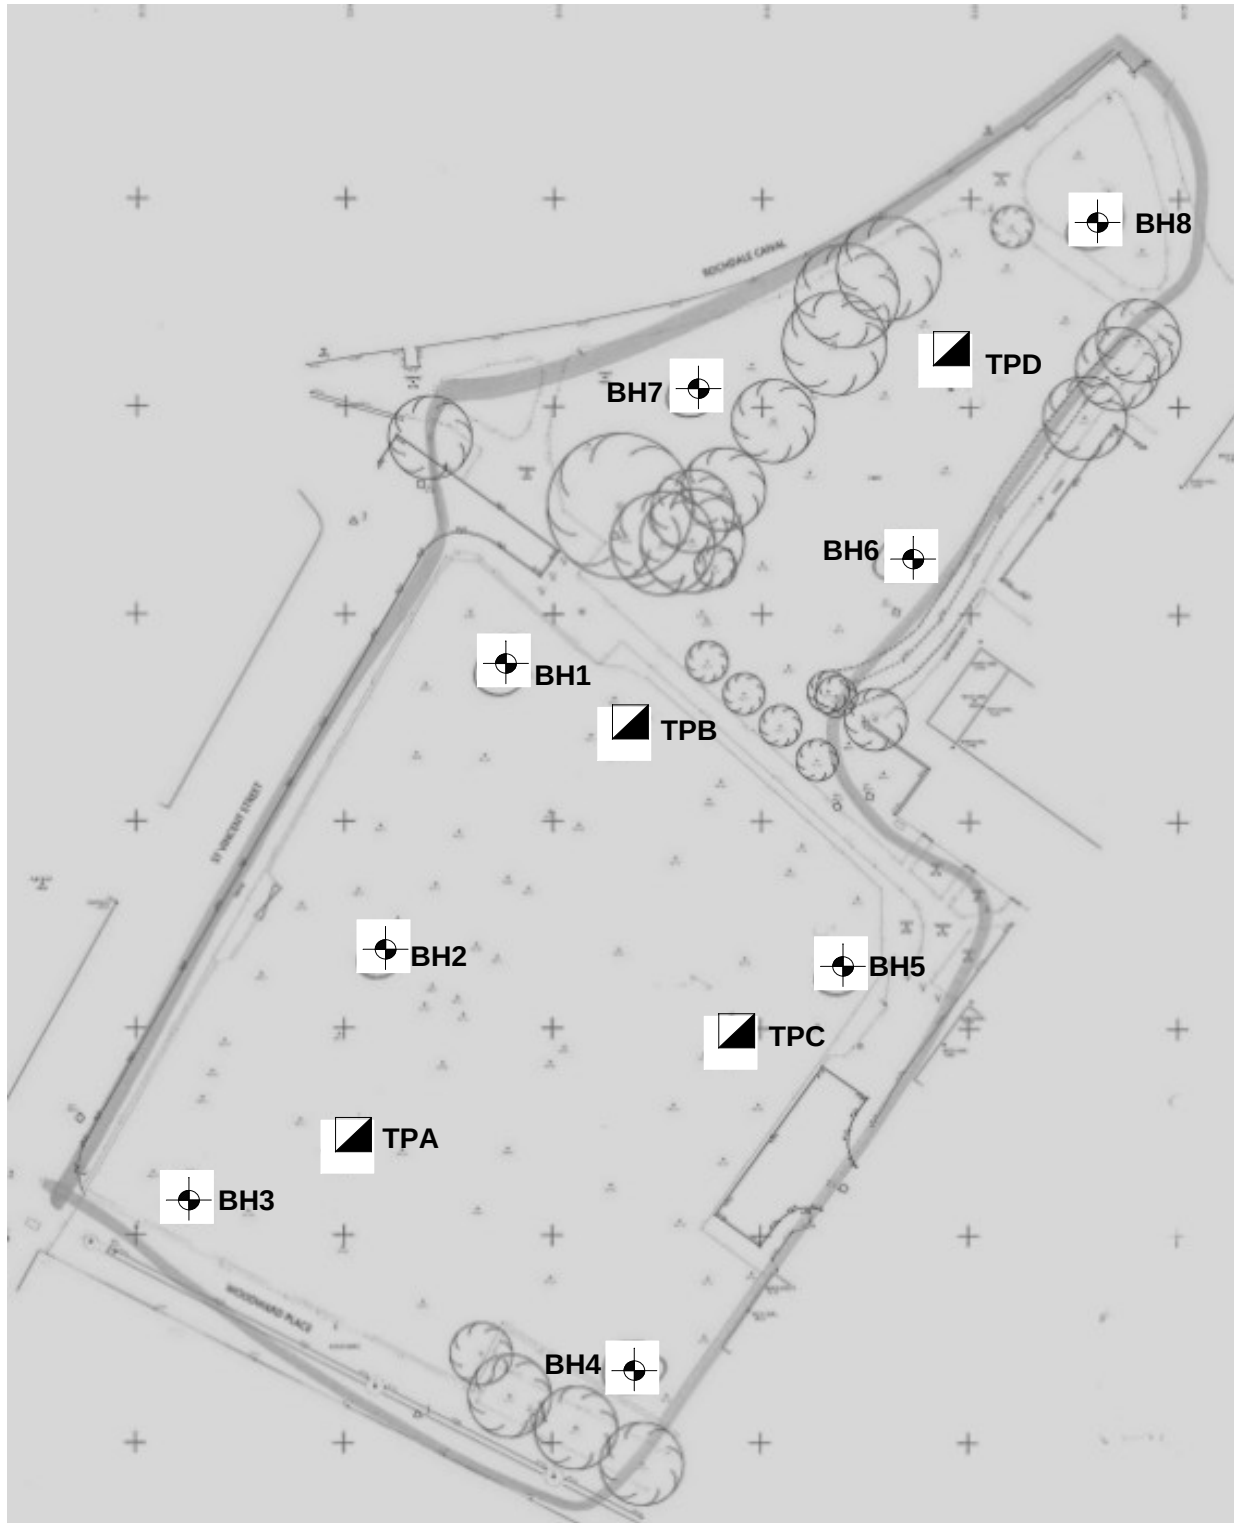
## KEY PLAN

### SITE: DOWNLEY DRIVE MANCHESTER

- 5.5 Ground investigation work was undertaken by Mini Soil Surveys, acting under our direct control and supervision. The work comprised the sinking of eight boreholes to a maximum depth of 6.0m, and the excavation of four trial pits to a depth of 1m. Work was undertaken on 15<sup>th</sup> and 16<sup>th</sup> December 2020.
- 5.6 The borehole and trial pit records are presented in Appendix 02 of this report.
