## 5 ROOM PLANS

## 7 SUMMARY

- (i) The soft strip survey and report has provided a comprehensive list of all finishes, fixtures and fittings within London Road Fire Station.
- (ii) Below we have summarised the items found within the building, their significance and action for any avoidance of doubt, unless otherwise stated in the schedules above. However, if there is any uncertainty over the significance of an item, please consult the Conservation Consultant or Project Architect for clarification.

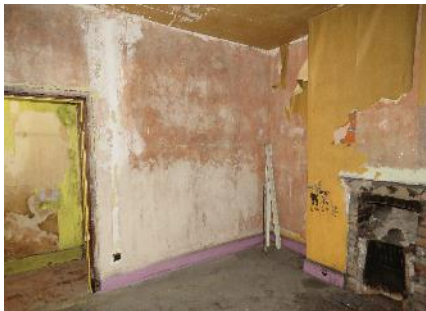
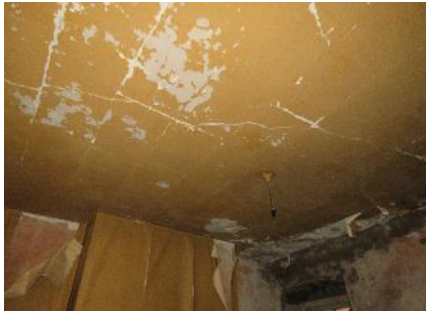
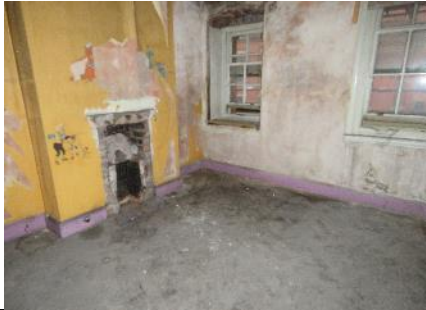
| Room Reference | Element | Description | Significance | Removed or Retained | Photographs | | |
|---|---|---|---|---|---|--|--|
| 3.118 | Wall Finish(es) | Wallpaper | None | Remove | | | |

| Room Reference | Element | Description | Significance | Removed or Retained | Photographs | | |
|---|---|---|---|---|---|--|--|
| | Ceiling Finish | Paint | Low | Remove flaking paint | | | |
| | Floor Finish | Wood block<br>Glazed tile | High<br>Low | Retain<br>Retain | | | |
| | M&E Items | Early light switch<br>Conduit<br>Light<br>Plug socket | Low<br>None<br>None<br>None | Remove all | | | |

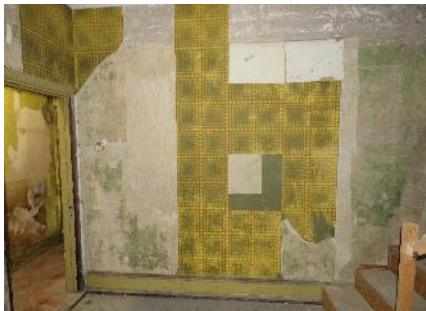
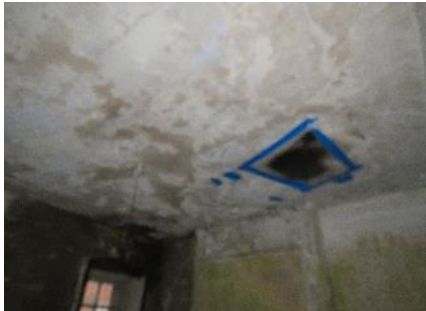
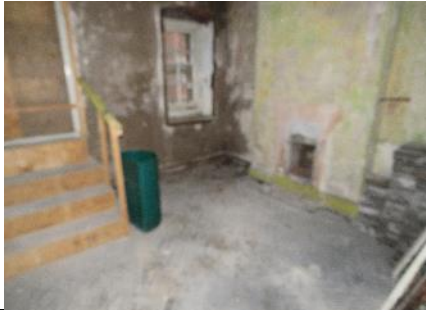
| Room Reference | Element | Description | Significance | Removed or Retained | Photographs | | |
|---|---|---|---|---|---|--|--|
| 3.119 | Wall Finish(es) | Wallpaper | None | Remove | | | |

| Room Reference | Element | Description | Significance | Removed or Retained | Photographs | | |
|---|---|---|---|---|---|--|--|
| | Ceiling Finish | Paint | Low | Remove flaking paint | | | |
| | Floor Finish | Wood block (lifted)<br>Glazed tile | High<br>Low | Retain<br>Retain | | | |
| | M&E Items | Early light switch<br>Light | Low<br>None | Remove all | | | |

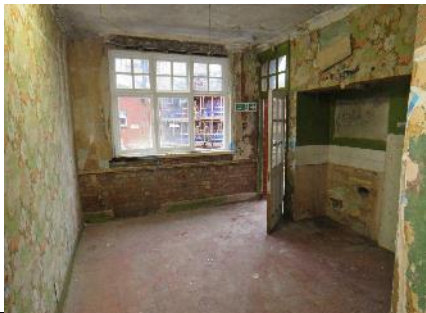
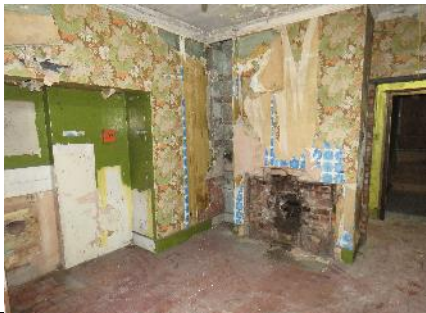
| Room Reference | Element | Description | Significance | Removed or Retained | Photographs | | |
|---|---|---|---|---|---|--|--|
| 3.120 | Wall Finish(es) | Wallpaper<br>White tile | None<br>None | Remove<br>Remove | | | |

| Room Reference | Element | Description | Significance | Removed or Retained | Photographs | | |
|---|---|---|---|---|---|--|--|
| | Ceiling Finish | Paint | Low | Remove flaking paint | | | |
| | Floor Finish | Red clay tile | Low | Retain | | | |
| | M&E Items | Early light switch<br>Light Switch<br>Plug sockets | Low<br>None<br>None<br>None | Remove all | | | |

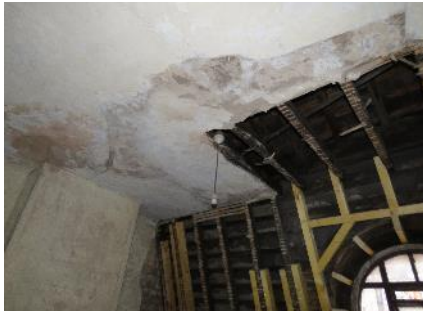
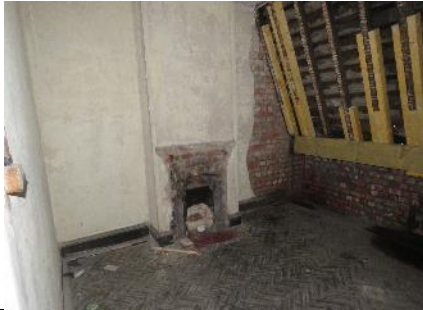
| Room Reference | Element | Description | Significance | Removed or Retained | Photographs | | |
|---|---|---|---|---|---|--|--|
| 3.122 | Wall Finish(es) | Paint | Low | Remove flaking paint | | | |
| | Ceiling Finish | Paint | Low | Remove flaking paint<br>Approx. 10m2 of plaster missing | | | |
| | Floor Finish | Wood block (lifted)<br>Glazed tile | High<br>Low | Retain<br>Retain | | | |
| | M&E Items | Light switch<br>Conduit<br>Light | None<br>None<br>None | Remove all | | | |

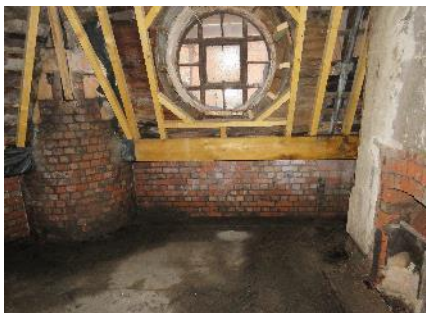
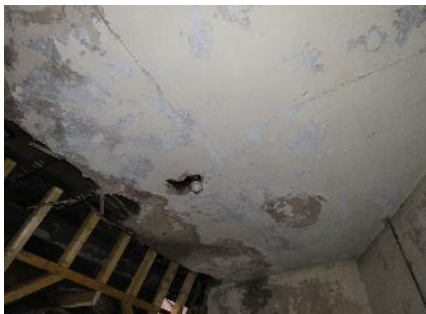
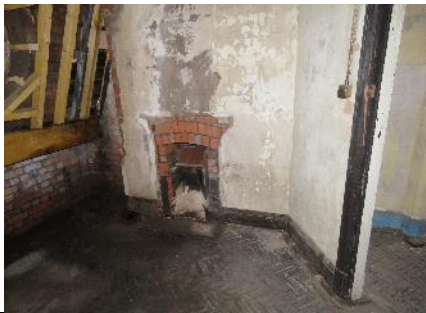
| Room Reference | Element | Description | Significance | Removed or Retained | Photographs | | |
|---|---|---|---|---|---|--|--|
| 3.123 | Wall Finish(es) | Paint | Low | Remove flaking paint | | | |

| Room Reference | Element | Description | Significance | Removed or Retained | Photographs | | |
|---|---|---|---|---|---|--|--|
| | Ceiling Finish | Paint | Low | Remove flaking paint<br>Approx. 15m2 of plaster missing | | | |
| | Floor Finish | Wood block (lifted)<br>Glazed tile | High<br>Low | Retain<br>Retain | | | |
| | M&E Items | Light switch<br>Conduit | None<br>None | Remove all | | | |

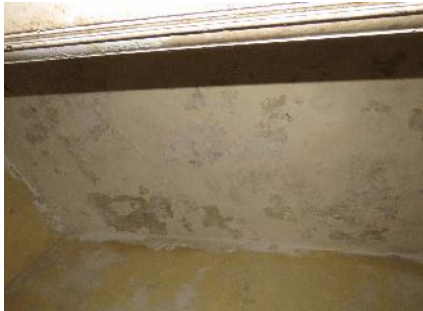
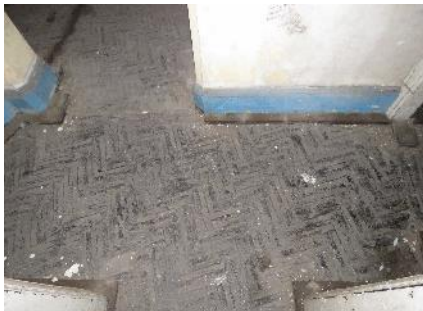
| Room Reference | Element | Description | Significance | Removed or Retained | Photographs | | |
|---|---|---|---|---|---|--|--|
| 3.124 | Wall Finish(es) | Paint | Low | Remove flaking paint | | | |
| | Ceiling Finish | Paint | Low | Remove flaking paint | | | |
| | Floor Finish | Wood block (lifted) | High | Retain | | | |

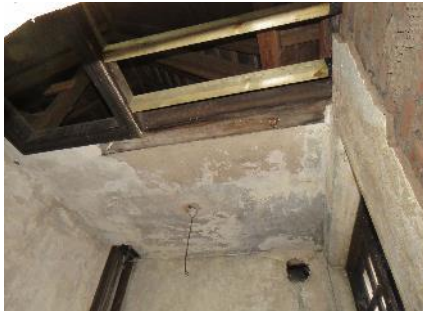
| Room Reference | Element | Description | Significance | Removed or Retained | Photographs | | |
|---|---|---|---|---|---|--|--|
| 3.125 | Wall Finish(es) | Paint | Low | Remove flaking paint | | | |
| | Ceiling Finish | Paint | Low | Remove flaking paint<br>Approx. 2m2 of plaster missing | | | |
| | Floor Finish | Wood block (partially lifted) | High | Retain | | | |
| | Fixtures & Fittings | Timber boxing in<br>Timber boards | None<br>None | Remove<br>Remove | | | |
| | M&E Items | Light<br>Misc. pipe | None<br>None | Remove all | | | |

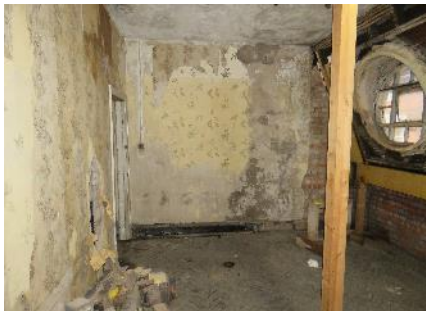
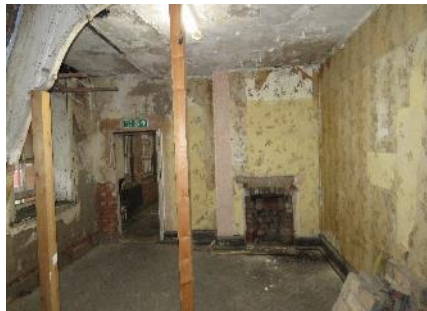
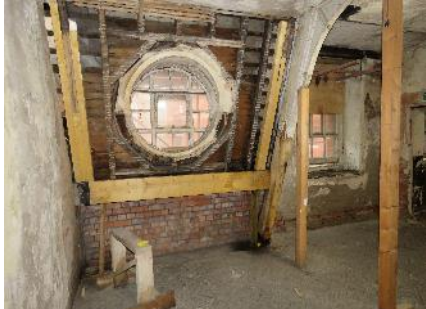
| Room Reference | Element | Description | Significance | Removed or Retained | Photographs | | |
|---|---|---|---|---|---|---|--|
| 3.126 | Wall Finish(es) | Wallpaper | None | Remove | | | |

| Room Reference | Element | Description | Significance | Removed or Retained | Photographs | | |
|---|---|---|---|---|---|---|--|
| | Ceiling Finish | Paint | Low | Remove flaking paint<br>Approx. 3m2 of plaster missing | | | |
| | Floor Finish | Wood block (lifted)<br>Glazed tile | High<br>Low | Retain<br>Retain | | | |
| | M&E Items | Light switch<br>Conduit<br>Light<br>Gas pipe | None<br>None<br>None<br>Low | Remove all | | | |

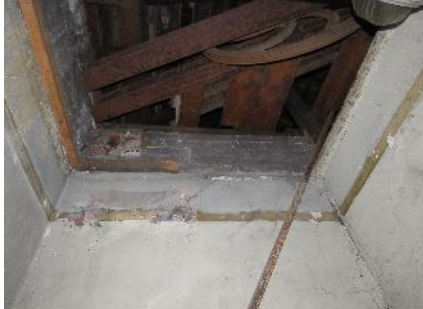
| Room Reference | Element | Description | Significance | Removed or Retained | Photographs | | |
|---|---|---|---|---|---|--|--|
| 3.128 | Wall Finish(es) | Paint | Low | Remove flaking paint | | | |

| Room Reference | Element | Description | Significance | Removed or Retained | Photographs | | |
|---|---|---|---|---|---|--|--|
| | Ceiling Finish | N/A | N/A | N/A | | | |
| | Floor Finish | Wood block | High | Retain | | | |
| | M&E Items | Light switch<br>Conduit<br>Misc. pipe | None<br>None<br>None | Remove all | | | |

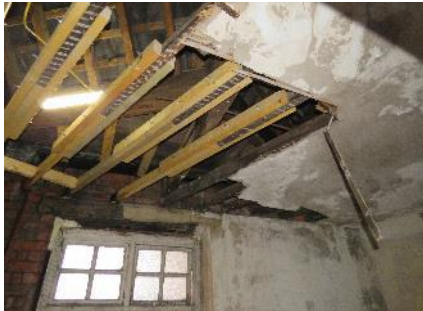
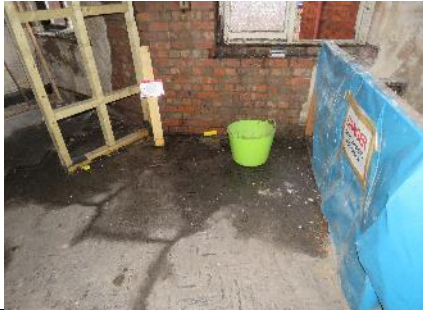
| Room Reference | Element | Description | Significance | Removed or Retained | Photographs | | |
|---|---|---|---|---|---|--|--|
| 3.130 | Wall Finish(es) | Paint | Low | Remove flaking paint | | | |
| | Ceiling Finish | Paint | Low | Remove flaking paint<br>Approx. 5m2 of plaster missing | | | |
| | Floor Finish | Wood block (lifted) | High | Retain | | | |
| | Fixtures & Fittings | Timber boxing in<br>Timber boards | None<br>None | Remove<br>Remove | | | |
| | M&E Items | Light switch<br>Conduit<br>Light | None<br>None<br>None | Remove all | | | |

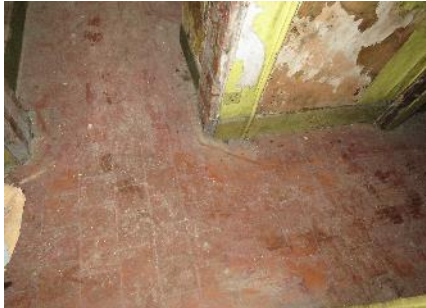
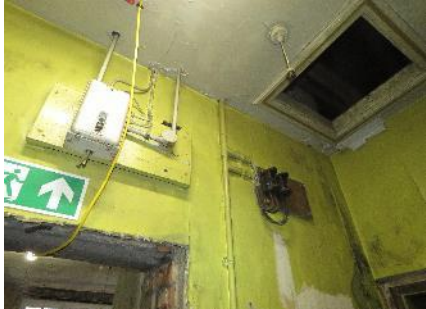
| Room Reference | Element | Description | Significance | Removed or Retained | Photographs | | |
|---|---|---|---|---|---|--|--|
| 3.131 | Wall Finish(es) | Wallpaper | None | Remove | | | |
| | Ceiling Finish | Paint | Low | Remove flaking paint | | | |
| | Floor Finish | Red clay tile | Low | Retain | | | |
| | Fixtures & Fittings | Ceiling hatch | None | Remove | | | |
| | M&E Items | Early light switch<br>Conduit<br>Misc. electrical items<br>Plug socket | Low<br>None<br>None<br>None | Remove all | | | |

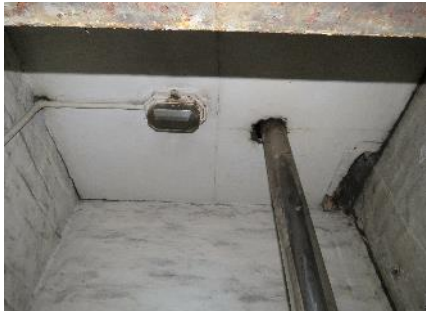
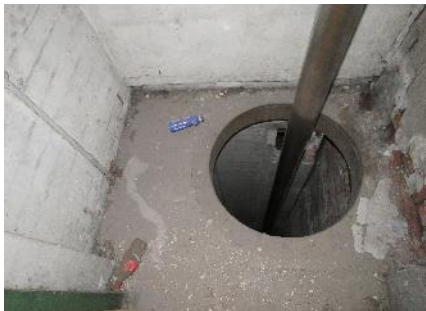
| Room Reference | Element | Description | Significance | Removed or Retained | Photographs | | |
|---|---|---|---|---|---|--|--|
| 3.132 | Wall Finish(es) | Painted brick | Low | Remove flaking paint | 4<br> | | |
| | Ceiling Finish | Exposed concrete | N/A | N/A | | | |
| | Floor Finish | Exposed concrete | N/A | N/A | | | |
| | Fixtures & Fittings | Fireman's pole | High | Retain | | | |
| | M&E Items | Conduit<br>Light | None<br>None | Remove all | | | |

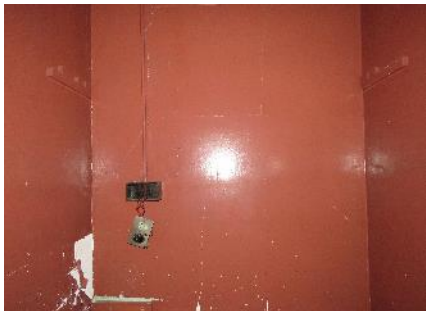
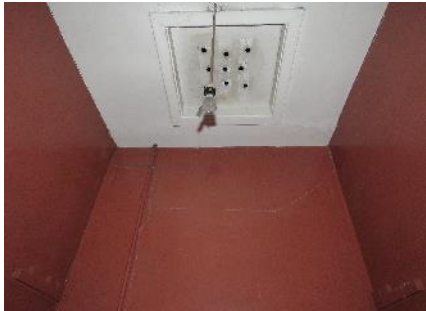
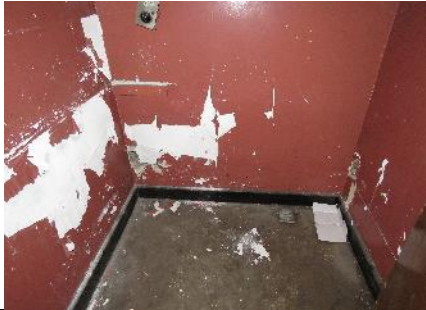
| Room Reference | Element | Description | Significance | Removed or Retained | Photographs | | |
|---|---|---|---|---|---|--|--|
| 3.133 | Wall Finish(es) | Paint | Low | Remove flaking paint | | | |

| Room Reference | Element | Description | Significance | Removed or Retained | Photographs | | |
|---|---|---|---|---|---|--|--|
| | Ceiling Finish | Paint | Low | Remove flaking paint | | | |
| | Floor Finish | Exposed concrete | N/A | N/A | | | |
| | Fixtures & Fittings | Ceiling hatch<br>Timber batten<br>Mesh vent | None<br>None<br>None | Retain<br>Remove<br>Remove | | | |
| | M&E Items | Switch<br>Light<br>Plug socket | None<br>None<br>None | Remove all | | | |

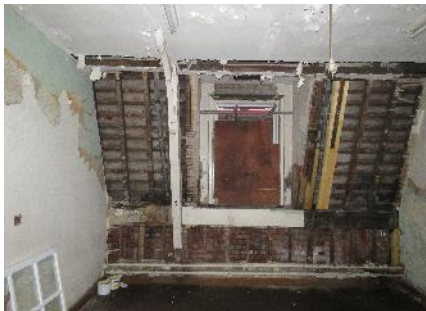
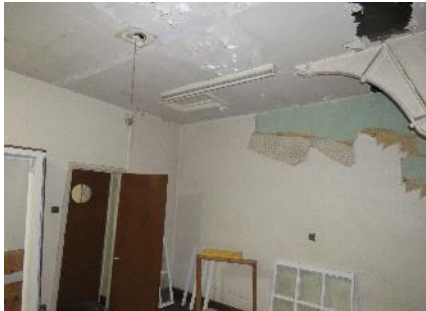
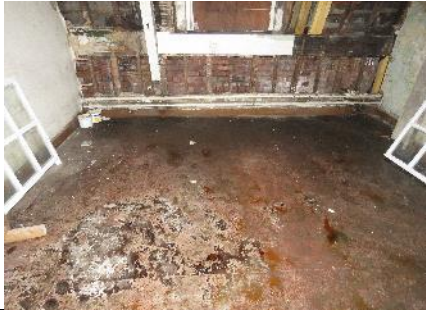
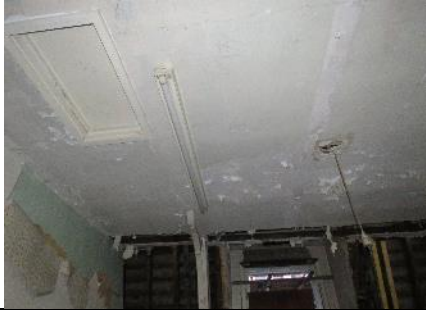
| Room Reference | Element | Description | Significance | Removed or Retained | Photographs | | |
|---|---|---|---|---|---|--|--|
| 3.134 | Wall Finish(es) | Wallpaper | None | Remove | | | |

| Room Reference | Element | Description | Significance | Removed or Retained | Photographs | | |
|---|---|---|---|---|---|--|--|
| | Ceiling Finish | Paint | Low | Remove flaking paint<br>Approx. 10m2 of plaster missing | | | |
| | Floor Finish | Painted concrete | Low | Remove flaking paint | | | |
| | Fixtures & Fittings | Ceiling hatch | Low | Retain | | | |
| | M&E Items | Switch<br>Light<br>Plug socket<br>Heating pipe | None<br>None<br>None<br>Low | Remove all | | | |

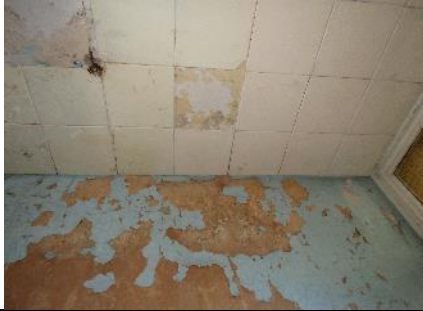
| Room Reference | Element | Description | Significance | Removed or Retained | Photographs | | |
|---|---|---|---|---|---|--|--|
| 3.135 | Wall Finish(es) | Paint<br>White tile | Low<br>None | Remove flaking paint<br>Remove | | | |
| | Ceiling Finish | Ceiling tile | None | Remove<br>Approx. 1m2 of plaster missing | | | |
| | Floor Finish | Floor tile over red clay tile | None / low | Remove floor tile and adhesive, retain red clay tile | | | |
| | M&E Items | Switch<br>Plug socket | None<br>None | Remove all | | | |

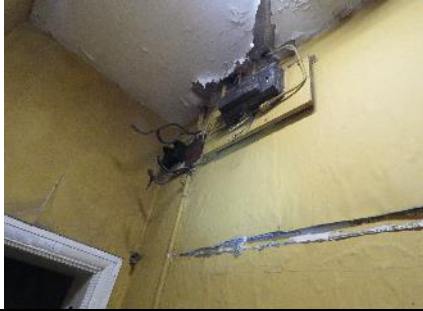
| Room Reference | Element | Description | Significance | Removed or Retained | Photographs | | |
|---|---|---|---|---|---|--|--|
| | Floor Finish | Red clay tile | Low | Retain | | | |
| | M&E Items | Conduit<br>Light<br>Misc. electrical items | None<br>None<br>None | Remove all | | | |

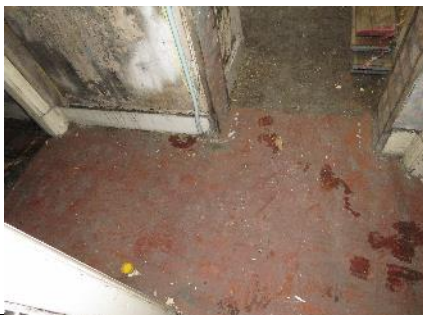
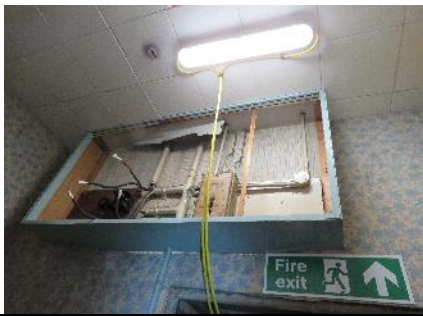
| Room Reference | Element | Description | Significance | Removed or Retained | Photographs | | |
|---|---|---|---|---|---|--|--|
| 3.139 | Wall Finish(es) | Wallpaper | None | Remove | | | |
| | Ceiling Finish | Ceiling tile | None | Remove | | | |
| | Floor Finish | Red clay tile | Low | Retain | | | |
| | Fixtures & Fittings | Cupboard | None | Remove | | | |
| | M&E Items | Early light switch<br>Conduit<br>Misc. electrical items | Low<br>None<br>None | Remove all | | | |

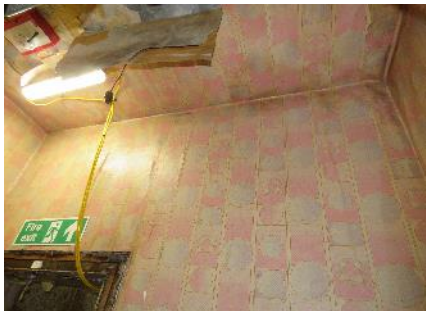
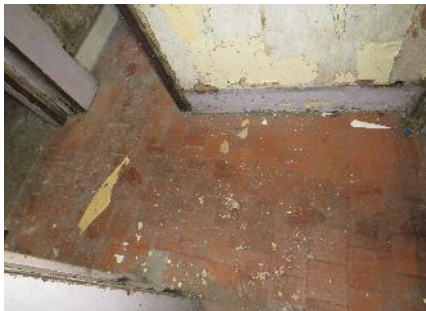
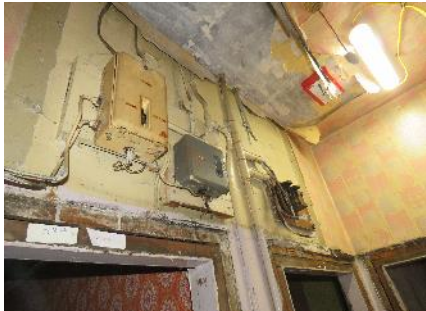
| Room Reference | Element | Description | Significance | Removed or Retained | Photographs | | |
|---|---|---|---|---|---|--|--|
| 3.140 | Wall Finish(es) | Wallpaper | None | Remove | | | |

| Room Reference | Element | Description | Significance | Removed or Retained | Photographs | | |
|---|---|---|---|---|---|--|--|
| | Ceiling Finish | Paint | Low | Remove flaking paint<br>Approx. 1m2 of plaster missing | | | |
| | Floor Finish | Red clay tile | Low | Retain | | | |
| | Fixtures & Fittings | Timber battens | None | Remove | | | |
| | M&E Items | Conduit<br>Light<br>Misc. electrical items | None<br>None<br>None | Remove all | | | |

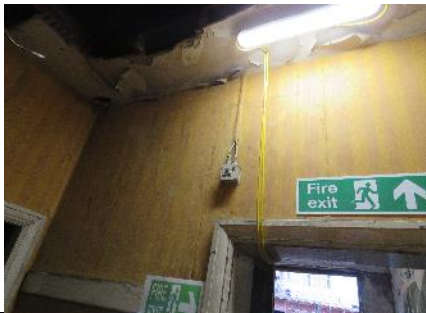
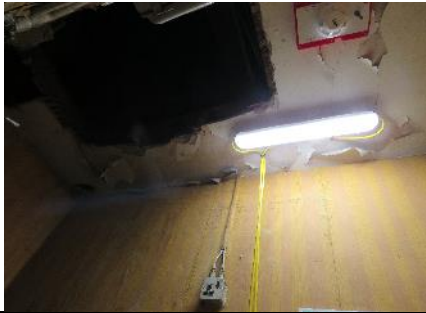
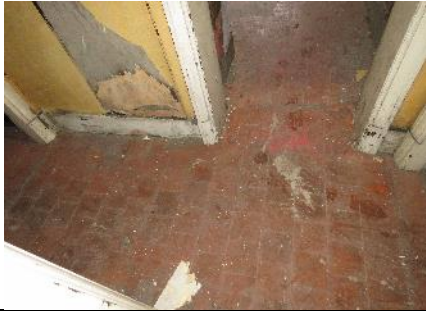
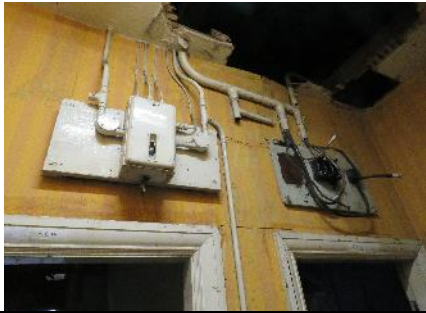
| Room Reference | Element | Description | Significance | Removed or Retained | Photographs | | |
|---|---|---|---|---|---|--|--|
| 3.141 | Wall Finish(es) | Wallpaper | None | Remove | | | |

| Room Reference | Element | Description | Significance | Removed or Retained | Photographs | | |
|---|---|---|---|---|---|--|--|
| | Ceiling Finish | Ceiling paper | None | Remove | | | |
| | Floor Finish | Red clay tile | Low | Retain | | | |
| | Fixtures & Fittings | Timber boards | None | Remove | | | |
| | M&E Items | Early light switch<br>Misc. electrical items<br>Plug socket | Low<br>None<br>None | Remove all | | | |

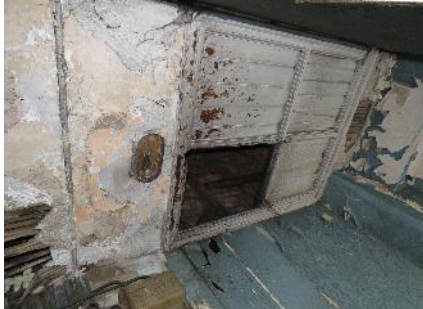
| Room Reference | Element | Description | Significance | Removed or Retained | Photographs | | |
|---|---|---|---|---|---|--|--|
| 3.142 | Wall Finish(es) | Paint | Low | Remove flaking paint | | | |

| Room Reference | Element | Description | Significance | Removed or Retained | Photographs | | |
|---|---|---|---|---|---|--|--|
| | Ceiling Finish | Paint<br>Timber boards | Low<br>Low | Remove flaking paint<br>Remove<br>Approx. 4m2 of plaster missing | | | |
| | Floor Finish | Timber staircase with carpet and vinyl over<br>Wood block (lifted) | High / none / none<br>High | Remove carpet and vinyl, retain timber staircase<br>Retain | | | |

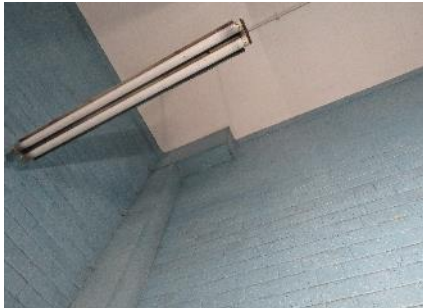
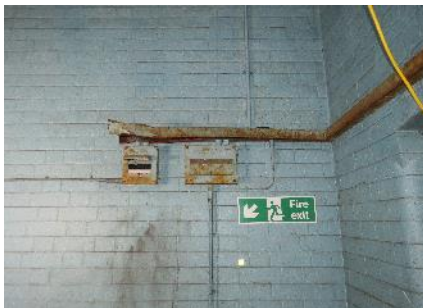
| Room Reference | Element | Description | Significance | Removed or Retained | Photographs | | |
|---|---|---|---|---|---|---|---|
| 3.143 | Wall Finish(es) | Paint on glazed brick<br>Wallboard to light shaft | None / High<br>None | Remove paint and retain glazed brick<br>Remove | | | |
| | Ceiling Finish | Paint | Low | Remove flaking paint | | | |
| | Floor Finish | Paint | Low | Remove flaking paint | | | |
| | Fixtures & Fittings | Fireman's hose pipe outlet<br>Lift shutters<br>Boxing in | High<br>High<br>None | Retain<br>Retain<br>Remove | | | |
| | M&E Items | Fuse box<br>Conduit<br>Light | None<br>None<br>None | Remove all | | | |

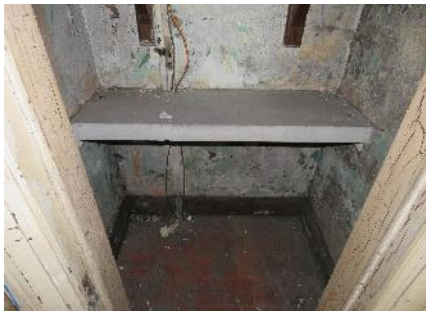
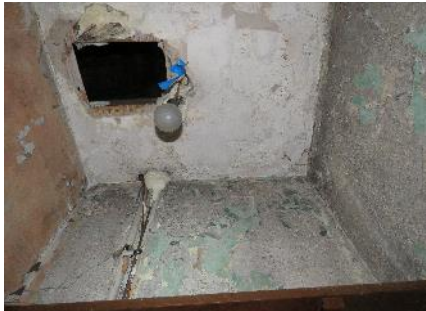
| Room Reference | Element | Description | Significance | Removed or Retained | Photographs | | |
|---|---|---|---|---|---|--|--|
| 3.144 | Wall Finish(es) | Paint | Low | Remove flaking paint | | | |

| Room Reference | Element | Description | Significance | Removed or Retained | Photographs | | |
|---|---|---|---|---|---|--|--|
| | Ceiling Finish | Paint | Low | Remove flaking paint<br>Approx. 1m2 of plaster missing | | | |
| | Floor Finish | Red clay tile | Low | Retain | | | |
| | Fixtures & Fittings | Shelves<br>Ceiling hatch | None<br>None | Remove<br>Retain | | | |
| | M&E Items | Conduit<br>Light<br>Waste pipe | None<br>None<br>None | Remove all | | | |

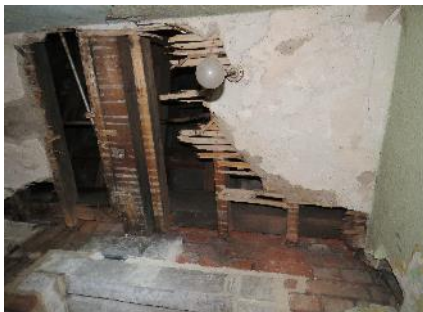
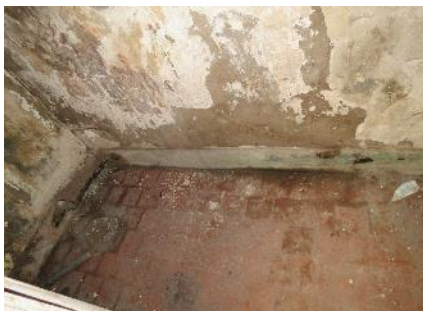
| Room Reference | Element | Description | Significance | Removed or Retained | Photographs | | |
|---|---|---|---|---|---|--|--|
| 3.145 | Wall Finish(es) | Wallpaper | None | Remove | | | |
| | Ceiling Finish | N/A | N/A | 4m2 of plaster missing | | | |
| | Floor Finish | Red clay tile | Low | Retain | | | |
| | M&E Items | Light | None | Remove | | | |

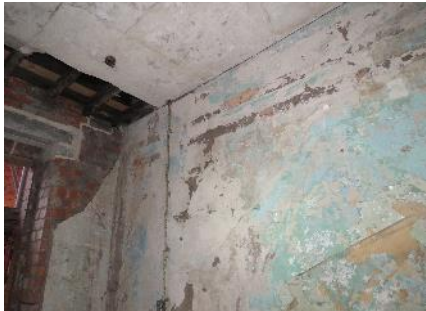
| Room Reference | Element | Description | Significance | Removed or Retained | Photographs | | |
|---|---|---|---|---|---|--|--|
| 3.146 | Wall Finish(es) | Wallpaper<br>Paint | None<br>Low | Remove<br>Remove flaking paint | | | |

| Room Reference | Element | Description | Significance | Removed or Retained | Photographs | | |
|---|---|---|---|---|---|--|--|
| | Ceiling Finish | Paint | Low | Remove flaking paint<br>Approx. 2m2 of plaster missing | | | |
| | Floor Finish | Red clay tile | Low | Retain | | | |

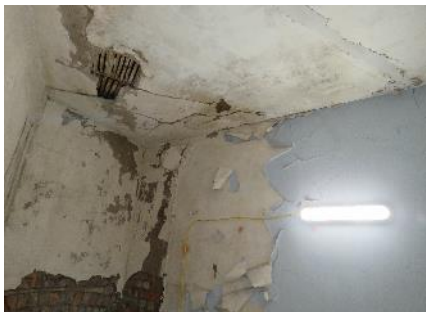
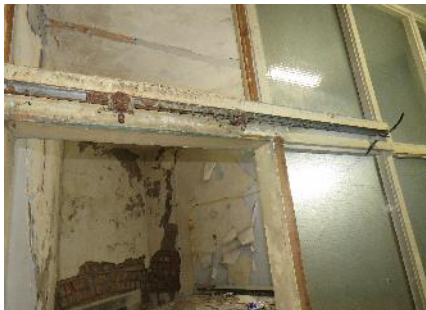
| Room Reference | Element | Description | Significance | Removed or Retained | Photographs | | |
|---|---|---|---|---|---|---|--|
| 3.147 | Wall Finish(es) | Wallpaper | None | Remove | | | |
| | Ceiling Finish | Paint | Low | Remove flaking paint<br>Approx. 6m2 of plaster missing | | | |
| | Floor Finish | Wood block<br>Vinyl and plastic nosing over timber staircase | High<br>None / none / high | Retain<br>Remove vinyl and nosing, retain staircase | | | |
| | Fixtures & Fittings | Timber staircase<br>Hooks on timber board<br>Door rail | High<br>None<br>None | Retain<br>Remove<br>Remove | | | |
| | M&E Items | Heating pipes<br>Misc. wires | Low<br>None | Remove all | | | |

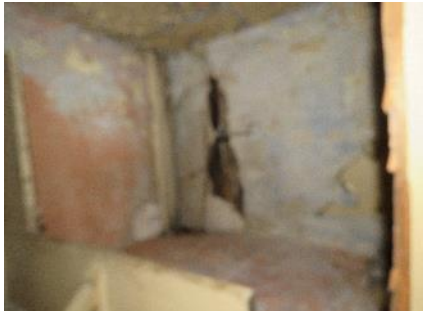
| Room Reference | Element | Description | Significance | Removed or Retained | Photographs | | |
|---|---|---|---|---|---|--|--|
| 3.148 | Wall Finish(es) | Wallpaper | None | Remove | | | |

| Room Reference | Element | Description | Significance | Removed or Retained | Photographs | | |
|---|---|---|---|---|---|--|--|
| | Ceiling Finish | Paint | Low | Remove flaking paint<br>Approx. 1m2 of plaster missing | | | |
| | Floor Finish | Red clay tile | Low | Retain | | | |
| | Fixtures & Fittings | Shelves | None | Remove | | | |

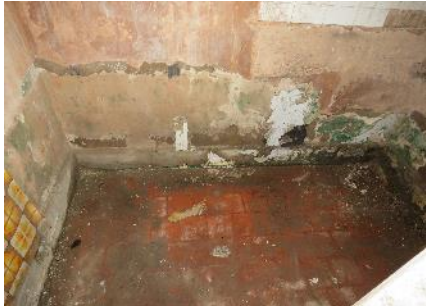
| Room Reference | Element | Description | Significance | Removed or Retained | Photographs | | |
|---|---|---|---|---|---|--|--|
| 3.149 | Wall Finish(es) | Wallpaper<br>White tile | None<br>None | Remove<br>Remove | | | |

| Room Reference | Element | Description | Significance | Removed or Retained | Photographs | | |
|---|---|---|---|---|---|--|--|
| | Ceiling Finish | Ceiling tile | None | Remove | | | |
| | Floor Finish | Red clay tile | Low | Retain | | | |
| | M&E Items | Conduit | None | Remove | | | |

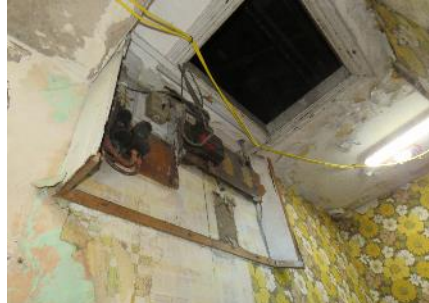
| Room Reference | Element | Description | Significance | Removed or Retained | Photographs | | |
|---|---|---|---|---|---|--|--|
| | Ceiling Finish | Paint | Low | Remove flaking paint<br>Approx. 4m2 of plaster missing | | | |
| | Fixtures & Fittings | Brackets<br>Timber board<br>Cupboard | None<br>None<br>None | Remove<br>Remove<br>Remove | | | |
| | M&E Items | Misc. electrical items<br>Gas pipe | None<br><br>Low | Remove all | | | |

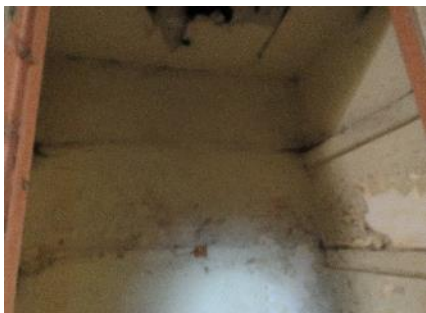
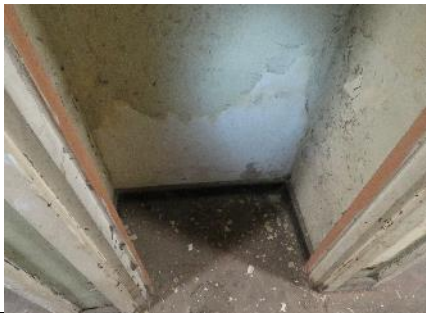
| Room Reference | Element | Description | Significance | Removed or Retained | Photographs | | |
|---|---|---|---|---|---|--|--|
| 3.151 | Wall Finish(es) | Paint | Low | Remove flaking paint | | | |

| Room Reference | Element | Description | Significance | Removed or Retained | Photographs | | |
|---|---|---|---|---|---|--|--|
| | Ceiling Finish | Paint | Low | Remove flaking paint | | | |
| | Floor Finish | Exposed concrete | N/A | N/A | | | |
| | Fixtures & Fittings | Timber battens | None | Remove | | | |

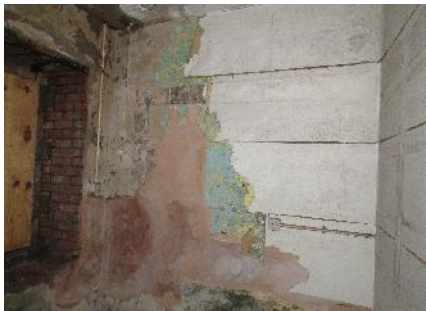
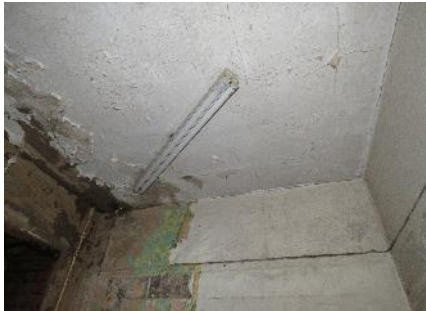
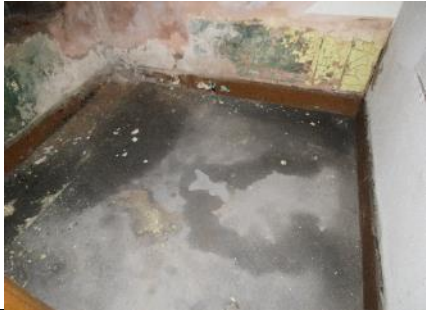
| Room Reference | Element | Description | Significance | Removed or Retained | Photographs | | |
|---|---|---|---|---|---|--|--|
| 3.152 | Wall Finish(es) | Wallpaper | None | Remove | | | |

| Room Reference | Element | Description | Significance | Removed or Retained | Photographs | | |
|---|---|---|---|---|---|--|--|
| | Ceiling Finish | Paint | Low | Remove flaking paint | | | |
| | Floor Finish | Vinyl | None | Remove | | | |
| | Fixtures & Fittings | Spiral staircase | High | Retain | | | |
| | M&E Items | Switches<br>Conduit<br>Light<br>Plug socket | None<br>None<br>None<br>None | Remove all | | | |
