# Photographic evidence to internal alteration/demolishing

**May 2021**

Project: Proposed conversion of  
2 Swinbourne Grove,  
Withington, into 6 self  
contained flats

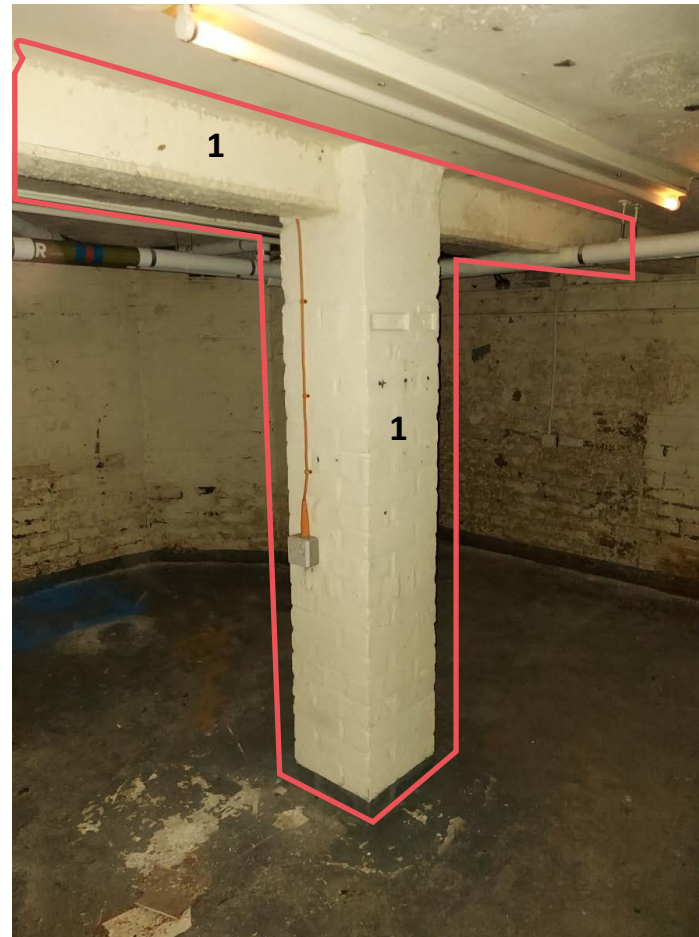
Column 1 - View number 1

Column and steel beam marked 1 (recently erected) to be dismantled to allow the use of the proposed bedroom.

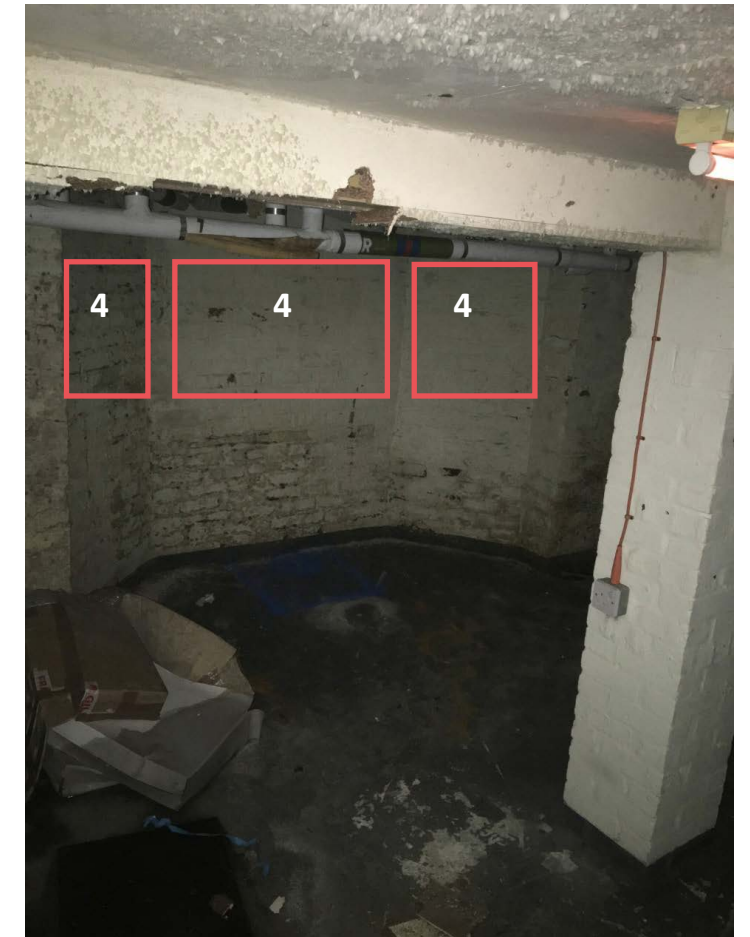
New openings for the proposed bedroom in flat 2

New windows marked 4 to be formed to provide light to proposed new bedrooms to flat 2 to comply with building regulations requirement to Achieve 10% of the floor area for window Opening Please note, basement windows were bocked by the former bank owner.

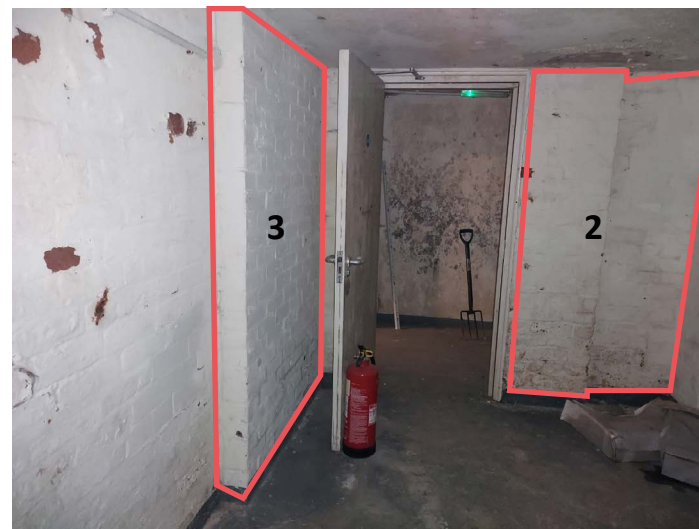
Walls marked (2 & 3) to form new openings to provide access to bedroom number 2 / stairwell.

Walls to be demolished - View numbers 2 and 3

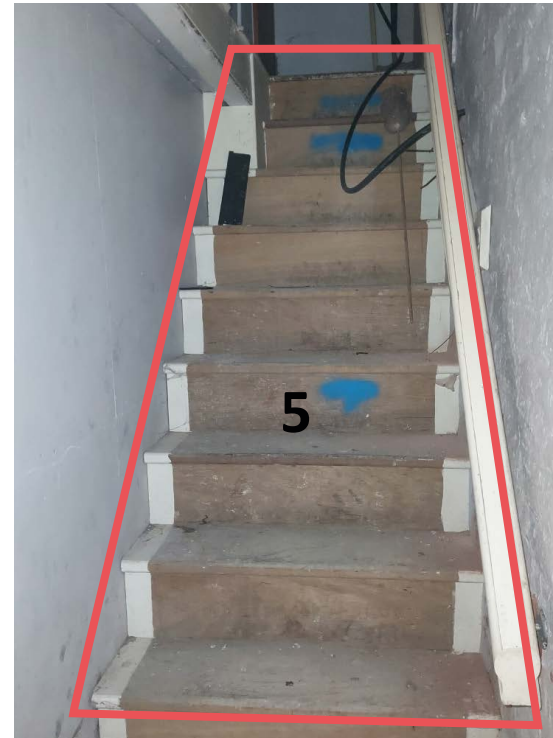
Staircase to be dismantled View numbers 5

Timber staircase marked 5, and its single brick wall marked 6 (both in poor condition) to be demolished to form the two small study rooms in bedroom 1 and bedroom 2.

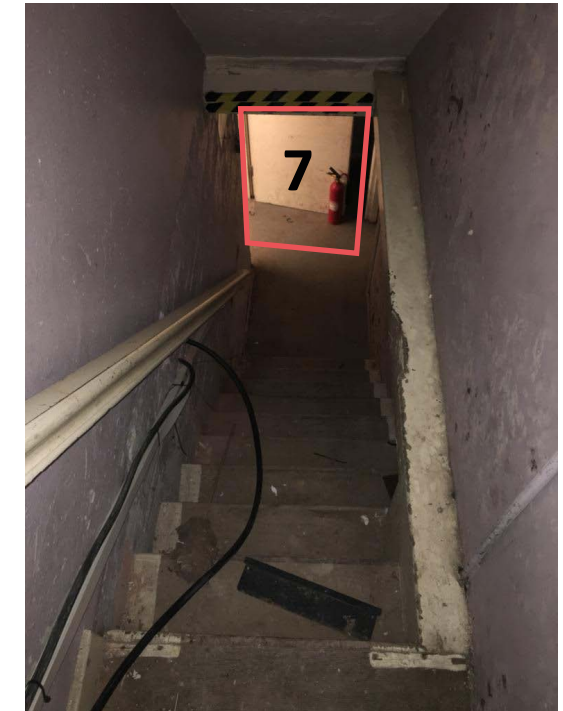
brick wall to be demolished- View numbers 7

Brick wall in hallway, marked 7, to be demolished to provide a study space to room bedroom 2 in flat 1.

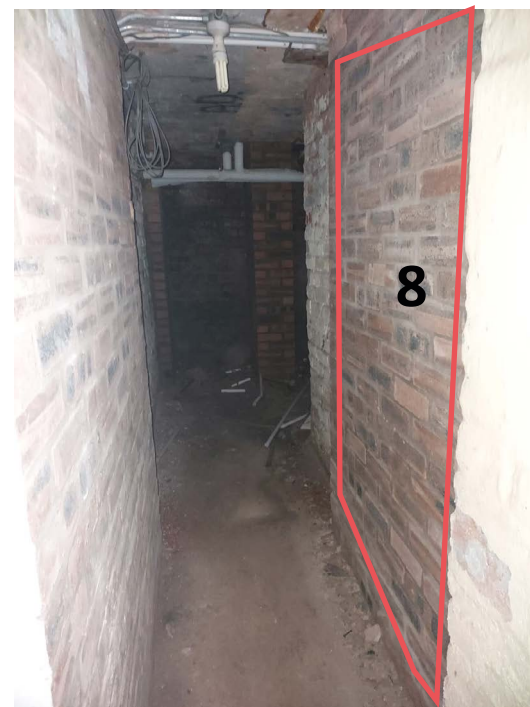
Corridor wall to be demolished, View numbers 8

Part of the corridor brick wall, marked 8, to be demolished to provide wider access to new staircase that leads to bedrooms in flat 2.

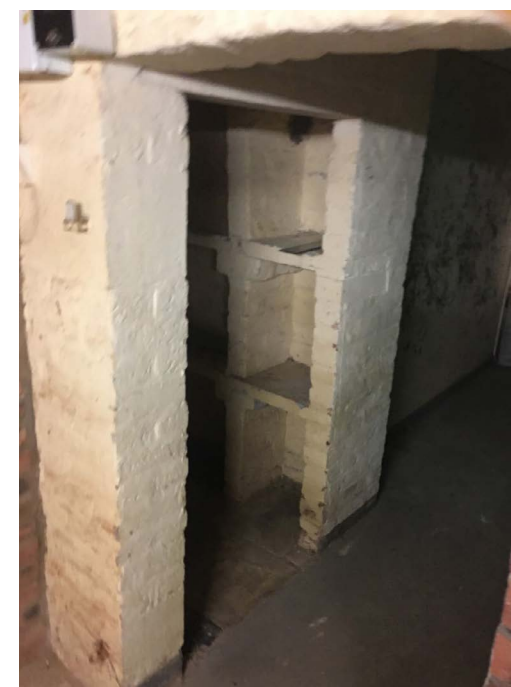
Views from the hallway - no change

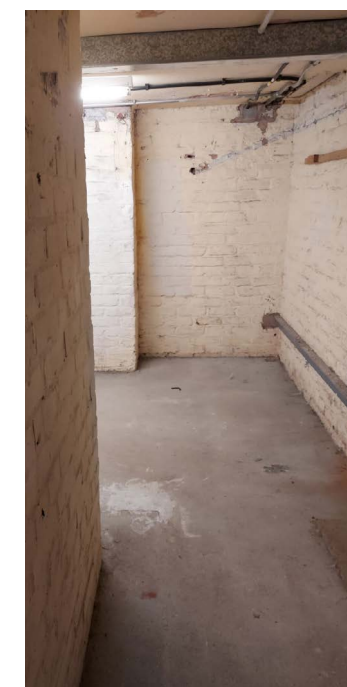
Views from hallway - to be retained

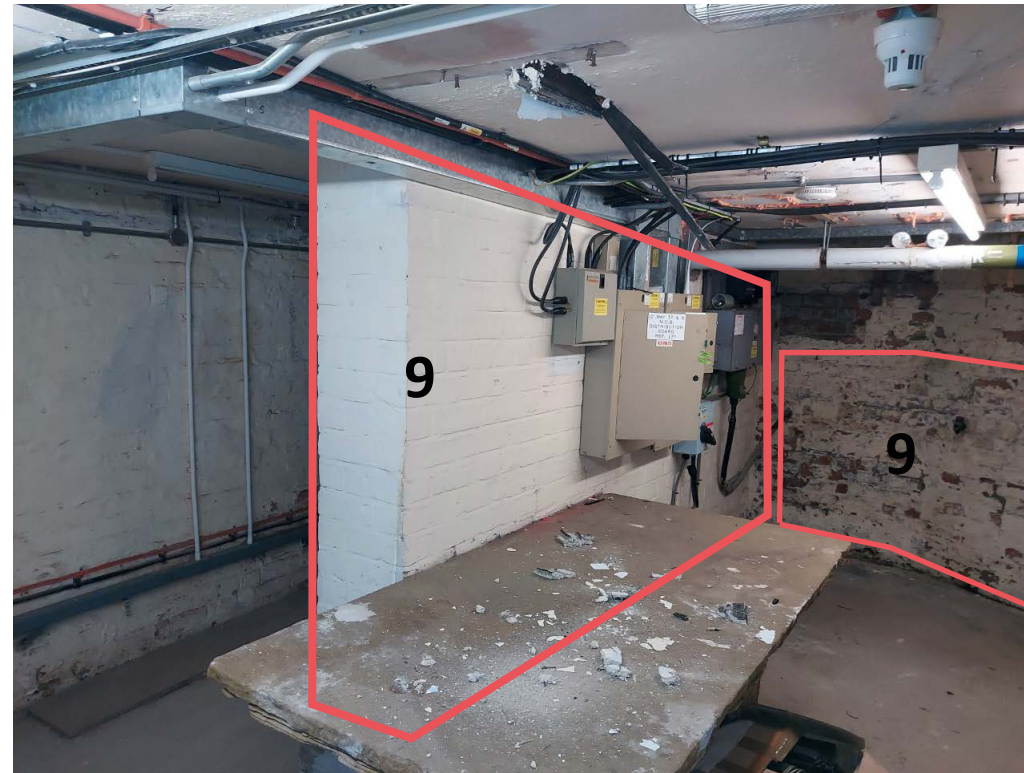
Double brick wall to be demolished, View numbers 9

Double brick wall (view 9) to be demolished to provide bigger and suitable bedroom for flat 1.

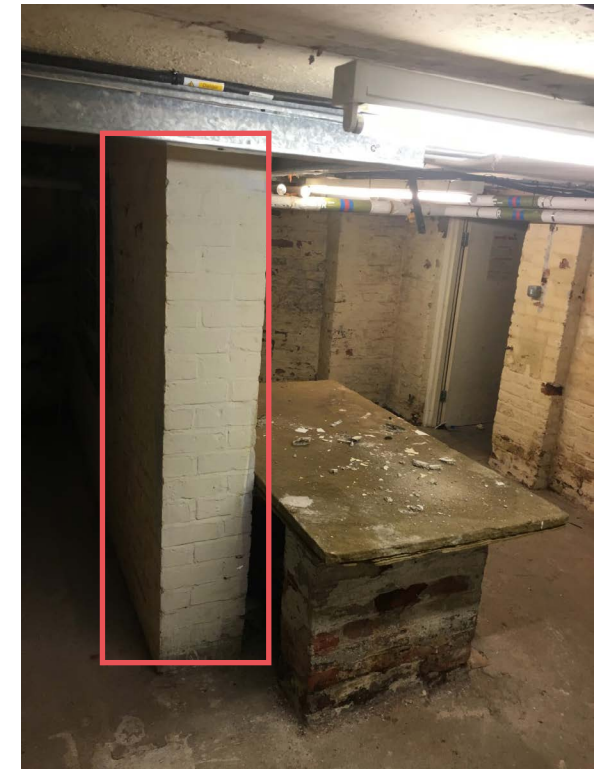
Views from room 2 - Stone worktop to be removed and kept in a safe area.

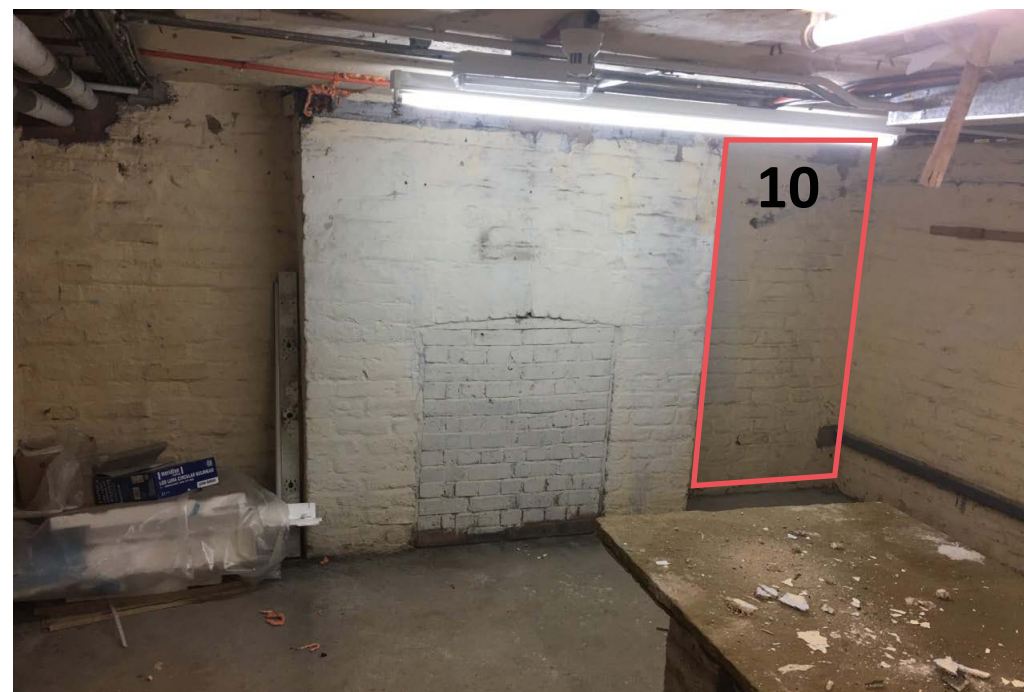
View numbers 10 - To form new opening

To form new opening (marked 10) to provide access to the new staircase and bathroom in flat 1

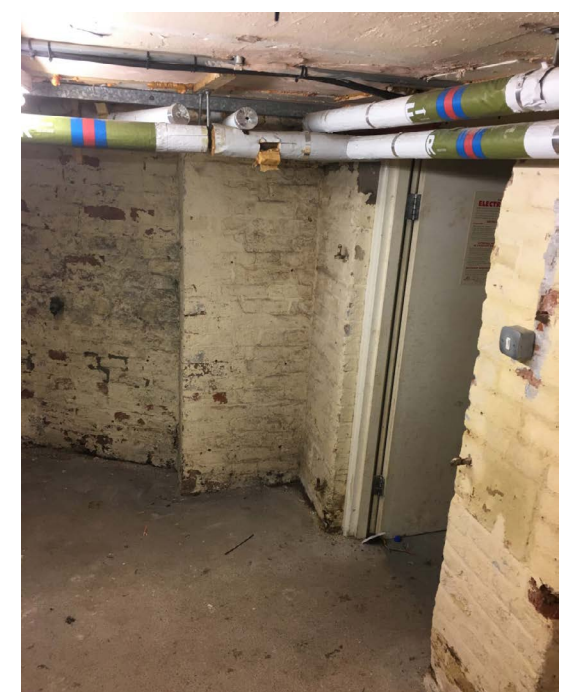
Views from room 2

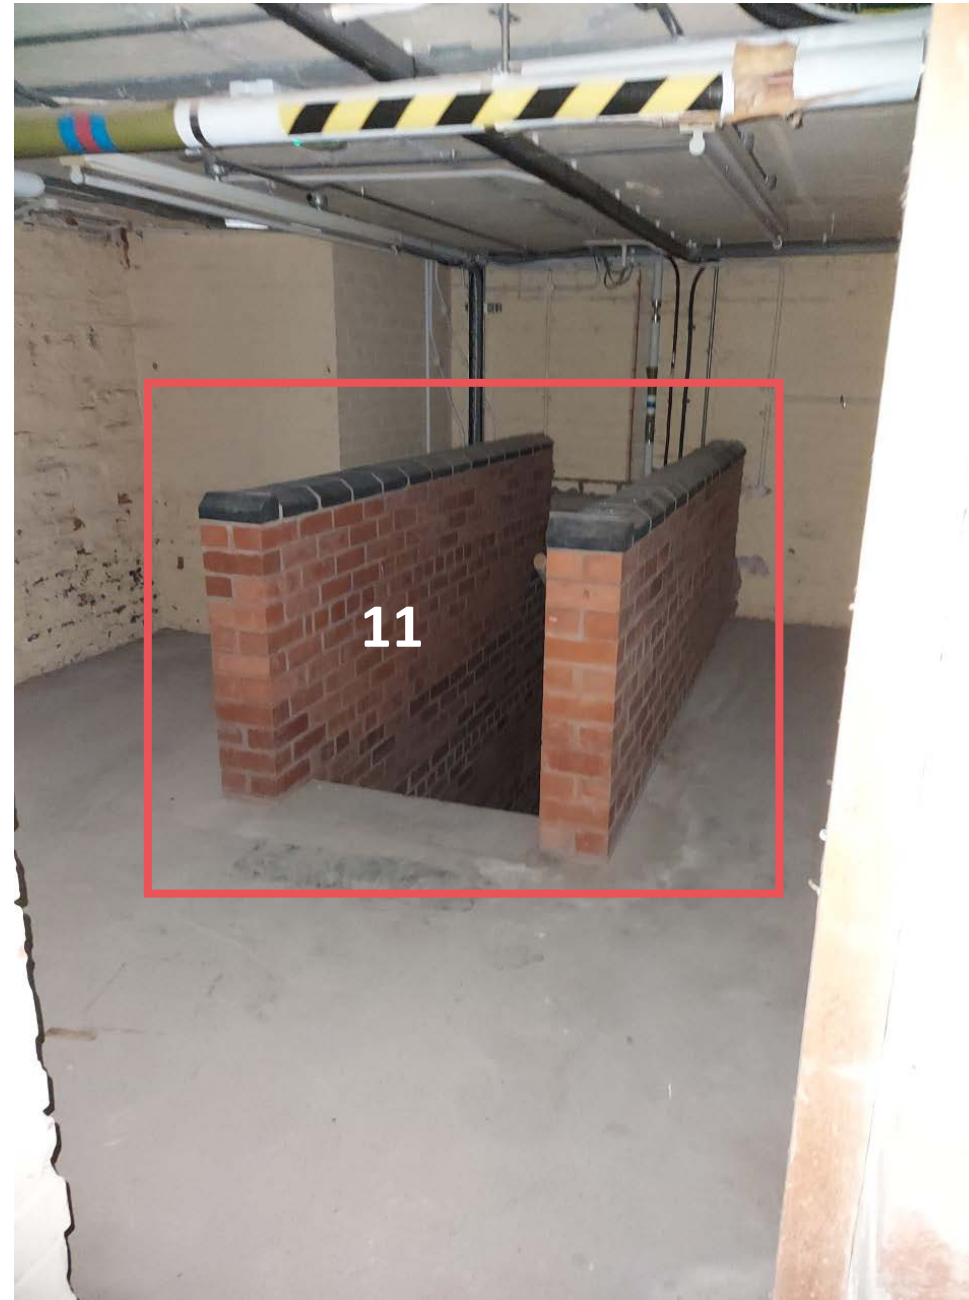
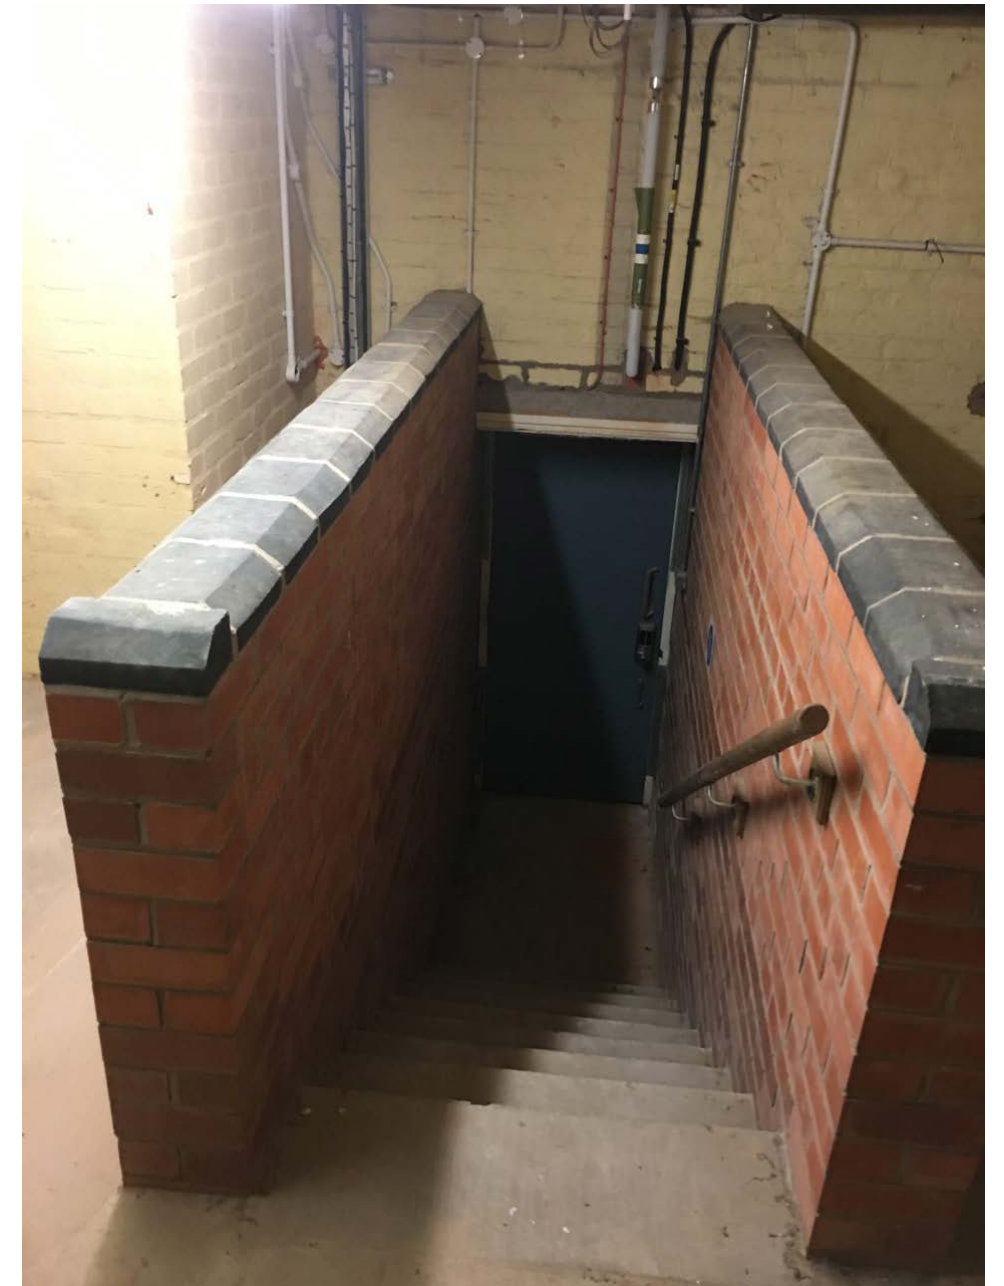
Staircase to be sealed - View 11

The recently built staircase that provides access to the Bank safe (marked 11 ) to be dismantled to provide access to the new bathroom and staircase to lounge at ground floor.

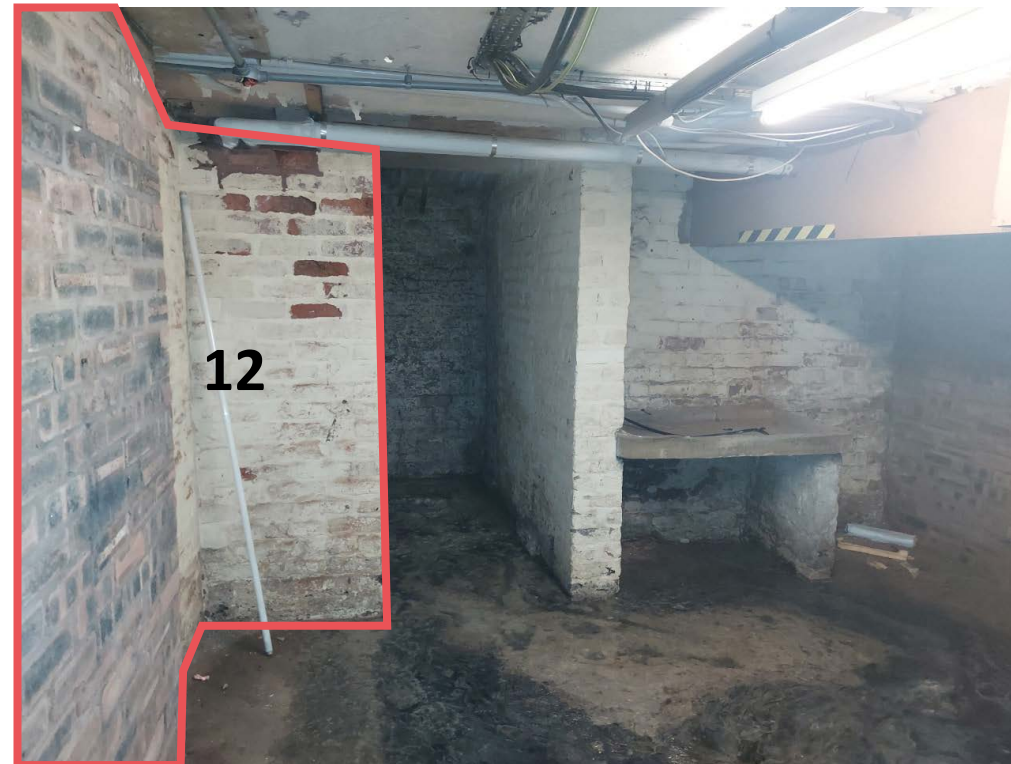
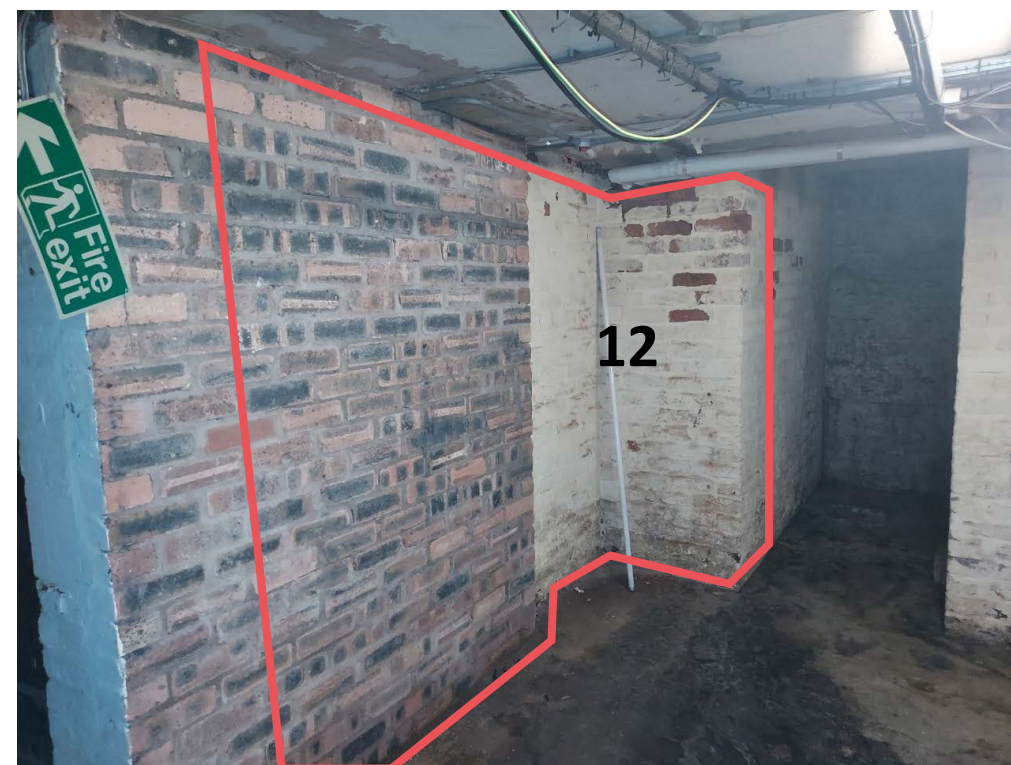
Brick wall to be demolished - View 12

Brick wall (marked 12) to be demolished to provide access to the new staircase that leads to flat 2 bedrooms.

View 12 - Brick wall to be demolished - Stoned sink to be retained

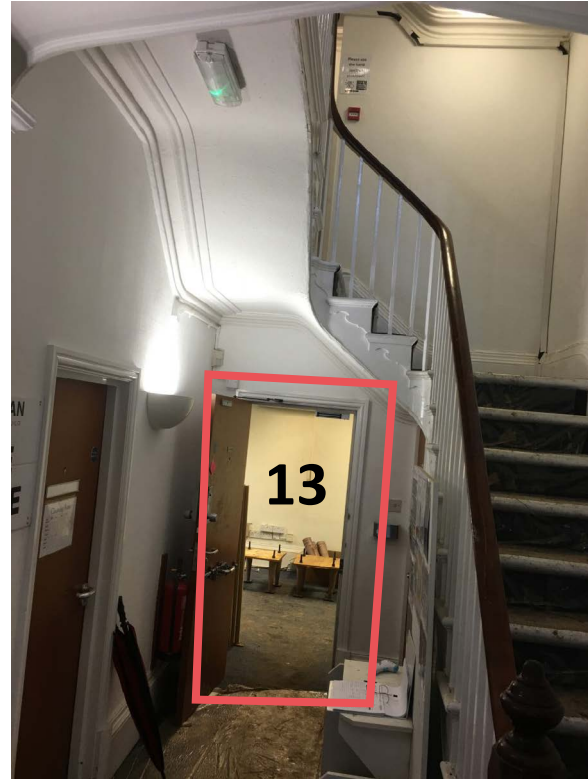
Door to be blocked - View 13

Door to room 8 (marked 13) to be blocked to form a new self contained flat.

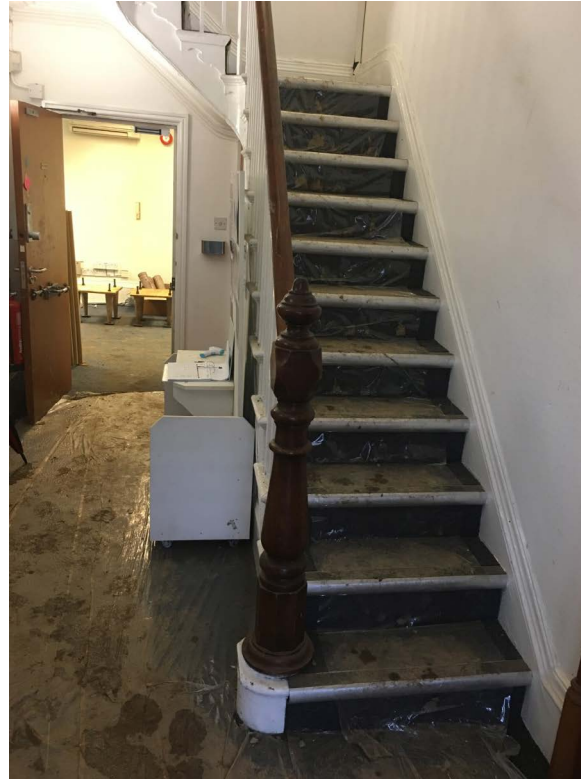
Views from ground floor lobby - Staircase

All existing coving, staircase, hand-rail, Balustrade will be retained, only one layer of 12mm plaster board and skimmed will be fixed to underneath the staircase / hallway ceilings to comply with Building Regulations Fire Regulations.

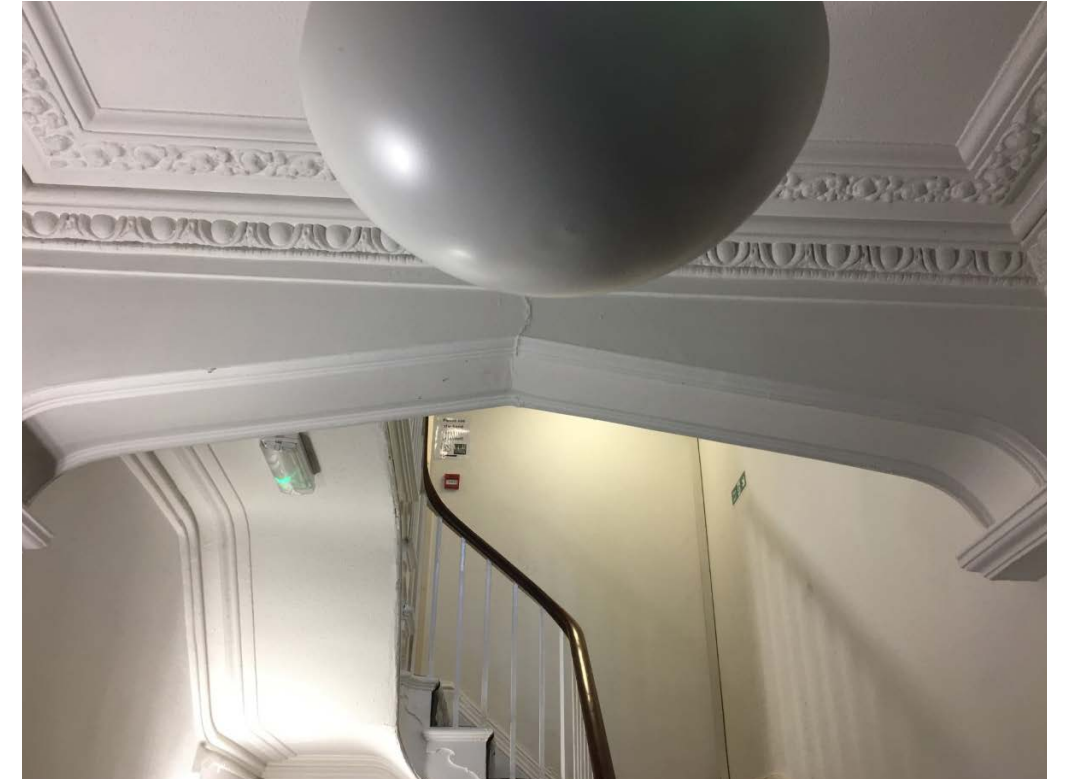
Views from ground floor lobby - Arch and ceiling

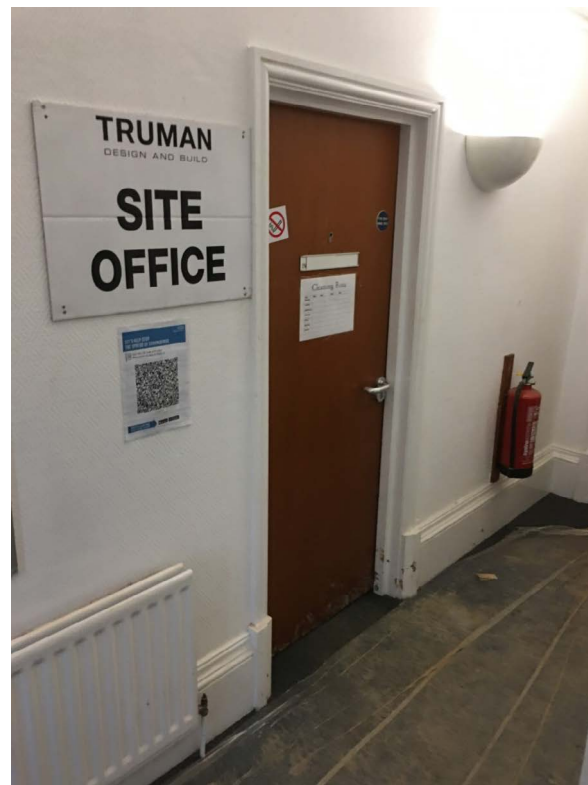
Views from ground floor lobby - Doorway, skirting and architrave to be retained

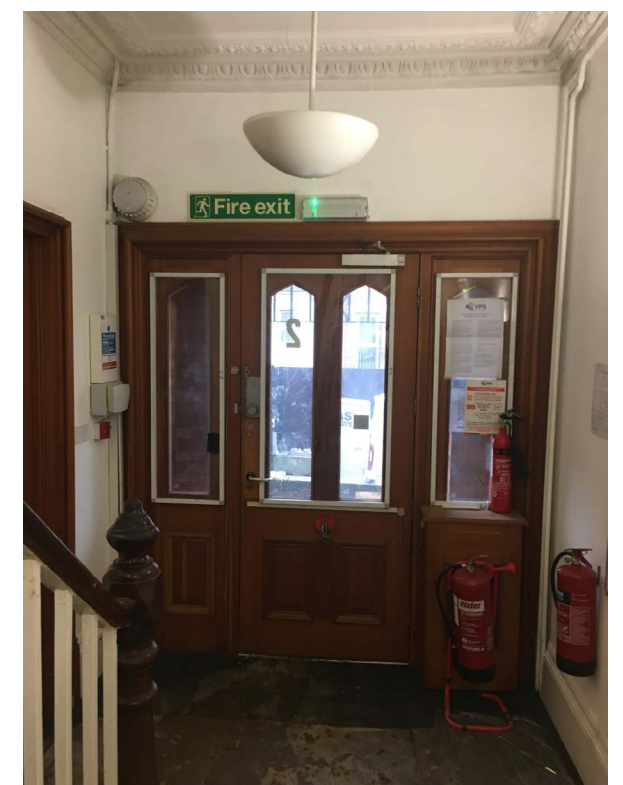
Views from ground floor, door to main entrance

Existing front wooden door entrance to be retained with no modification.

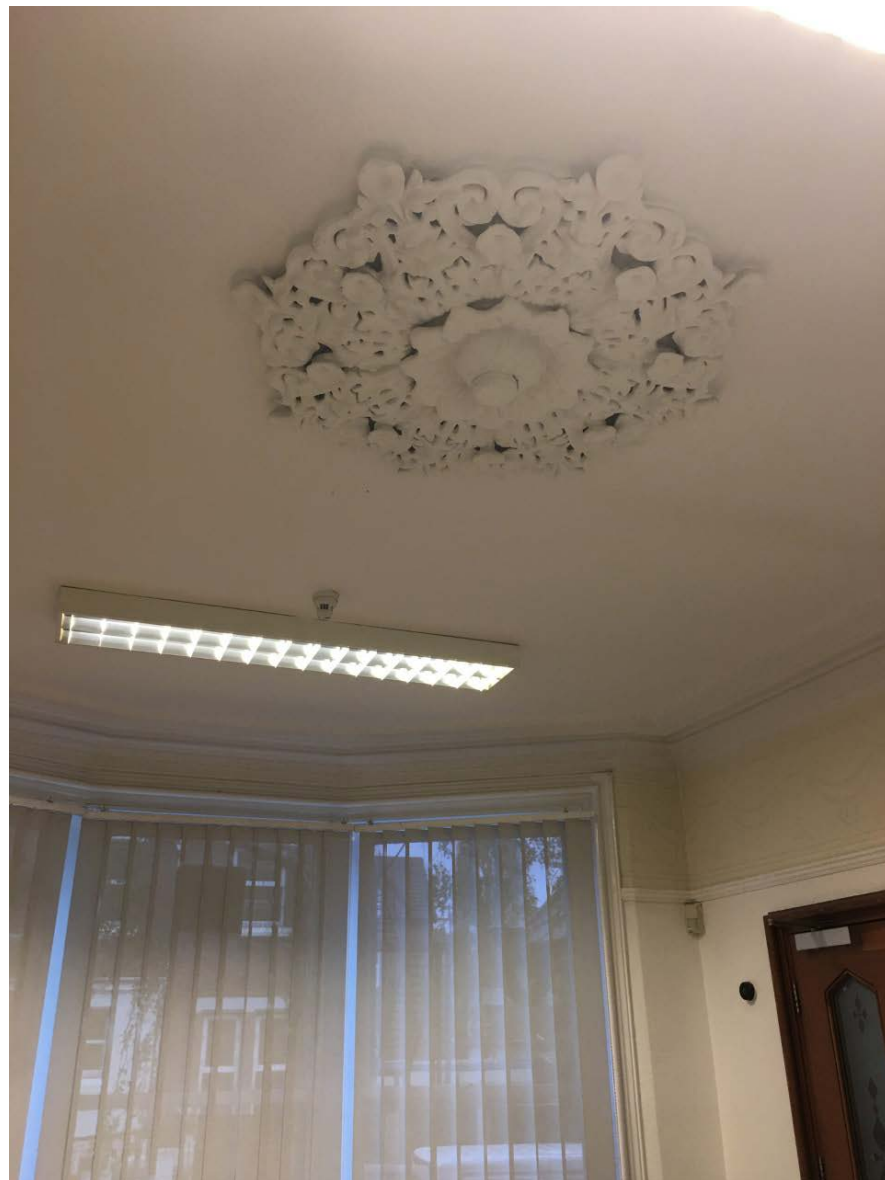
Views from room 5- ceiling rose

Ceiling rose and coving to be retained, new suspended ceiling with insulation will be installed 300mm below the existing ceiling to comply with Building Regulations Fire and Sound Insulation. Bulk head to be chamfered at 45 degree above the window top.

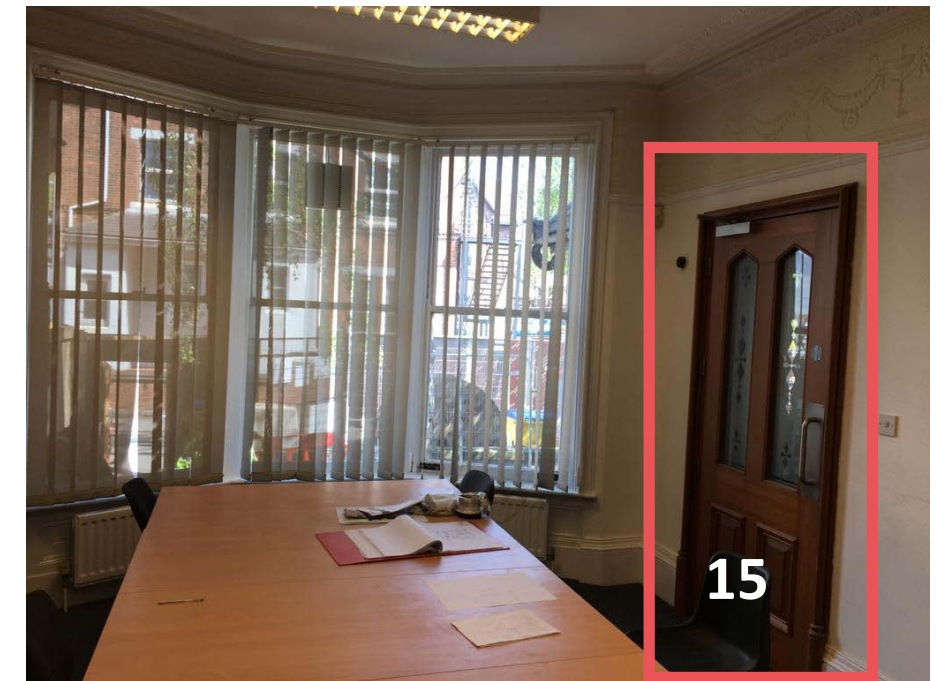
Views from room 5- Door to be blocked, view 15

Wooden door marked 15 opening to be blocked as no functional connection is needed between the two rooms

Views from room 5- Door to be blocked, view 14

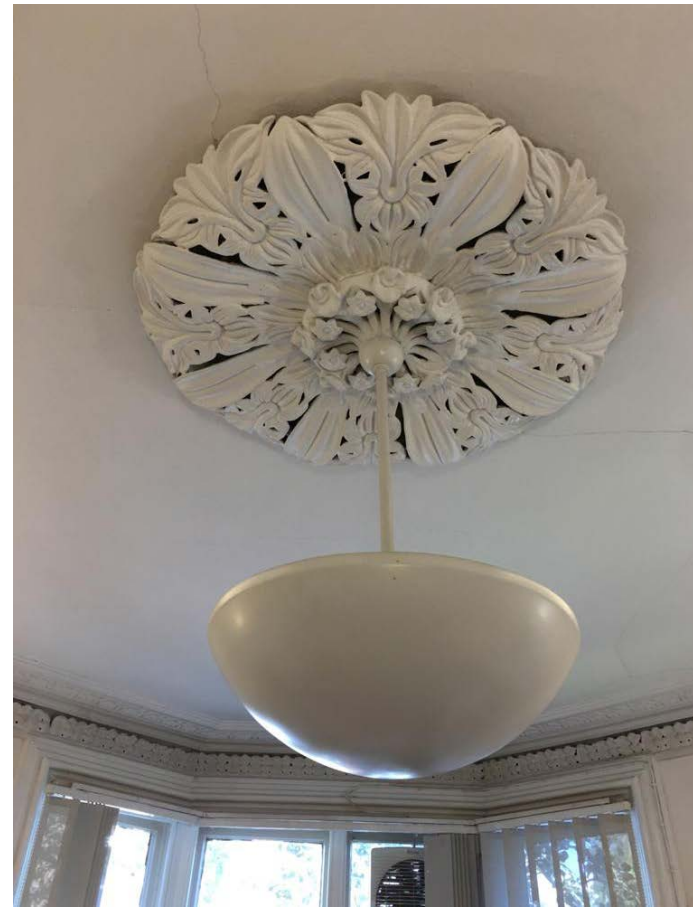
Views from room 6 - ceiling flower

Ceiling rose and coving to be retained, new suspended ceiling with insulation will be installed 300mm below the existing ceiling to comply with Building Regulations Fire and Sound Insulation. Bulk head to be chamfered at 45 degree above the window top.

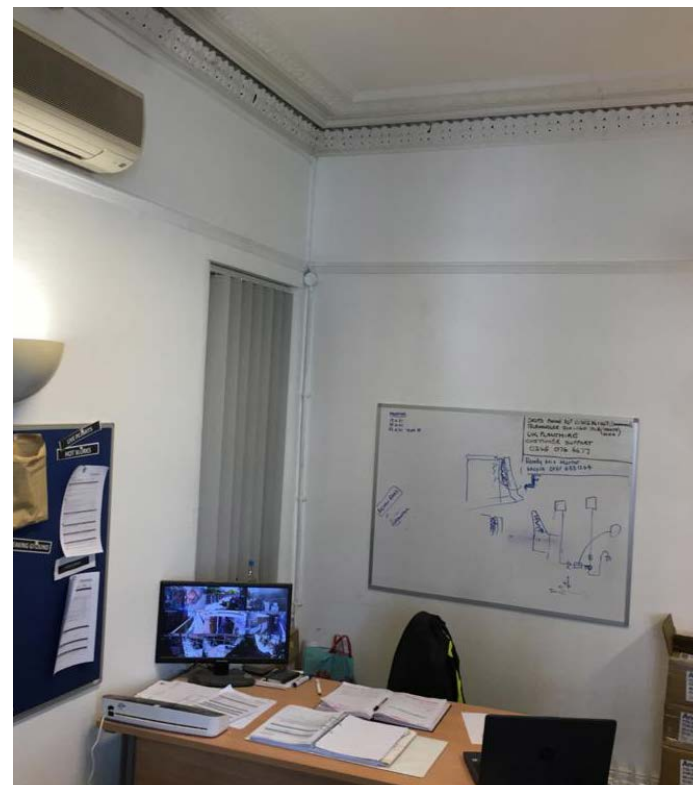
Views from room 6

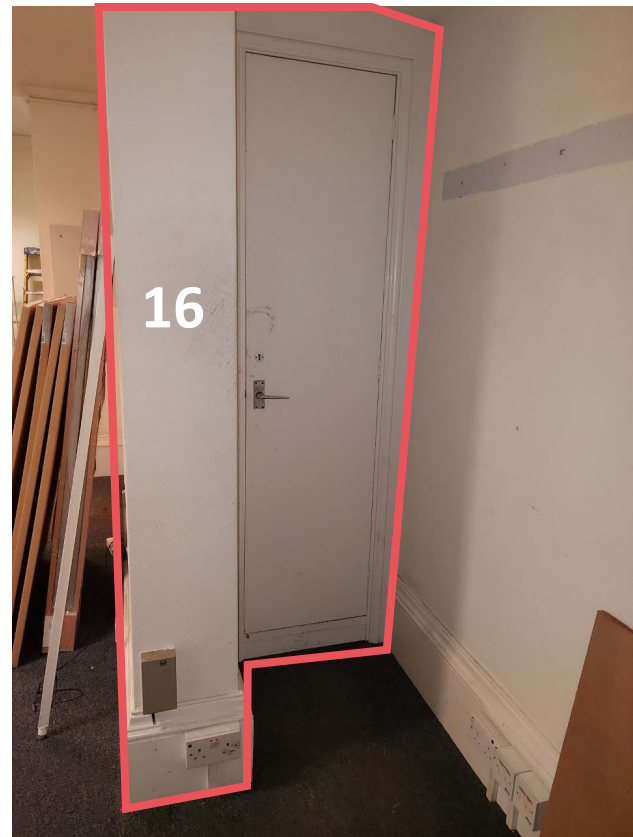
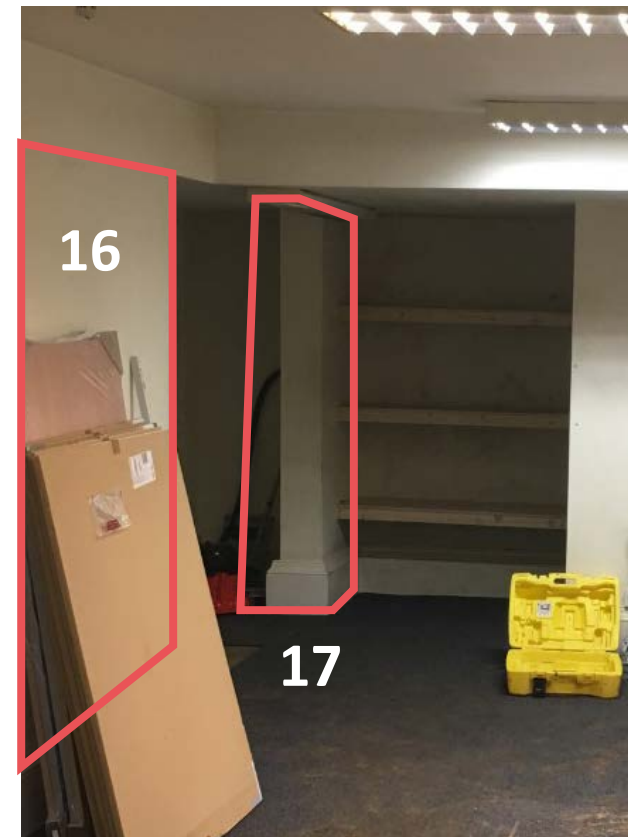
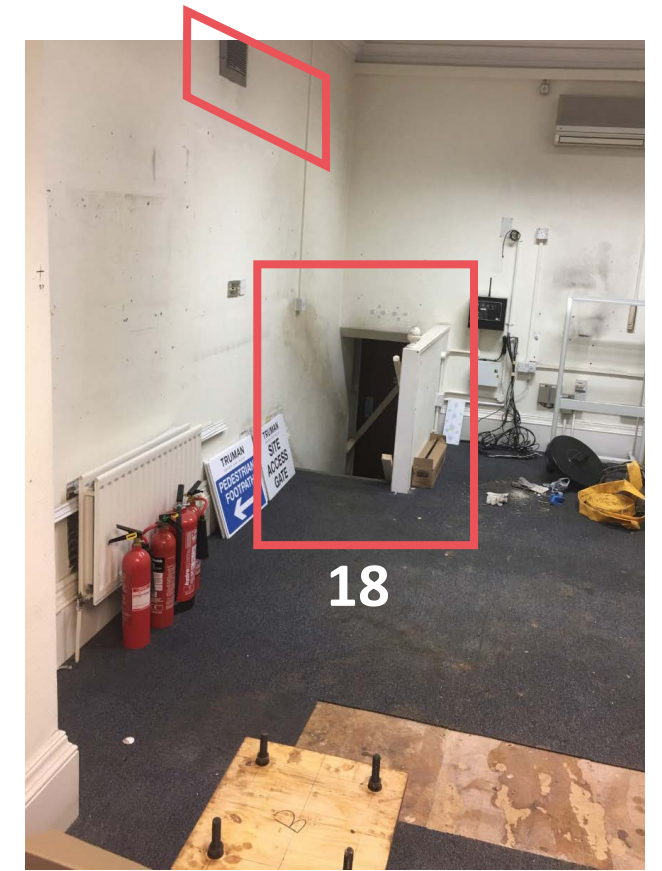
Brick walls, marked 16 and 17, to be demolished to provide a suitable and wide new staircase to access the new proposed bedroom/bathroom in the basement.

The staircase (marked 18) leading to the back offices to the rear of the bank main building to be sealed as there is no longer connection required between the two properties.

A opening (can be seen from view 18) to be formed to form a new window to the new proposed bedroom for flat 1.

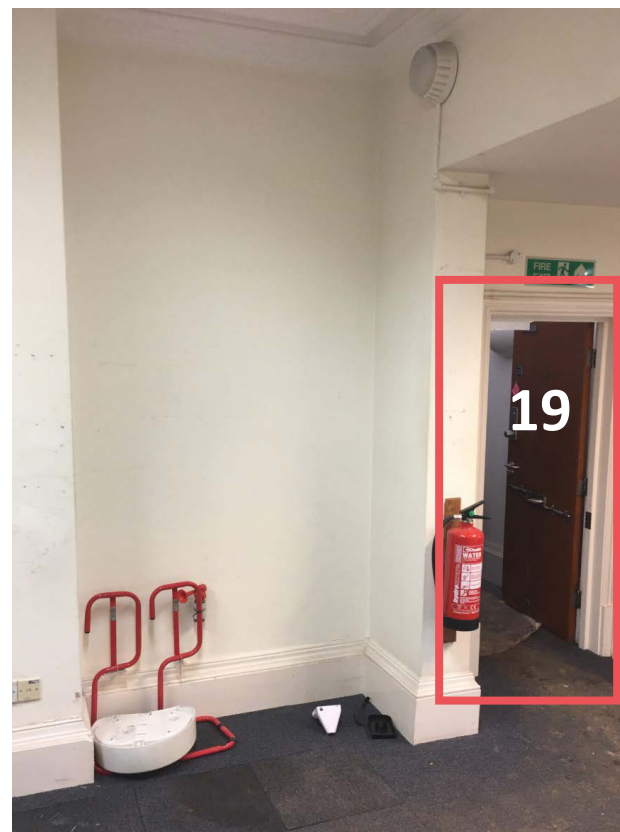
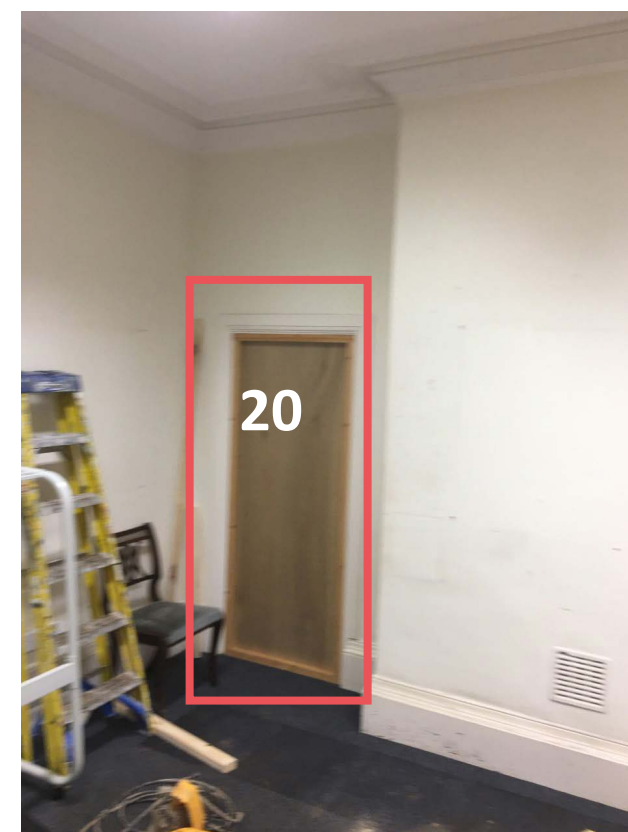
Door to lobby (marked 19) to be blocked as no connection is required between the rooms.

Door to room 5 (marked 20) to be blocked as no connection is required between the rooms.

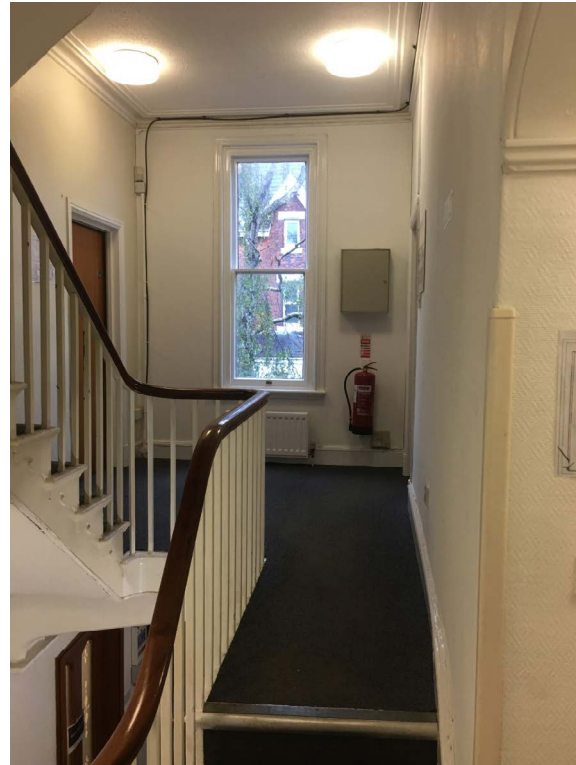
Views from first floor landing

All existing coving, staircase, handrail, Balustrade will be retained, only one layer of 12mm plaster board and skimmed will be fixed to underneath the stairs to comply with Building Regulations Fire Regulations.

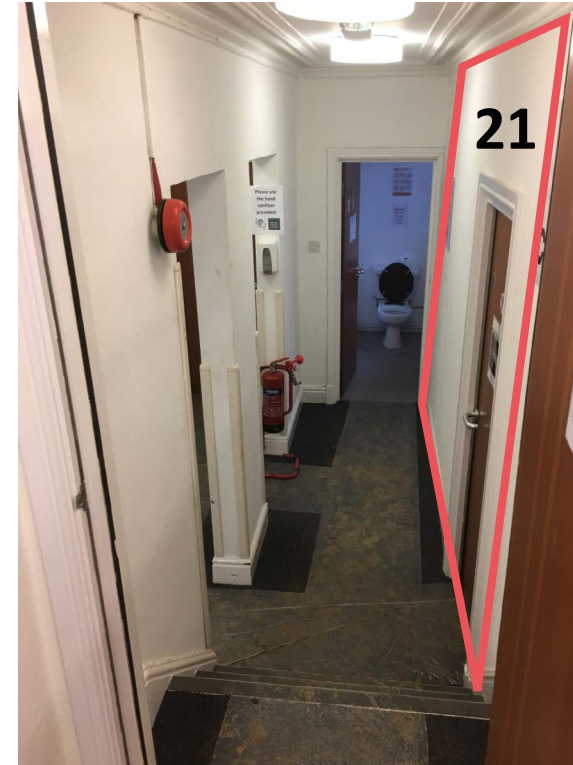
Views from first floor - hallway

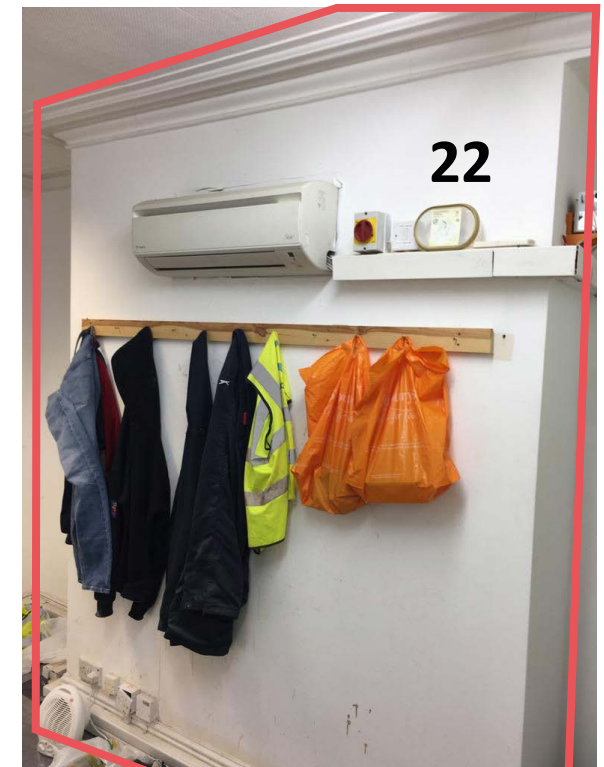
Chimney breast recess approx 200mm inside room 12 to be removed to create a continuous wall in the bedroom in flat 3.

Views from first floor - Chimney breast to be demolished to enlarge bedroom

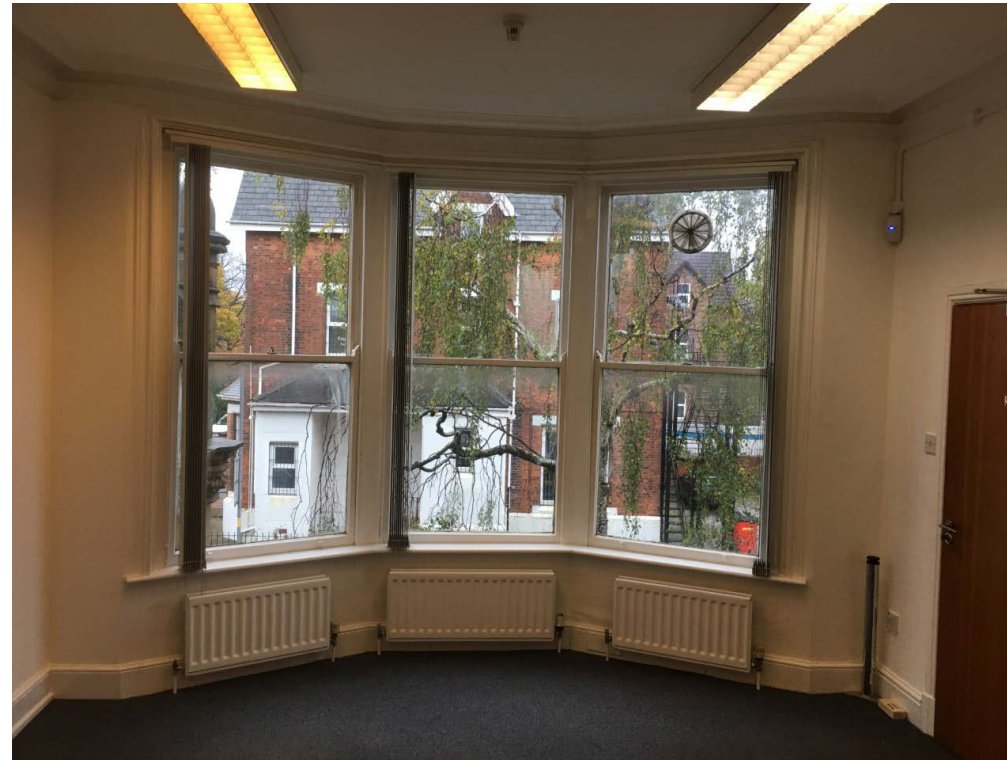
Views from room 9 -Room bay window

New suspended ceiling with insulation will be installed 300mm below the existing ceiling to comply with Building Regulations Fire and Sound Insulation. Bulk head to be chamfered at 45 degree above the window top.

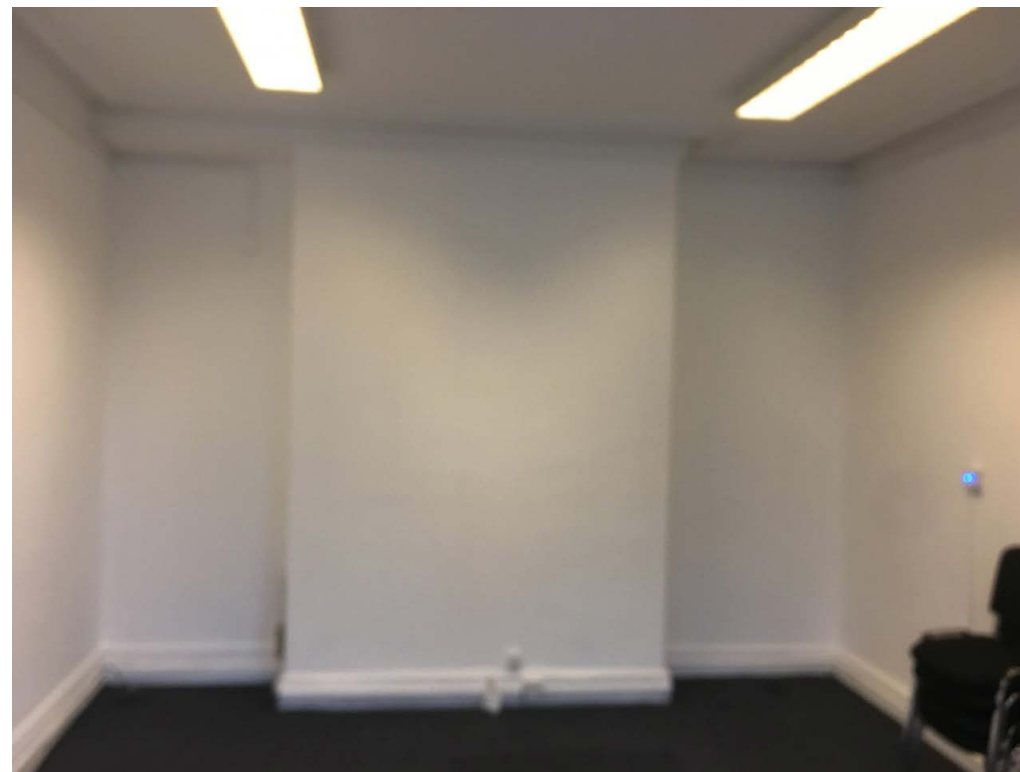
Views from room 9 - chimney breast
