# Photographic evidence to internal alteration/demolishing

**May 2021**

Project: Proposed conversion of  
2 Swinbourne Grove,  
Withington, into 6 self  
contained flats

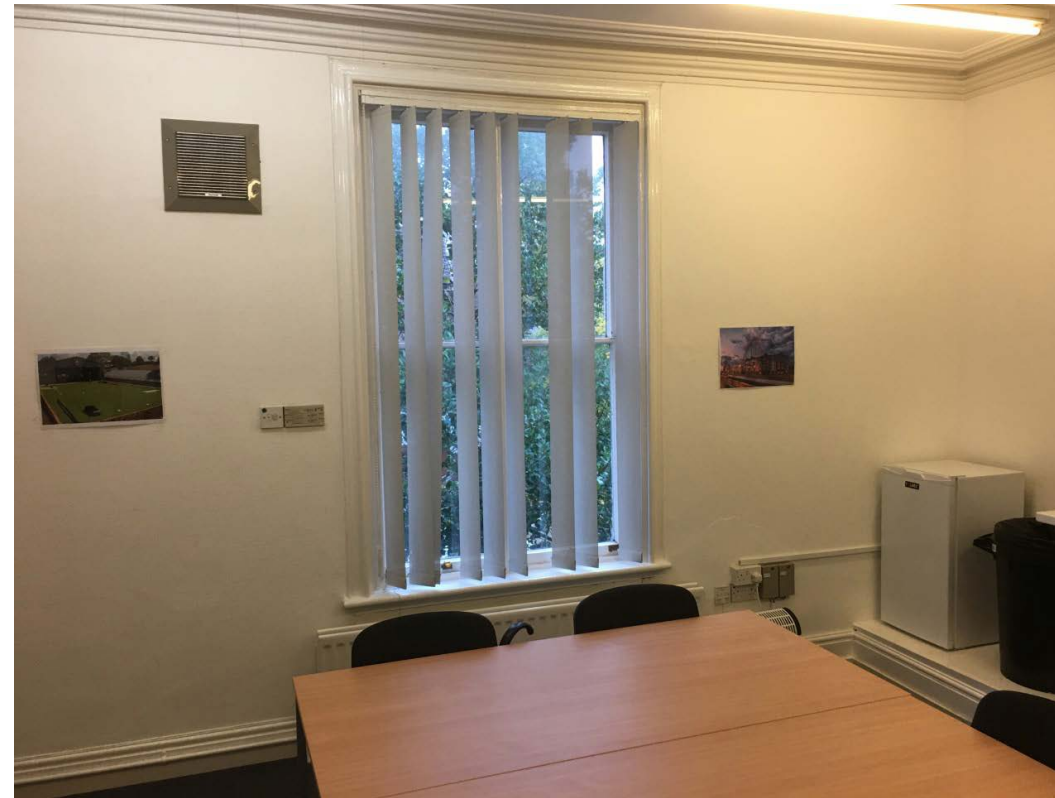
Views from room 10 - Room window

New suspended ceiling with insulation will be installed 300mm below the existing ceiling to comply with Building Regulations Fire and Sound Insulation. Bulk head to be chamfered at 45 degree above the window top.

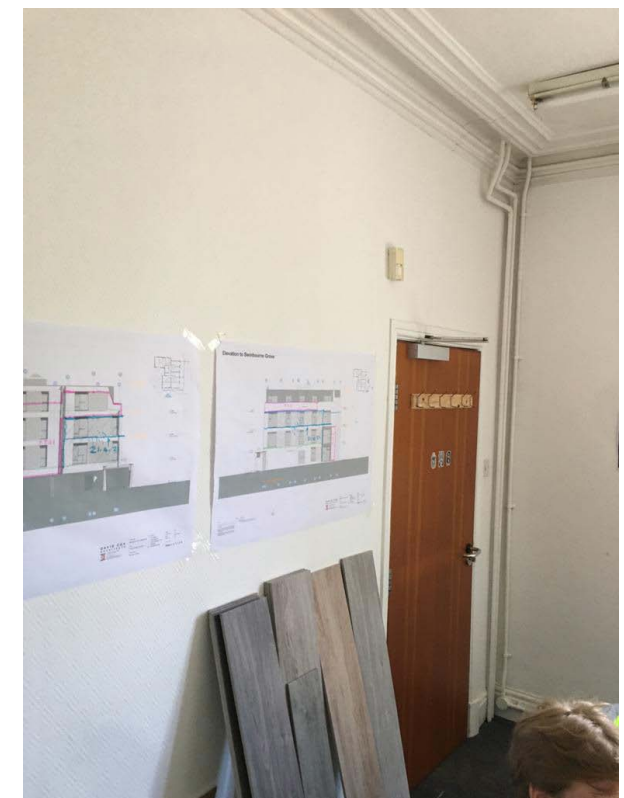
Views from room 10 - Room door

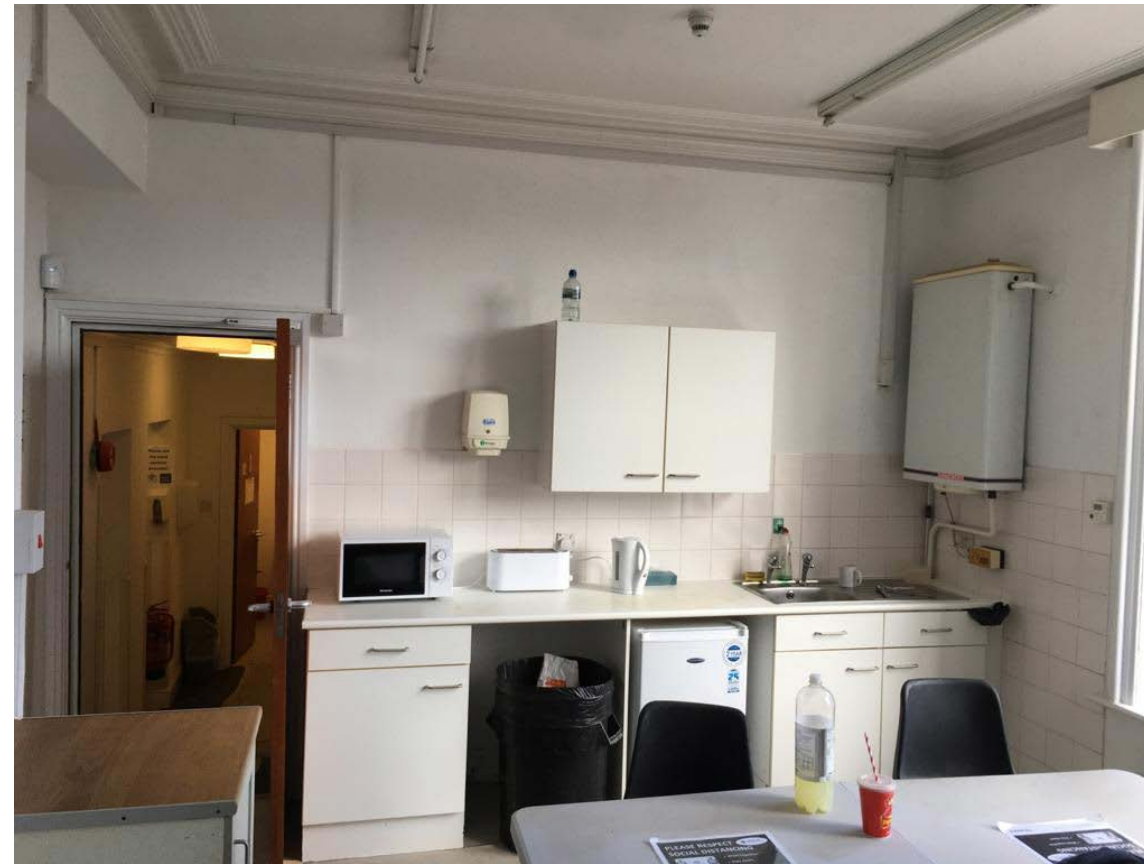
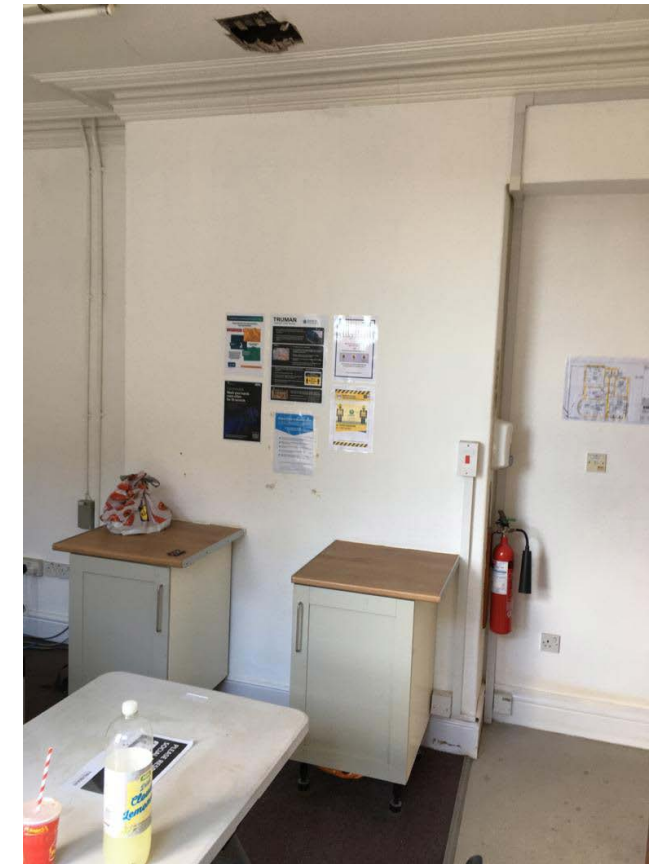
Views from room 11

New suspended ceiling with insulation will be installed 300mm below the existing ceiling to comply with Building Regulations Fire and Sound Insulation. Bulk head to be chamfered at 45 degree above the window top.

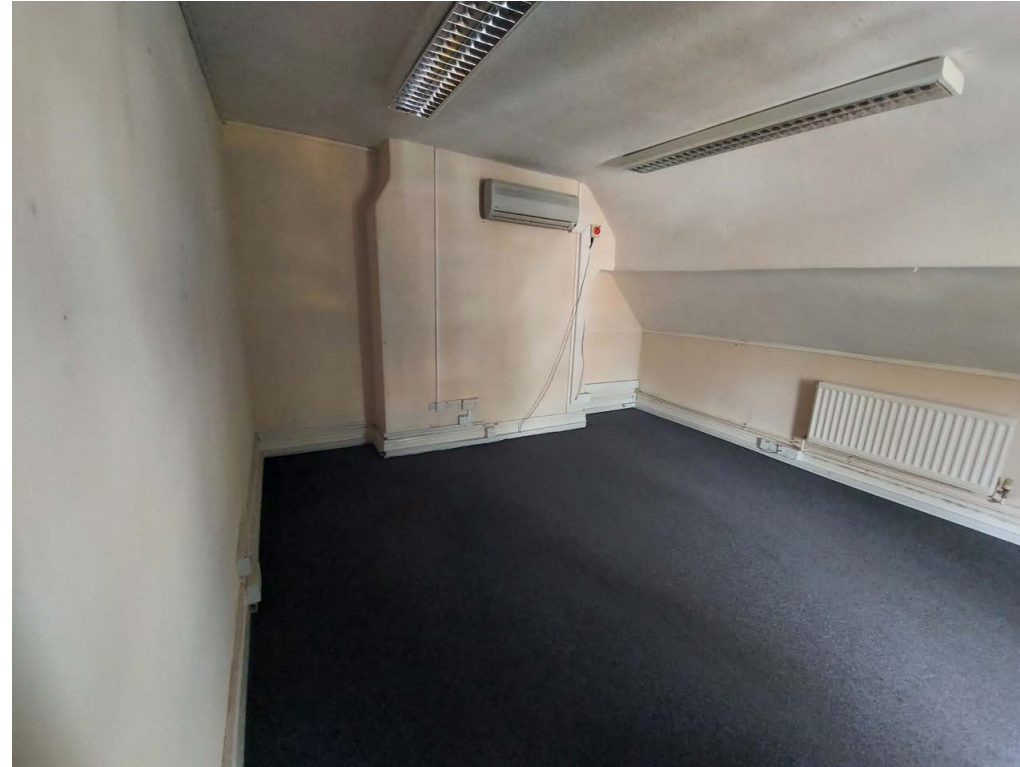
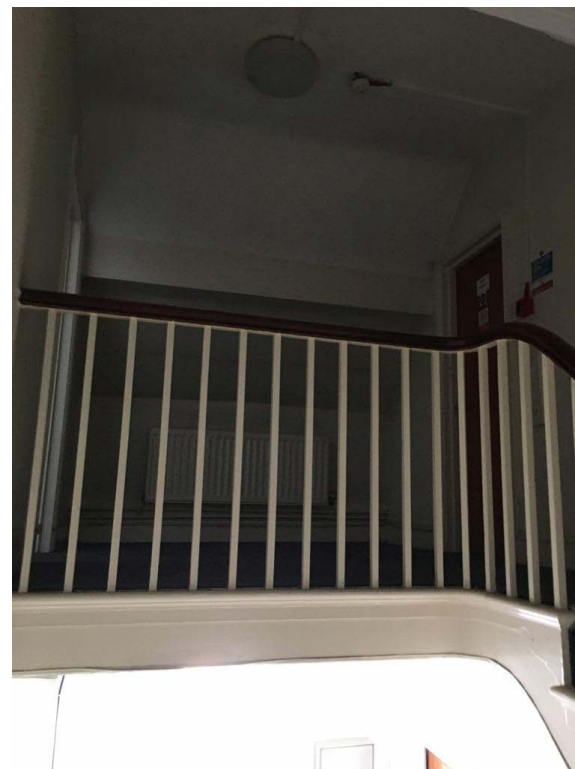
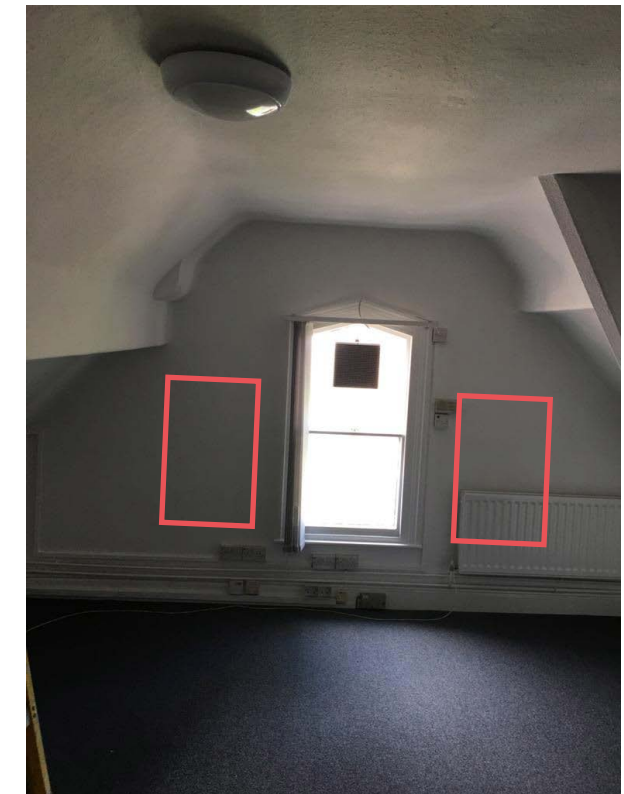
Views from room 13

All rooms in the second floor to have new 12mm layer of plasterboard skimmed with 3mm to be fixed directly to the existing ceiling with 50x20 timber lats at 600 centre.

Two new openings to be formed to provide two new windows to match existing in terms of materials to provide extra light to the bedroom to meet the requirement of 10% opening of the floor area of the room.

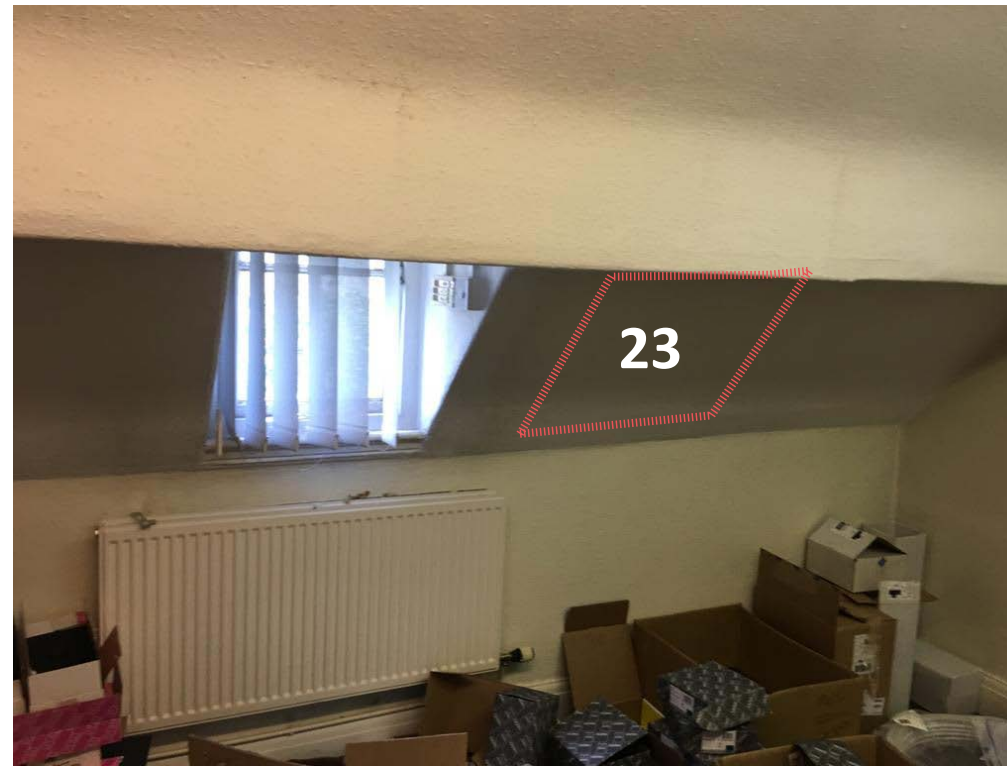
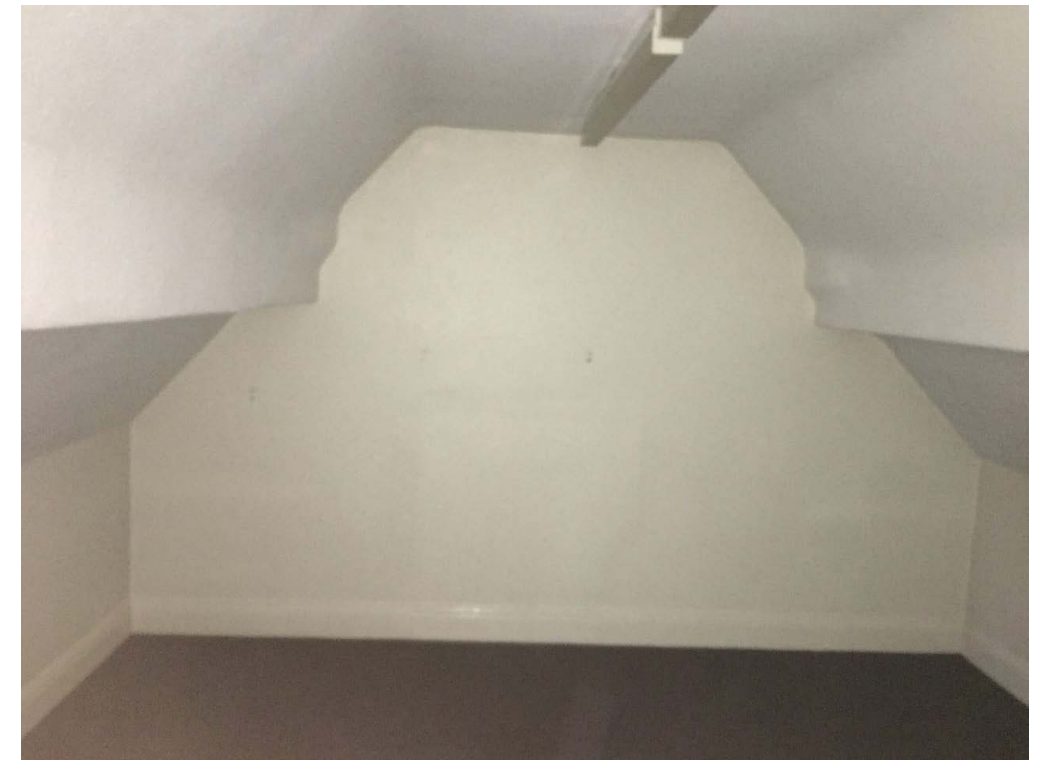
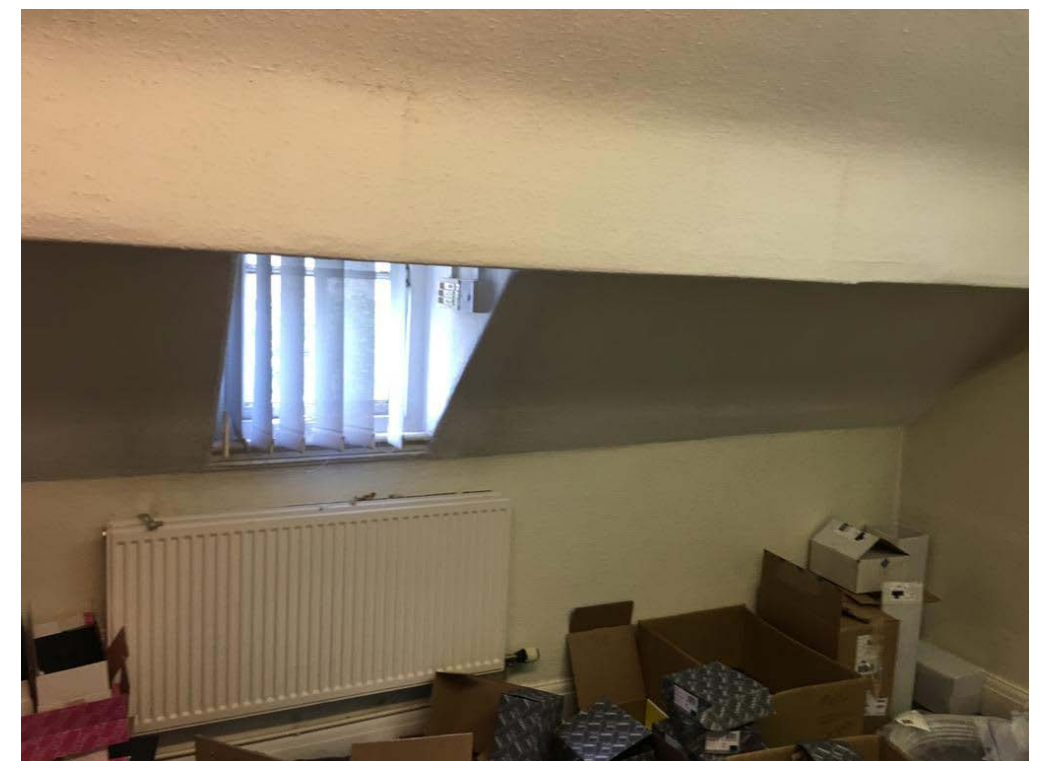
Views from room 14.

A new opening (marked 23) to be formed to provide a new dormer window to match existing in terms of size and materials to provide extra light to the bedroom to meet the requirement of 10% opening of the floor area of the room.

All rooms in the second floor to have new 12mm layer of plasterboard skimmed with 3mm to be fixed directly to the existing ceiling with 50x20 timber lats at 600 centre.

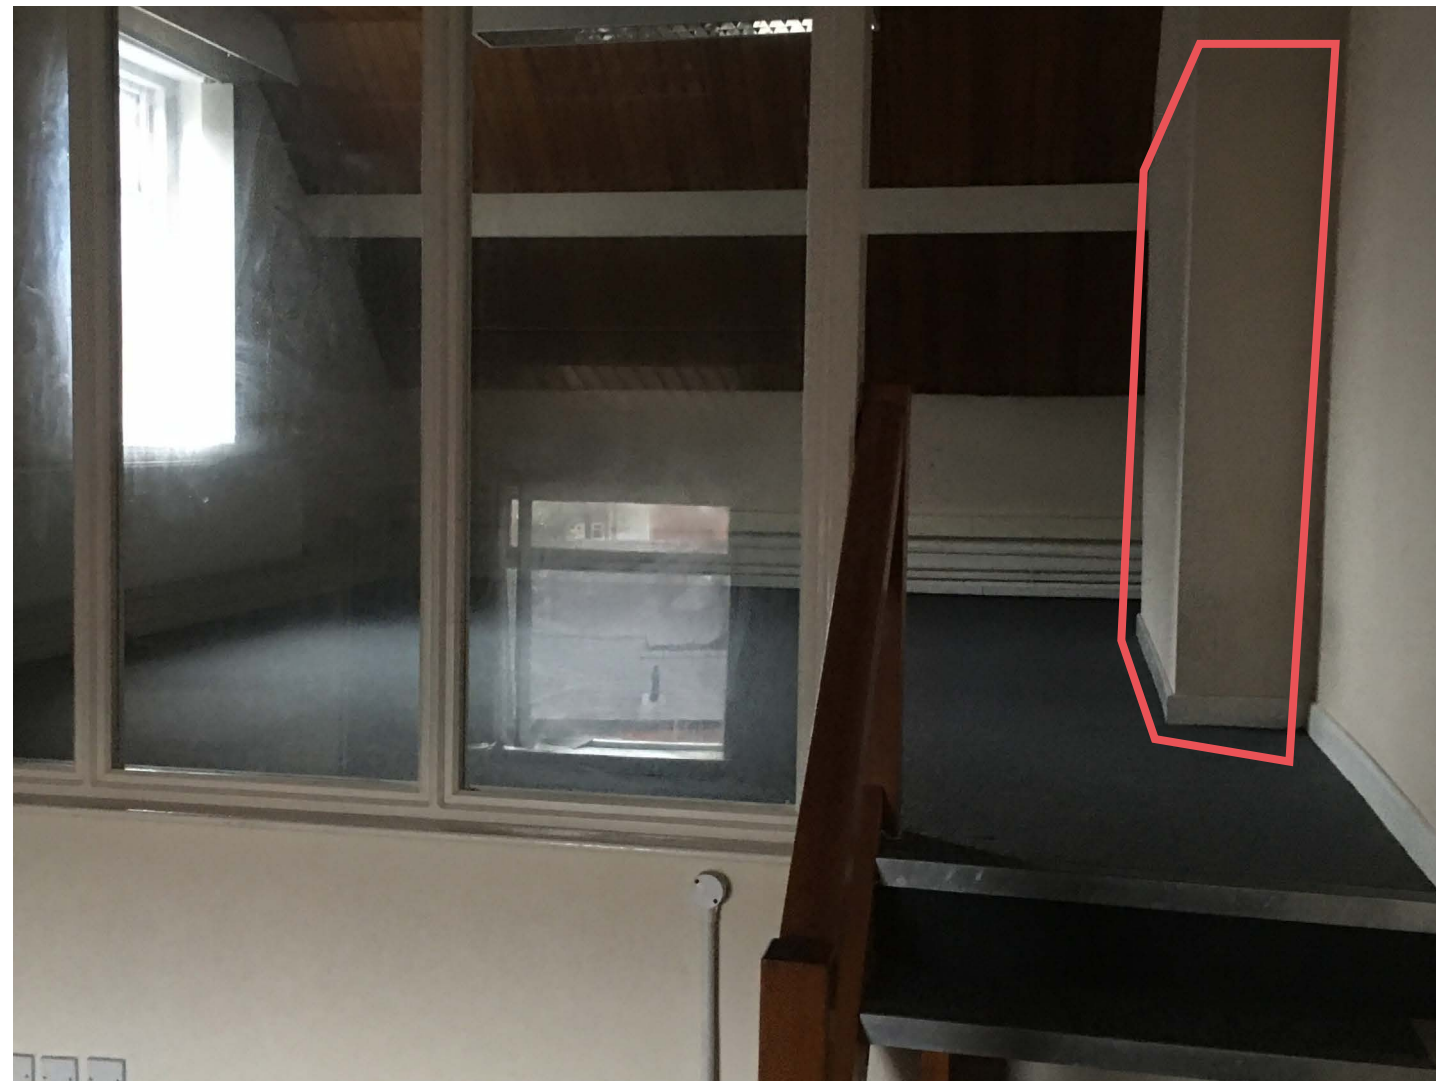
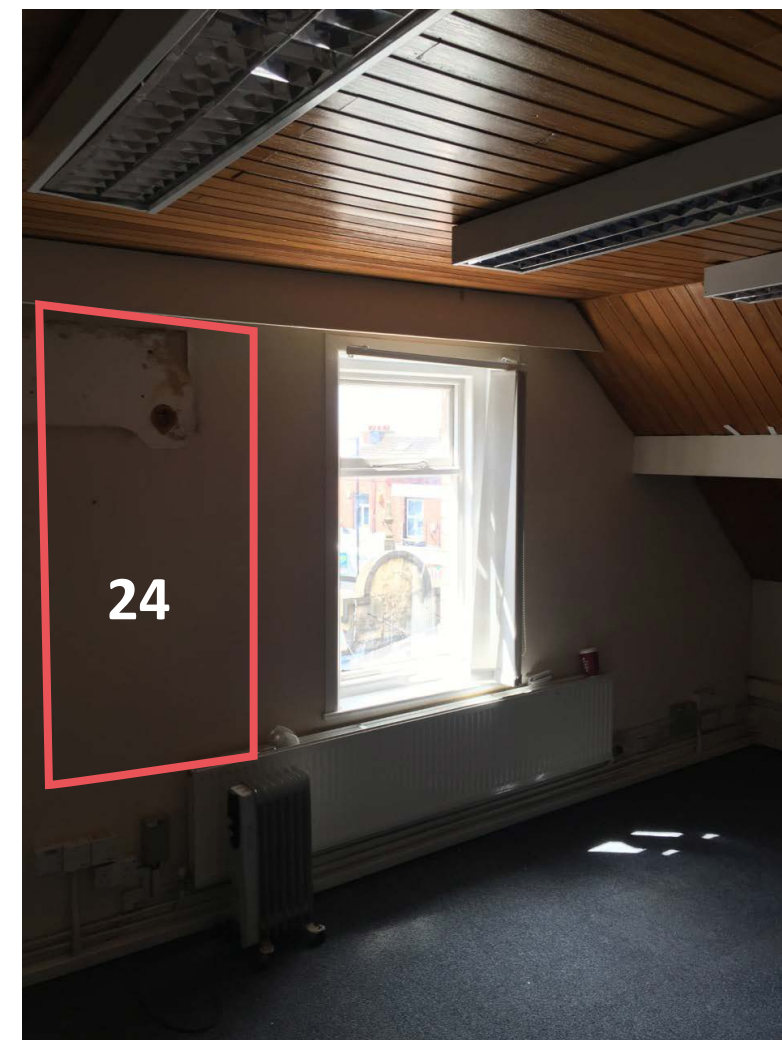
Chimney breast to be removed to enlarge bathroom in flat 5.

A new opening (marked 24) to be formed to provide a new window to match existing in terms of size and materials to provide extra light to the bedroom to meet the requirement of 10% opening of the floor area of the room.

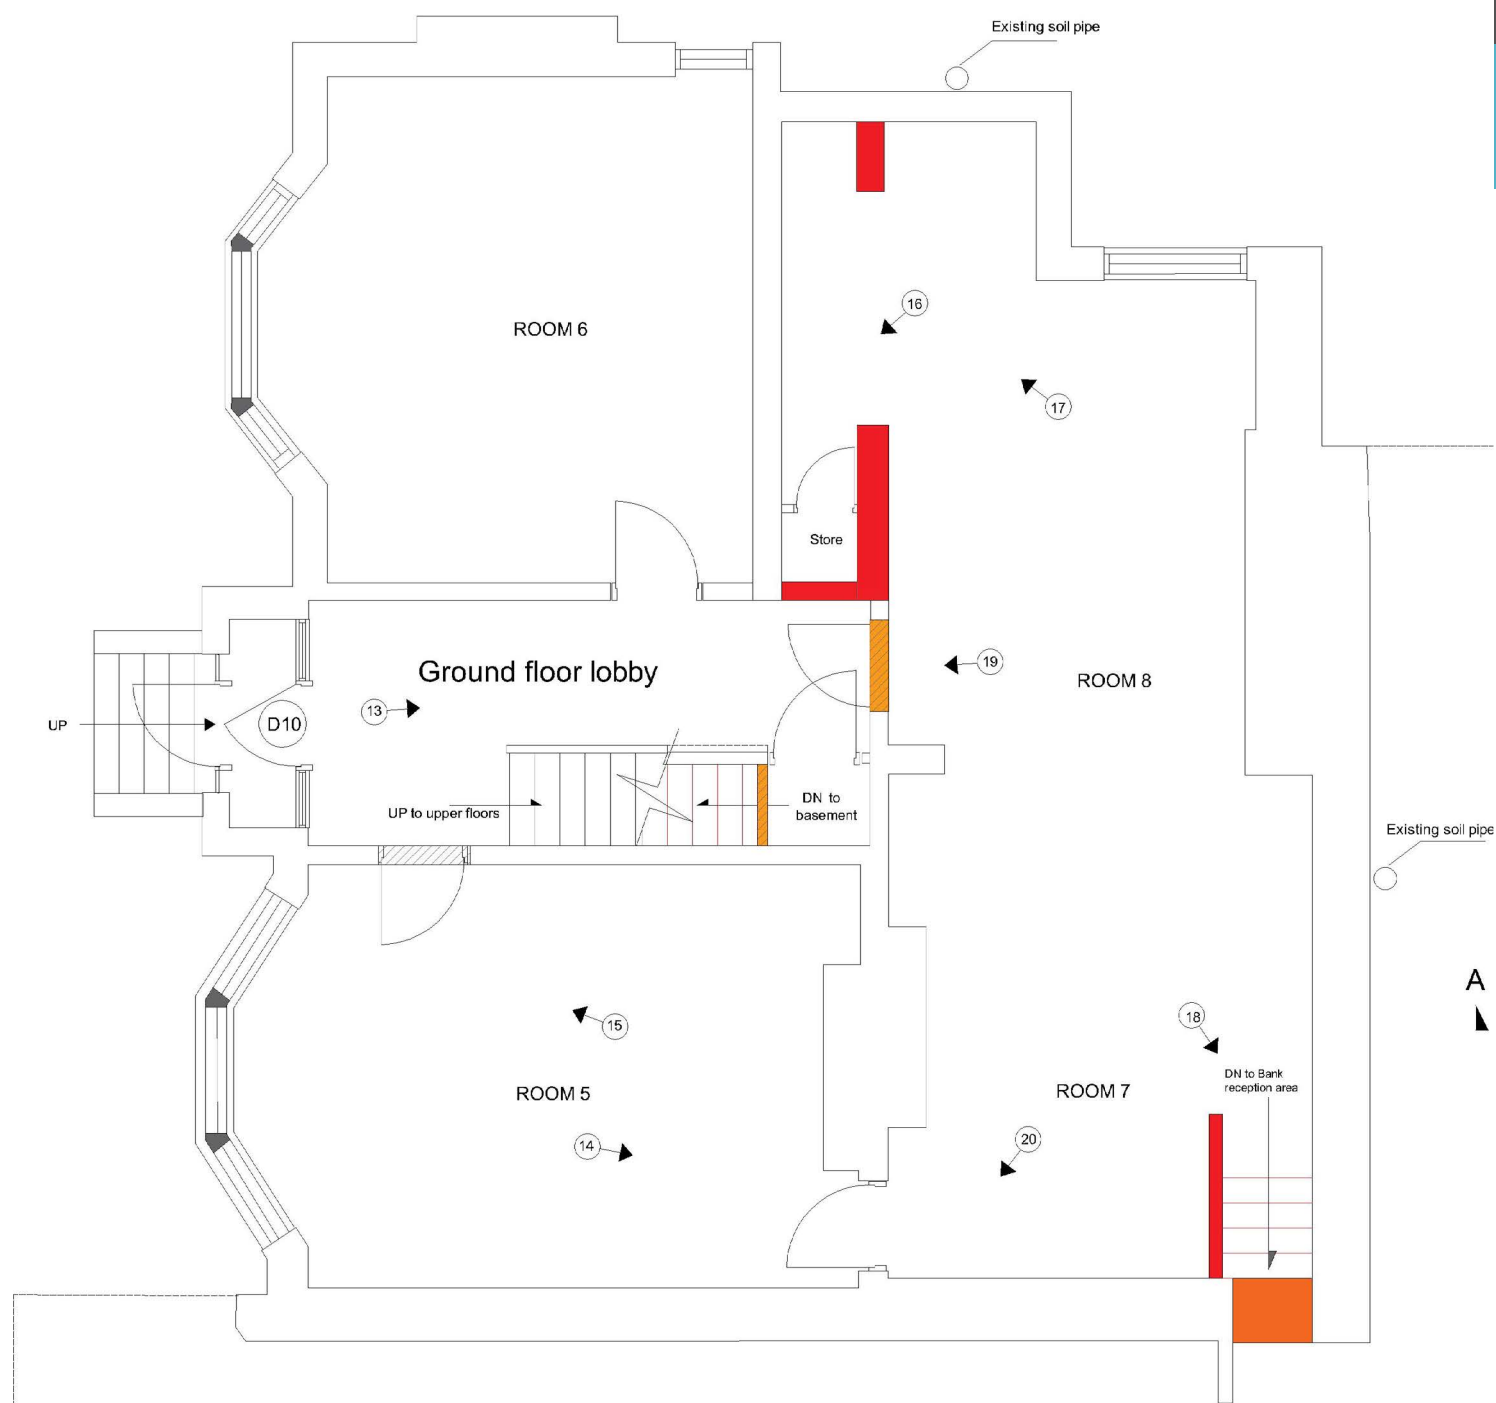
Drawing number 2

Existing ground floor

Existing doorway to be blocked  
using stud partition with two  
layers plasterboards both sides

Existing walls to be demolished

Existing steps to be demolished

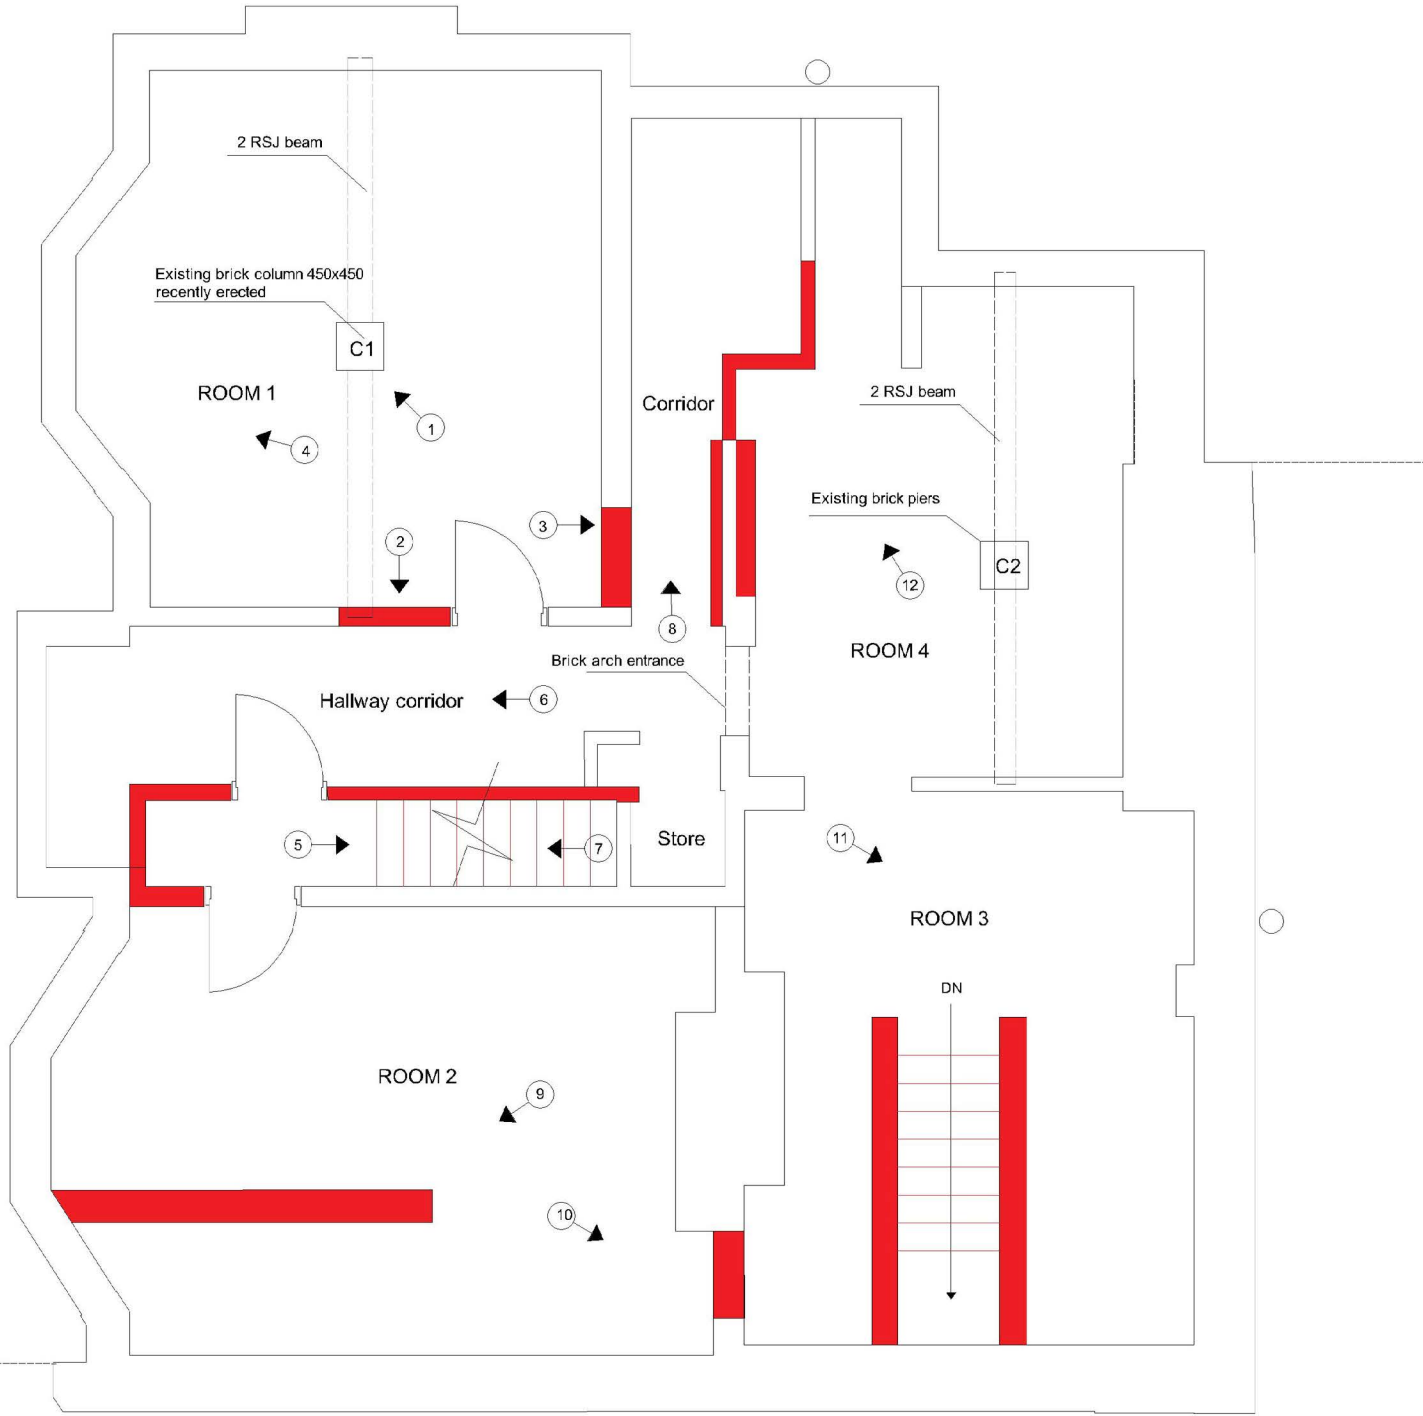
Drawing number 3

Existing basement

Existing walls to be demolished

Existing steps to be demolished

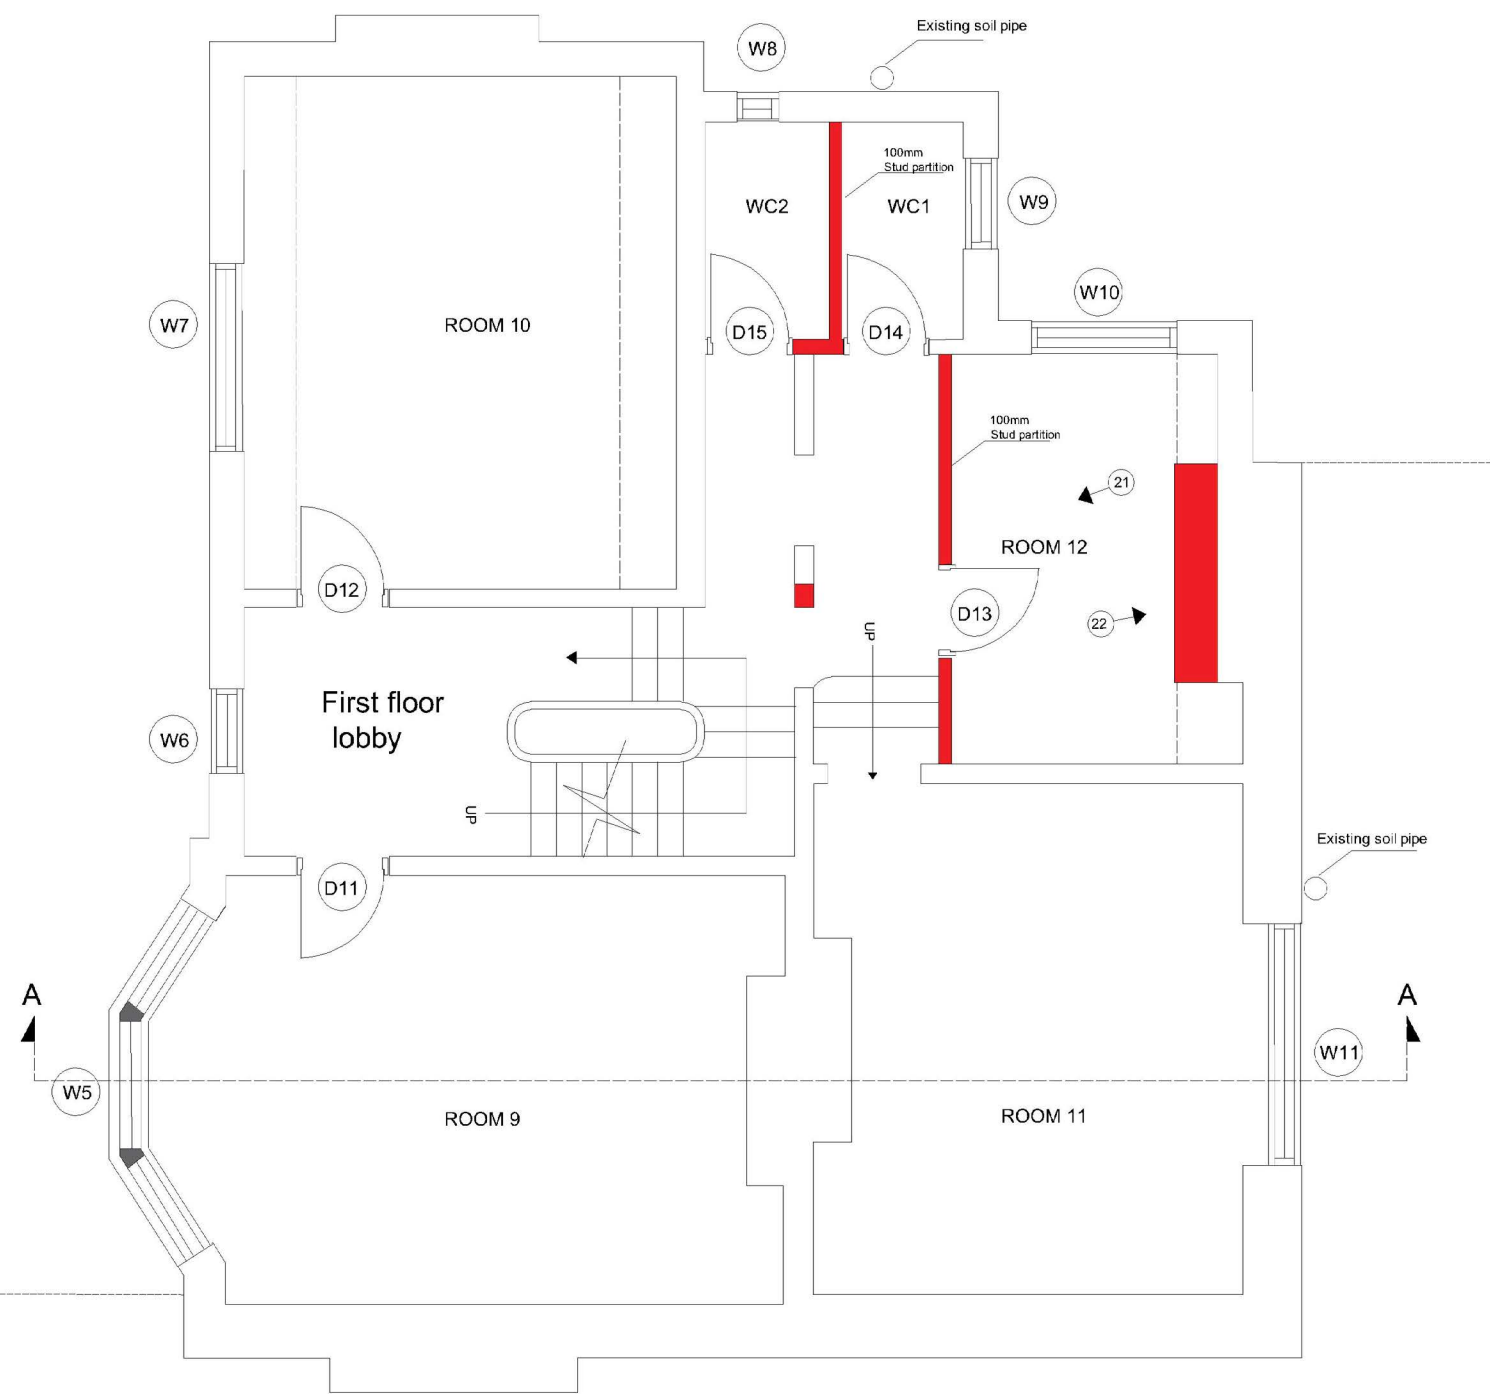
Drawing number 4

Existing first floor

Existing walls to be demolished

Existing steps to be demolished

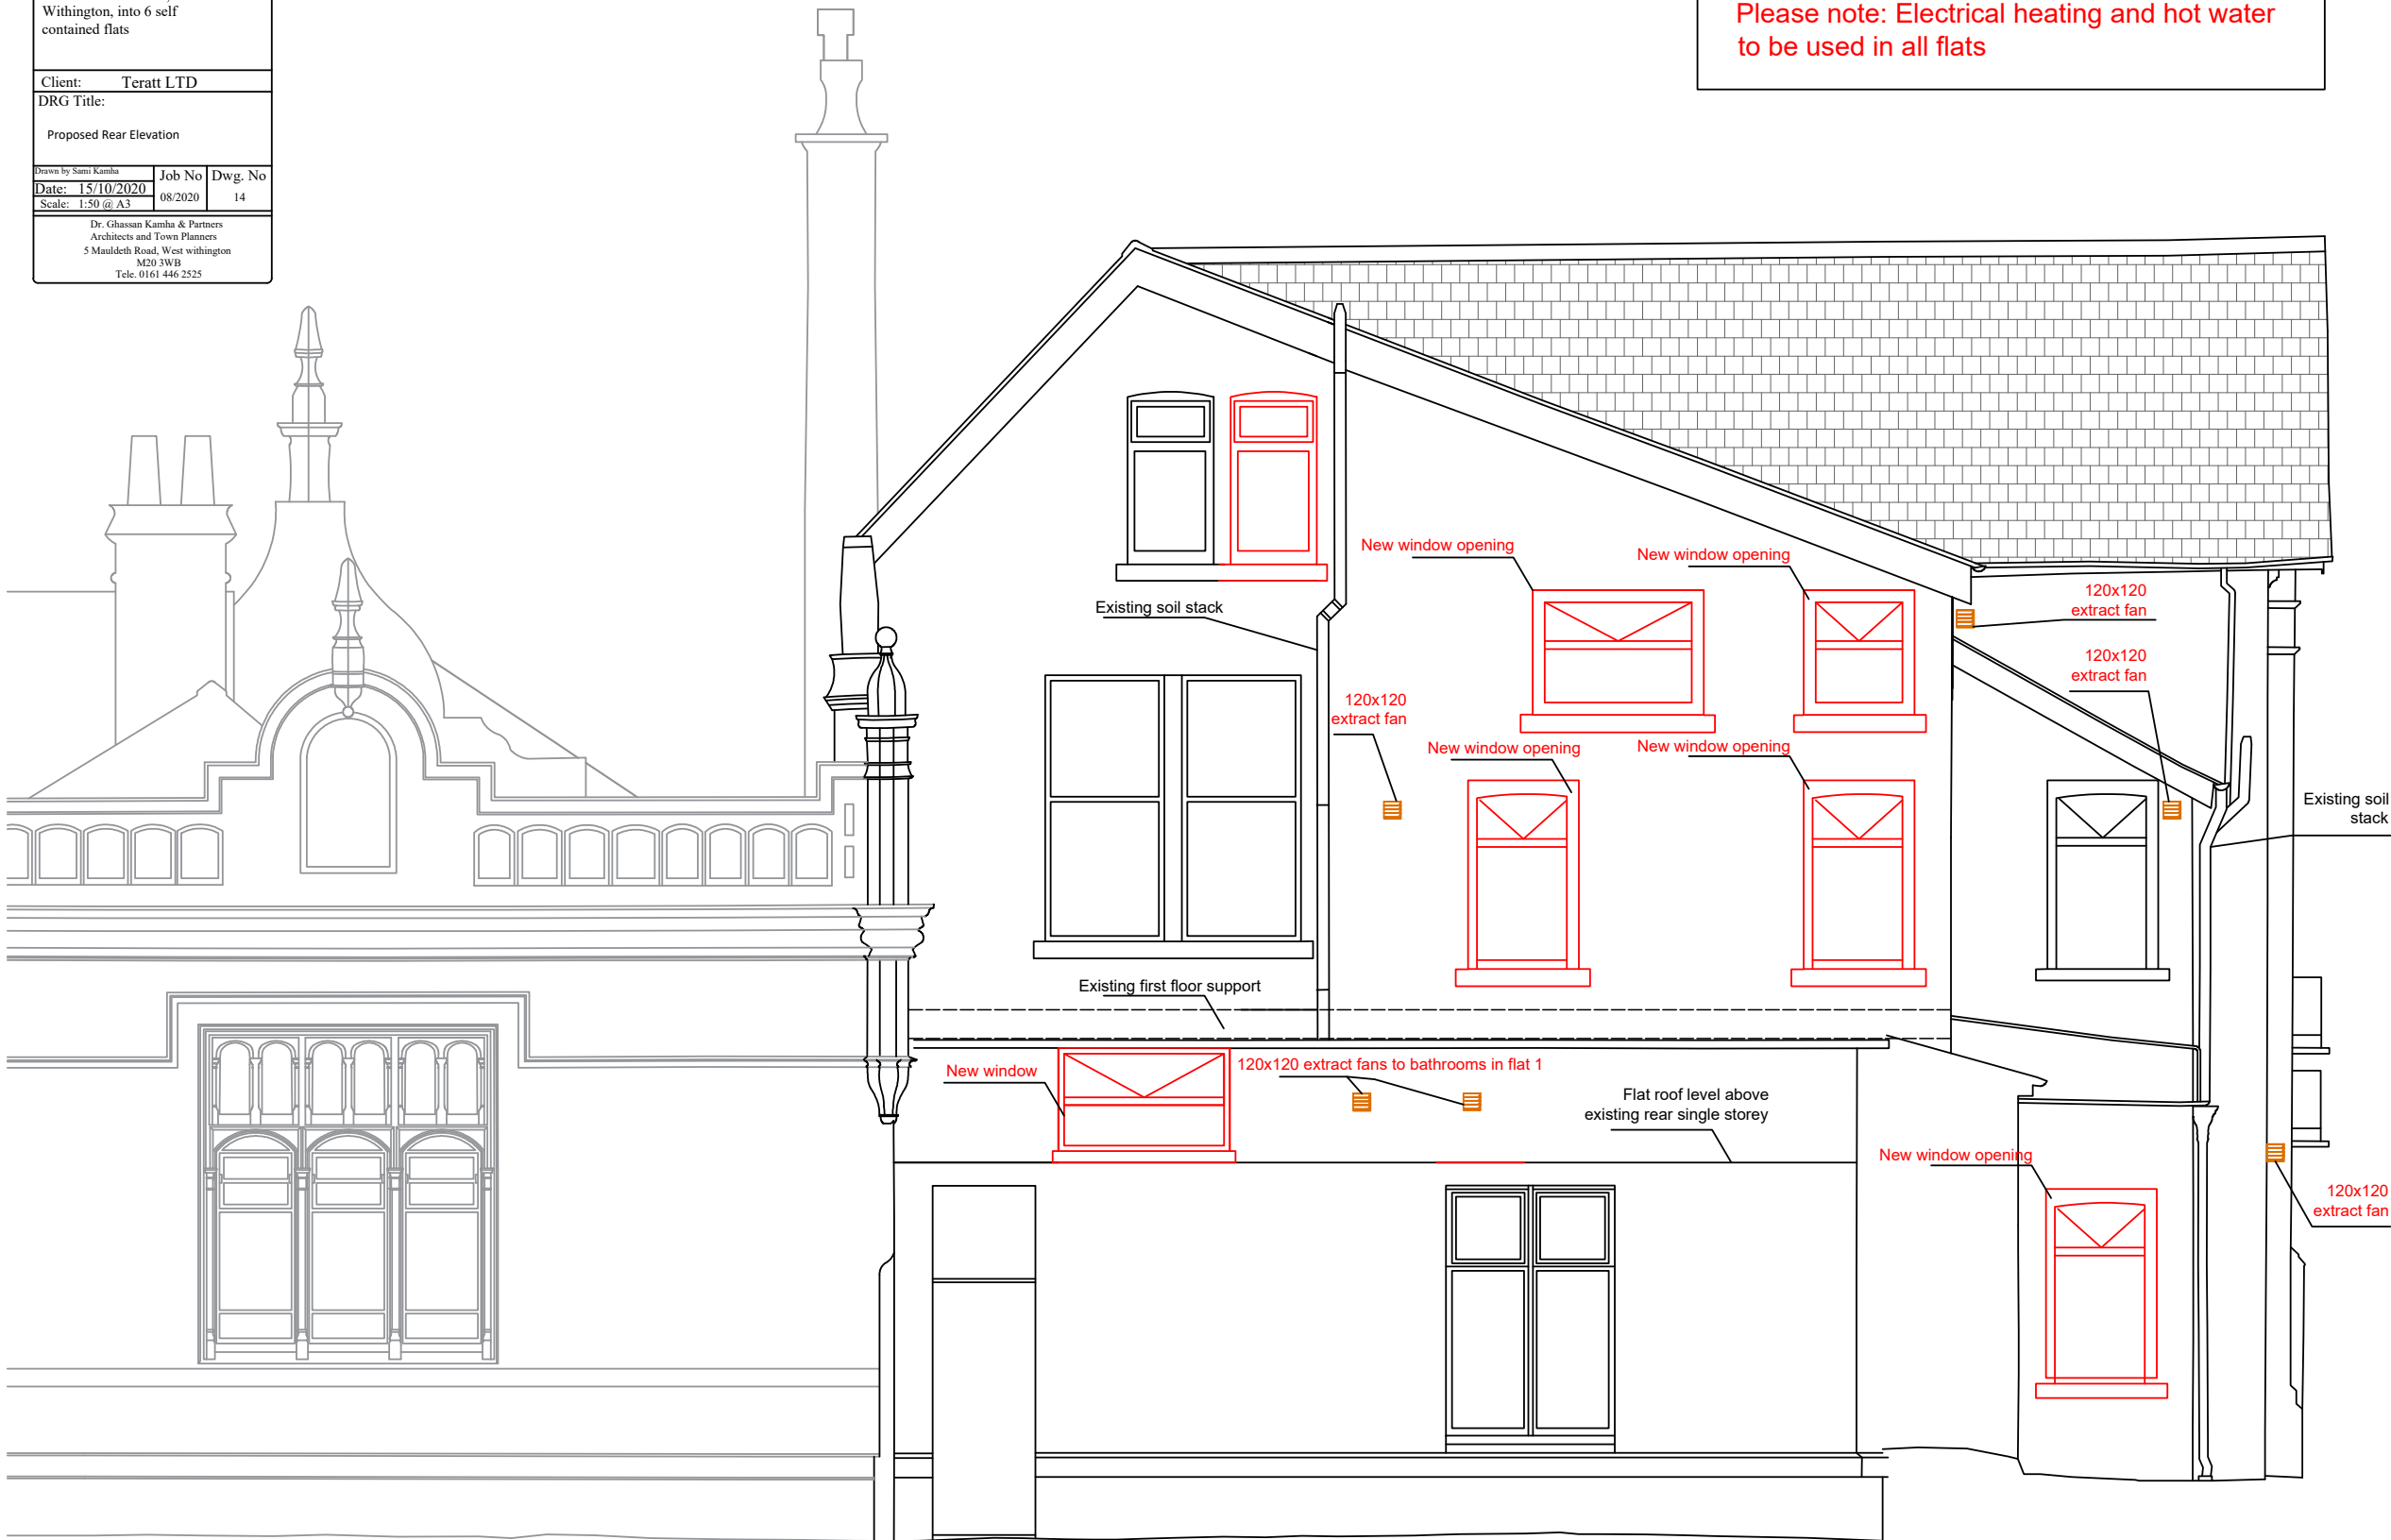
Proposed Rear Elevation (annex)

Proposed Rear Elevation (offices)

The majorities of the ventilation will be extracted through the existing chimney flue stacks with only 3 small vents provided through the wall at the rear as indicated in our drawings number 14.
