## 3.0 VISUAL CONDITION STUDY

### 3.1 Existing Facade Condition

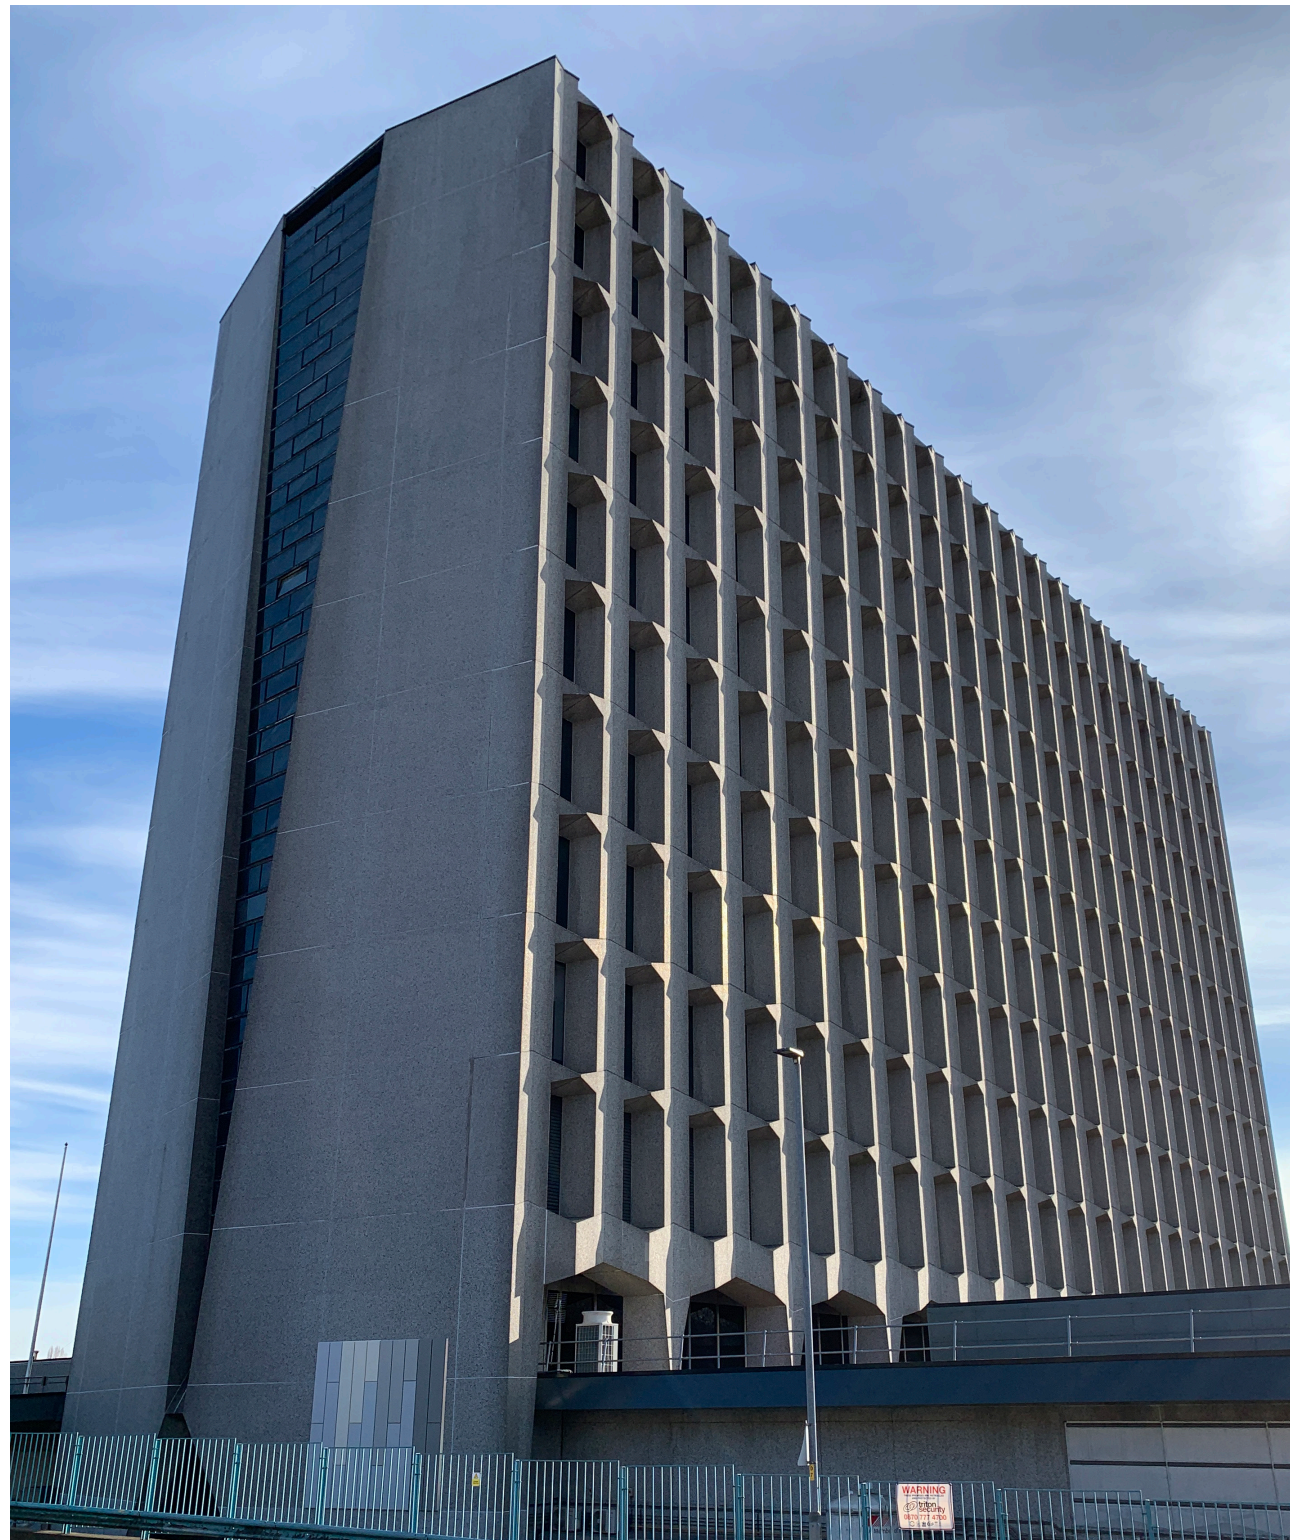
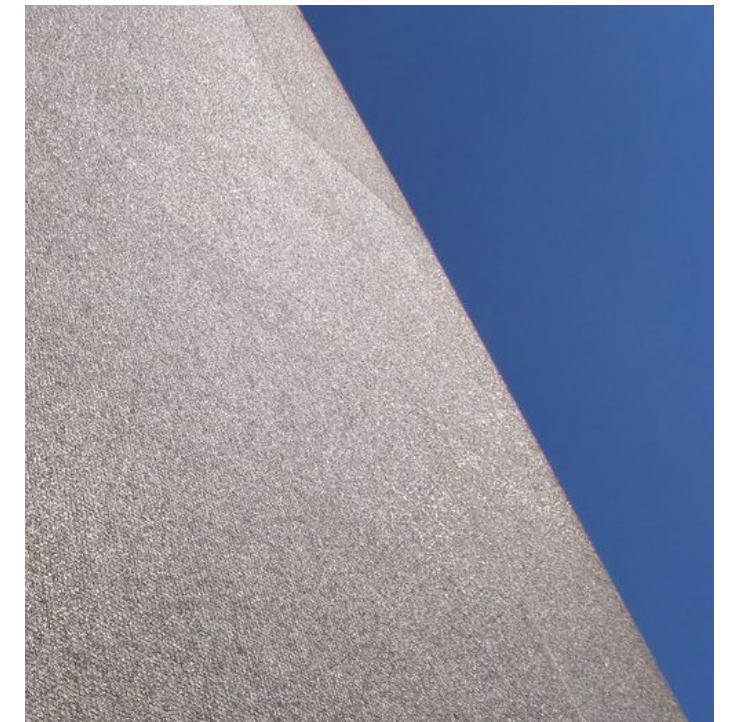
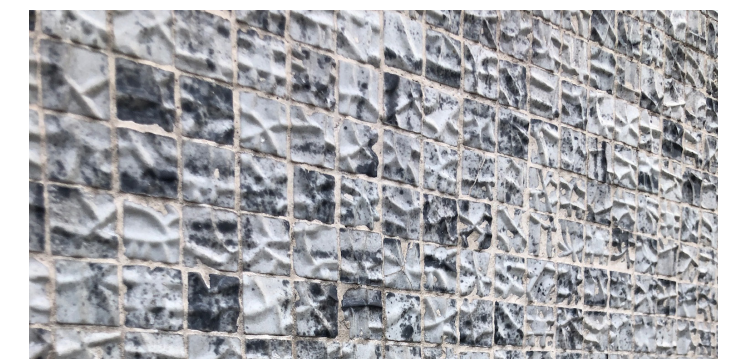
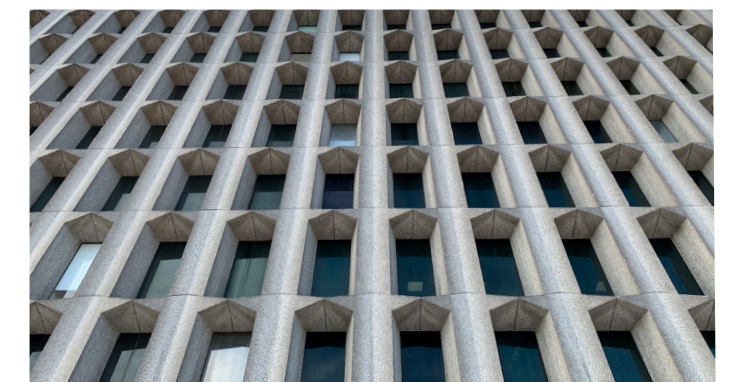
Where panels of tiling are missing or have been repaired this visual uniformity is disrupted. Missing tile panels can be read very clearly and replacement tiles are not weathered in the same manner as the rest of the tiling meaning that they contrast visually.

Where panel joints have also been replaced it has often been with white silicone rather than grey, as original. Again, these white joints can be read very clearly and disrupt Seifert & Partner's design intent for a uniformity of finish to the precast panels.

The materiality of the tiles originally set out to shimmer and look different depending on the seasons. The tiles would add further drama to the buildings faceted form. It is this visual effect which is key to people's experience of the building rather than the tiles themselves. Due to lack of maintenance and general wear and tear over the years, this visual effect has been lost.

**Providing a shimmer is therefore a key visual characteristic to inform a new material selection.**
