## 3.2 Facade Condition Photographs - 2012

### 2012 Deterioration of the Facade

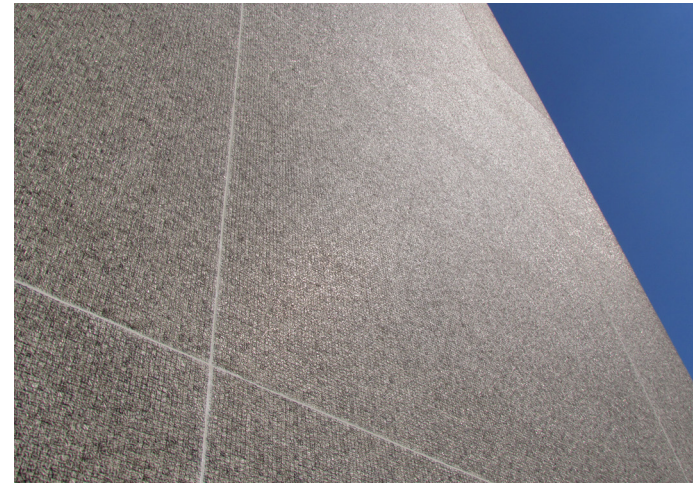
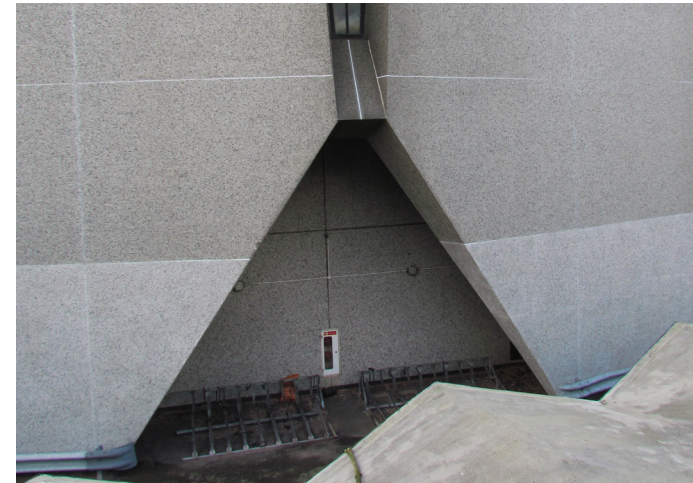
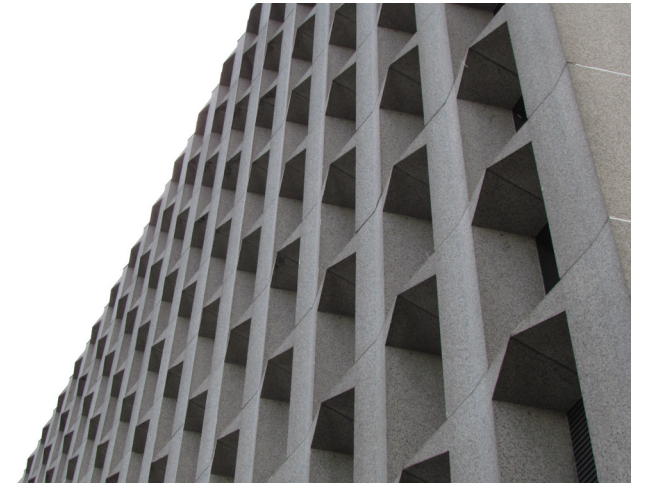
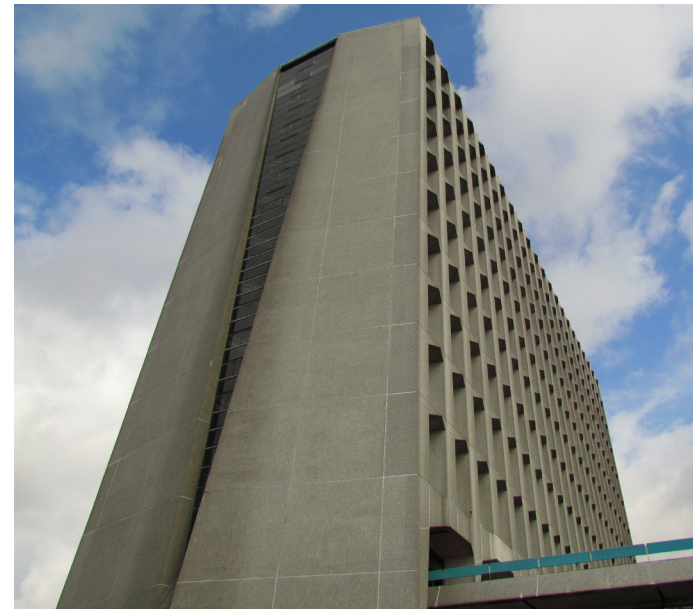
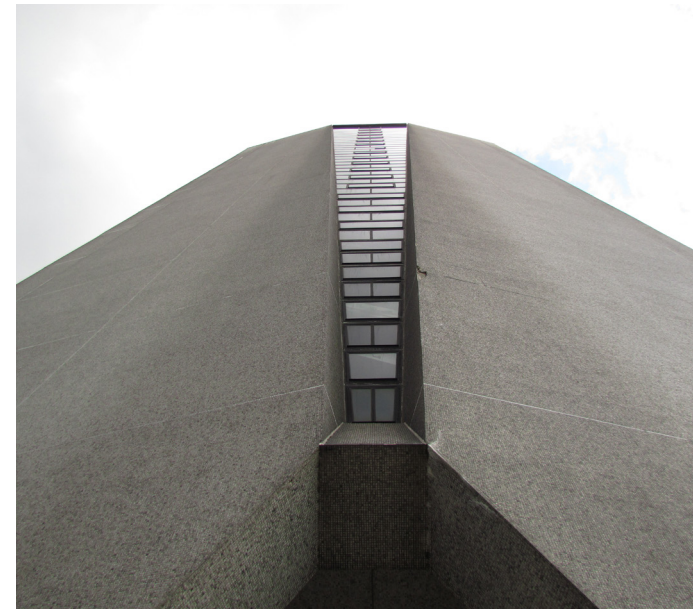
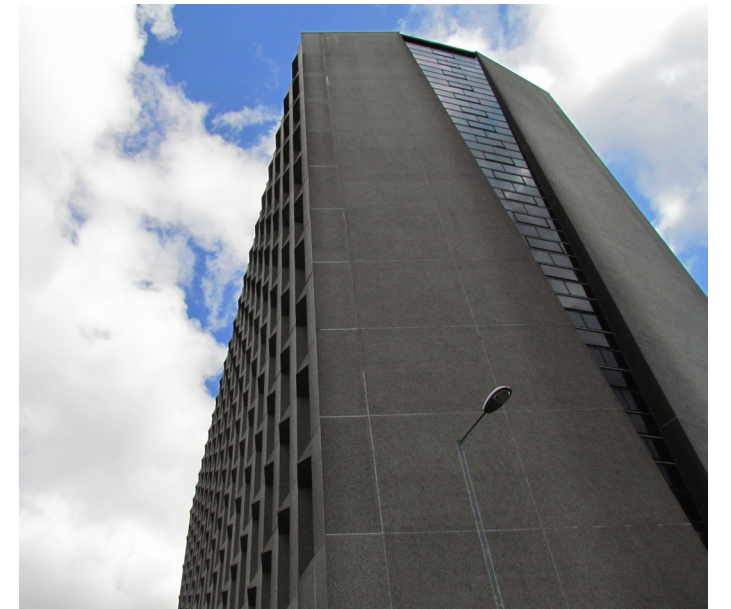
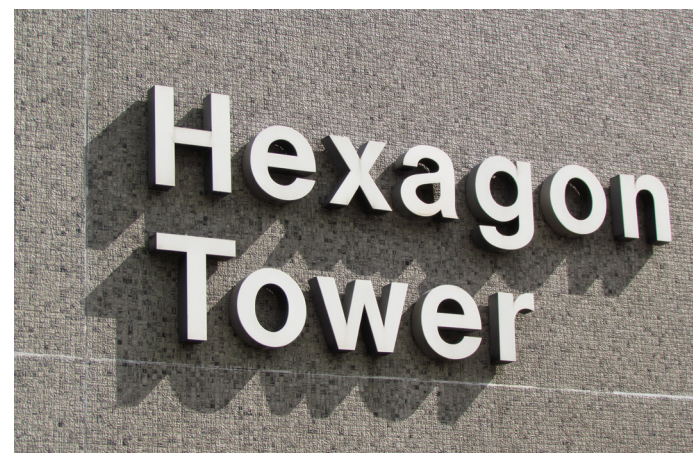
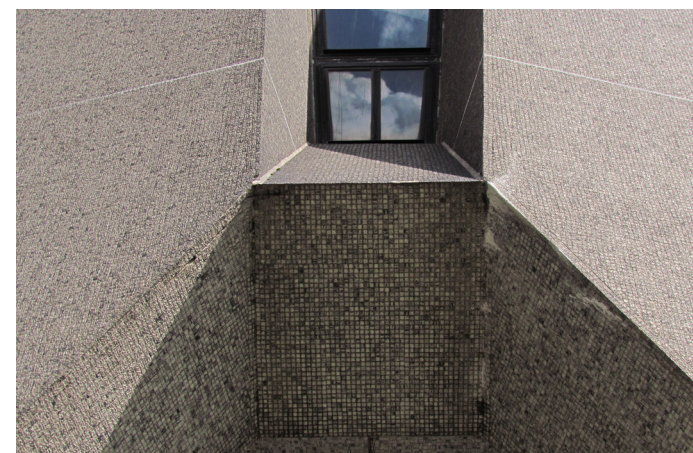
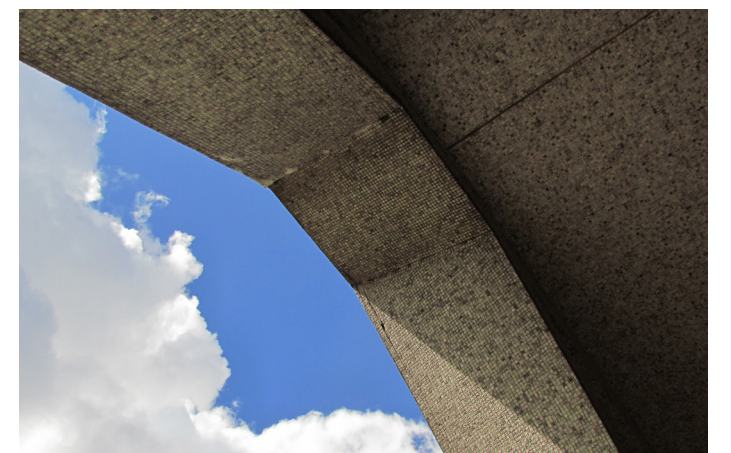
During 2012 a member of the Corstorphine + Wright team visited Hexagon Tower to photograph it out of personal interest in the building. When viewing these photos and comparing them to the photographs recorded this month (overleaf) it is apparent that the façade is deteriorating in a progressive manner, qualifying the statement made in the IF Building Consultancy report.
