# INVICTA HOUSE

2-4 ATKINSON STREET  
MANCHESTER  
M3 3HH

BAT & NESTING BIRD SURVEY

MARTIN PRESCOTT  
ENVIRONMENTAL SERVICES  
APRIL 2017

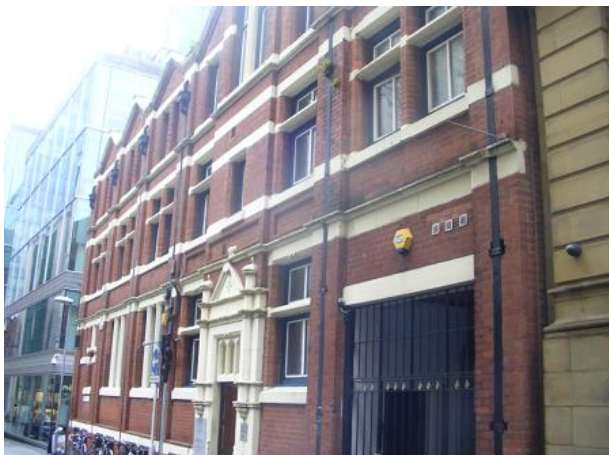
**PHOTO 1**  
**South-eastern View along Atkinson Street**

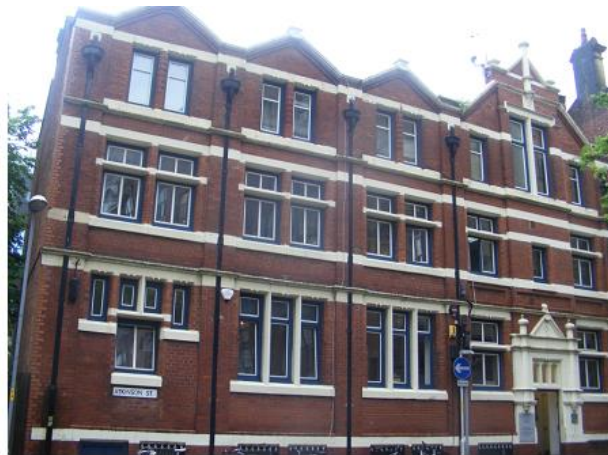
All around the roof of the main building on Atkinson Road, was a low parapet wall, with a chimney part way along the northern boundary, and several roof lights in the northern part of the roof. Located along the boundary of the eastern part of the roof, were several dormers, one being quite large, whilst the others were smaller, and their roofs were all pitched and covered in slate but without roof voids. At several locations around the roof, there were holes in the parapets where drain pipes passed through the walls. Inspection of these holes through close focus binoculars, found them to offer no bat roosting potential, (refer to **fig 3** and **photos 2 and 11**).

**PHOTO 2**  
**Southern Elevation of Main Building**

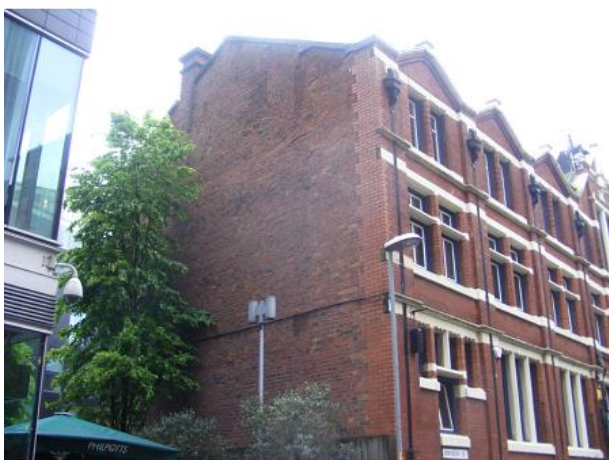
**PHOTO 3**  
**Western Elevation of Main Building**

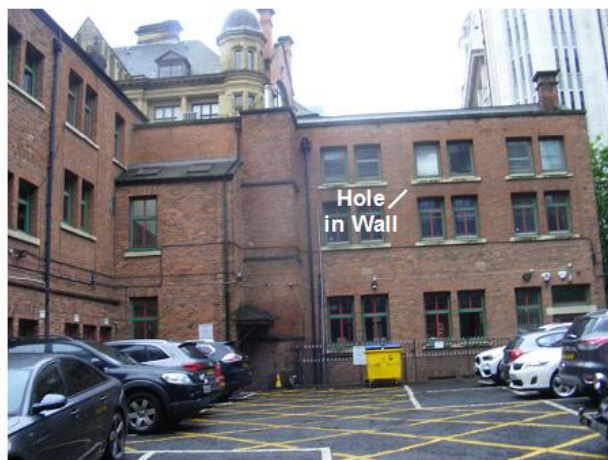
There were two holes in the northern elevation of the main building; the first was between the ground and first floor levels, where a small drainpipe had been inserted into a larger hole. Close inspection around this hole, and using the endoscope internally, found no evidence of bat droppings, no remains of invertebrate prey, or any grease marks from repeated contact or passage through the hole, and therefore it was deemed unlikely that the hole would be used by roosting bats. The second hole was at third floor level, where a small area of brick had spalled away, however close inspection with binoculars, found this hole to be very shallow, and therefore was unsuitable for roosting bats, (refer to **fig 3** and **photos 4 and 5**).

**PHOTO 4**  
**Northern Elevation of Main Building**

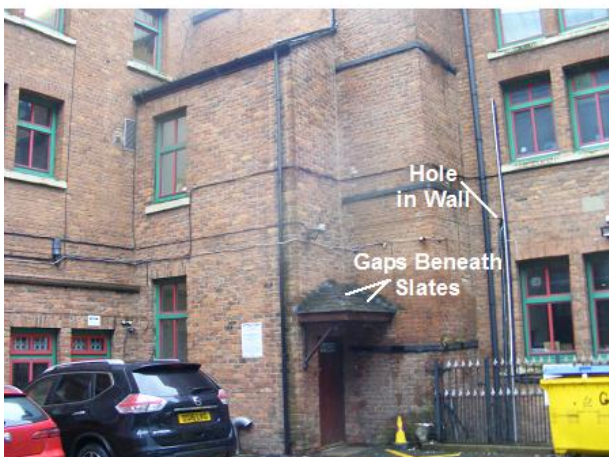
Located at the south-eastern corner of the car park, at the junction of the two buildings, was a two-story stairwell with a sloping slate covered roof and no searchable roof void. At ground level of the stairwell was an external entrance porch, with a sloping hipped roof and no void. There were two gaps between the roof slates, large enough to allow bat access, but inspection found no evidence to suggest that the gaps were used by roosting bats, (refer to **fig 3** and **photo 5**).

**PHOTO 5**  
**North-western View of Entrance Porch**

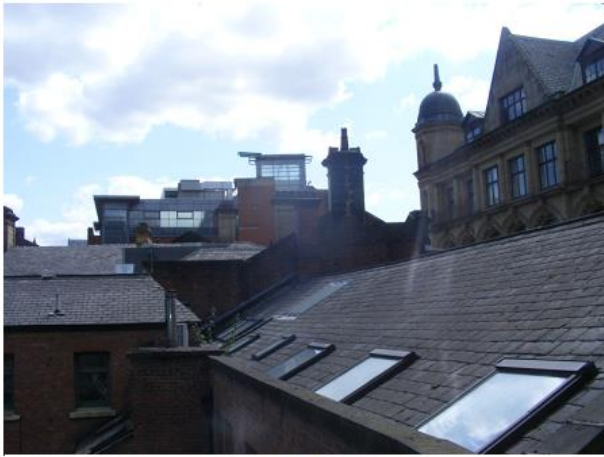
**PHOTO 7**  
**Western View Along Roofline**

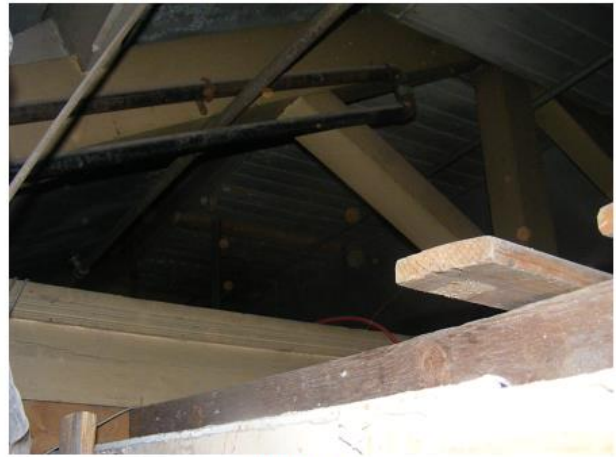
Each part of the complex had its own roof void, which was insulated, and a thorough internal inspection found both voids to be well sealed, with no evidence of roosting bats, however, the third-floor interior ceiling, of the stairwell on Atkinson Street, followed the line of the roof itself and the remaining small void could not be searched, (refer to **fig 3** and **photos 8 and 12**).

**PHOTO 8**  
**Underside of Main Building Roof**

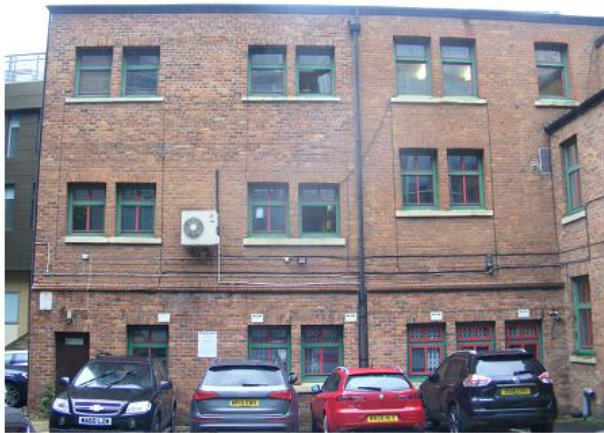
The eastern elevation of the second building, was attached to adjacent buildings and could not be searched, however, the other two elevations of the building, and the building roof were of sound construction, and offered no bat roosting potential, (refer to **fig 3** and **photos 9 to 11**).

**PHOTO 9**  
**Western Elevation of Second Building**

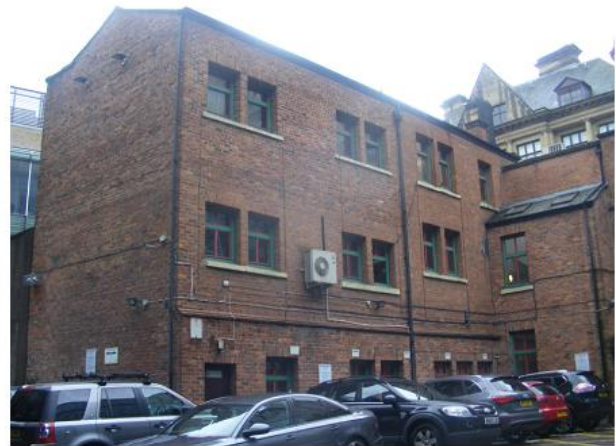
**PHOTO 10**  
**North-western Corner of Second Building**

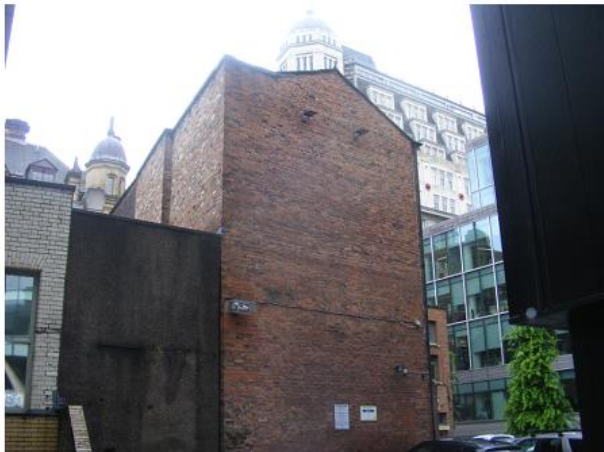
**PHOTO 11**  
**Northern Elevation of Second Building**

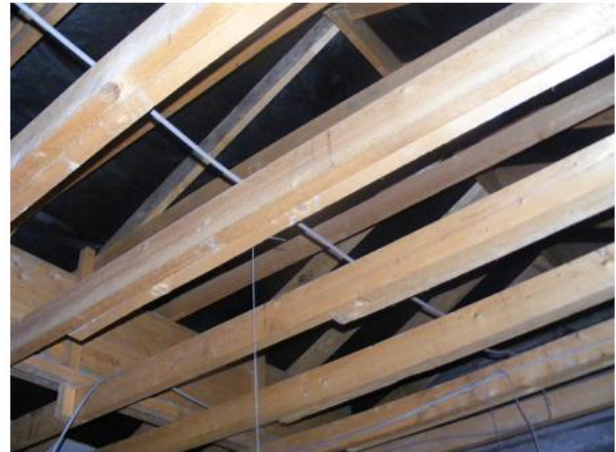
**PHOTO 12**  
**Underside of Second Building Roof**
