## Completion Report

Site 1 Broadoak Road, Wythenshawe

| <b>Report Title:</b> | <b>Site 1 Broadoak Road, Wythenshawe<br/>Validation Completion Report</b> |
| <b>Report Reference:</b> | <b>8398G-WML-XX-ZZ-RP-G-0006</b> |

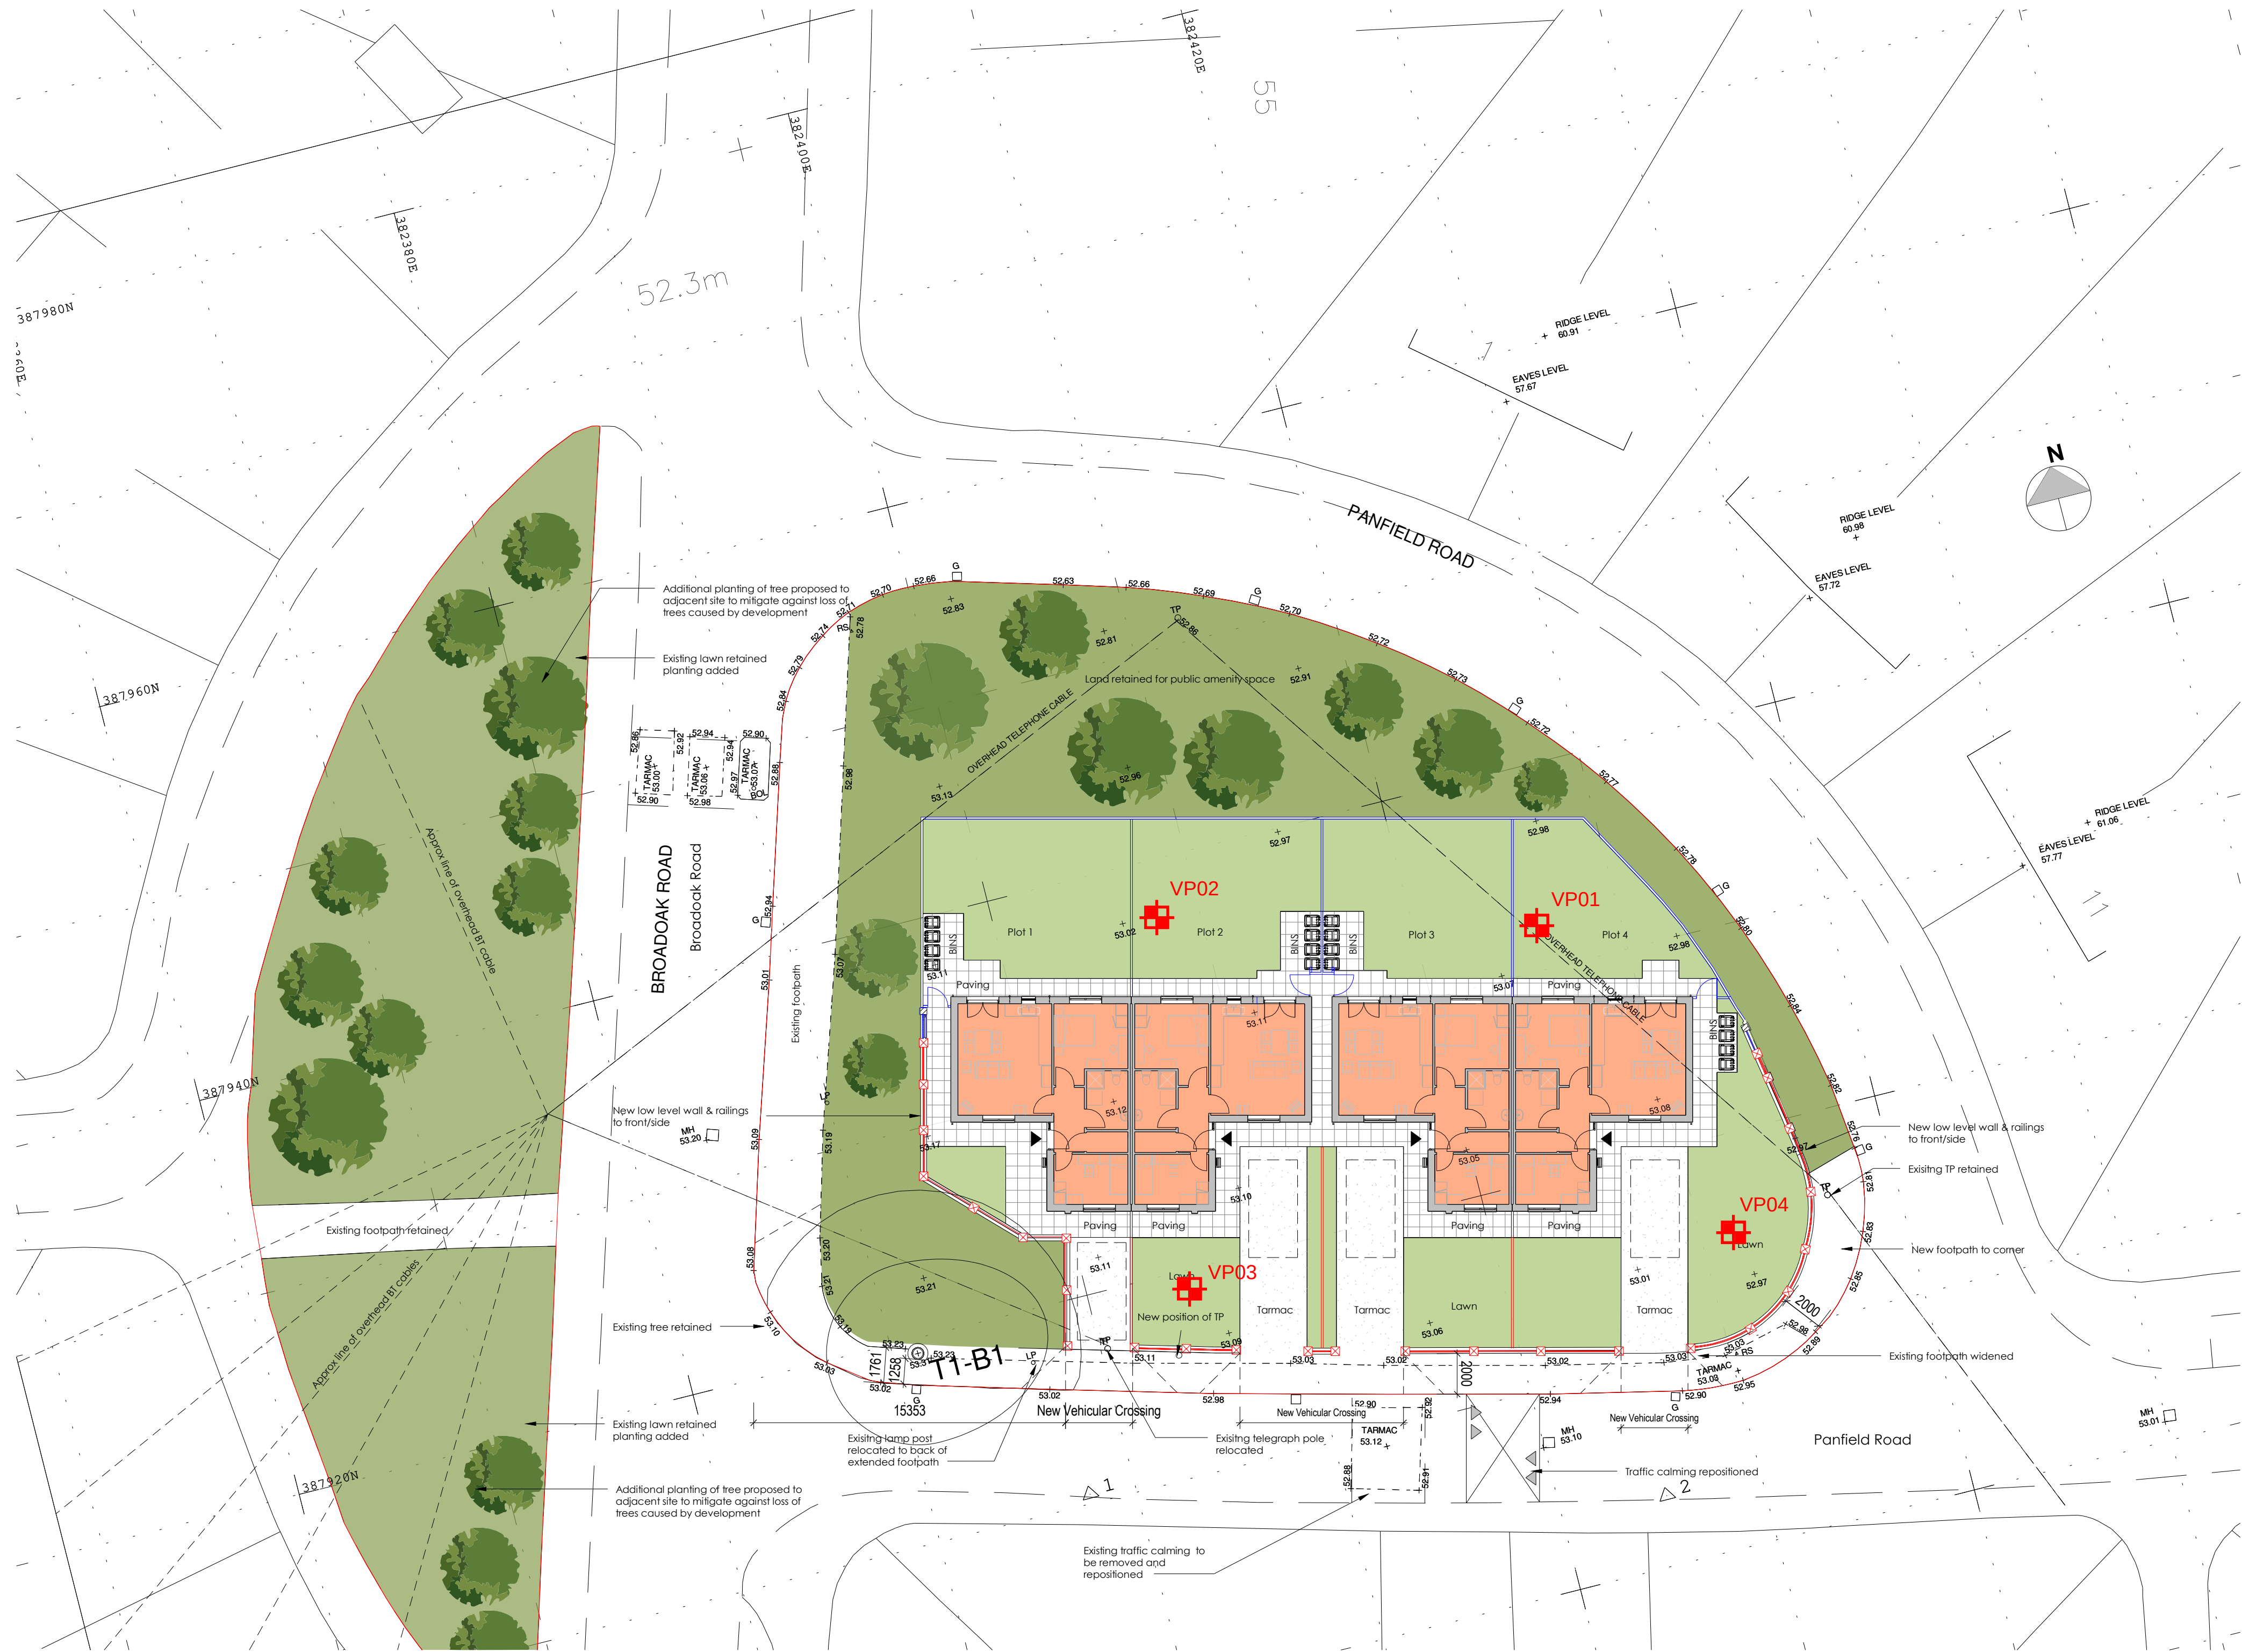
Project: Broadoak Road – Site 1  
Drg Title: Validation Pit Locations  
Job No: 8398G By: TPB  
Drg No: SK01 Rev: -  
Date: 11/03/21 Scale: NTS

Validation Pit

- 4.22 The capping thicknesses were verified by the formation of hand excavated validation pits on 4<sup>th</sup> March 2021 by WML.
- 4.23 Selected photographs of the validation pits are provided in Appendix 02 and indicate 450mm of subsoil and 150mm of topsoil in garden areas. A drawing showing the locations of the validation pits is presented in Appendix 01.

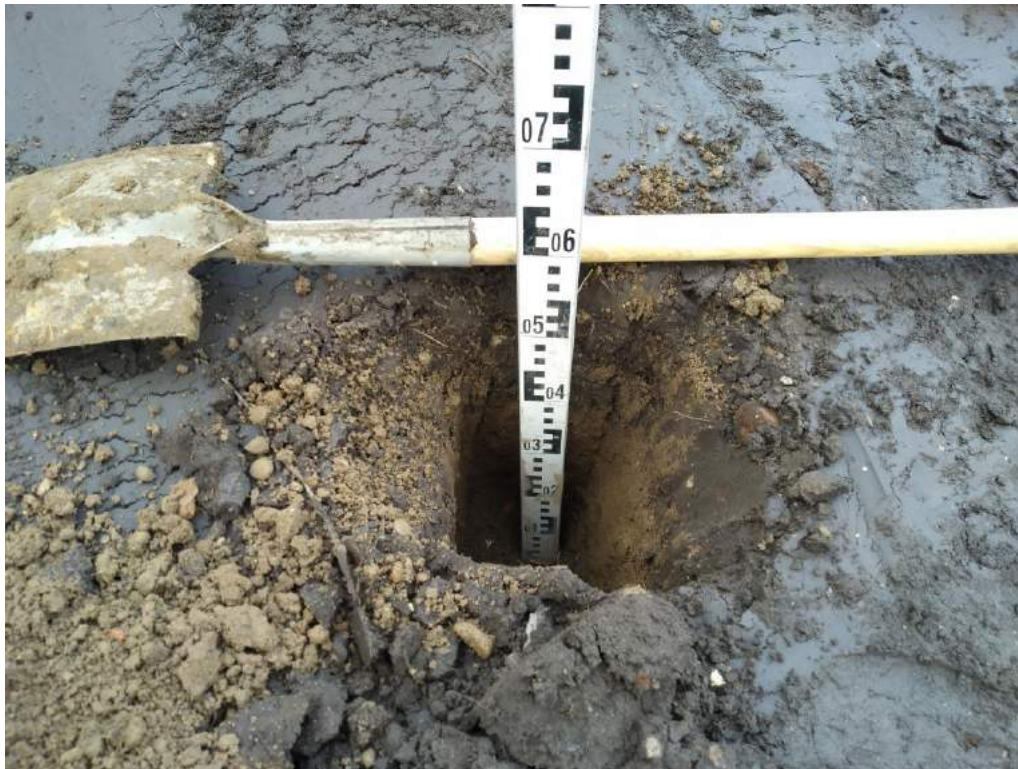
**Photograph 9**  
**150mm to topsoil and 450mm of subsoil emplaced in VP01.**

- 4.24 The imported topsoil generally comprised a dark brown clayey, organic sand. The imported subsoil generally comprised a brown, slightly silty, gravelly sand.

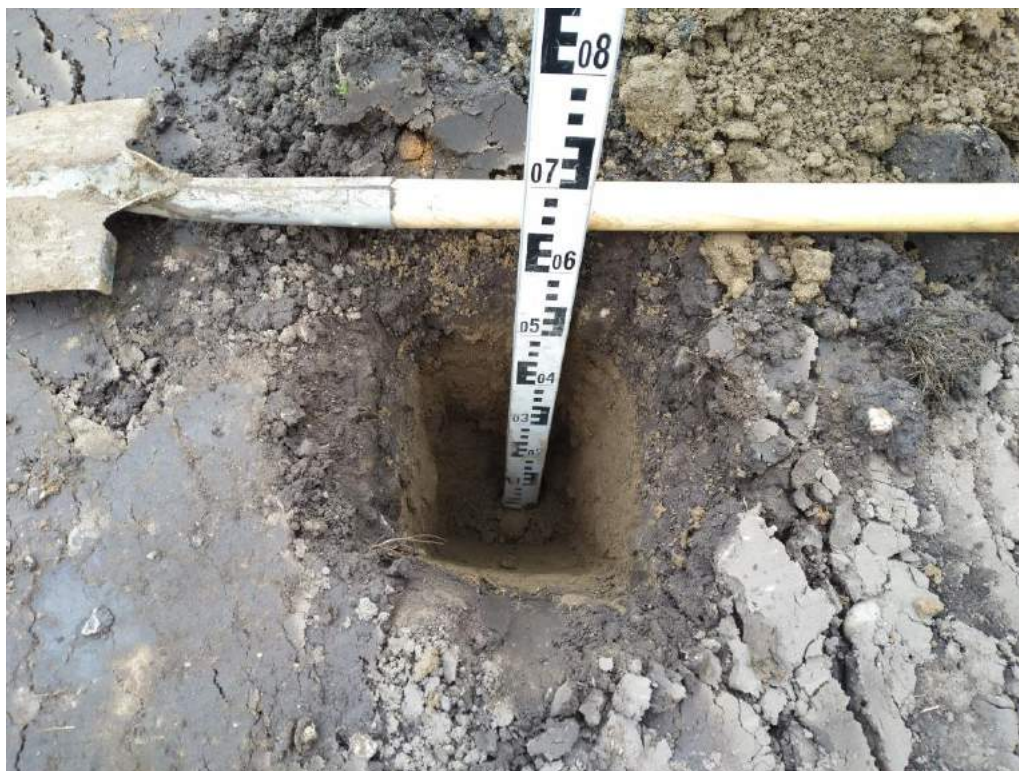
**Photograph 13**  
**150mm to topsoil and 450mm of subsoil emplaced in VP03.**

- 4.21 The exceedance of dibenz[a,h]anthracene is very slight and localised to a single sample of subsoil. In addition, no visual or olfactory evidence of hydrocarbon contamination was identified on site. Therefore, the soil was considered suitable, in terms of contamination levels, for the intended use.
