Our Ref: Nell Lane/M21 7UH/2019  
Date: 19 February 2020

**PROPOSED APARTMENTS**  
**NELL LANE/BROOKSTONE CLOSE, MANCHESTER, M21 7UH**  
**LANDFILL and GROUND GAS REPORT**

A residential development is proposed. Following a PRA (12/2/19) and intrusive report (6/1/20) this report considered findings of the now completed gas monitoring.

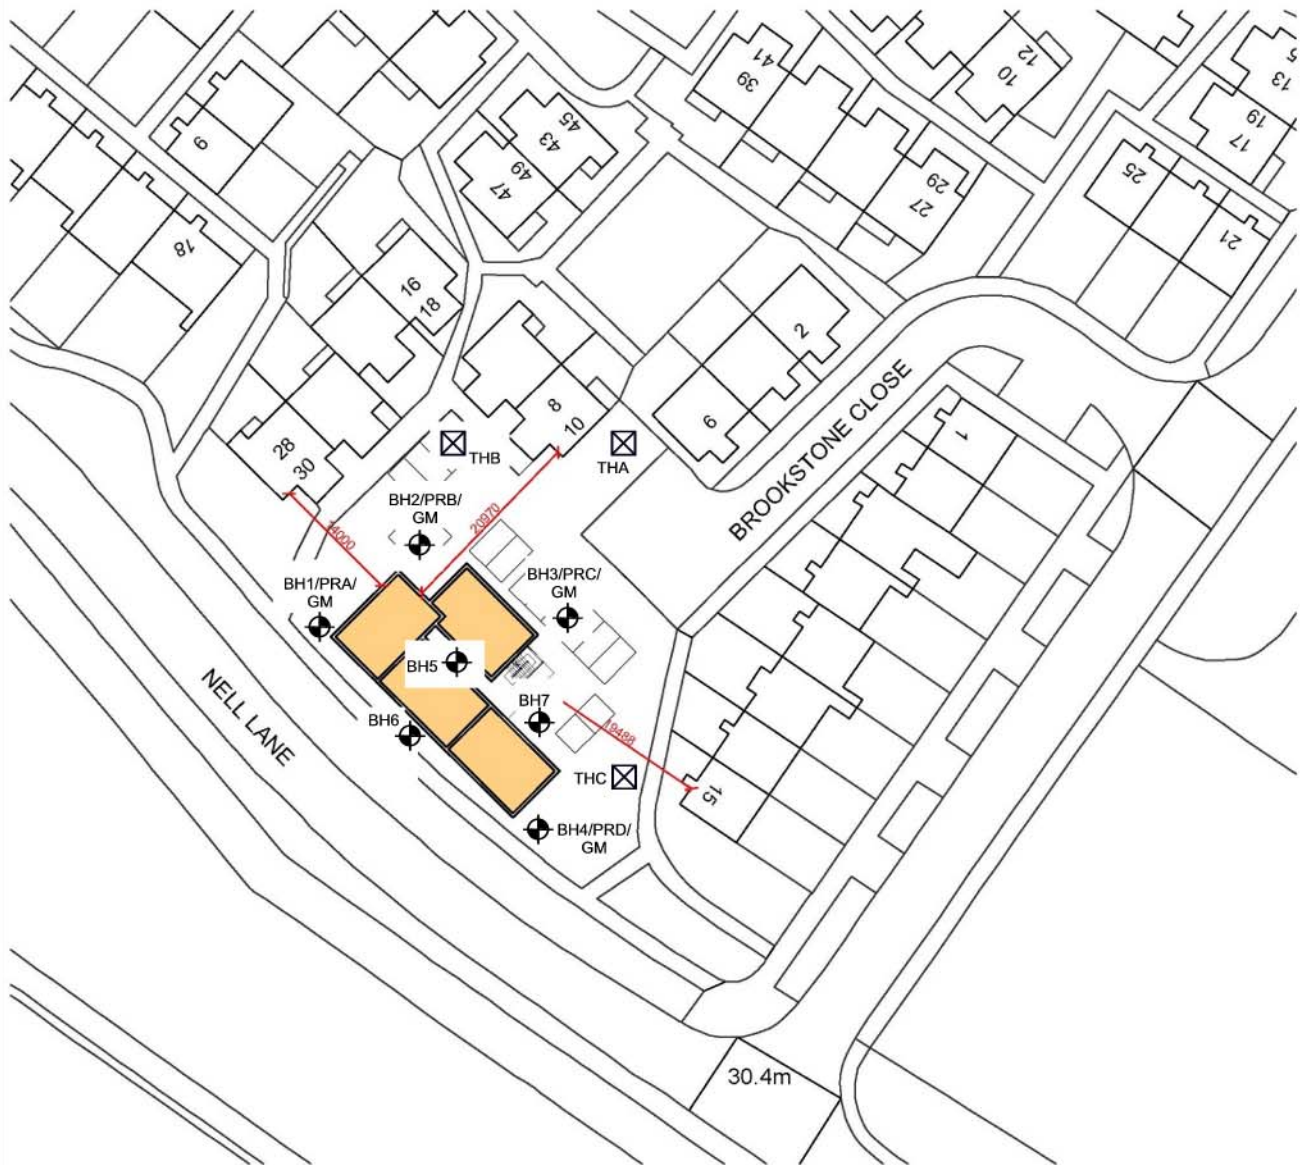
| Scale: 1:500@A3<br>Date: Dec 18 | Description:<br>Proposed Site Plan:<br>Nell Lane |

Borehole
 Trialhole

**Proposed site plan - showing borehole, trial hole and probe locations**
