# Heritage Statement

Client: Manchester Metropolitan University

Project: Ormond Building

Reference: 20608 | P500

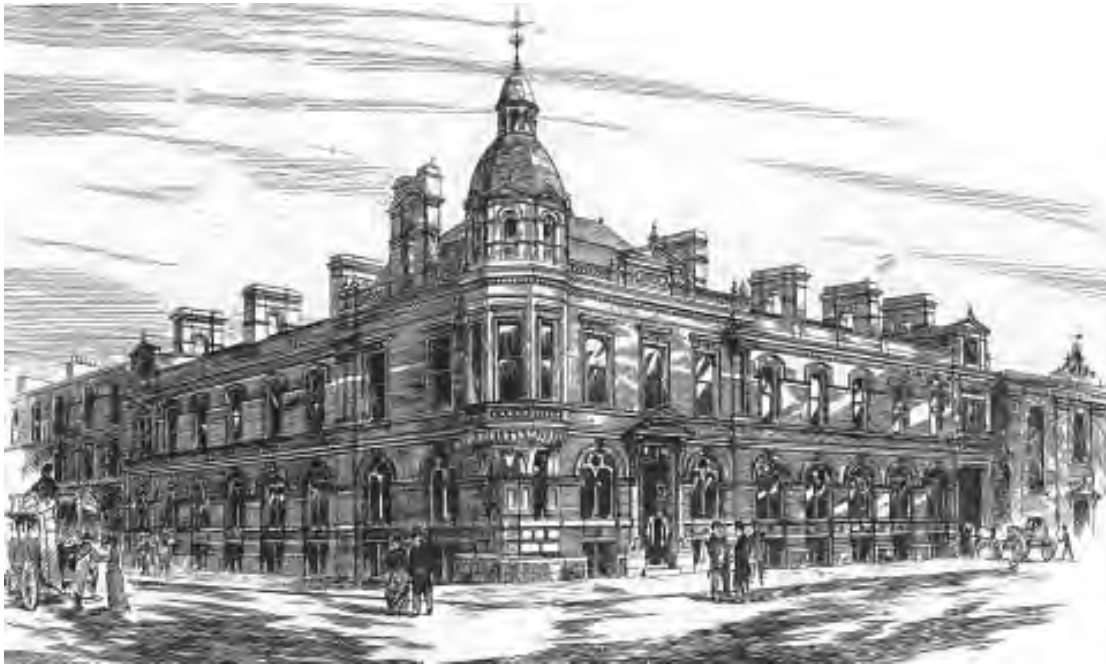
**Figure 3.6**

Artist's impression of the proposed elevations to Ormond Street and Cavendish Street of the new Chorlton Union Offices in 1880 by architects Mangall & Littlewood  
(Source : [www.bing.com](http://www.bing.com) accessed 12/03/2021)

By February 1881 the entire site had been cleared and work started with the new building on 25<sup>th</sup> March 1881. The proposed building was described in The Builder Magazine as "Italian in character and was of red/orange brickwork to its principal elevations, with Yorkshire Stone to the plinth. Decoration was largely in red terracotta".

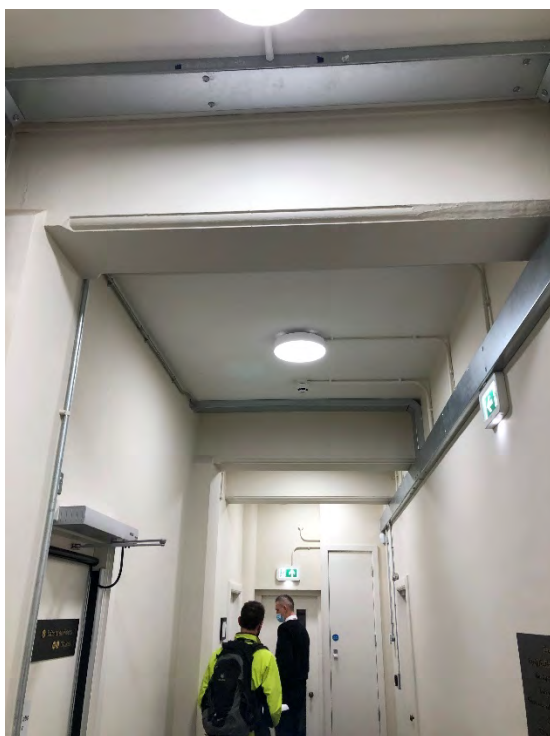
**Figure 3.23**

Photograph of the ground floor corridor with new M&E installations

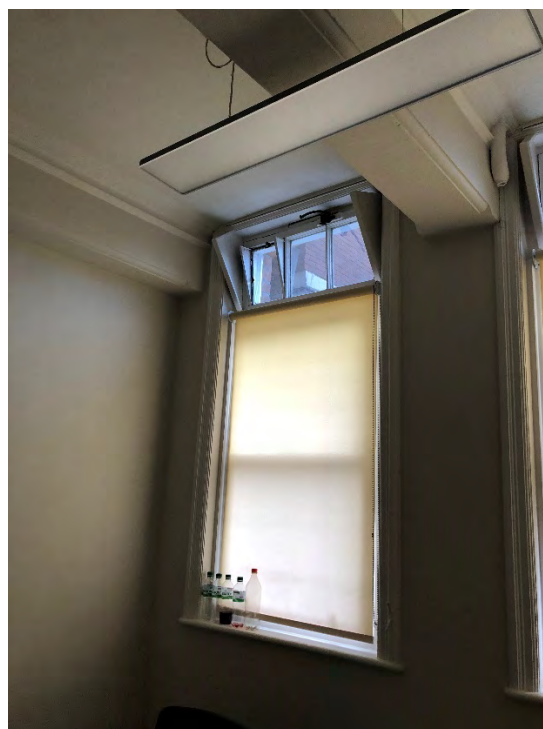
**Figure 3.24**

Photograph of the ground floor offices with new M&E installations

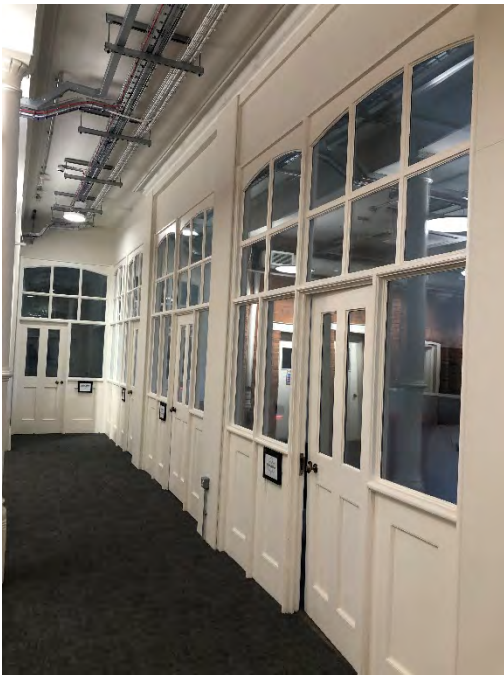
**Figure 3.25**  
Photograph of the replacement glazed screens to the Ground Floor level offices fronting Lower Ormond Street  
(Source : photograph taken by author 21/03/2021)

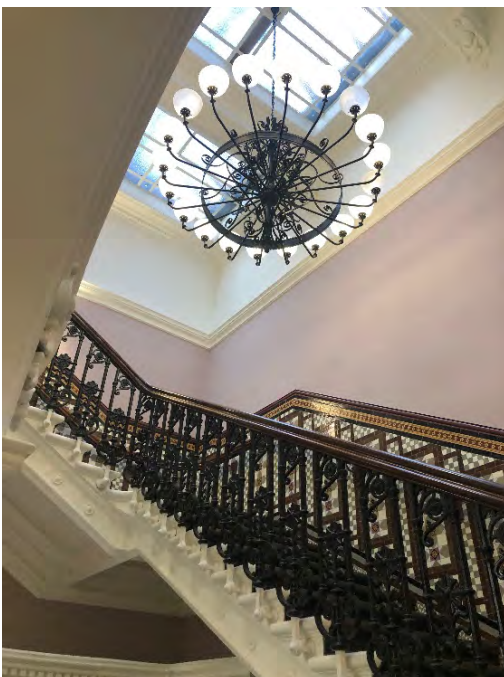
**Figure 3.27**  
Photograph of the restored main stair and rooflight over  
(Source : photograph taken by author 21/03/2021)

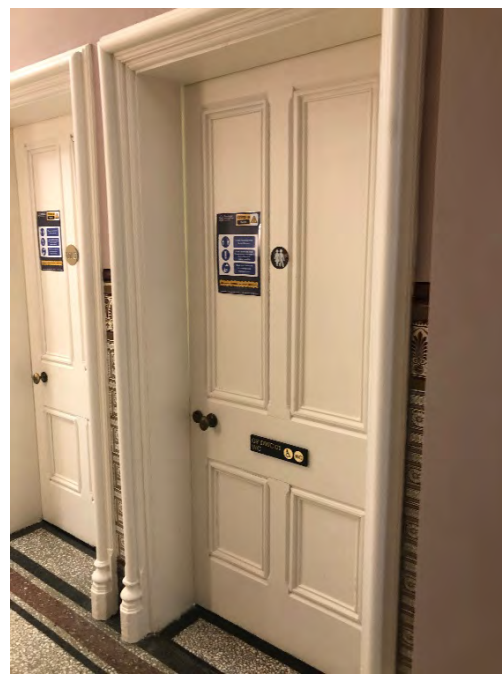
**Figure 3.28**  
Photograph of the restored historic doors and architraves  
(Source : photograph taken by author 21/03/2021)

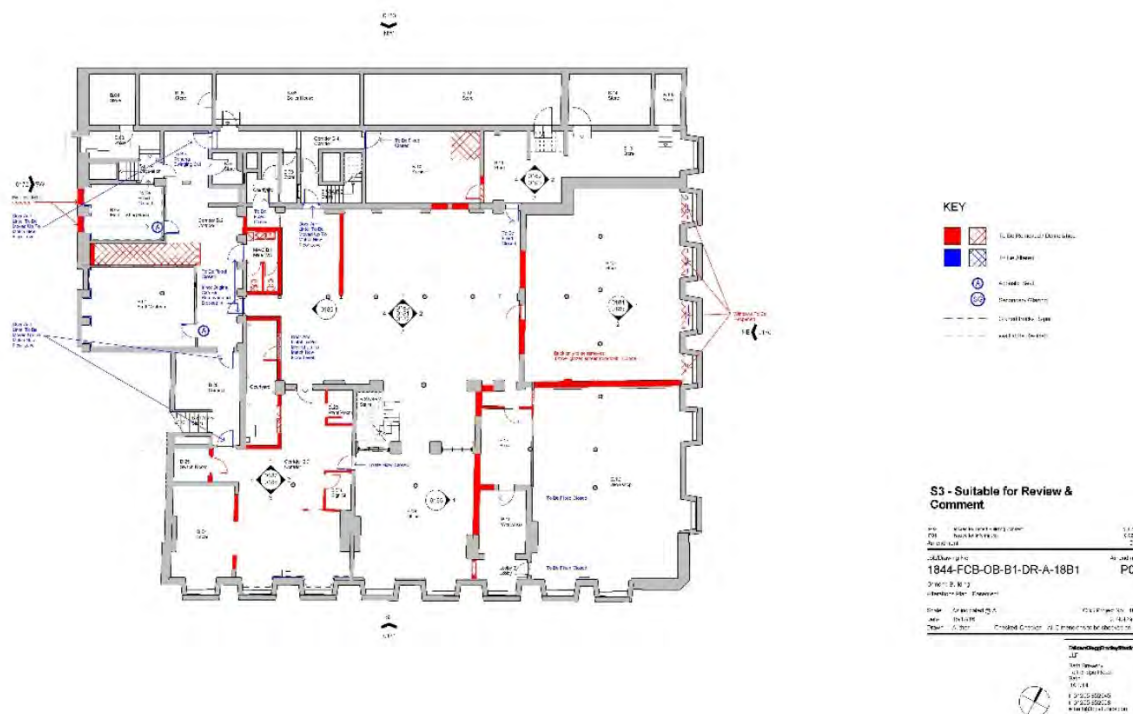
Figure 3.33

Basement Level floor plan showing the extent of demolition proposed and approved under application Reference : 115517/LO/2017, Drawing by FCB Studio (Source :[www.pamanchester.gov.uk](http://www.pamanchester.gov.uk), accessed 31/03/21)

The following drawings set out the approved alterations to the Basement Level (Figure 3.33) and the Proposed Basement Floor Plan (Figure 3.34)

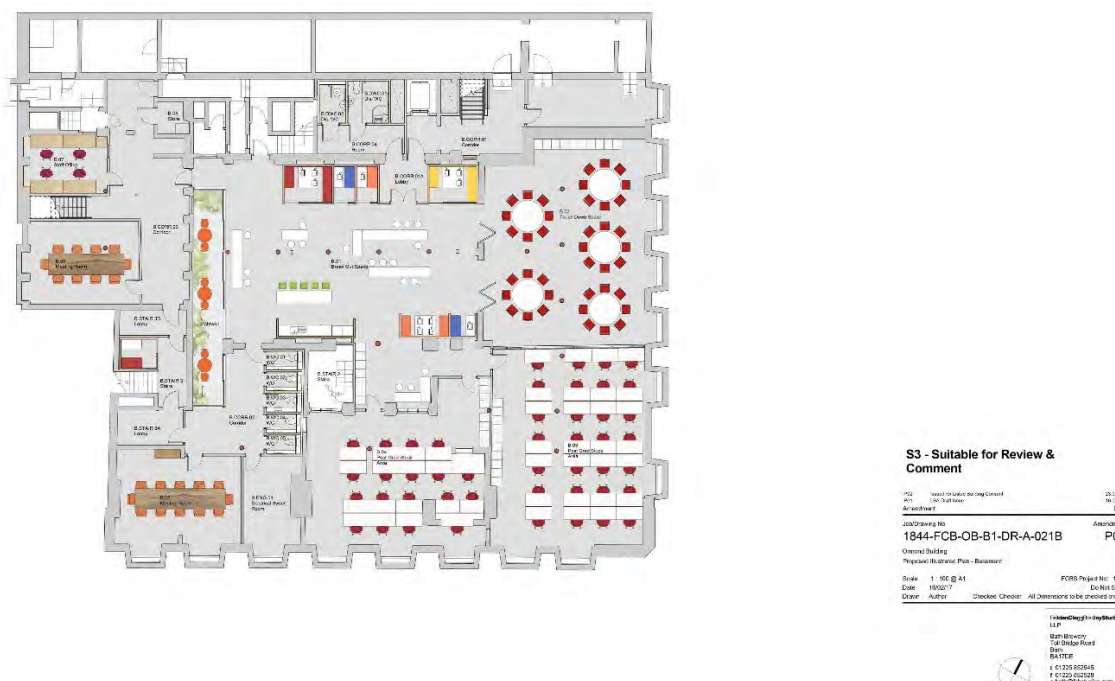
Figure 3.34

Basement Level floor plan showing the Proposed Basement Floor Plan as approved under application Reference : 115517/LO/2017, Drawing by FCB Studio (Source :[www.pamanchester.gov.uk](http://www.pamanchester.gov.uk), accessed 31/03/21)

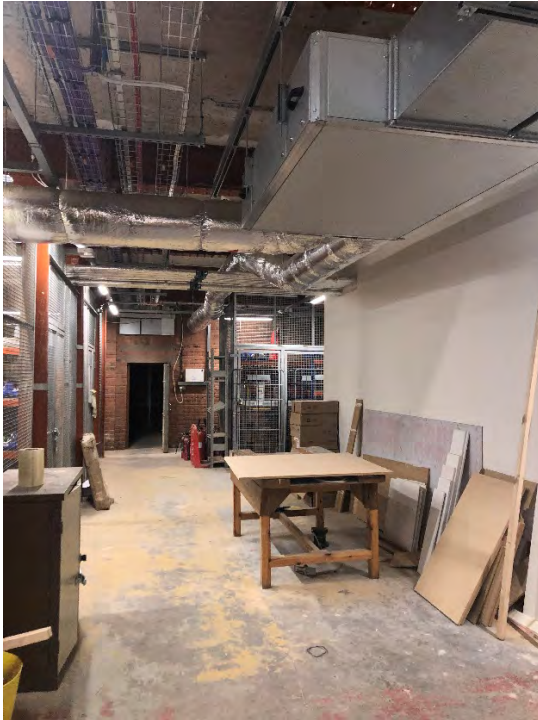
**Figure 3.36**  
Photo of Room B1.01 Basement Storage area  
(Source : Photograph taken by author, 21/03/21)

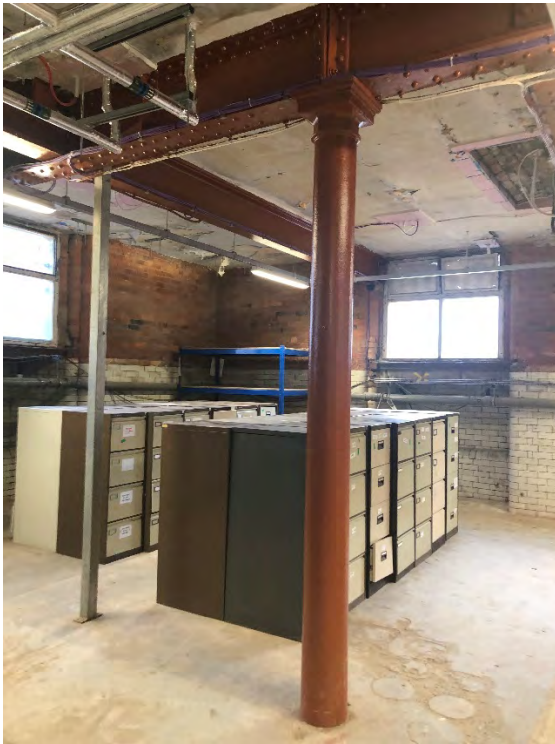
**Figure 3.40**  
Photo of Room B1.03 currently used as Archive Storage  
(Source : Photograph taken by author 21/03/21)

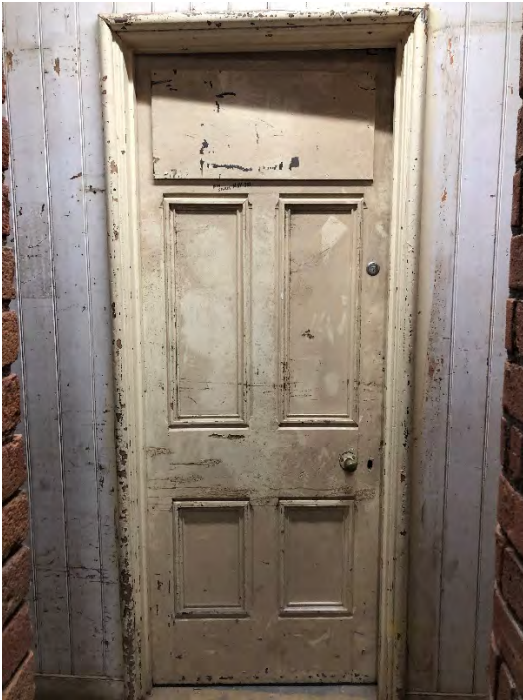
**Figure 3.43**  
Photo of the door to Room B1.04 currently used as a Store  
(Source : Photograph taken by author 21/03/21)

| Door replacement with FD30S or FD60S as required. | Historic door to B1.04 to be removed and retained in storage and replaced with new FD60s door. Existing later addition doors of no heritage value to be removed and replaced with new FD30s or FD60s doors to achieve continuous line of fire protection all areas within the basement. | <b>Neutral</b><br><br>The new fire doors will replace doors that are not considered to be of historical value with the exception of one existing door to B1.04 which will be photographed in position and retained in storage on site. The installation of a door that will achieve the required fire resistance will be located in the same position as existing thus enabling the timber clad partition to be retained in situ. The intervention will also protect the building from fire damage and enable the basement floor level to be brought into use. |

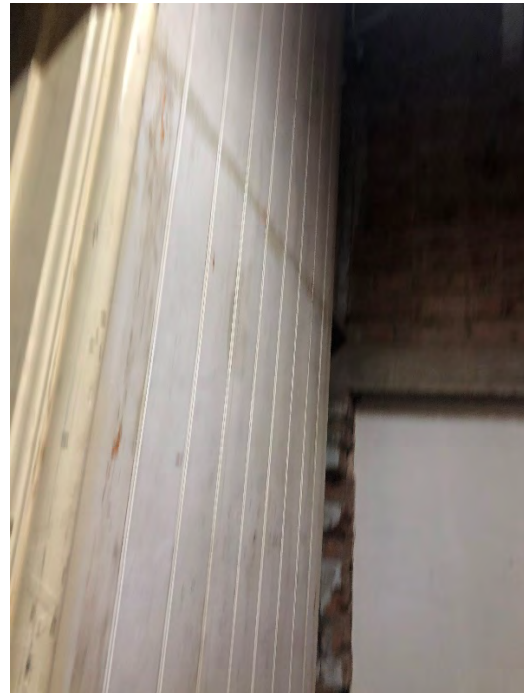
**Figure 3.44**  
Photo of the partition wall to Room B1.04  
(Source : Photograph taken by author 21/03/21)
