**Results of Architectural Paint Research to Manchester Reform Club**

**MANCHESTER REFORM CLUB  
81 KING ST / 50 SPRING GARDENS  
MANCHESTER  
M2 4AH**

| <b>Project:</b> | The investigation of architectural paint finishes to the turret louvres and rainwater downpipe to the exterior of the Reform Club, Manchester. |

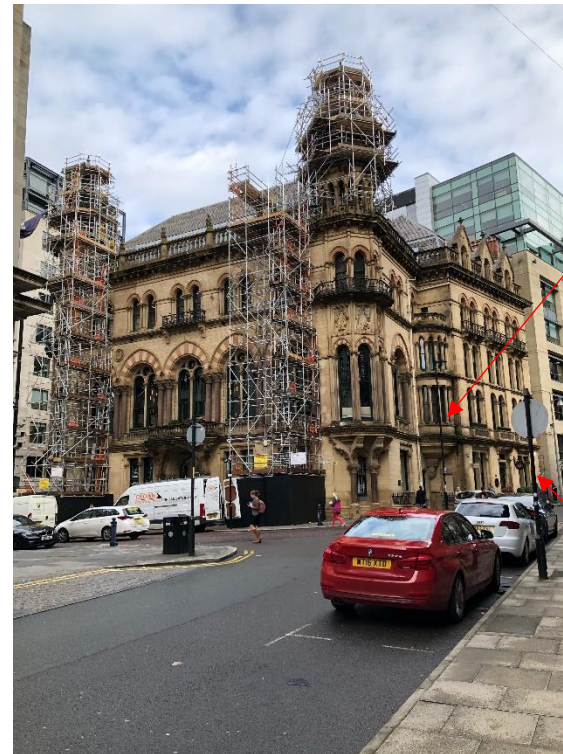
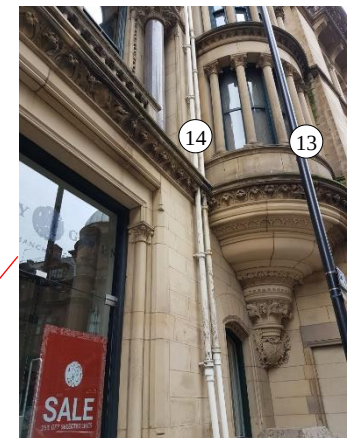
- 01 – King Street, lower right louvre, vertical timber
- 02 – King Street, lower right louvre, lower horizontal
- 03 – King Street, lower right louvre, slate vent
- 04 – King Street, upper right louvre
- 05 – King Street, lower left louvre, vertical timber
- 06 – King Street, lower left louvre, vertical timber
- 07 – Spring Gardens, lower right louvre

- 08 – Spring Gardens, lower right louvre
- 09 – Spring Gardens, lower left louvre
- 10 – Spring Gardens, lower left louvre
- 11 – Spring Gardens, window 2<sup>nd</sup> in from the right 2<sup>nd</sup> floor, timber sill
- 12 – Spring Gardens, rainwater goods to right of Grand Pacific restaurant, pipe
- 13 – Spring Gardens, lower oriel first floor window, timber sill
- 14 – Spring Gardens, rainwater goods adjacent to oriel window to 1<sup>st</sup> floor, pipe

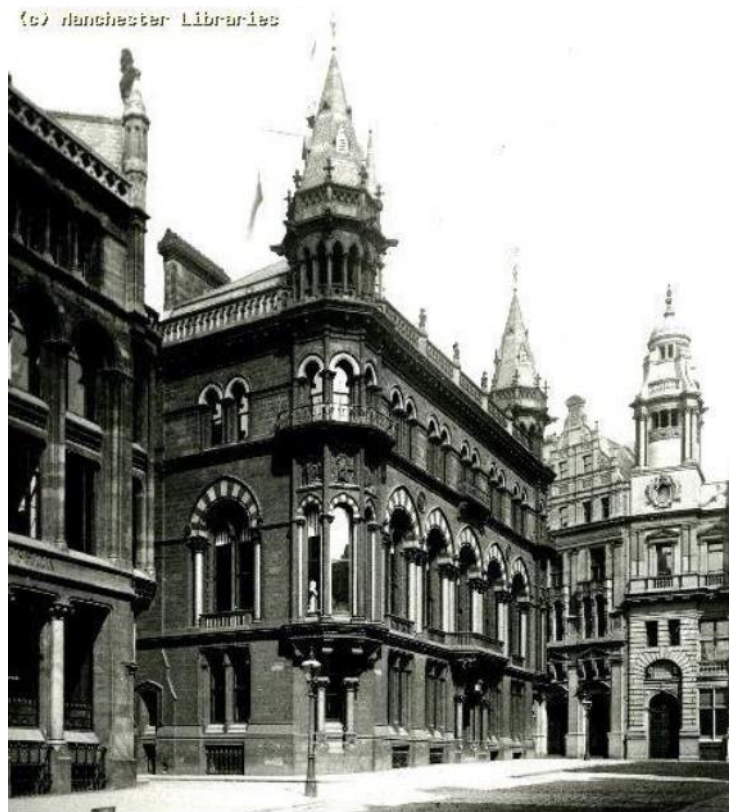
Image of the Reform Club 1890 (courtesy of Manchester Image Collection m83867)

An archive image found online clearly shows the louvres of a lighter appearance and the stone facade appears darker<sup>3</sup>. Whilst black and white images obviously cannot indicate use of colour they can help to provide a reference for a scheme seen in cross section. The lighter appearance

of the louvres in this image, combined with the darker appearance of the window surrounds (notice how they recess into the stone work and depth of the glass) is supported by the findings in the cross sections. It may also help to inform the building archaeology that the louvres were not painted in a dark finish until after 1890 when the image was taken. By contrast an image of the building from the 1930's (seen below) clearly shows that the louvres are painted in a dark finish, the window surrounds here are also of a dark appearance, again support by the paint archaeology.

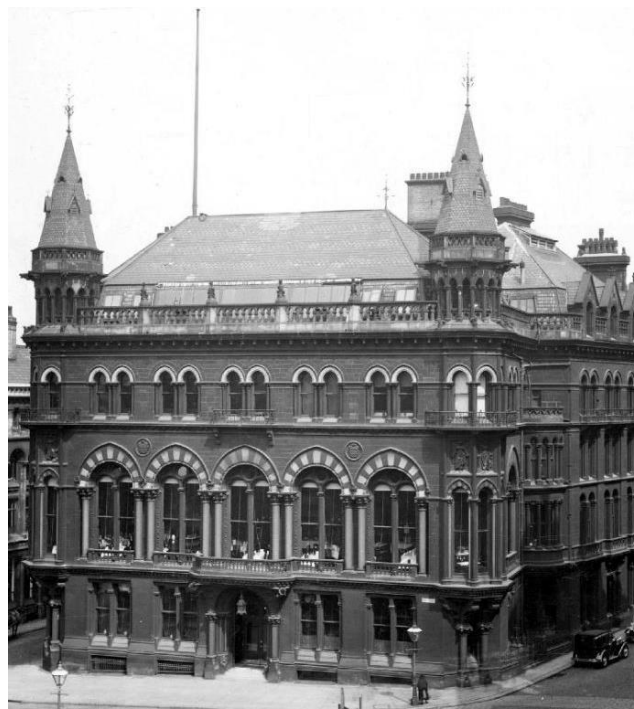
An image of the Reform Club from 1930 (Manchester Image Collection m02427)
