## GeoEnvironmental Desk Study

38 Broughton Street

Manchester

**Report No. A3434/20**

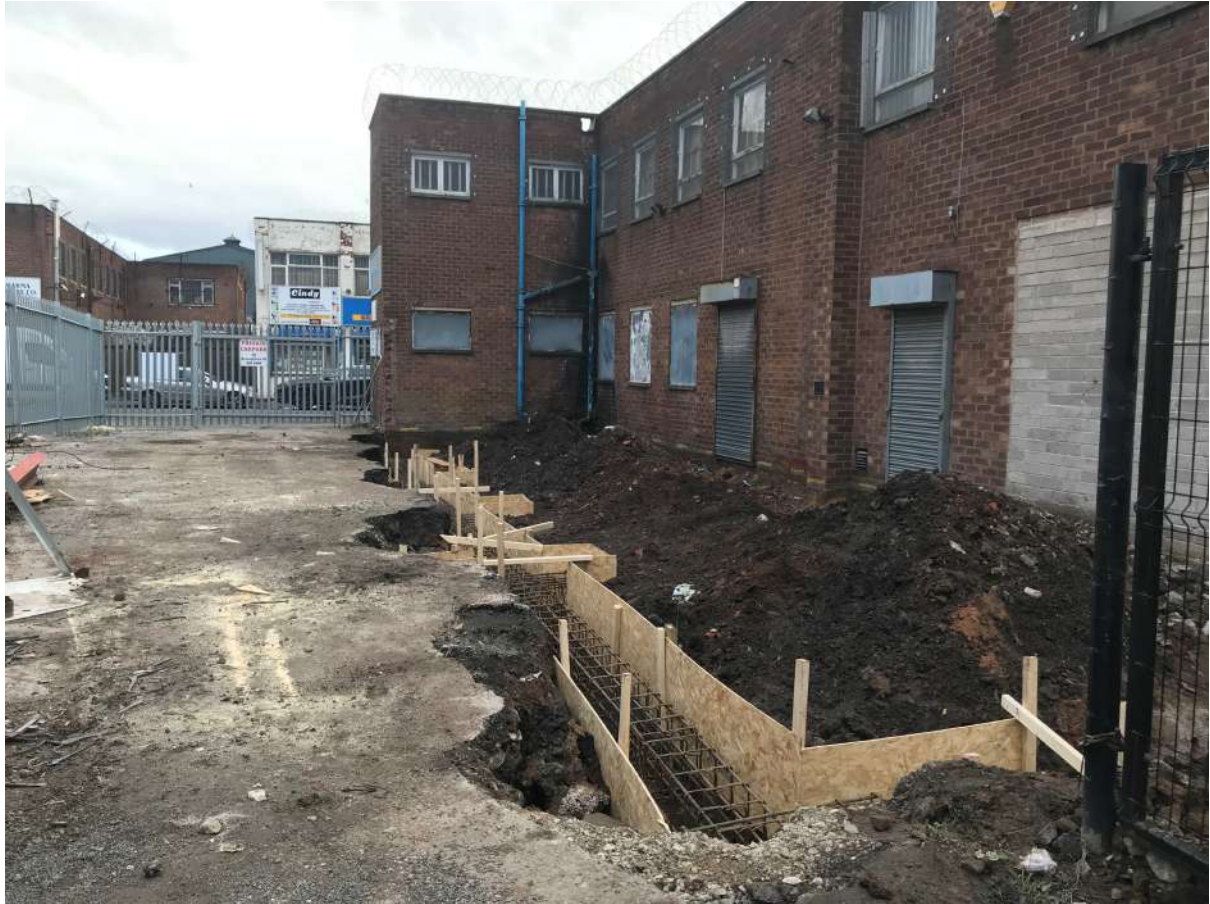
**Figure 3 Site Photograph**

- 2.3 The site is currently occupied by a singular commercial building located on the western side of the property. The remainder of the site is completely covered by concrete. The eastern boundary and part of the north and south boundaries are bordered by palisade fencing. The western border is contained withing the current building walls.

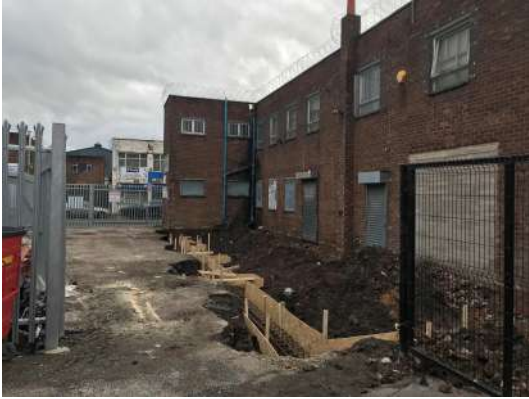
| <p><b>Plate 1 View across site, looking southwest</b></p> | <p><b>Plate 2 View across site, looking northwest</b></p> |

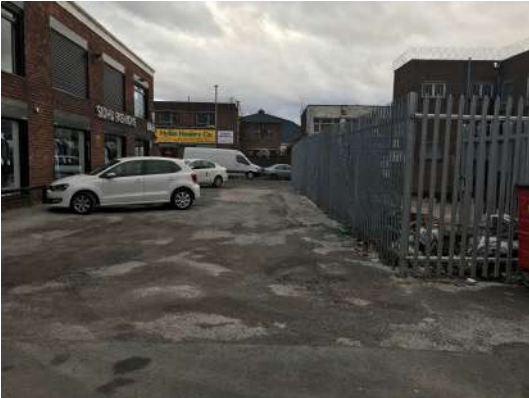
| <p><b>Plate 3 View towards Broughton Street, looking southwest</b></p> | <p><b>Plate 4 Area of proposed construction, looking southwest</b></p> |
