## PHASE I GEO-ENVIRONMENTAL SITE ASSESSMENT

Land off Palatine Road  
Northenden  
Greater Manchester  
M22 4FY

Report Ref: 13-092-r1  
Date Issued: December 2018

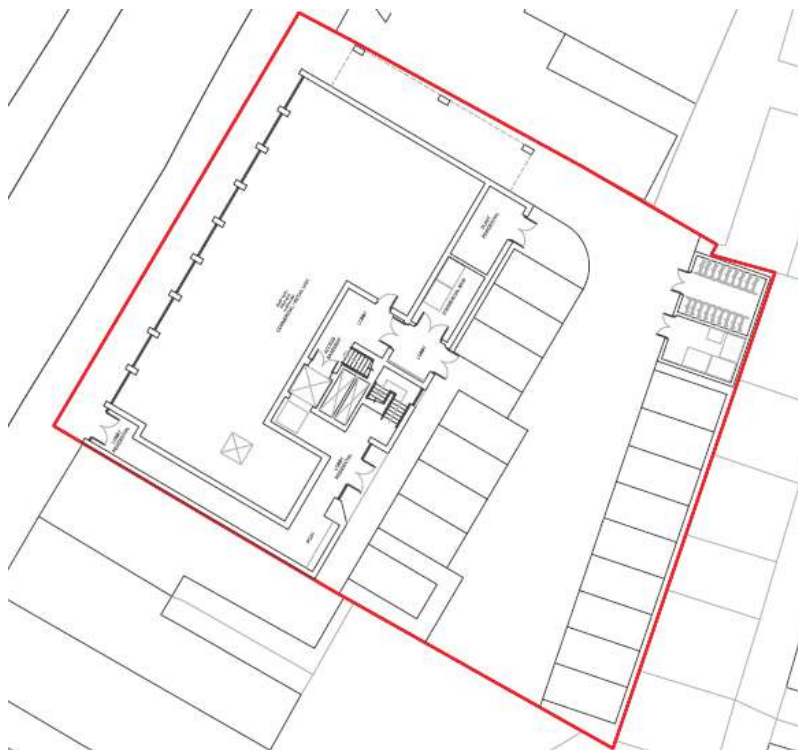
**Figure 1.1**     *Snapshot of Proposed Development*

A snapshot of the proposed development layout is indicated in Figure 1.1 below:

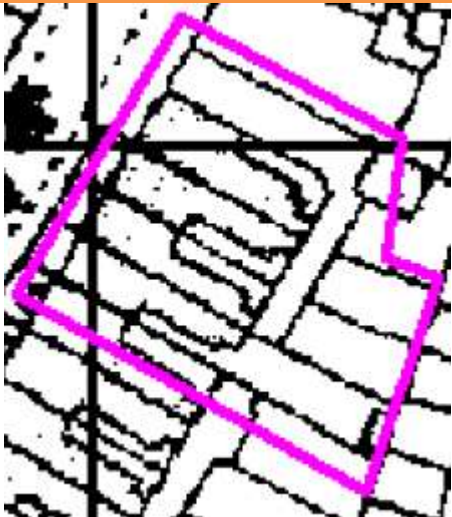
| MAP EDITION | HISTORICAL LAND USE | HISTORICAL MAP EXCERPT |
|---|---|---|
| 1910 | <p>A series of five properties in the form of terraced housing have been constructed in the western sector of the site, adjacent to Palatine Road.</p> <p>An access road from Palatine Road runs along the north and eastern sides of the terraces.</p> <p>Furthermore, a series structures or garden plots are now present in the eastern sector of the site and a small square structure partly encroaches within the north eastern boundary.</p> | |

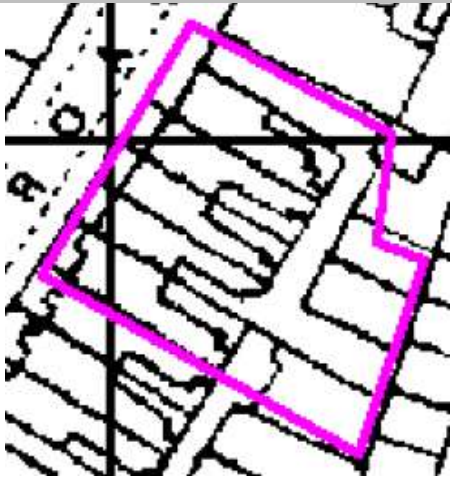
| MAP EDITION | HISTORICAL LAND USE | HISTORICAL MAP EXCERPT |
|---|---|---|
| 1922 | <p>There are no significant changes to the subject site.</p> | |

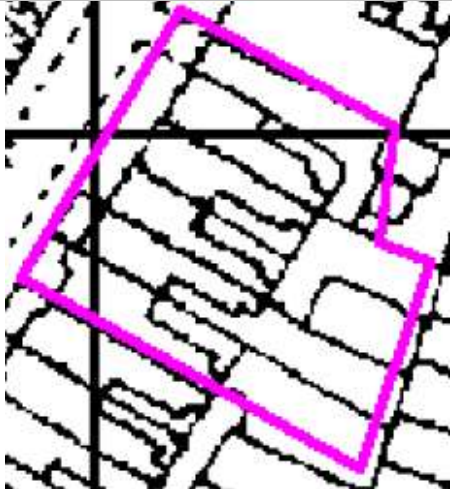
| MAP EDITION | HISTORICAL LAND USE | HISTORICAL MAP EXCERPT |
|---|---|---|
| 1934-1935 | <p>The boundaries of the structures / garden plots in the eastern sector of the site have been altered slightly.</p> <p>There are no other significant changes to the subject site.</p> | |

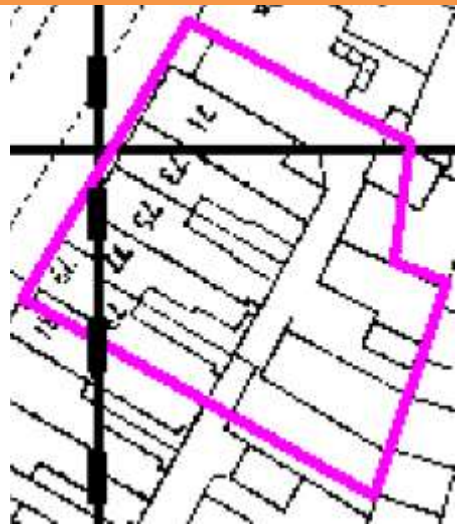
| MAP EDITION | HISTORICAL LAND USE | HISTORICAL MAP EXCERPT |
|---|---|---|
| 1955-1959 | No significant changes other than minor alterations to the structures / garden plots in the eastern sector of the site. | |

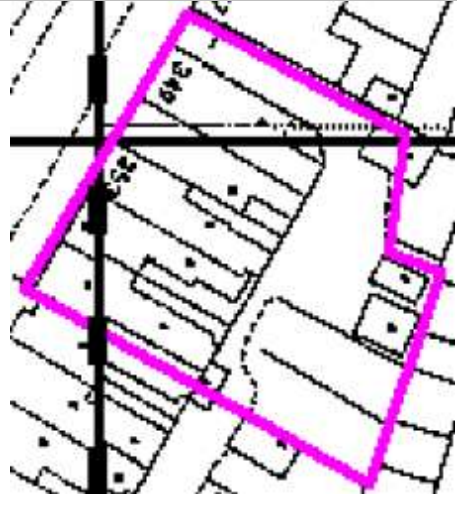
| MAP EDITION | HISTORICAL LAND USE | HISTORICAL MAP EXCERPT |
|---|---|---|
| 1992 | <p>Two small structures are now present along the eastern boundary of the site.</p> <p>The road to the rear of the terrace building has been widened to create an open area of hardstanding, presumably utilised for car parking.</p> | |

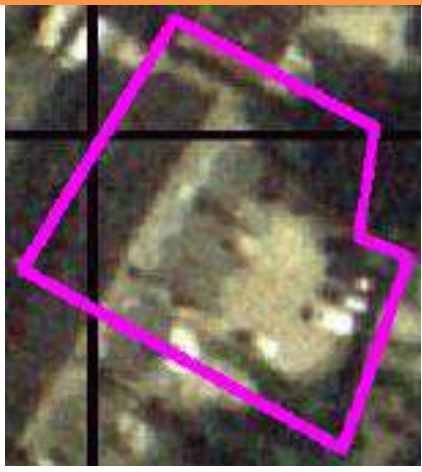
| MAP EDITION | HISTORICAL LAND USE | HISTORICAL MAP EXCERPT |
|---|---|---|
| 2000 | <p>The satellite image shows the terraces unchanged in the western sector of the site and the majority of the remainder of the site comprising a car parking area.</p> <p>Mature trees are also present at the north eastern and south eastern boundaries.</p> | |

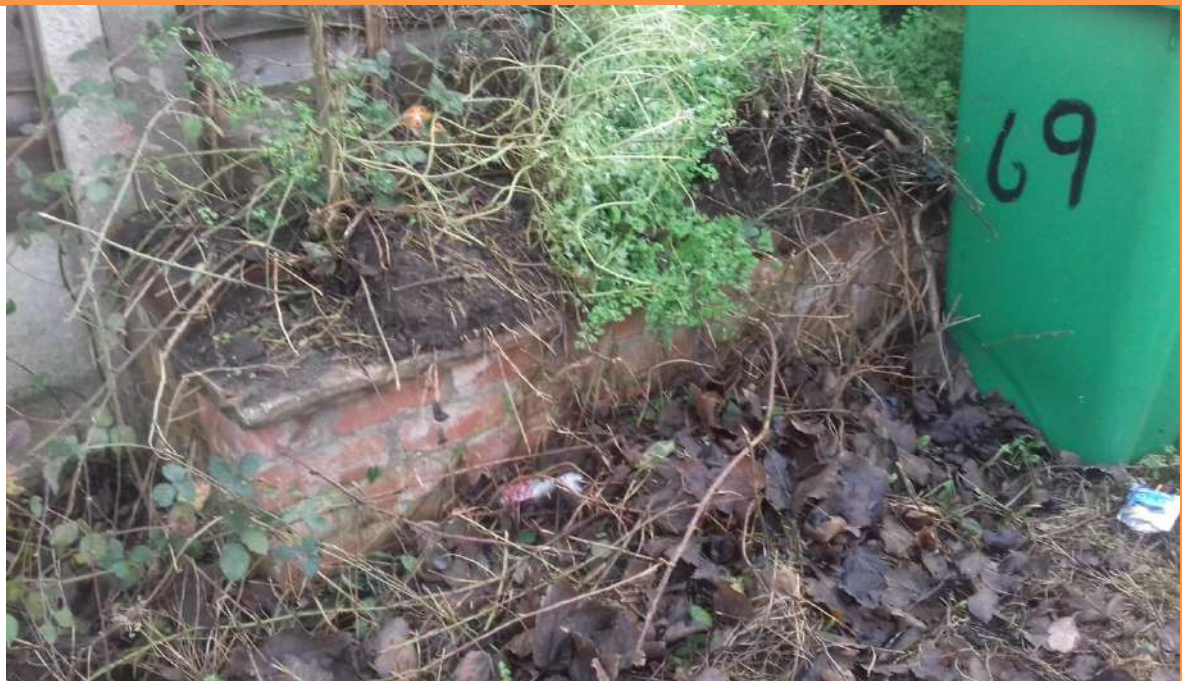
**PLATE 10 – SMALL BRICK WALL ALONG EASTERN BOUNDARY**

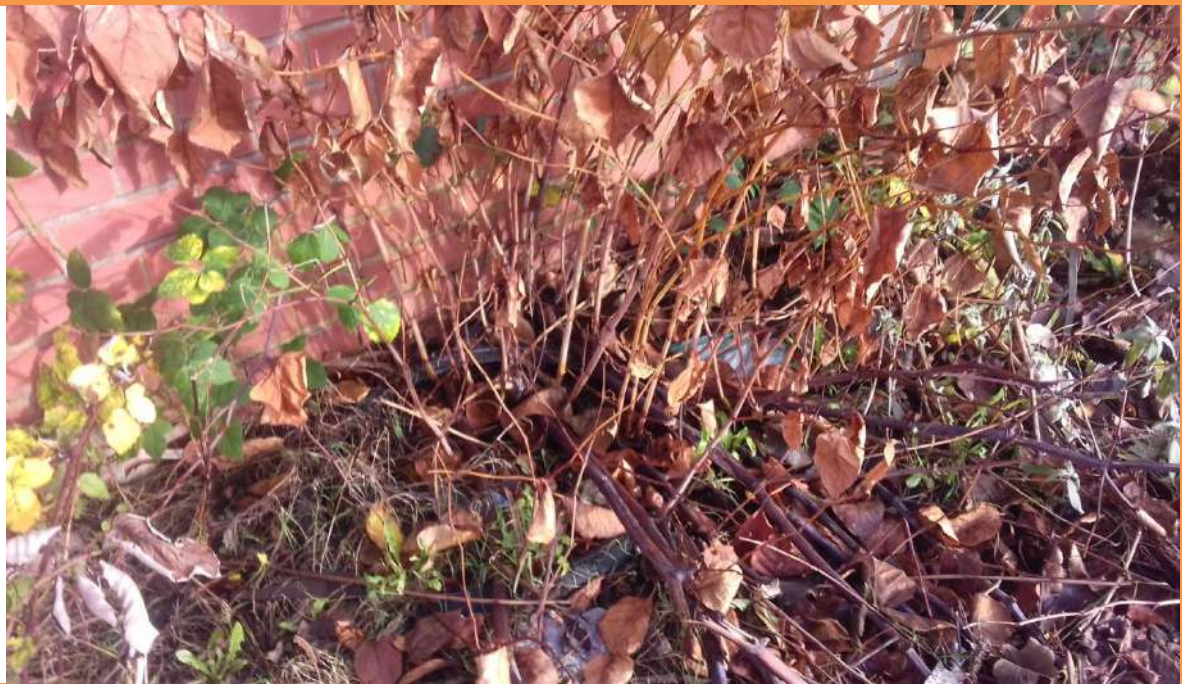
| <b>Invasive Plant Species</b> | A small area of suspected Japanese knotweed was identified during the site walkover along the northern boundary of the site, further investigation and treatment may be required. |

**PLATE 11 – SUSPECTED KNOTWEED ALONG NORTHERN BOUNDARY**

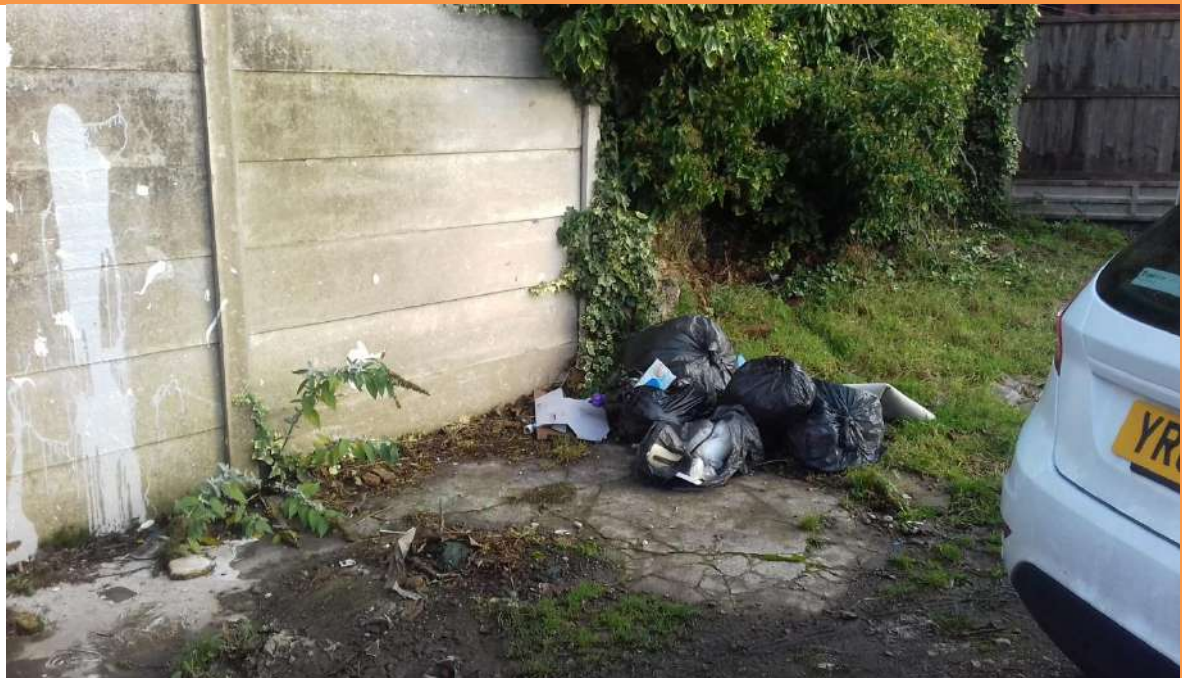
**PLATE 12 – EVIDENCE OF FLY-TIPPING AT NORTH EASTERN BOUNDARY**
