Phase II Geoenvironmental Site Assessment  
Oldham Road, Manchester

Reference: 12-730-R2-2  
Date: 5<sup>th</sup> February 2021

## PHASE II GEOENVIRONMENTAL SITE ASSESSMENT

Oldham Road  
Manchester  
M4 5FU

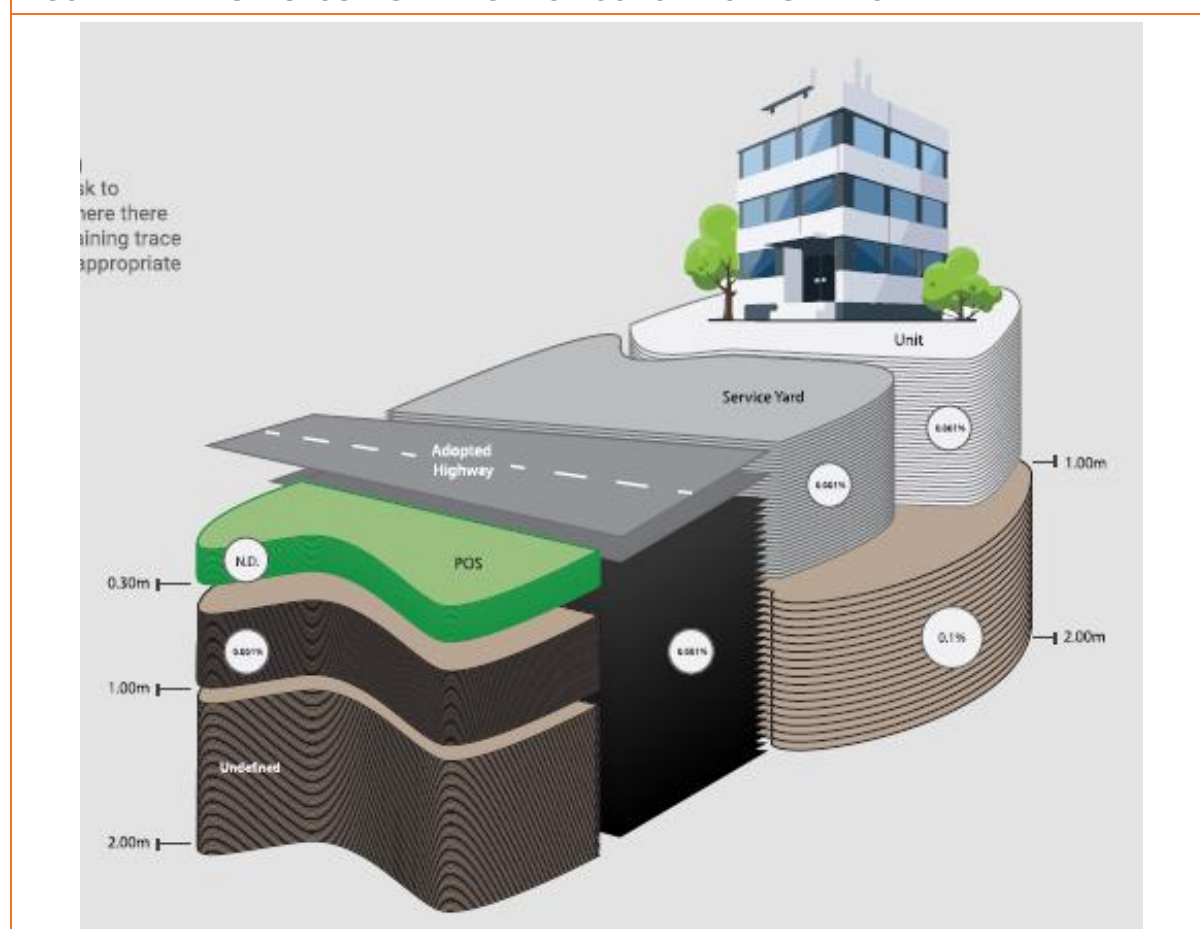
FIGURE 4.1 ASBESTOS RISK MITIGATION CONCEPTUAL SITE MODEL

Asbestos has not been identified in the soils analysed to date and no visual signs of ACM were encountered during the ground investigation. However, if any asbestos is identified in the soils during remediation works, impacted soils should be managed according to the asbestos risk mitigation conceptual site model shown in Figure 4.1 below.

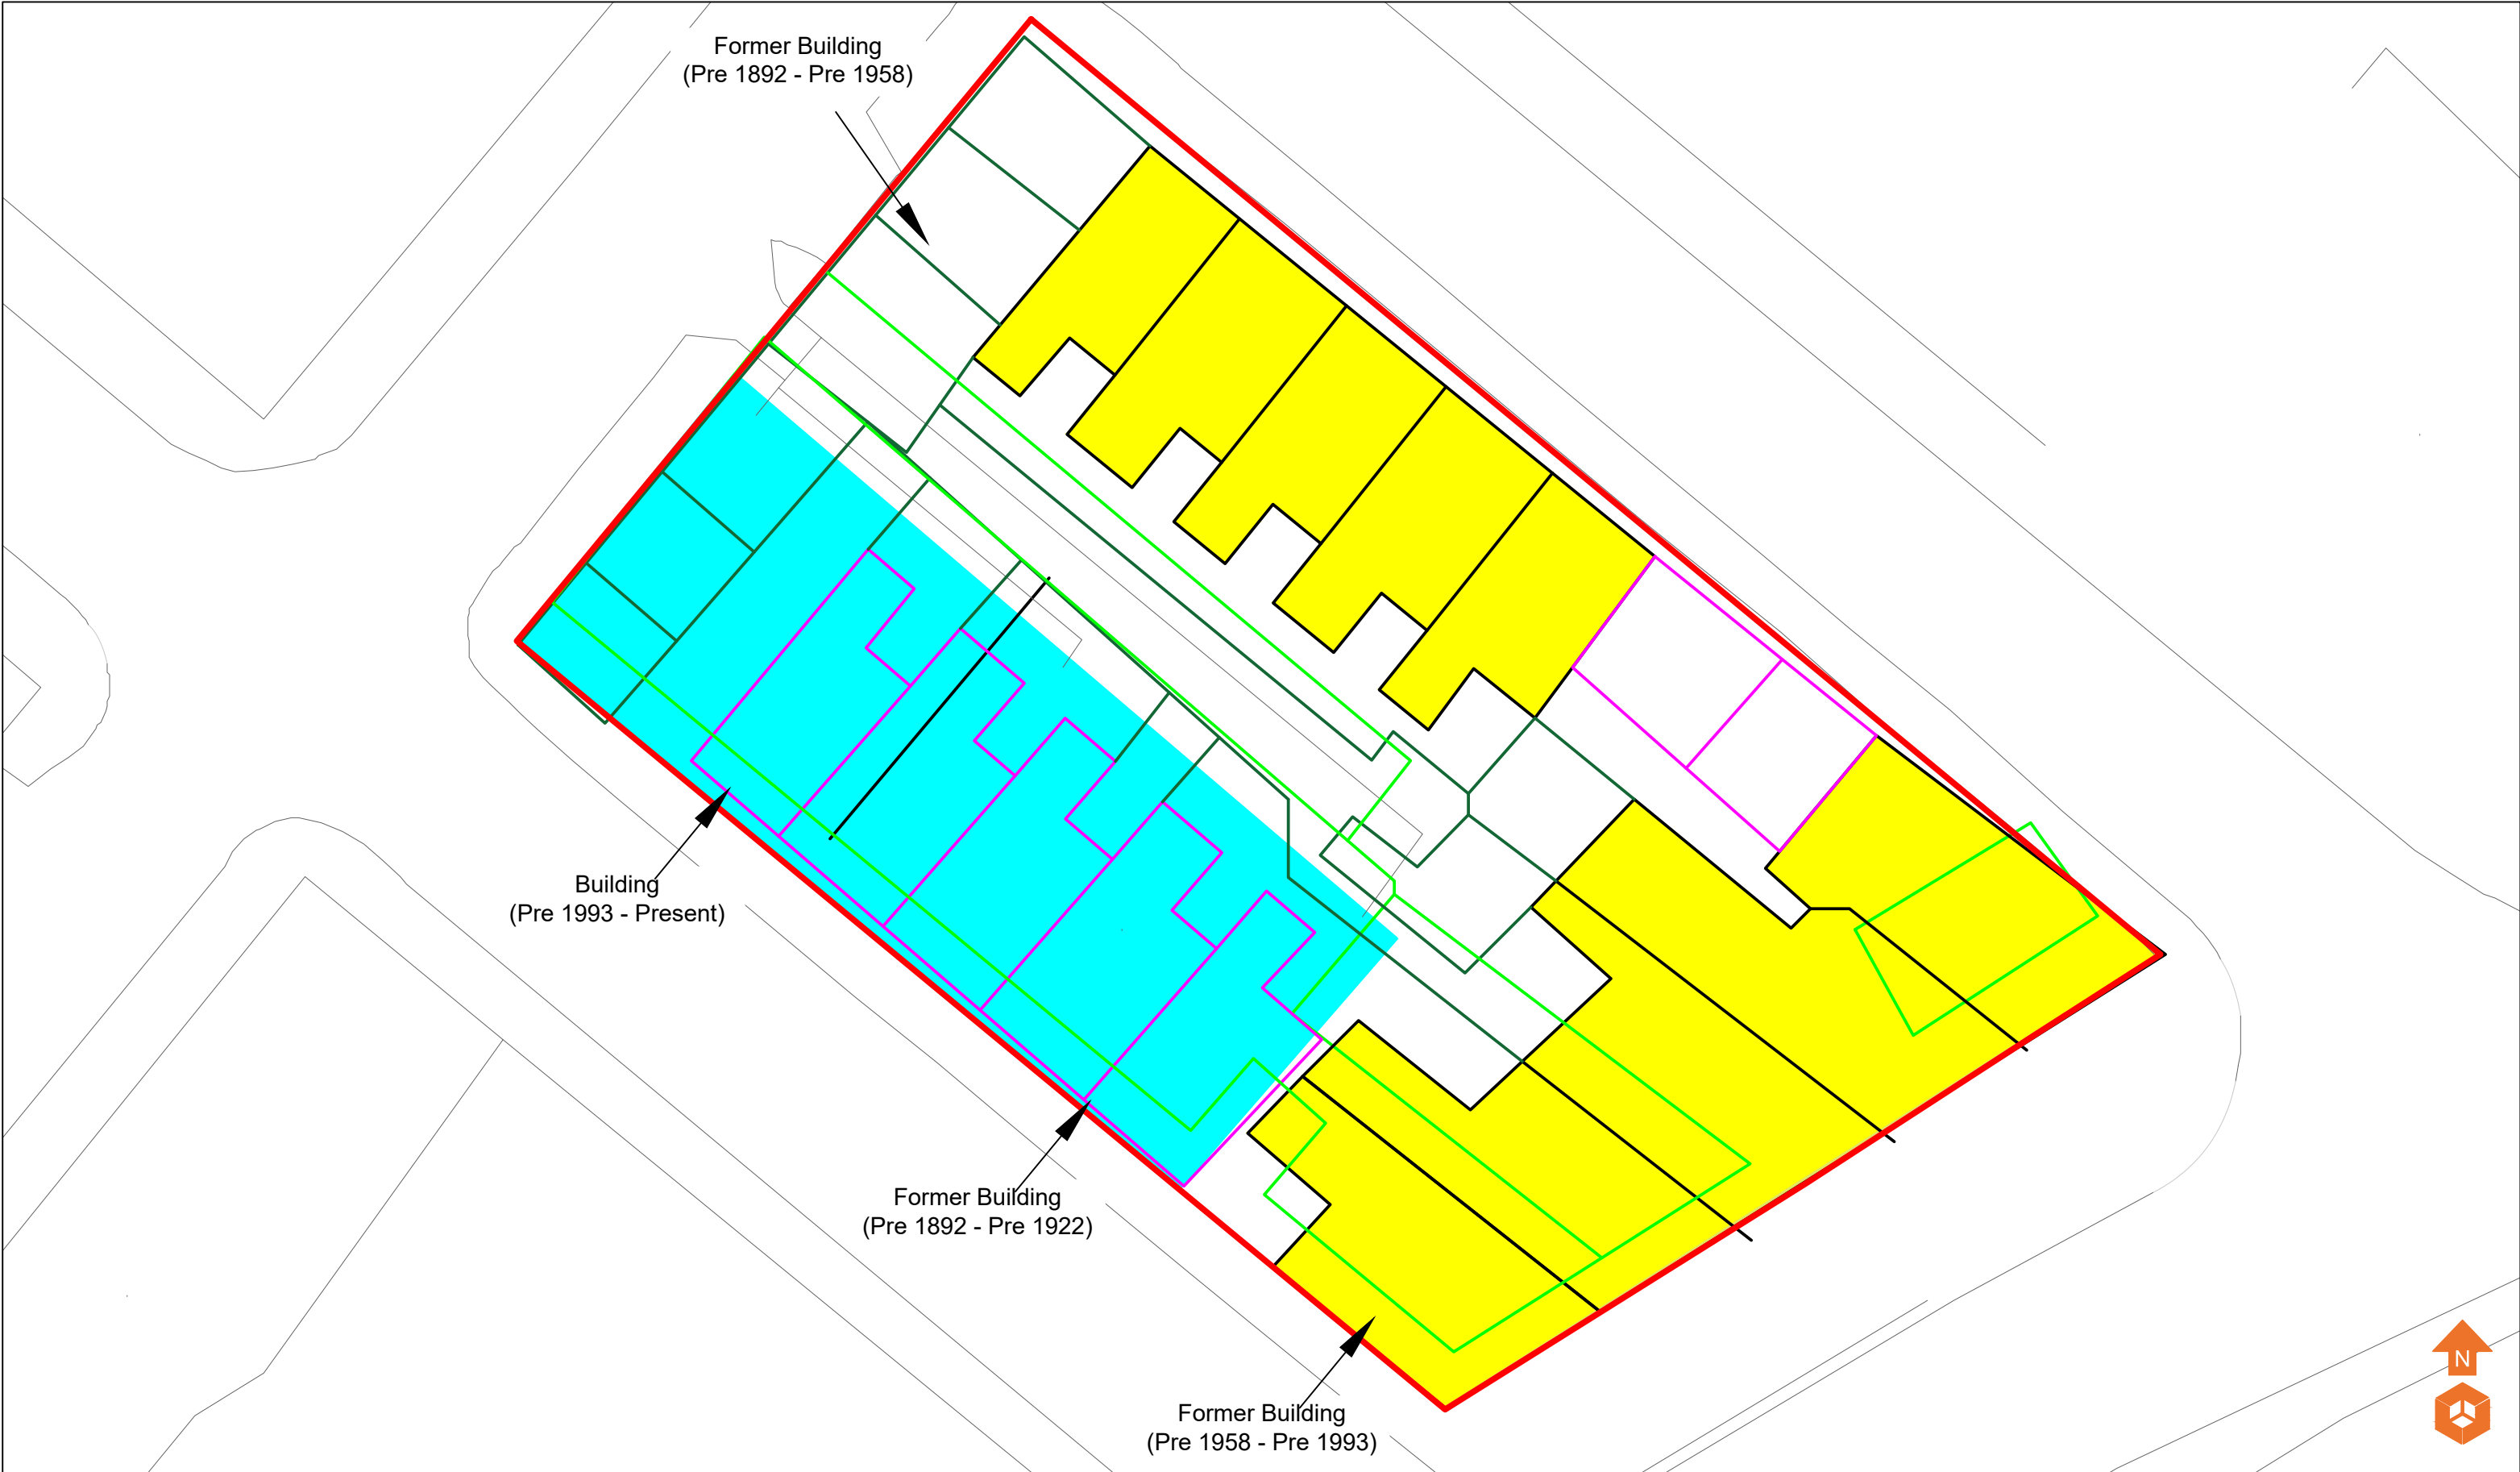
| <b>Site History</b> | <p>The site has been occupied by residential and industrial buildings throughout its mapped history. The terraced housing across the site was gradually removed during the 20<sup>th</sup> century and replaced by industrial buildings.</p> | |

| <div>Location Symbols</div> <div><div></div>Former Buildings (Pre 1892 - Pre 1922)</div> <div><div></div>Former Boundary (Pre 1892 - Pre 1958)</div> <div><div></div>Former Buildings (Pre 1892 - Pre 1958)</div> <div><div></div>Former Buildings (Pre 1958 - Pre 1993)</div> <div><div></div>Buildings (Pre 1993 - Present)</div> |

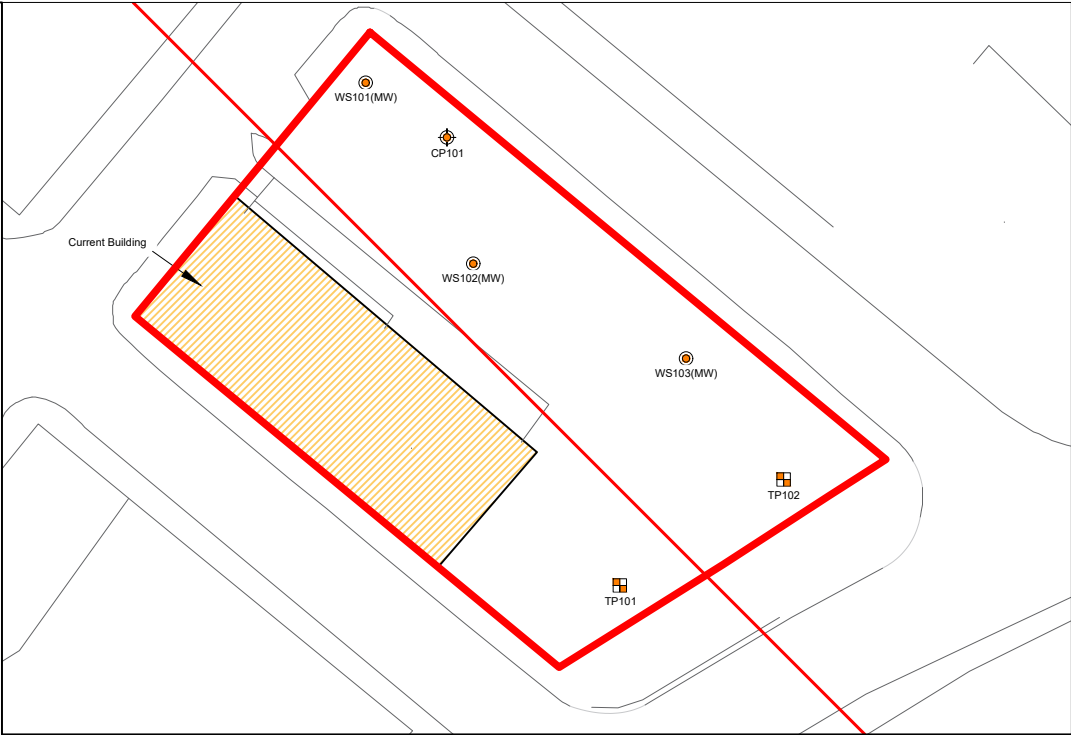
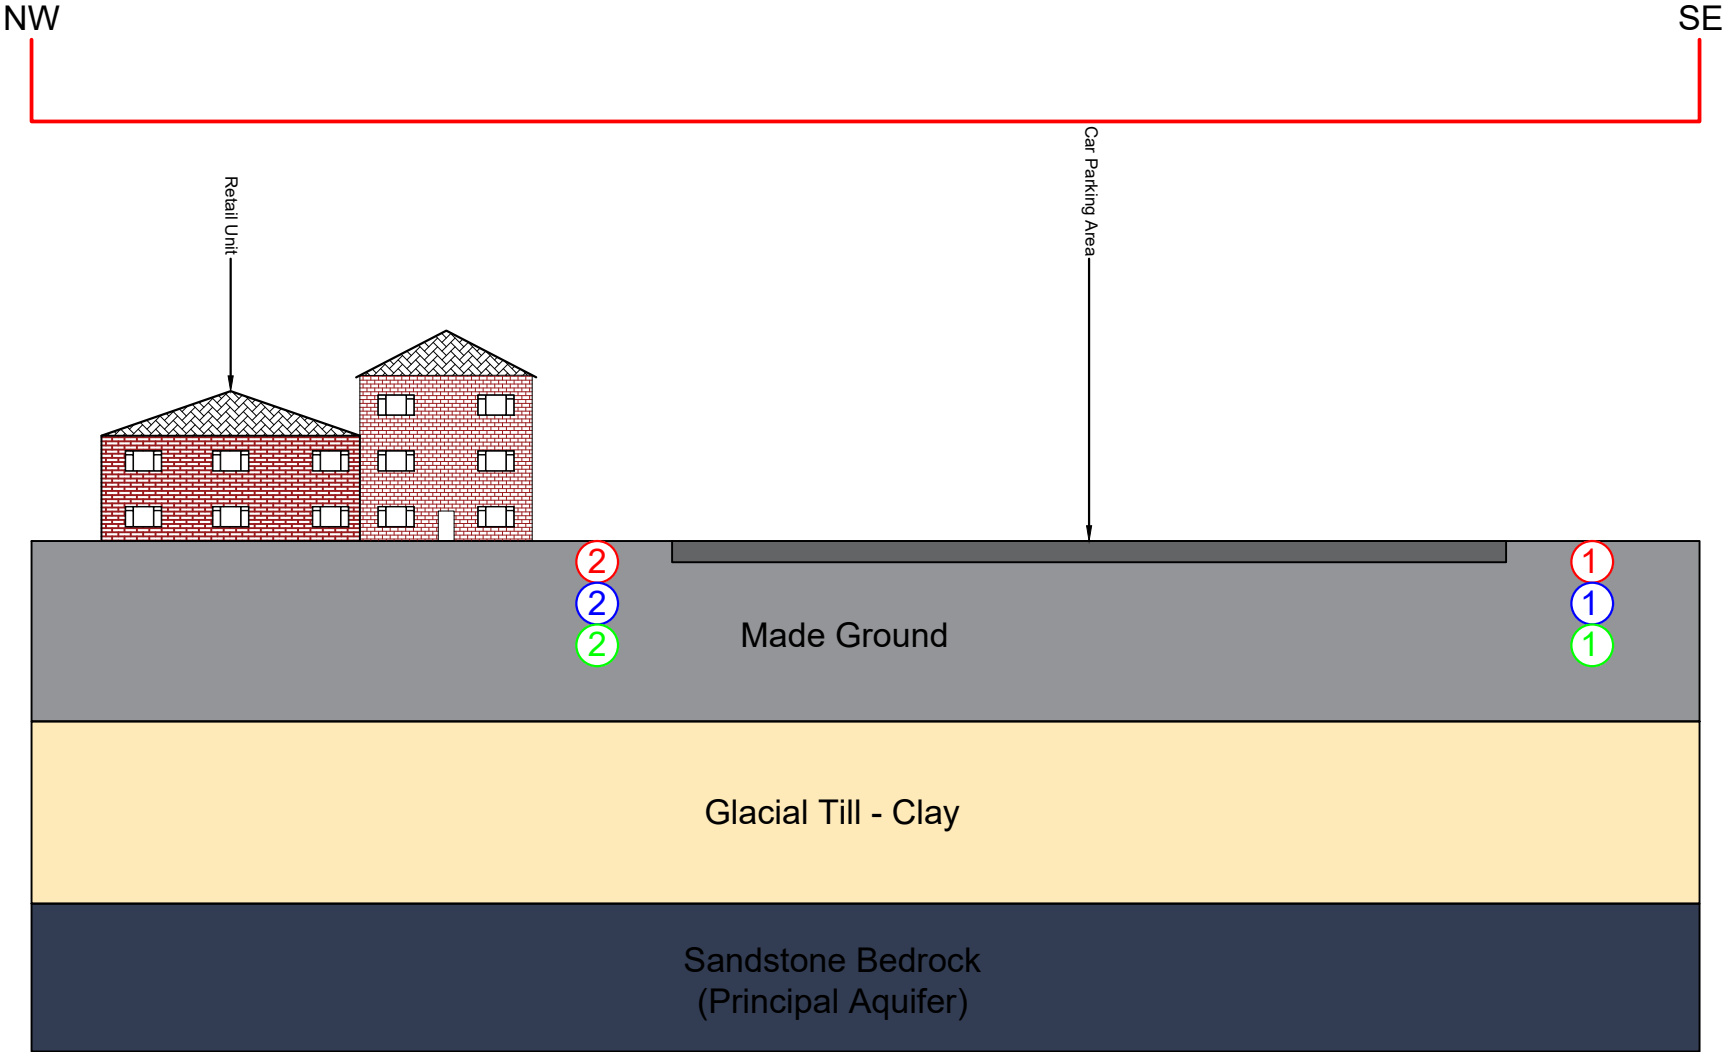
| <div>Geology Key</div> <div><div>Made Ground</div><div>Clay</div><div>Sandstone Bedrock</div><div>Car Parking Area</div></div> | <div>Sources</div> <div><div>① Heavy Metals, Non Volatile PAH</div><div>② PH &amp; Sulphate</div></div> | <div>Receptors</div> <div><div>① Future Residential Site Users . Commercial Employees</div><div>② Foundations / Concrete</div></div> | <div>Pathways</div> <div><div>① Dermal Contact / Ingestion</div><div>② Corrosion of Concrete</div></div> | Notes: | | | | | Client: | | Job No: | Date: | <div><div><div></div></div><div>e3p</div><div>Environmental Engineering Partnership Ltd<br/>Taylor Road, Trafford Park<br/>Urmston, Manchester, M41 7JQ<br/>Tel: 0161 707 9612<br/>E-mail: info@e3p.co.uk<br/>Website: www.e3p.co.uk</div></div> |

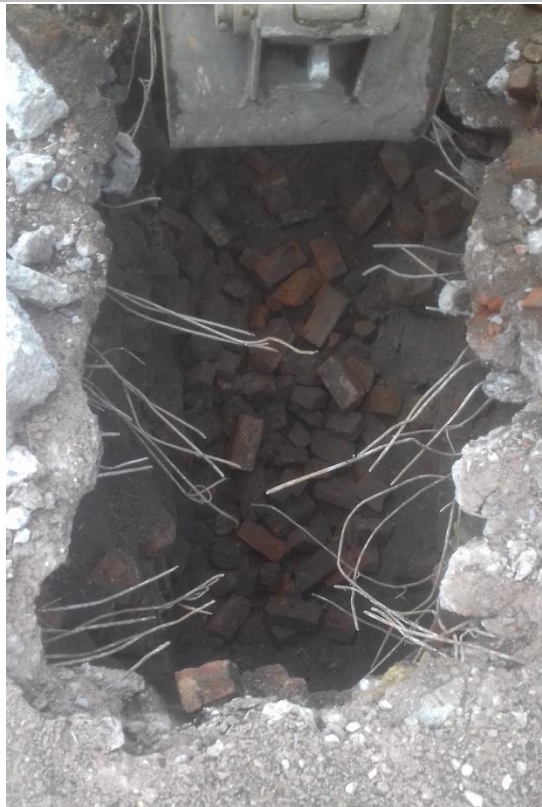
PLATE 1 TP101 EXCAVATION

Made Ground deposits vary across the site comprising of both brown sandy gravel and firm brown to black gravelly clay with frequent cobbles of brick and sandstone. Timber and pipes were also noted in the Made Ground in TP101 and TP102. The greatest depths of Made Ground have been encountered in the south east of the site where old basement structures have been infilled.

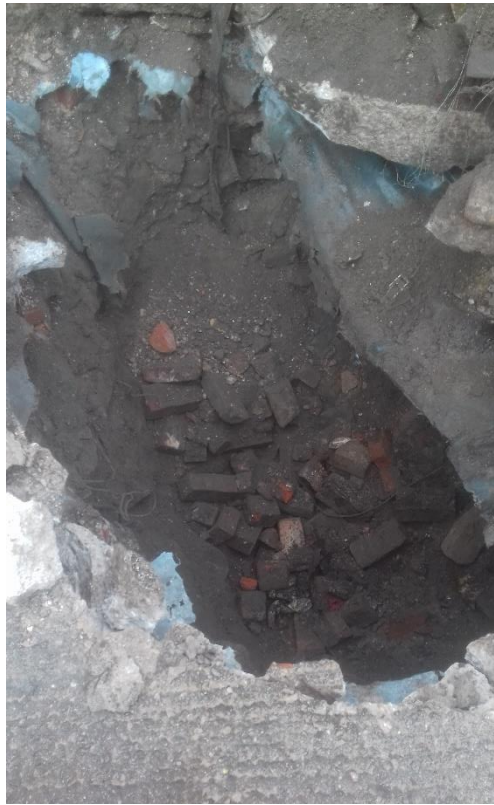
PLATE 3 TP102 EXCAVATION

Perched groundwater was noted on the plastic membrane at the base of the concrete slab in TP102 at 0.35 m bgl. No other groundwater strikes were identified during the ground investigation.

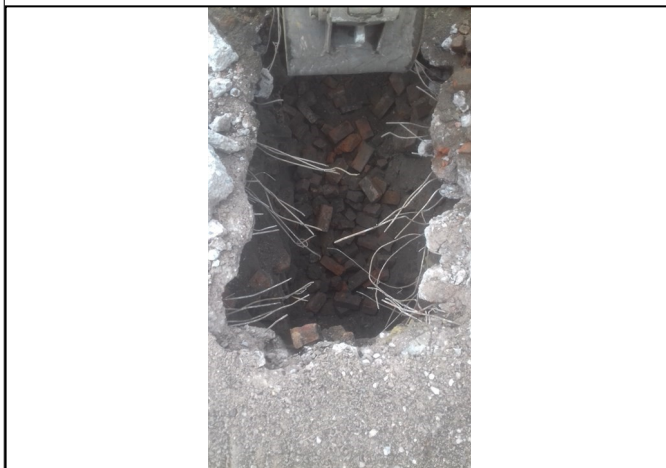
Trial Pit 101

Remarks: 1.Complete. 2. Brick wall at southern end of trial pit.

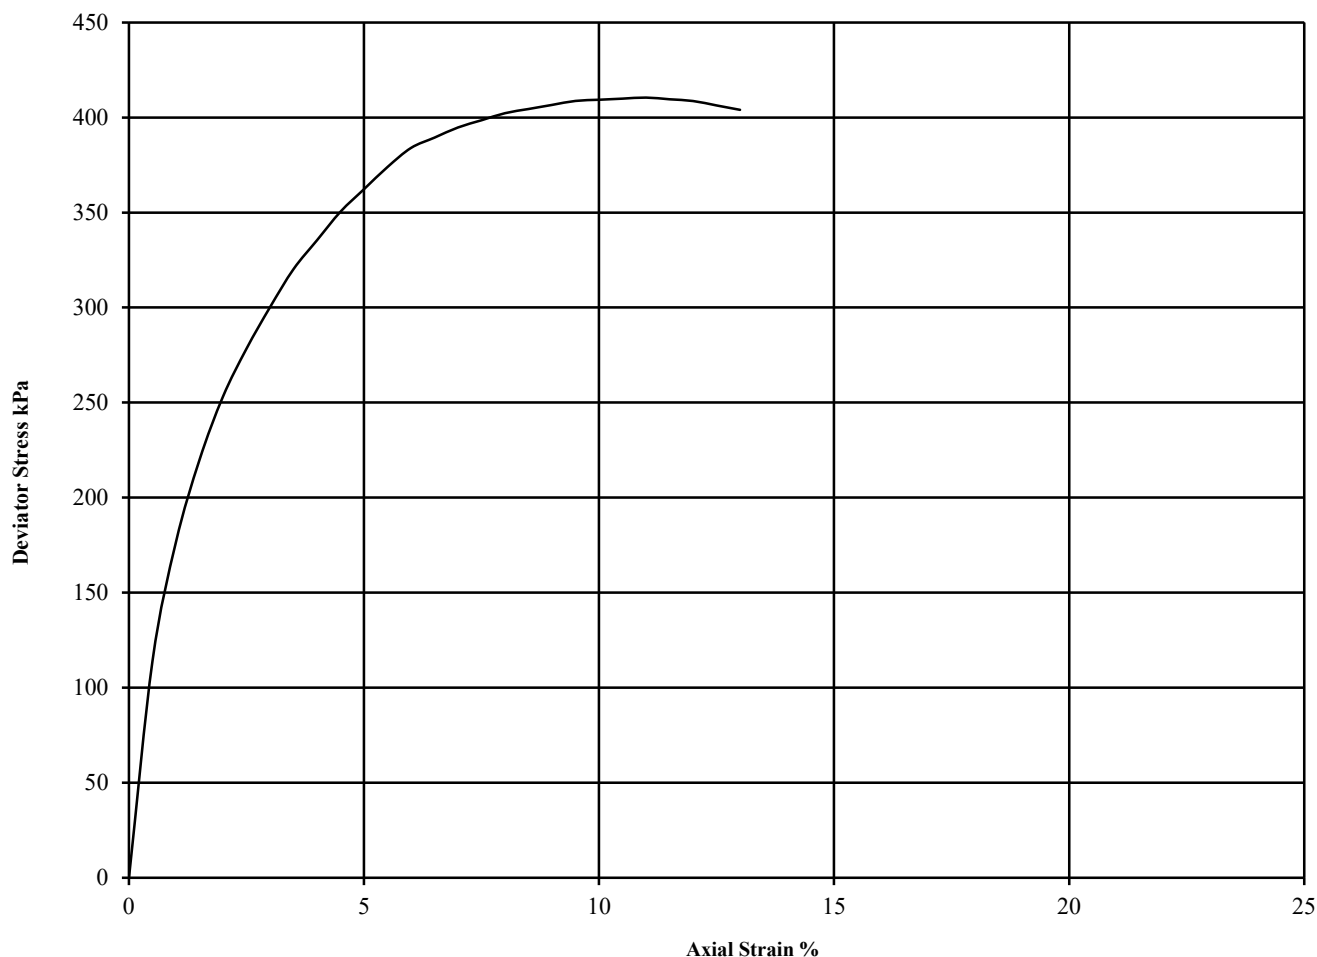
| Diameter (mm): | | 85 | | Height (mm): | | 170 | Test: | UU Single Stage | | Remarks: |

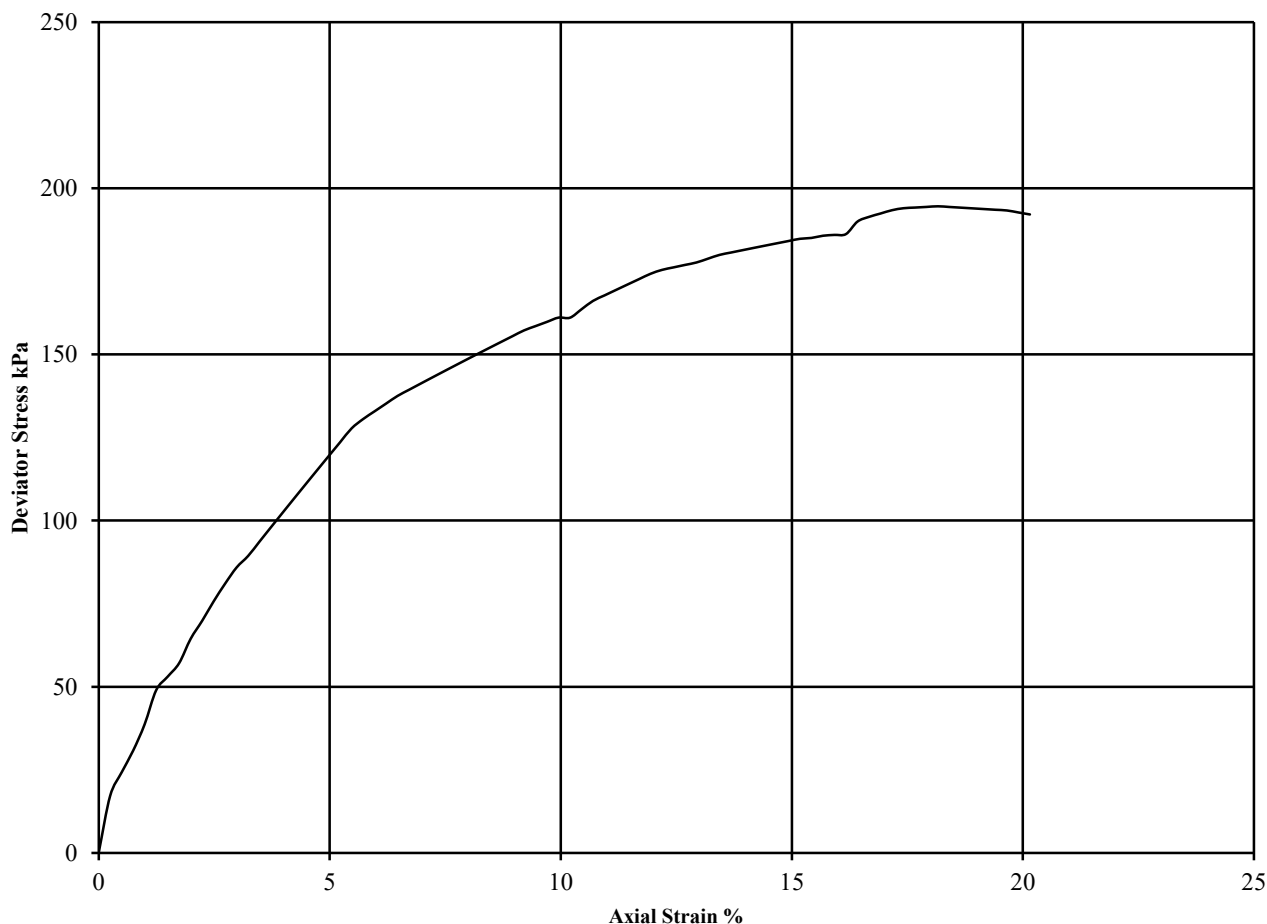
| Diameter (mm): | | 103 | Height (mm): | | 207 | Test: | UU Multistage | | Remarks |
