# Heritage Statement

1830 Warehouse,  
Museum of Science  
and Industry,  
Manchester

February 2021 | Project Ref 4700C

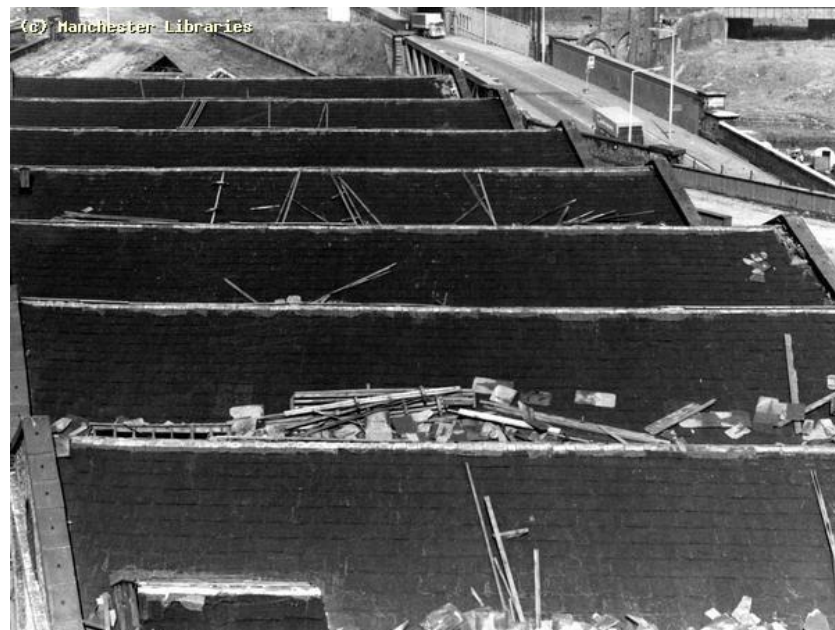
Figure 6: Photograph dated to 1978 showing the western end of the roof without skylights, bay1 in the distance to part of Bay 4 in the foreground (provided by SIMM).

**3.13** In 1992-96, the remaining four bays were carefully restored by the repairing of the timber frame, followed by the installation of two lift and staircase cores with skylights installed above (compare figure 6 and 7). The restoration ethic at this time was to retain as much original historic fabric as possible and to make any new interventions clearly identifiable through the use of modern materials. Bay 4 was chosen as an area that would be repaired and preserved 'as was' with minimal intervention and a more traditional approach, it had the least post 1830 alterations. The roof was left uninsulated with traditional torching applied beneath the slates; timber replacements were achieved where necessary using salvaged period timber from the removals from Bay 5; the only change was the glazing of openings in the doors to prevent rain ingress. Elsewhere the roof was fully repaired with date stamped timbers, and insulated between the rafters, windows were glazed, and in Bay 3 the mezzanine was removed to create a more welcoming and spacious 'entrance' into the building.

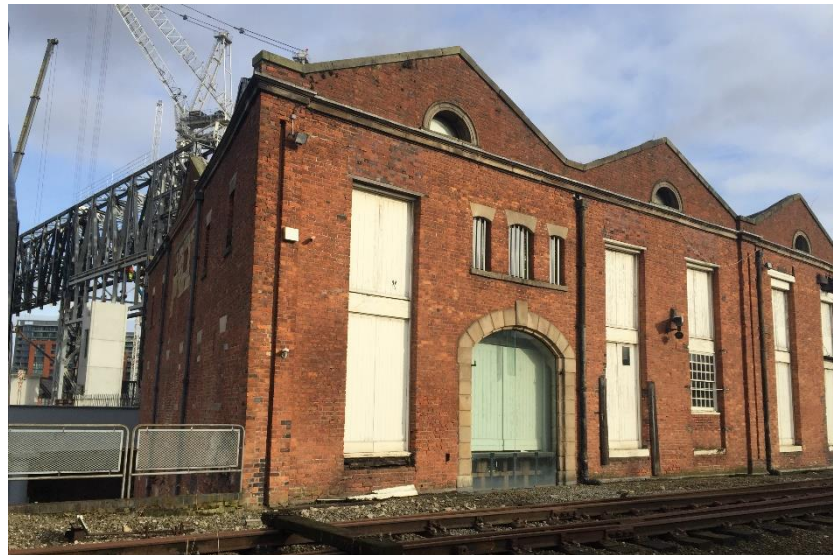
*Figure 7: Bay 1, southern façade showing typical details.*

**3.16** The 1830 Warehouse is built in red brick in a Flemish bond. It has sandstone dressings and grey slate roofs, three storeys high, but two storeys at track level (south elevation) where the tracks are elevated. There are 10 individually gabled

bays arranged in pairs, with slotted pilasters between each pair. There is a moulded stone cornice (carried round the whole), and a small lunette window accentuating the gable of each bay. The gable copings are stone linked by short flat parapets which conceal the roof valleys. Windows feature wrought-iron window bars with mostly later glazing. The roof is a series of ten gables running north to south, covered in Welsh slate with leaded ridge rolls and two large later roof lights located in Bay 1 and Bay 3. A much smaller roof light is located to the left in Bay 1 over the location of the former drive wheel. The roof of Bay 5 has been re-slatted and the whole roof was insulated and re-laid in the mid-1990s restoration. There is an existing access hatch within the roof in Bay 5 and a further much smaller hatch in Bay 4.

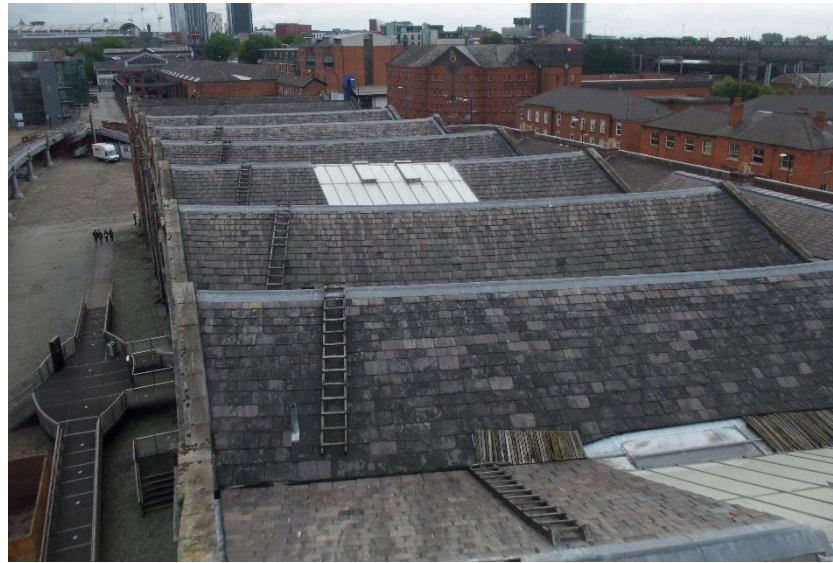
Figure 8: The roof today looking from Bay 1 to the east (Image from SDA).

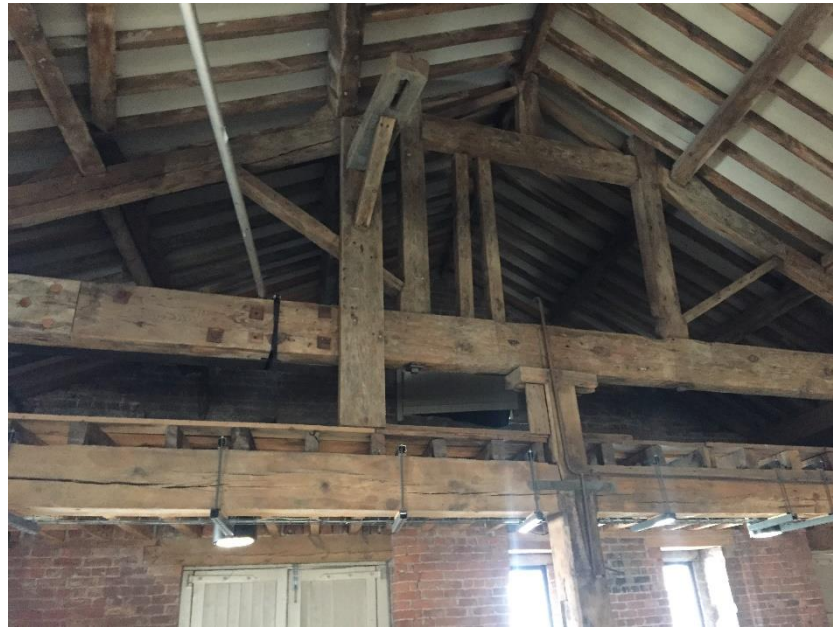
*Figure 9: Typical roof truss detail including supporting mezzanine post and deck as well as additional vertical member to carry equipment*

**3.18** European pine was used for the roof timbers internally which feature substantial queen post principal trusses with raking struts out to the principal rafters, which carry the purlins over on triangular chocks. The apex and ridge of the roofs are supported on minor king posts off the top member of the queen-post truss (Figure 9).

**3.19** In c.1870 the top floor and rail level were modified to accommodate the installation of hydraulically powered machinery. This included the cross-bracing of affected roof beams and addition of new posts to support heavy hydraulic hoists in Bays 2 and 3 of the warehouse. Notwithstanding those changes the original roof structure is clearly visible and is a striking visual element of the upper storey's internal character.

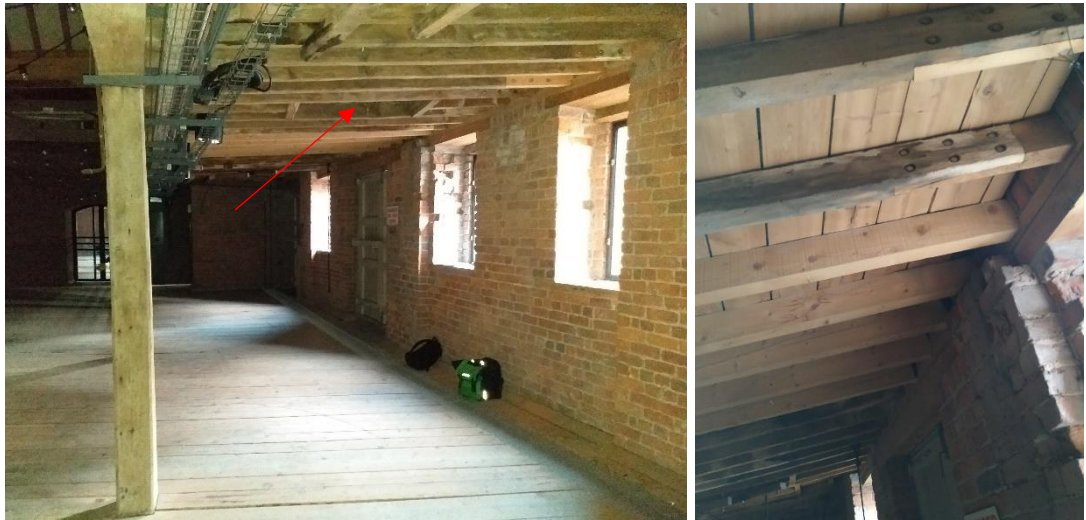
Figure 10: Bay 2, area beneath the mezzanine with existing hatch marked with an arrow and (right) example of typical restored mezzanine structure.

**3.20** The area of the proposed hatch sits in the central valley of Bay 2, on the western facing slope. Internally this area features the second floor mezzanine against the northern elevation, with an existing timber hatch set into the mezzanine between two windows. Various elements of the mezzanine, from their colour and texture, are restored timbers. The mezzanine deck has various fixtures including cabling runs and lighting fixtures, they are honestly applied and clearly identifiable as separate from the historic structure. The northernmost roof truss in this area is aligned with the edge of the mezzanine, between the common rafters the insulation installed in the 1990s forms the 'ceiling'.

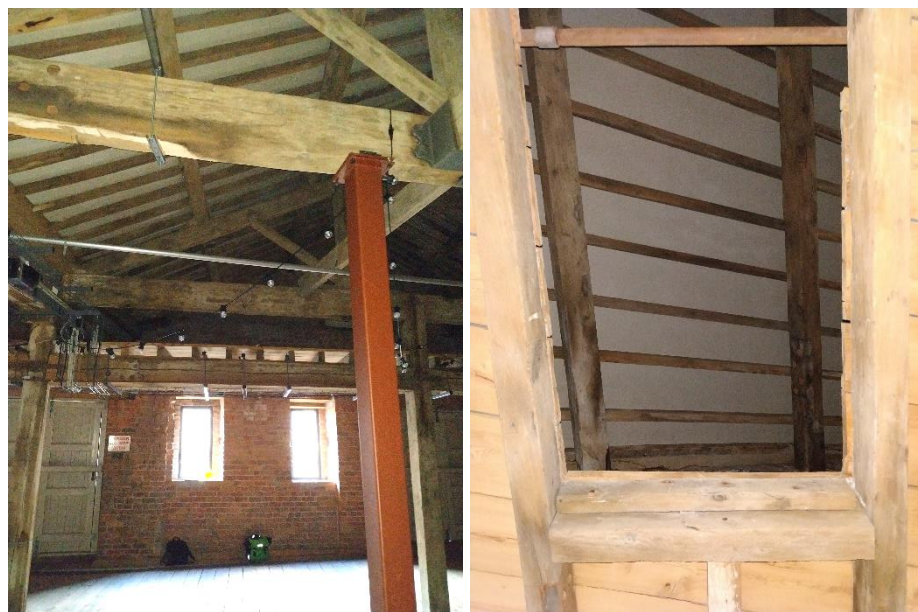
Figure 11 (left): slightly more distant view towards the Bay 2 mezzanine and area of the proposed hatch, note the existing hatch is concealed by the substantial beam on the front edge of the mezzanine.

Figure 12 (right): looking up through the existing hatch to the common rafters between the purlins with modern insulated ceiling between.

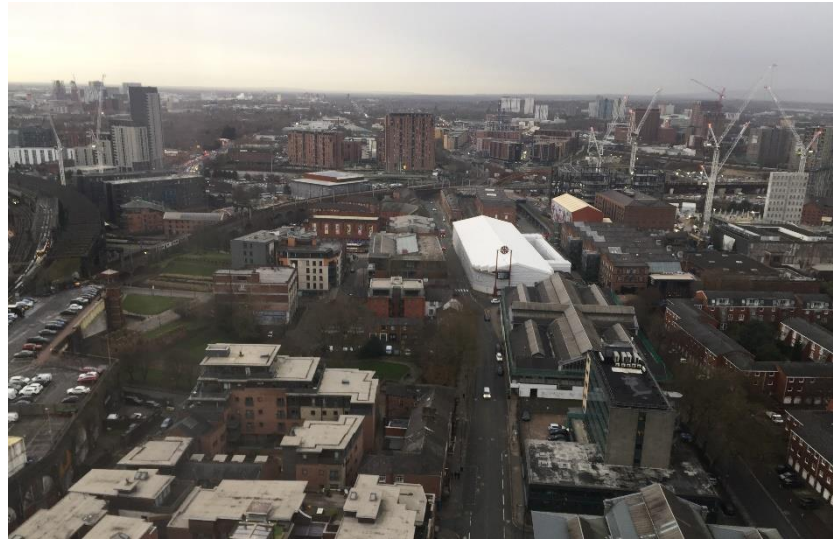
*Figure 15: Publicly available view from the Hilton Hotel bar, the 1830 Warehouse is visible within this view and the proposed roof hatches will not alter its prominence or role within this view if they are visible at all.*

- 5.27** The low level of the hatches and platforms, located on the north side of the building and low within the roof slopes away from the main east and west sides, will mean that there is not anticipated any visible change to be perceivable from within the surrounding area. Even where publicly accessible higher vantage points are possible the character of the view will not change.
