**Invicta House, Manchester**

**Proposed New Moxy Hotel**

**Phase 1 Geo-Environmental Ground Investigation**

Ref: 2801ENV  
Job: 2801  
Rev: -  
By: AE

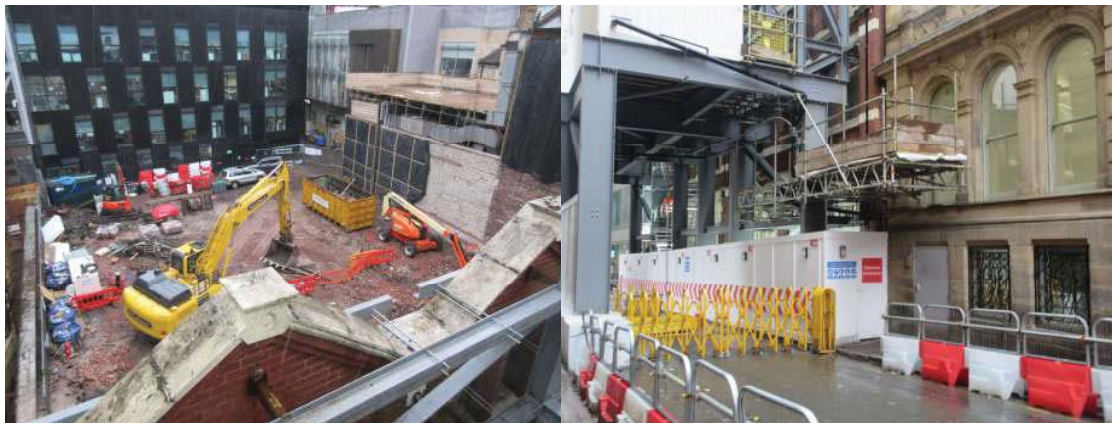
A second site walkover was undertaken in April 2020 following the demolition of the former Invicta House and the façade retention scheme. With the exception of the existing façade along the southern boundary, the previous building has been completely demolished and the site remains relatively unchanged. Photos taken in April 2020 are included below:

Figure 1; Photos showing the site (photo 1) taken from the south western corner and the remaining Invicta House façade along the southern boundary (photo 2)
