# DAYTIME BAT SURVEY OF STATION BUILDING, MUSEUM OF SCIENCE AND INDUSTRY, MANCHESTER

NOVEMBER 2020

**RACHEL HACKING ECOLOGY**

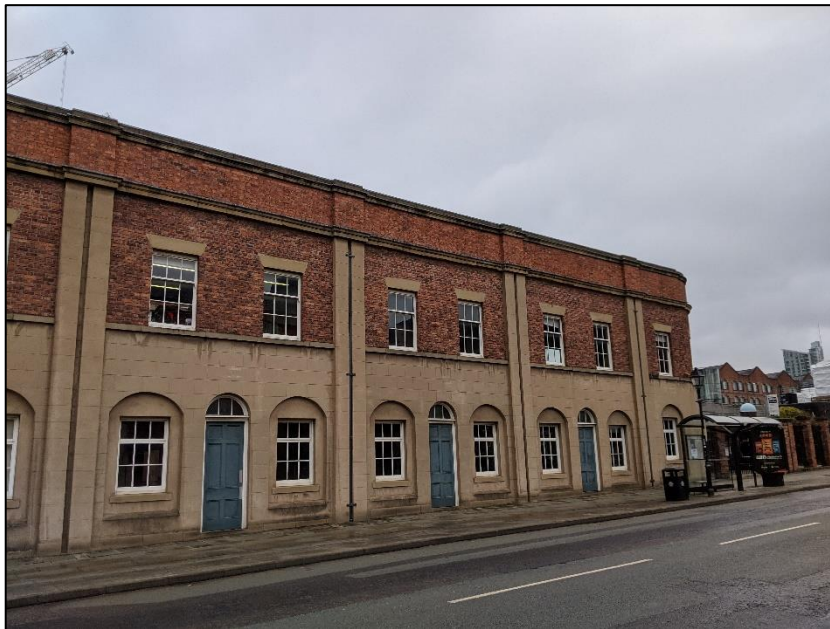
- 2.1 A daytime bat survey at the Station Building was undertaken to search for, and to assess the potential for, a bat roost within the site.
- 2.2 An external survey was carried out, which included, for example, looking for gaps between any soffit boards and walls, gaps between window frames and the walls, and looking for bat droppings on the walls and window ledges.
- 2.3 The building was also searched internally for evidence of a bat roost, which included looking for the following signs:
  - live or dead bats
  - bat droppings
  - bat entry/exit points
  - bat urine staining
  - grease marks on any timbers
  - feeding remains such as insect wings
  - areas clear of cobwebs.
- 2.4 A pair of close-focussing binoculars, a high-powered torch and an endoscope were used to search for evidence of bats externally and internally.

Photograph 1 showing the exterior of the station building

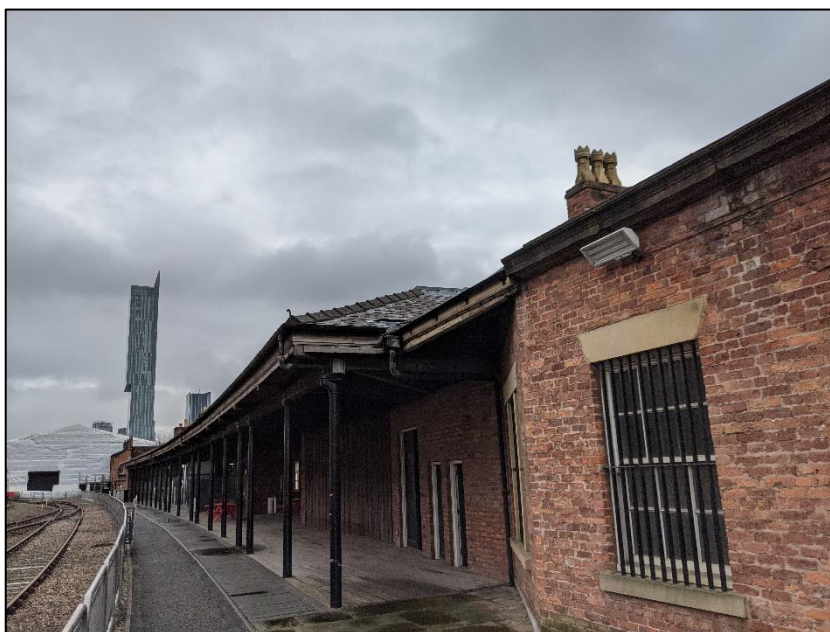
Photograph 2 showing the exterior of the station building

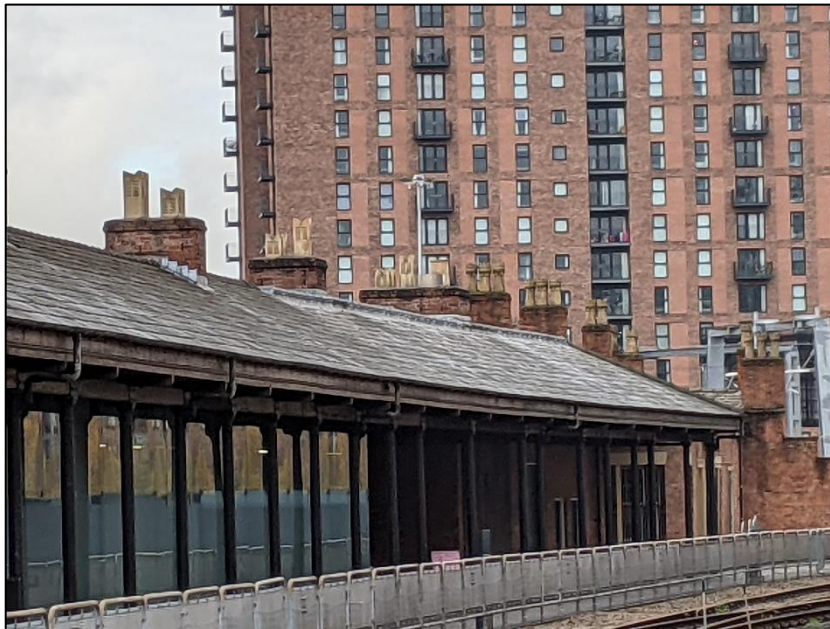
- 3.3 The roof of the Station Building is pitched and has slate roof tiles (see Photographs 3 and 4). The tiles and ridge tiles are all intact and in place, leaving no potential access points for bats. Lead flashing is present in some areas. This is well-sealed to the masonry and tiles. The elevations facing east and onto Liverpool Road are sealed with brick courses and a small parapet wall (see Photograph 4).

**Photograph 3 showing the roof of the station building**

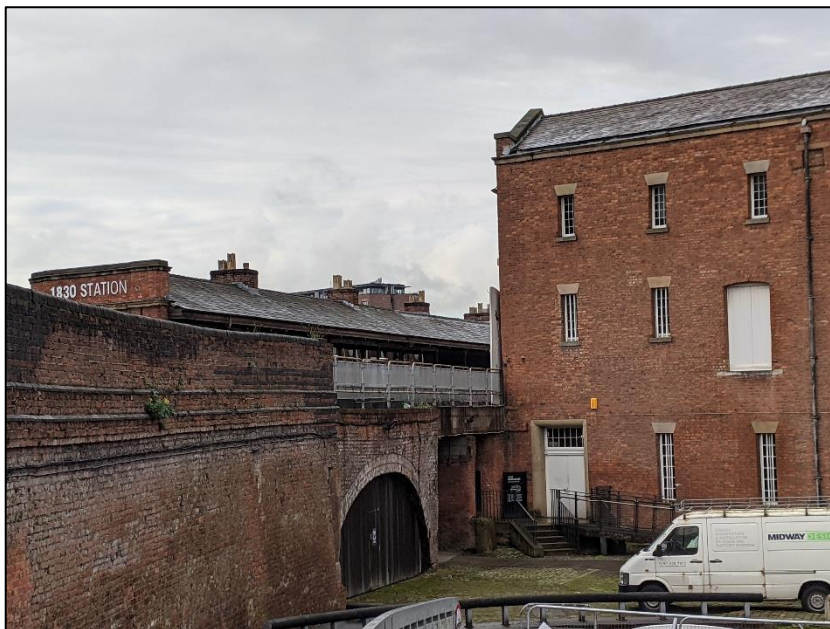
**Photograph 4 showing the roof of the station building**

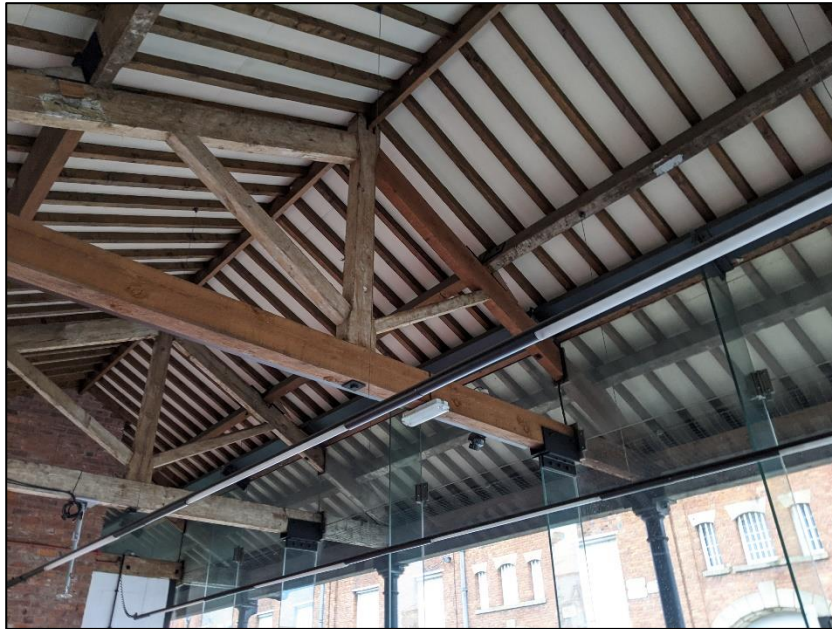
- 3.4 The building has two storeys, with an additional floor on the former station platform adjacent to the railway track (see Photographs 5 and 6). This upper section is open, with a small section sealed off and used as an office space. The wooden roof joists are complete and without gaps

or cracks for bats to exploit (see Photograph 5). The roof lining is intact, with no major tears in the lining. This space is well-lit and sections of the roofing are covering with mesh netting to prevent bird access.

**Photograph 5 showing the canopy of the former rail station**

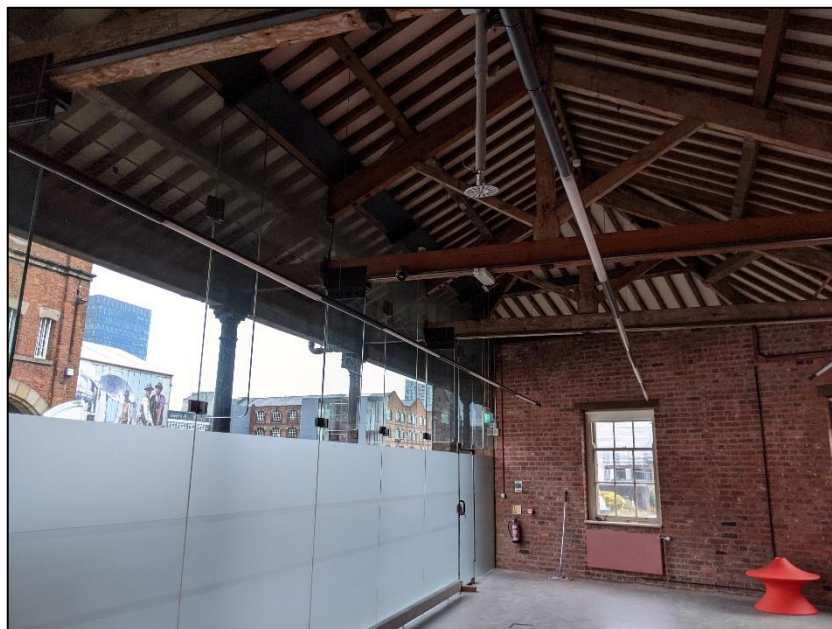
**Photograph 6 showing the canopy of the former rail station**

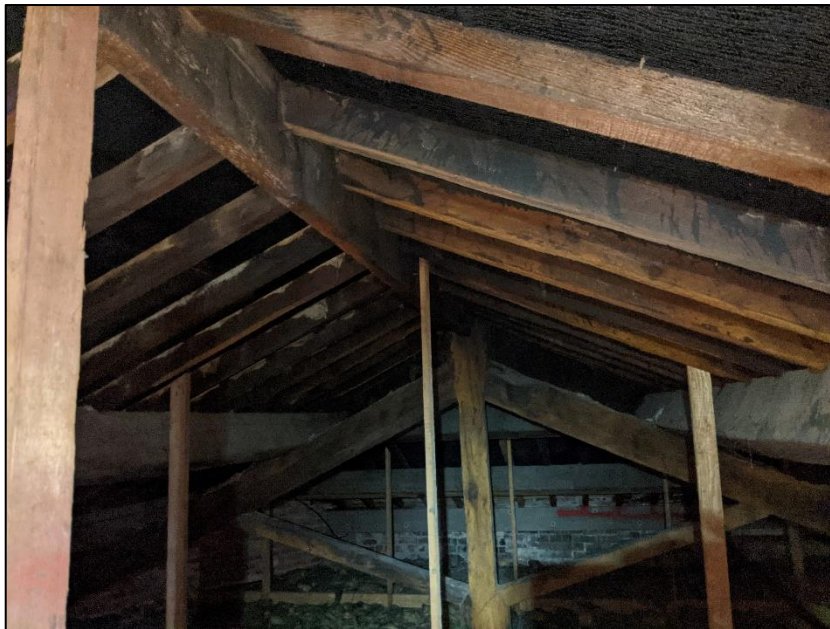
- 3.5 The western section of the former station platform area has several internal spaces that are used as a museum exhibit room and for storage. None of these rooms offer suitable bat roosting habitat. A large roof void exists covering two of these rooms. The roof has wooden roof joists, which are complete and intact. The roof is lined throughout, and the lining is complete and intact, with no major tears or rips in the lining (see Photograph 7).

**Photograph 7 showing the roof void of the Station Building**

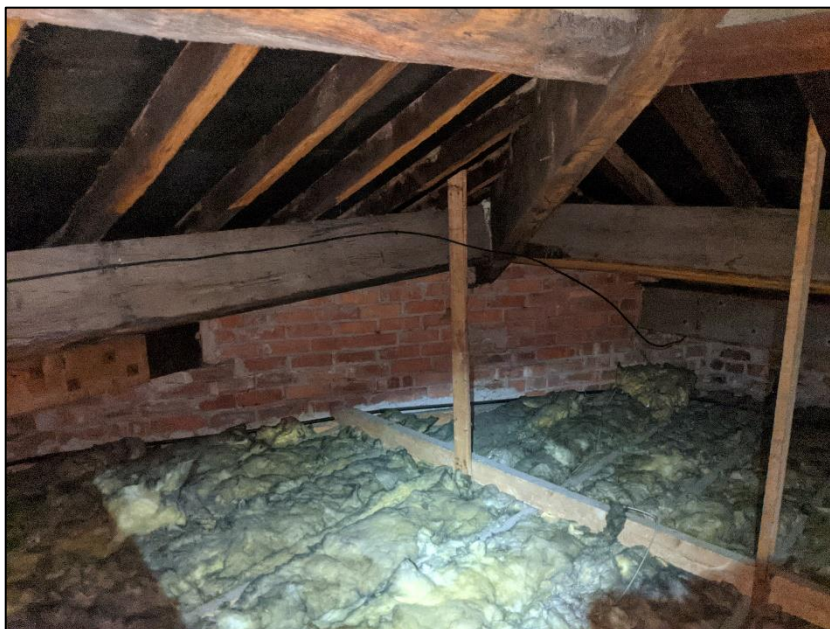
- 3.6 The roof void is fully insulated throughout (see Photograph 8). The internal brickwork is complete and mortared, offering no suitable cavities for crevice-dwelling bat species (see Photograph 9). The roof void is well-sealed, with no daylight visible at the roof edges.

**Photograph 8 showing the roof void of the Station Building**

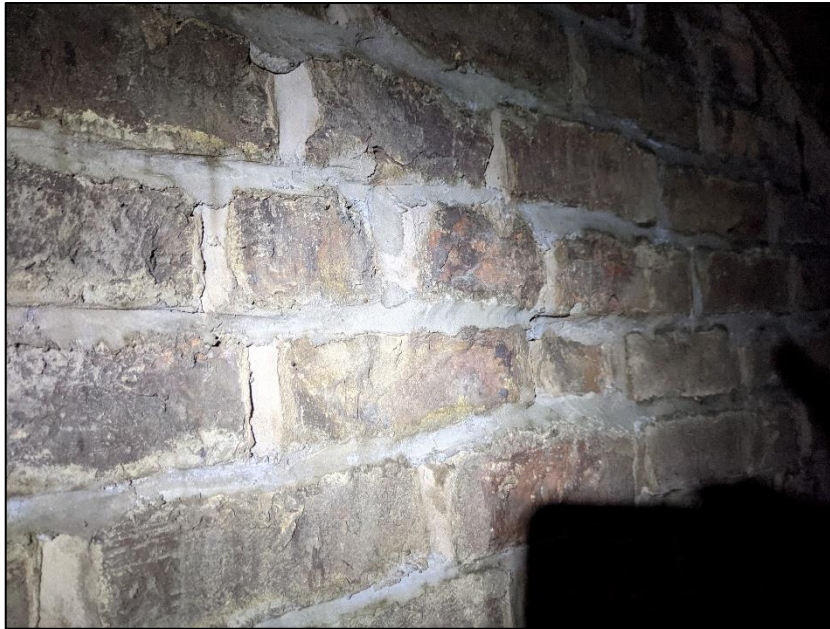
**Photograph 9 showing the internal brickwork in the roof void**
