## **Heritage Statement**

**Wythenshawe Hall, Wythenshawe Park, Nathans Road, M23 0AB**

**Refurbishment Works & Security Improvements**

**Ref: LS44862**

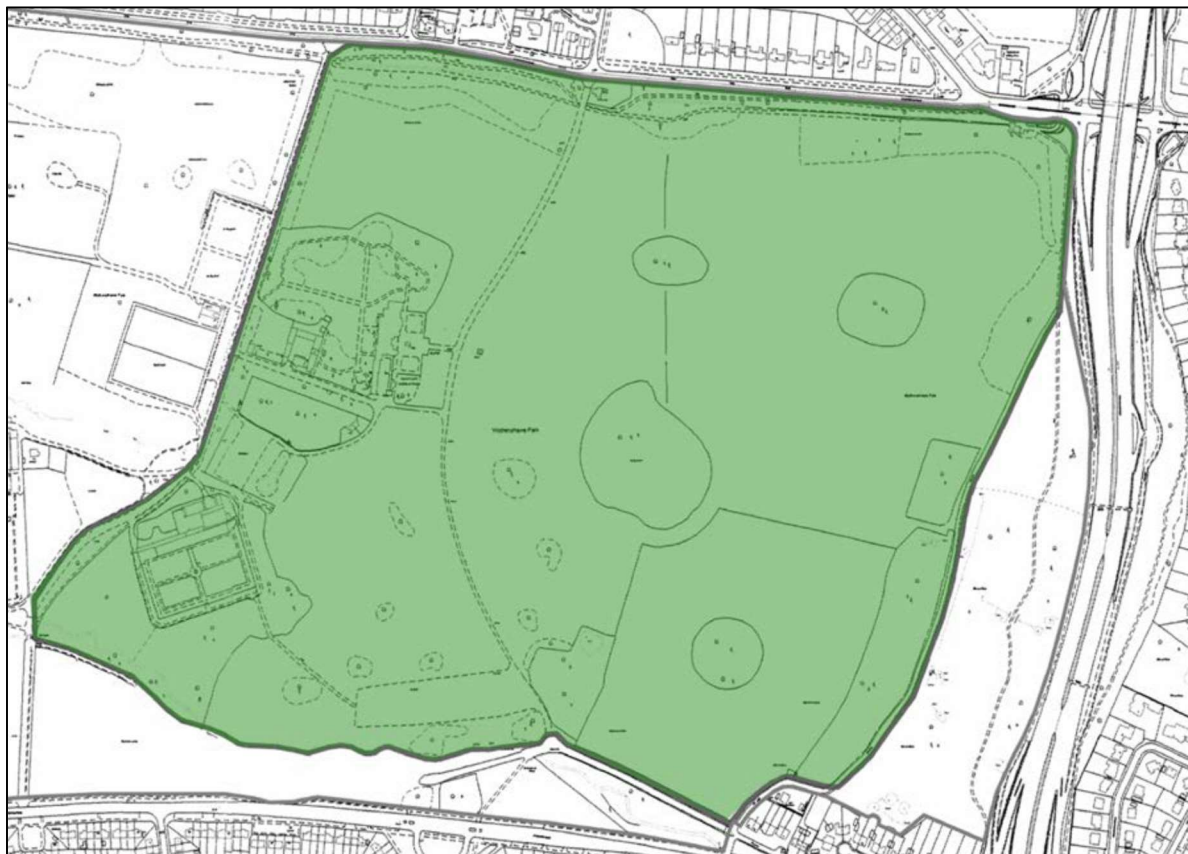
Figure 2 Wythenshawe Park designation boundary.

Wythenshawe Park is a grade II listed registered park which occupies 109 hectares of land surrounding Wythenshawe Hall, situated 8km from Manchester City Centre. The boundaries are formed by Wythenshawe Road to the north, the M56 motorway to the east, and Altrincham Road to the south. The western boundary is a drive running south from Wythenshawe Road to Baguley Brook where the boundary of the historic park merges with former fields to the west. It contains 'historic and ornamental woodlands, herbaceous borders, formal bedding, open grassland and beautiful wildflower meadows.'<sup>2</sup> There are also sports facilities and a community farm. The Park's general arrangement was laid out by 1830, but contains elements shown on maps from the mid-17<sup>th</sup> century, as well as a formal garden dating from 1850.

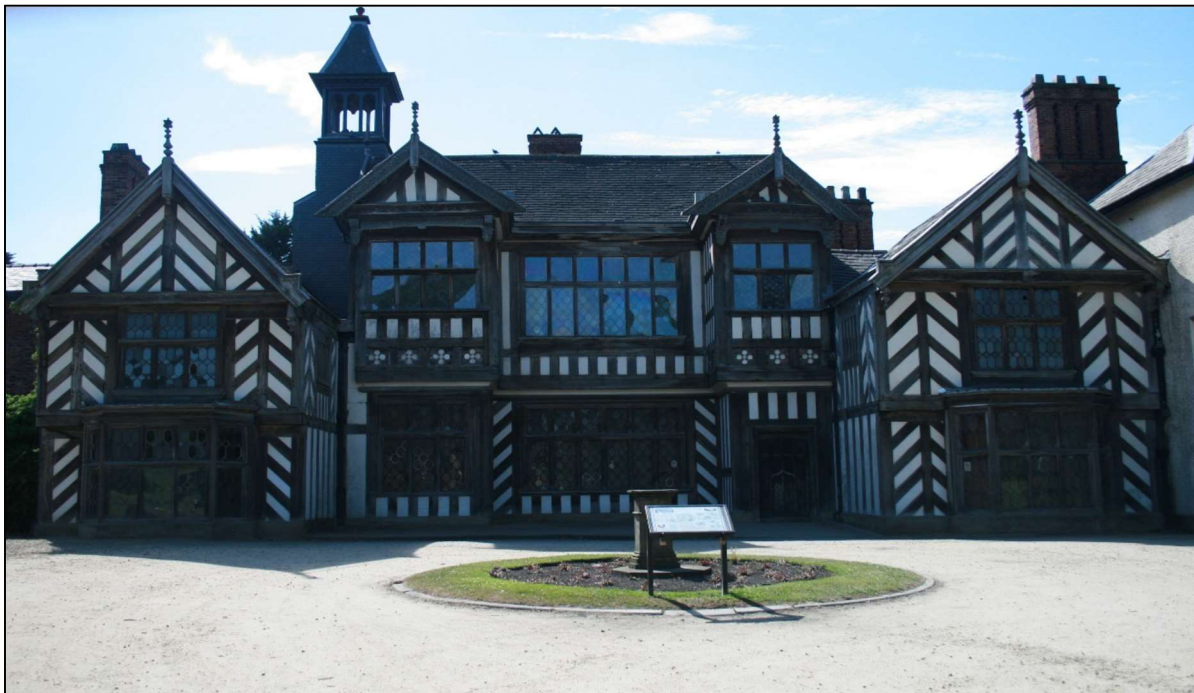
Figure 5 Hall Forecourt, before the fire, 2010.

The forecourt to the Hall is situated to the east. Two rectilinear lawns with circular planting beds are enclosed by a stone wall which has a gated entrance aligned with the main entrance of the Hall.

The lawns flank a circular planting bed with a central sundial and an adjacent interpretation panel. This layout is approximate to the 1882 OS map configuration.

**GARDENS AND PLEASURE GROUNDS** On the east side of the Hall a stone wall encloses a forecourt which has a central circular bed with a sundial and rectilinear lawns on each side, approximating to the layout shown on the 1882 OS map. Early C19 views suggest that this replaced a less formal arrangement with shrubberies and specimen trees. There is a gated entrance in the stone wall aligned with the main entrance to the Hall.

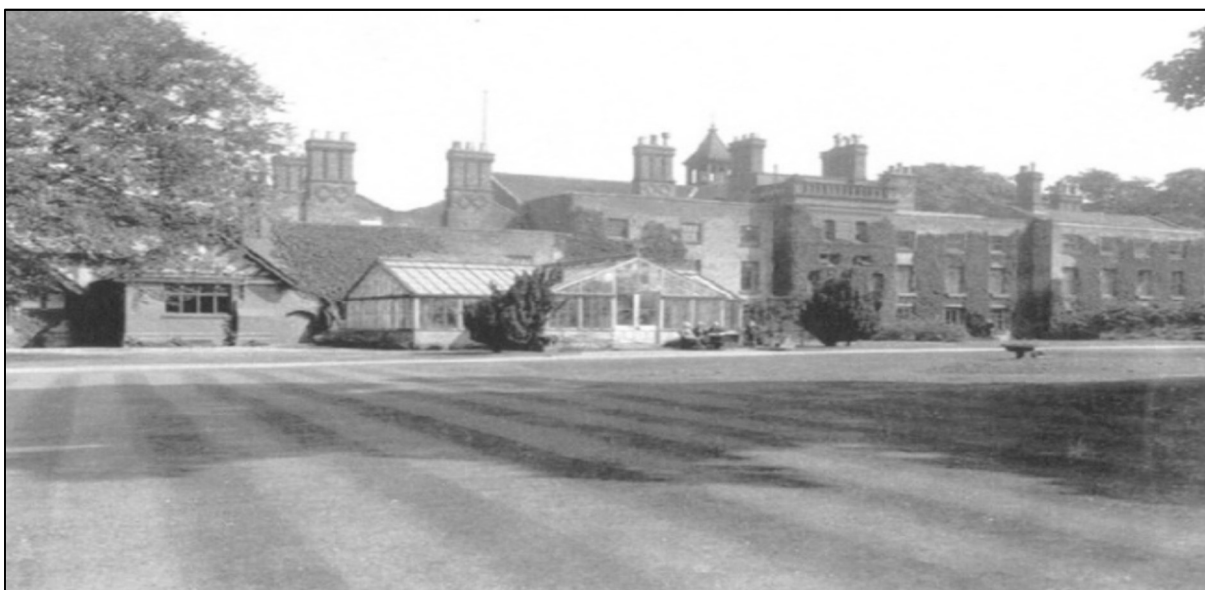
Figure 8 View of the Hall from the West, showing the conservatory (1927)

A conservatory probably designed by John Shaw and constructed in 1855 has been demolished, as has a first-floor conservatory in the Hall which overlooked the rock garden.

In 1855 the second Thomas William Tatton (1816-85) added a conservatory on the west side of the Hall in collaboration with a local landscape gardener and nursery man John Shaw. The conservatory was enlarged in 1891 creating a cruciform plan. In c1862 a billiard room was added at the north end of the library, designed by J Medland and Henry Taylor. Adjoining this on the north again, the Tenants' Hall, by James Redford, was added in 1879 and provided a larger venue for meetings of staff and tenants than the Georgian Servants Hall.

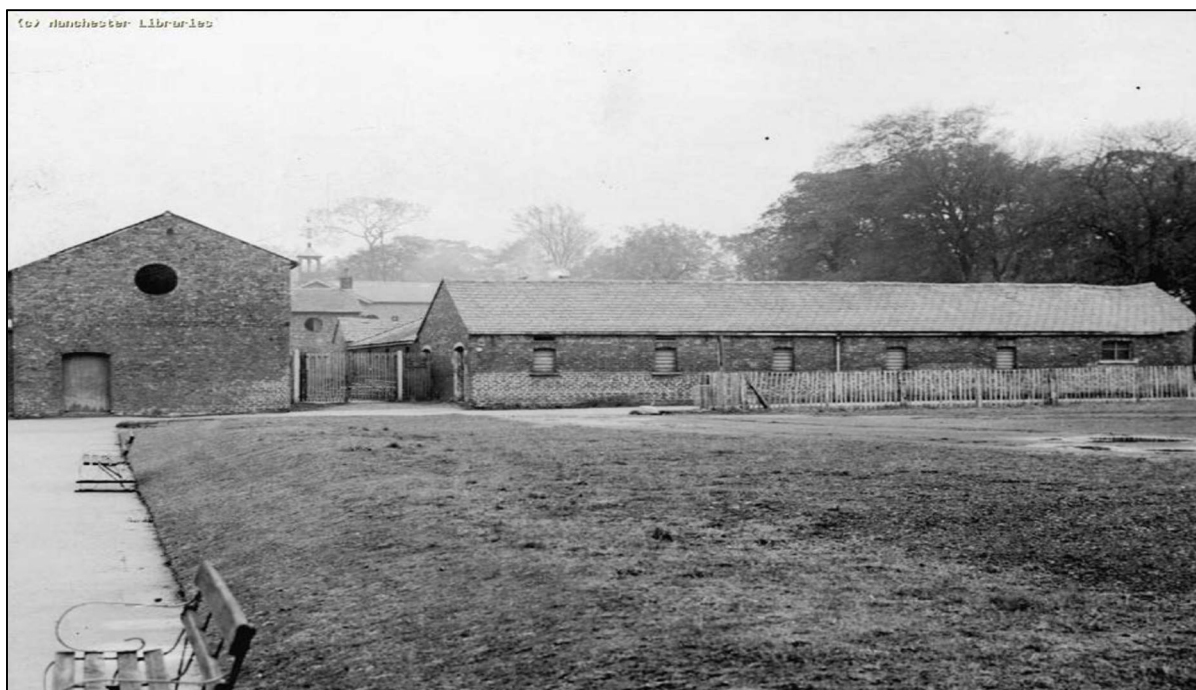
Figure 10 The farm buildings, the north range (left) and south building (right), viewed from the west, 1949 © Manchester Libraries

Excavations in 2007 uncovered the 18<sup>th</sup>-19<sup>th</sup> century 'Home Farm' which included the stables, dairy and workshops which are shown on the Northenden tithe map of 1839. The walls of a long range running west and an L-shaped building in the south, appeared to have survived well buried beneath the gardens.

There was previously a collection of farm buildings, also known as the dairy yard, to the immediate west of the stable block. Photographic evidence shows that the style of these buildings was consistent with the stables. However, these outbuildings were demolished c.1965, leaving only one small structure.

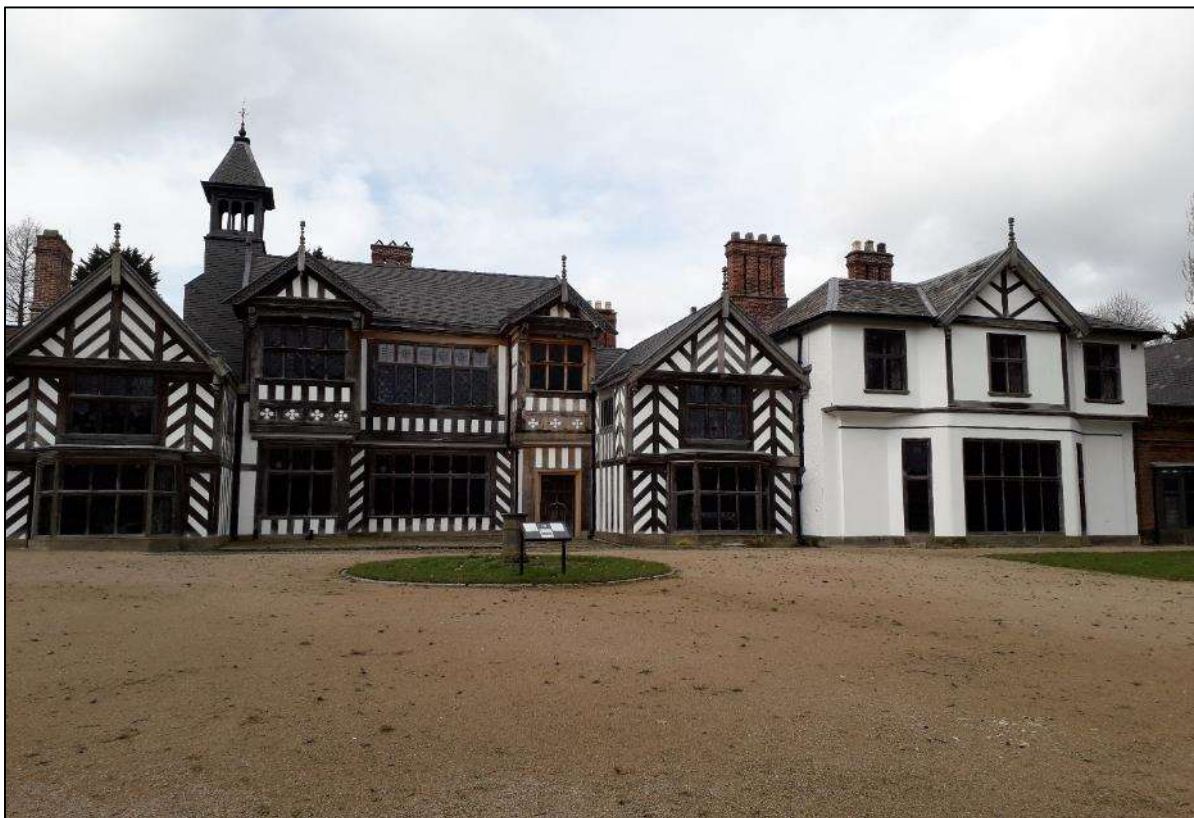
Figure 16 Wythenshawe Hall, March 2021

Wythenshawe Hall is a 2/3 storey hall dating from the early sixteenth century with additions being made at various stages. The Hall is of timber frame and brick construction and is surmounted with pitched and hipped slate roofs. The rear elevations are of brick construction with brick parapets and internal gutters to flat or pitched roofs. A plaque on the centre of the rear elevation indicates the Hall to have been restored in 1953. Wythenshawe Hall was a family home for nearly four hundred years. The original Hall was built around 1540 by Robert Tatton, possibly on the site of an earlier medieval building. It was further developed over the following centuries by fourteen generations of the Tatton family until 1926, when the estate was sold to provide new housing for the people of Manchester. The Hall and parkland became an art gallery and public park and have been open to the public ever since.

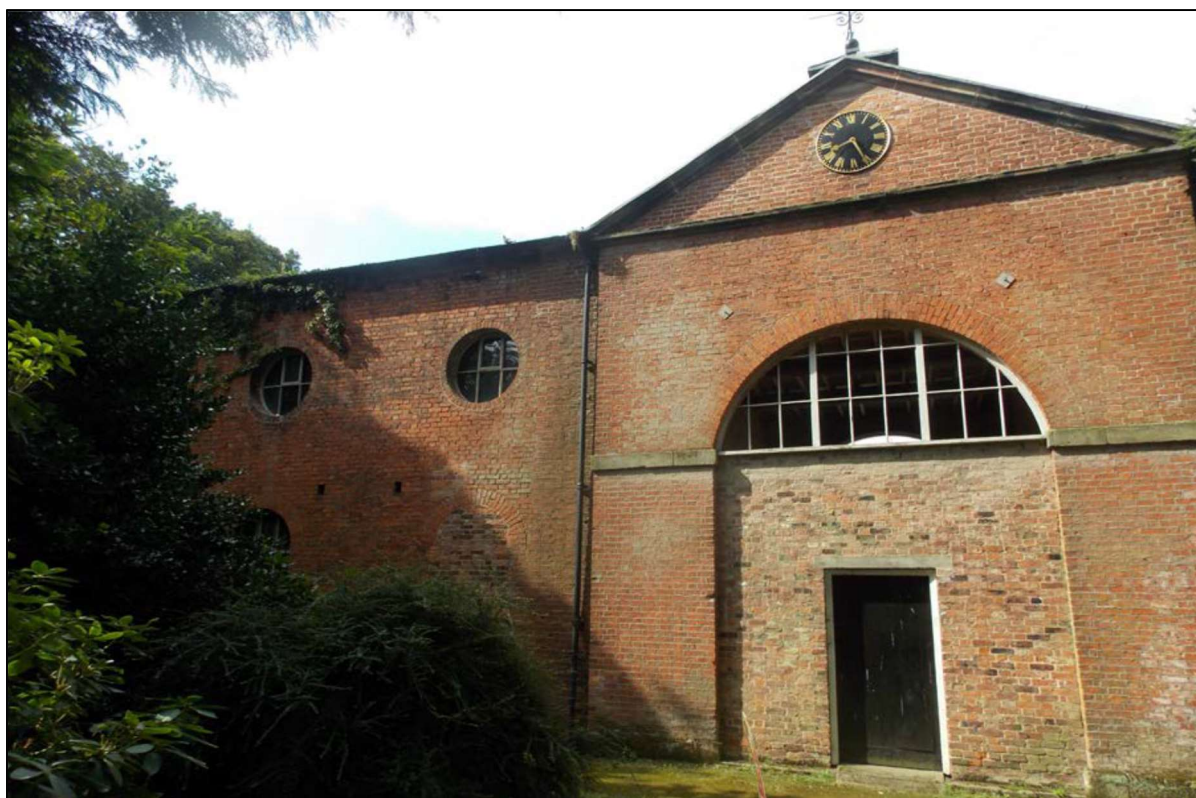
Figure 17 Former Stable Block, 2016.

There is no clear date for the construction of the stables, but some were already in existence on the estate during the time of William Tatton (1774-99), at which time the staff included two coachmen, two racing servants, and a rider. Inventories between 1785 and 1792 also show that there were stables with sleeping accommodation for five above. It is possible that in 1841, the upper storey of the stables was still being used in this manner as the census records show that two people were listed as living in the stables.

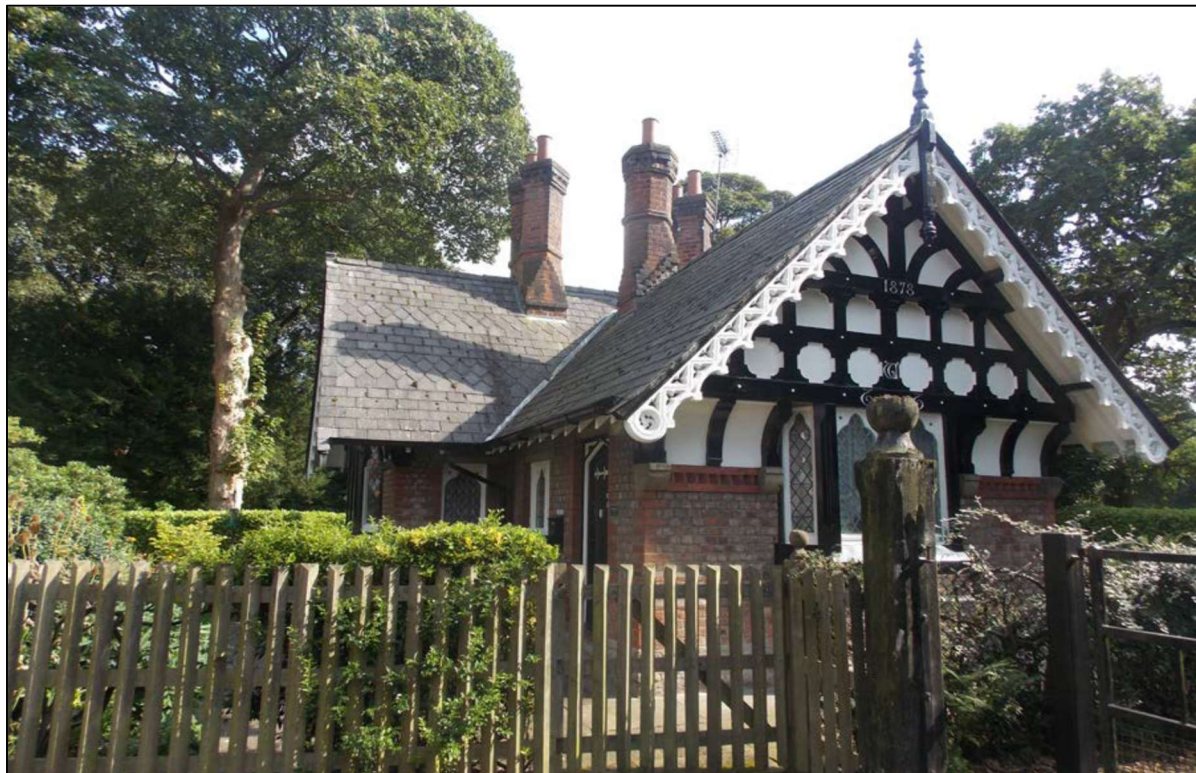
Figure 19 North Lodge, 2016

The Tudor-style North Lodge is a Grade II listed building situated on Wythenshawe Road, built in 1878 for Thomas William Tatton, likely alongside the construction of a corresponding South Lodge, now lost. It is possible that the architect was James Redford, the architect of the Tenants Hall

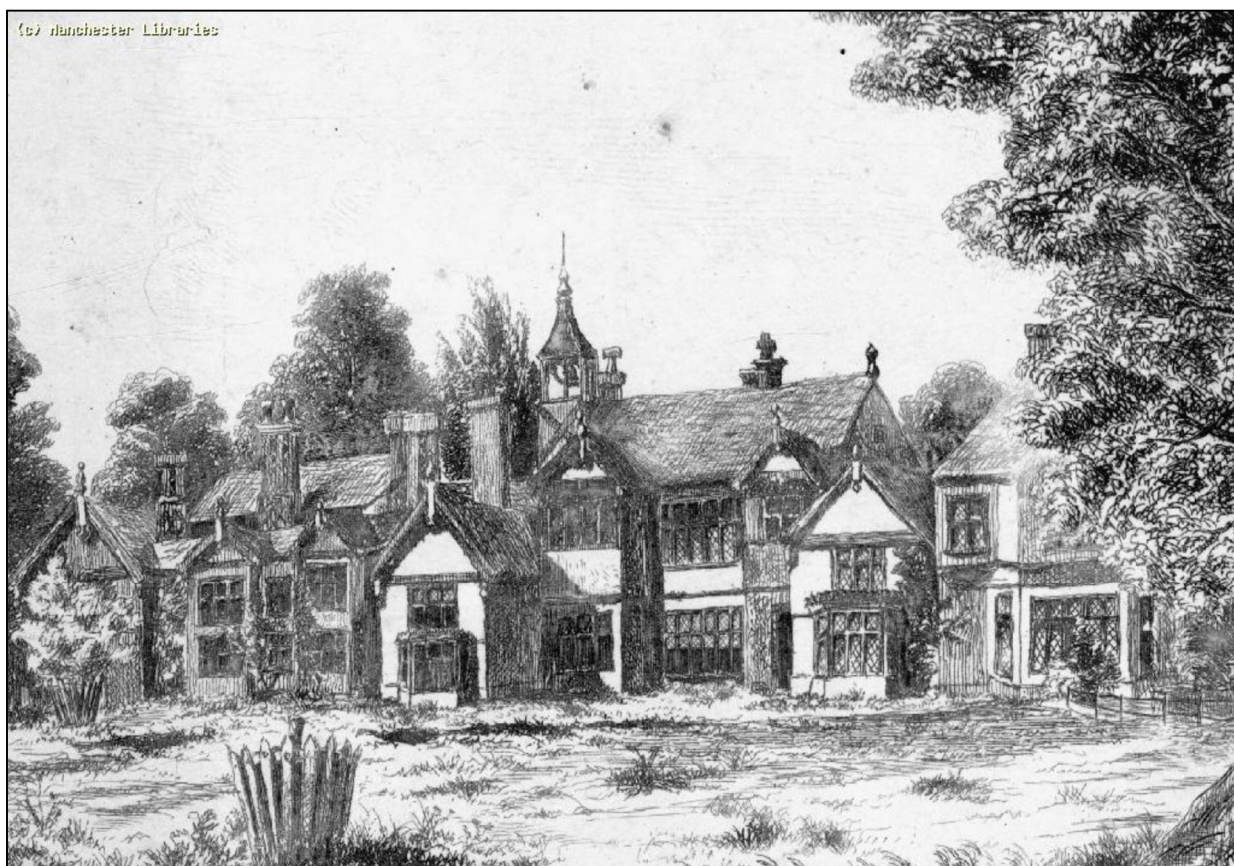
Figure 20 Wythenshawe Hall (c1740) © Manchester Libraries

The early 16th century hall, is the timber framed core consisting of a two-storey block containing the great hall, now known as the Dining Room, and the room above this known as the Withdrawing Room, with lower two-storey cross-wings projecting well forward at either end of this block. In each of the two angles between the core block and the cross-wings is a shallower bay, which mark the upper and lower ends of the great hall; that on the north contains the entrance porch, while that on the south lit the high table.

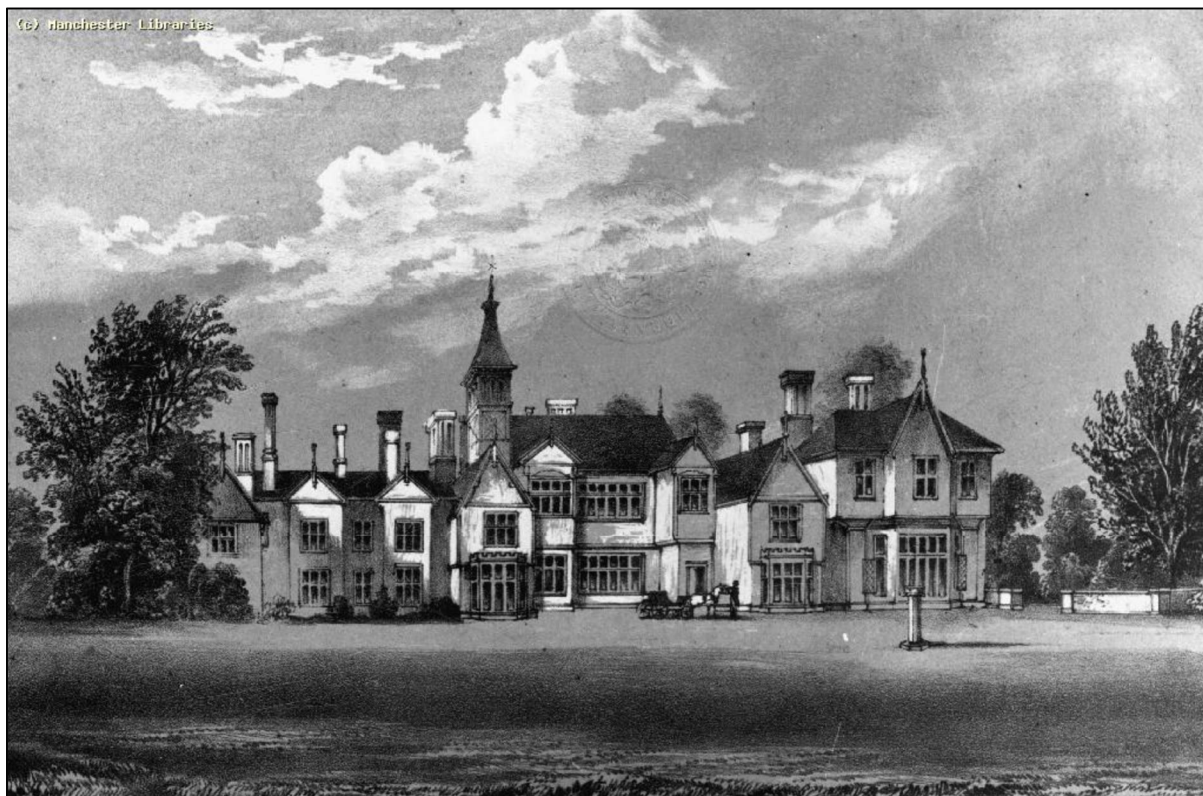
Figure 21 Unknown, Wythenshawe Hall c1850 © Manchester Libraries

The following centuries were quieter and much more prosperous. As the Tatton family acquired more land, the Hall expanded to become a much grander home. The next phase of development was during the occupancy of William Tatton who carried out some improvements to the Hall during his marriage to Hester Egerton. Before the end of the 18<sup>th</sup> century a new wing was added at the north end of the Hall including a library and the rooms in the south wing, at the high end of the great hall, now became service rooms. Extensions were also added at this southern end in brick. In the same period the west side of the Hall was refronted in brick, and the timber-framed core was stuccoed to help give the building a unified appearance.

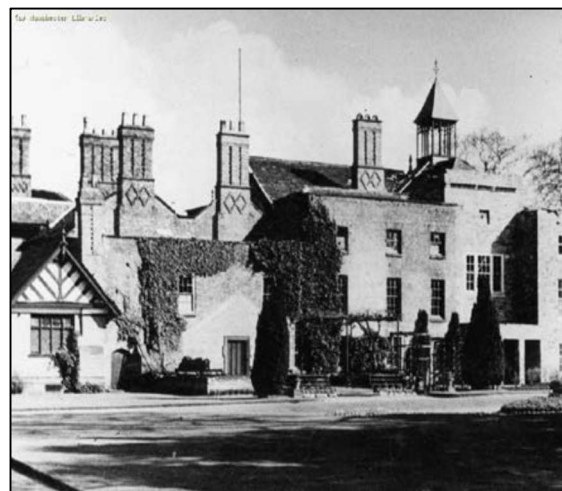
Figure 27 T Baddley, west of Wythenshawe Hall  
showing scarring (1952) © Manchester Libraries

By the 1920s the Tatton estate comprised some 2,500 acres of farmland worked by tenant farmers, many of whose families still live locally. In the 1940s and 1950s Manchester City Council carried out an extensive programme of repair and alteration at the Hall. On the east front the stucco was removed and replaced with cement rendering with timber imitating the original framing in order to project a pastiche retrospective vision of Tudor architecture. These are modern interventions and should not be considered original. The Georgian brick elevation on the west of the Hall was partly rebuilt but the south-east wing, identified as a 'store,' was demolished due to dry rot and woodworm. The conservatory built against the west elevation was also removed at this period. A further programme of repair was carried out in 1978-83, during which the bell tower was rebuilt.

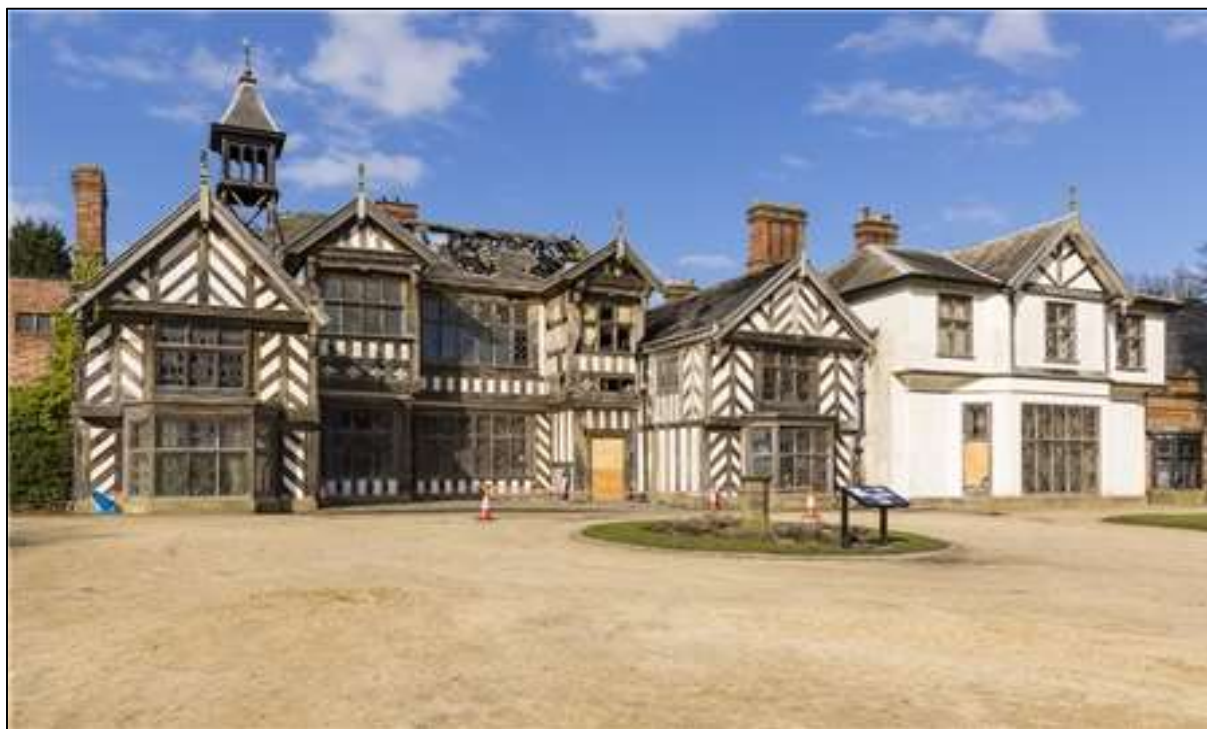
Figure 29 Wythenshawe Hall March 2016, after the fire.

Wythenshawe Hall suffered a devastating fire in March 2016 and the core of the building suffered considerable damage. A multi-million pound restoration was carried out including external and internal fabric repairs and roofing works. Reinstatement of historic details, finishes and materials were carried out to repair the fire damaged core and return it to its pre-fire condition.

The fire damage to the hall created an opportunity for materials analysis within the building for such items as paints, mortars, glass etc. which has created a more in depth understanding of the building's construction and design. The health and safety file which was produced for the fire damage reinstatement works has been used to inform these proposed works. Plastered surfaces will be repaired using lime plasters, which were specified for the fire damage reinstatement works. Breathable paints will be utilised to assist in the long-term drying of the masonry core of the structure.
