HYDE ROAD SECONDARY SCHOOL

EXISTING  
PRE-DEVELOPMENT  
DRAINED AREAS

HRS-BDP-ZZ-00-DR-C-50\_10-0001

# PHASE I GEO-ENVIRONMENTAL DESK STUDY

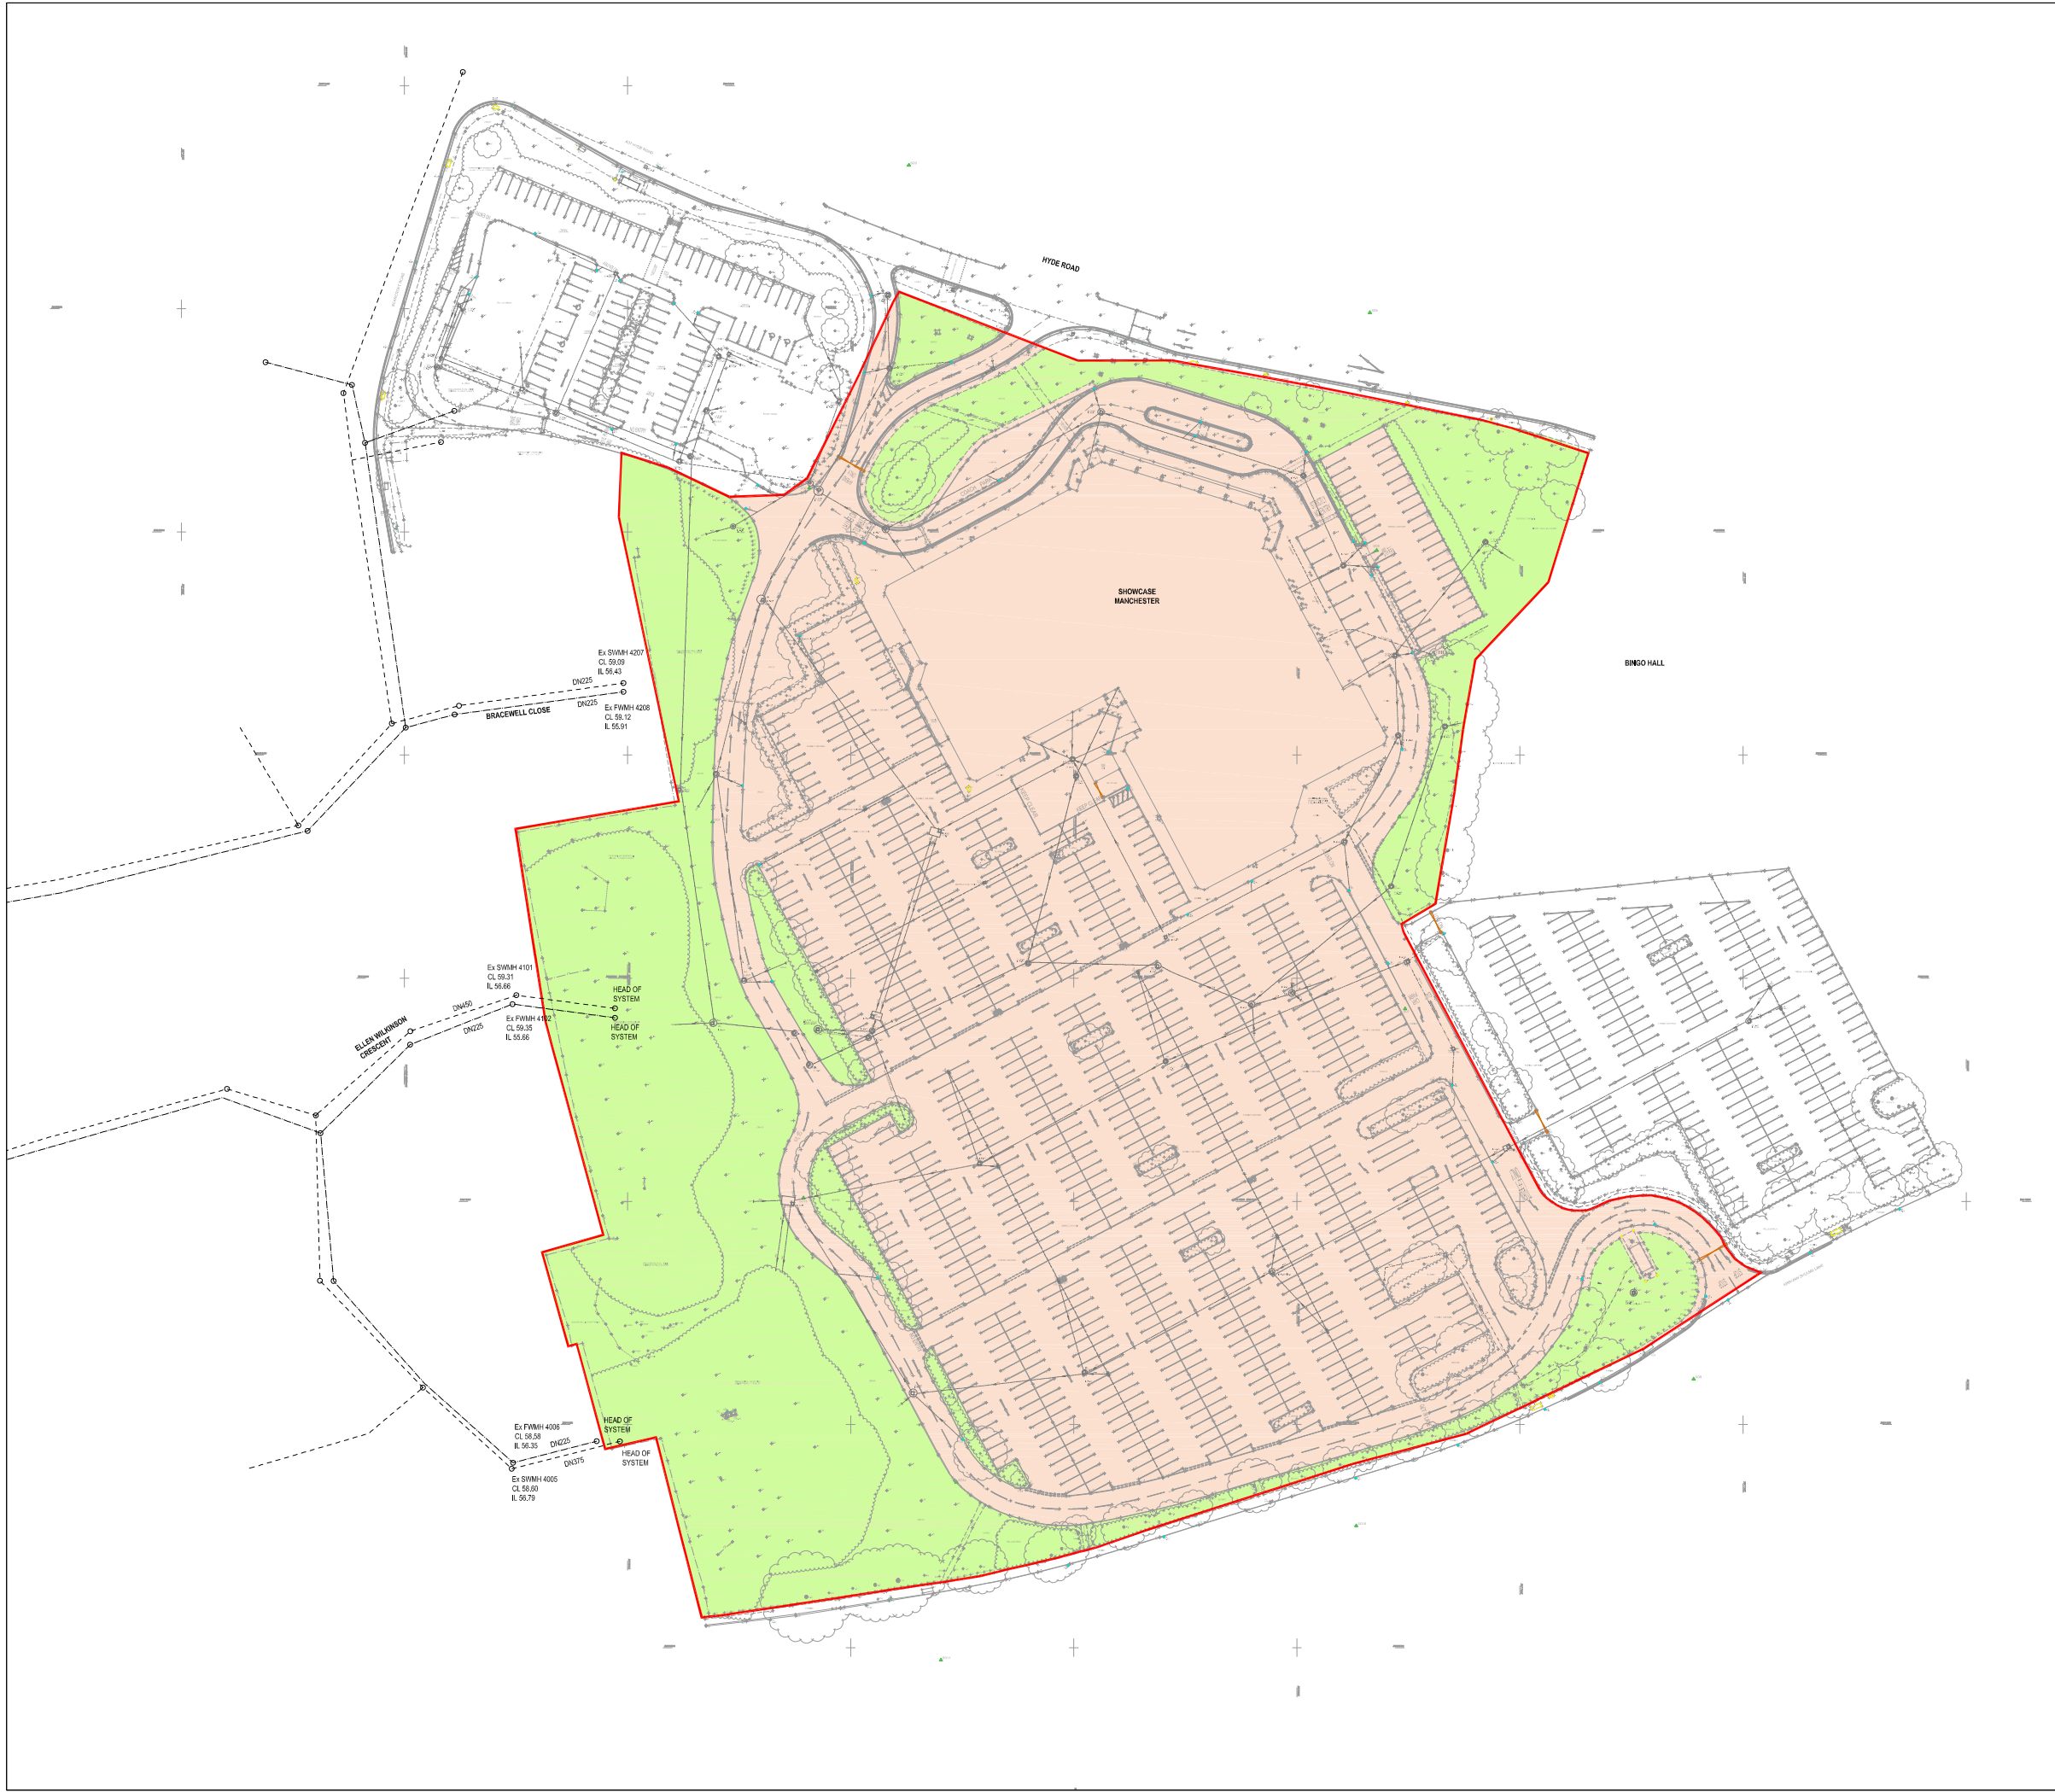
PRE-DEVELOPMENT SOFT LANDSCAPING (1.67ha)

PRE-DEVELOPMENT HARD-STANDING (3.63ha)

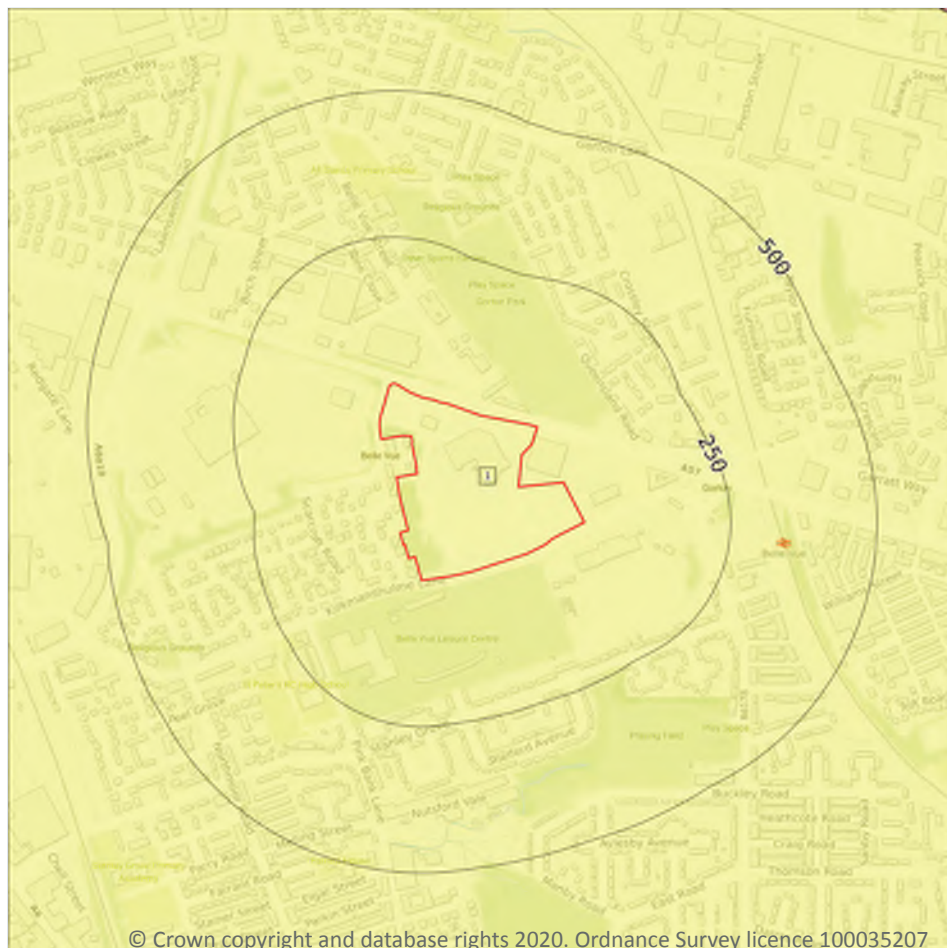
## 5 Hydrogeology - Superficial aquifer

- Site Outline
- Search buffers in metres (m)
- Principal
  - Secondary A
  - Secondary B
  - Secondary Undifferentiated
  - Unproductive
  - Unknown

The Groundsure report indicates that the Superficial geology is classified as a Secondary Undifferentiated Aquifer. Generally, these layers have been previously designated as minor and non-aquifers due to variable characteristics of the rock type.

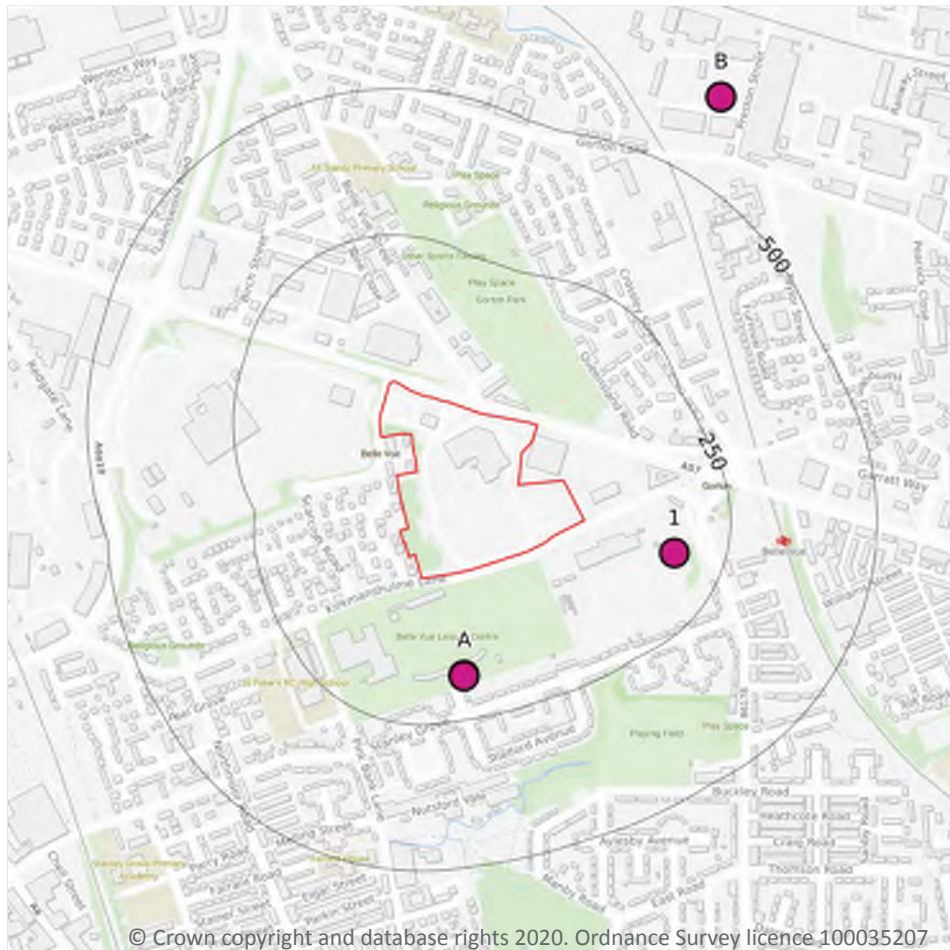
## Abstractions and Source Protection Zones

- Site Outline
- Search buffers in metres (m)**
- Source Protection Zone 1  
Inner catchment
- Source Protection Zone 2  
Outer catchment
- Source Protection Zone 3  
Total catchment
- Source Protection Zone 4  
Zone of Special Interest
- Source Protection Zone 1c  
Inner catchment - confined aquifer
- Source Protection Zone 2c  
Outer catchment - confined aquifer
- Source Protection Zone 3c  
Total catchment - confined aquifer
- Drinking water abstraction licences  
Point features
- Drinking water abstraction licences  
Polygon features
- Drinking water abstraction licences  
Linear features
- Groundwater abstraction licence (point)
- Groundwater abstraction licence (area)
- Groundwater abstraction licence (linear)
- Surface Water Abstractions (point)
- Surface Water Abstractions (area)
- Surface Water Abstractions (linear)

The Groundsure report found no current records relating to licensed groundwater abstractions within 1km of the site. There are six records of historical groundwater abstractions, the nearest located 163m east for groundwater from the Permo-Triassic sandstone for dust suppression at Belle Vue.

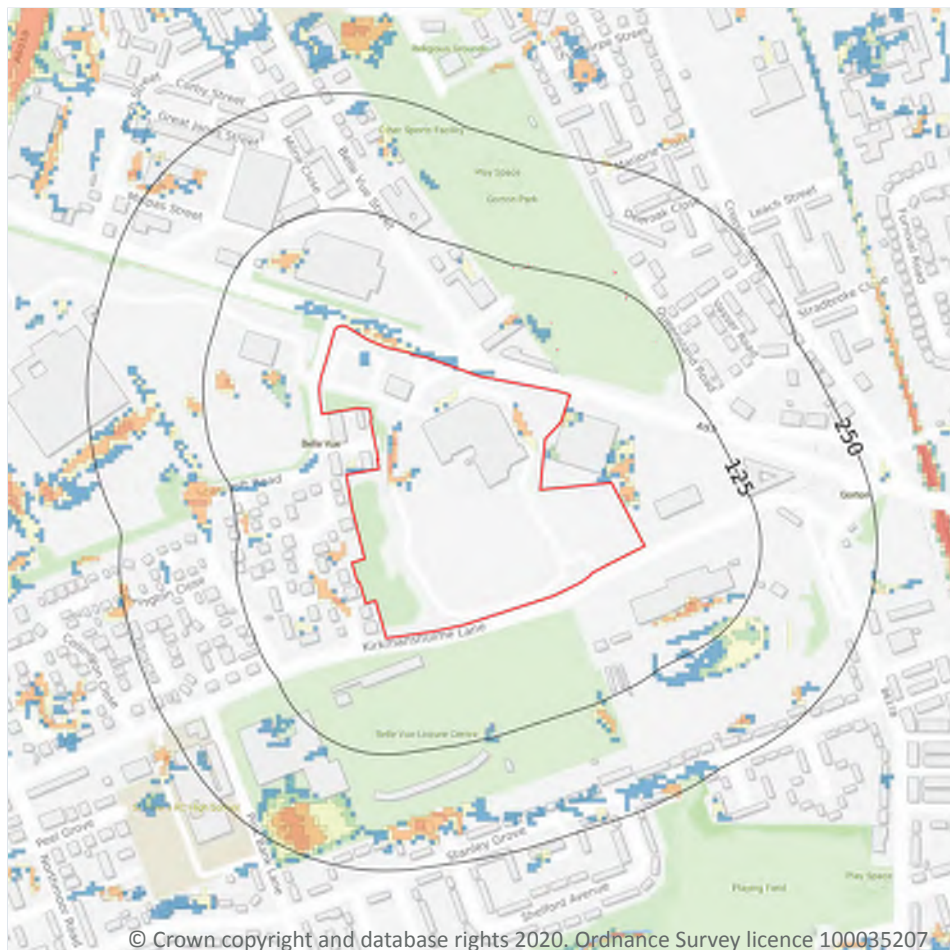
## 8 Surface water flooding

— Site Outline

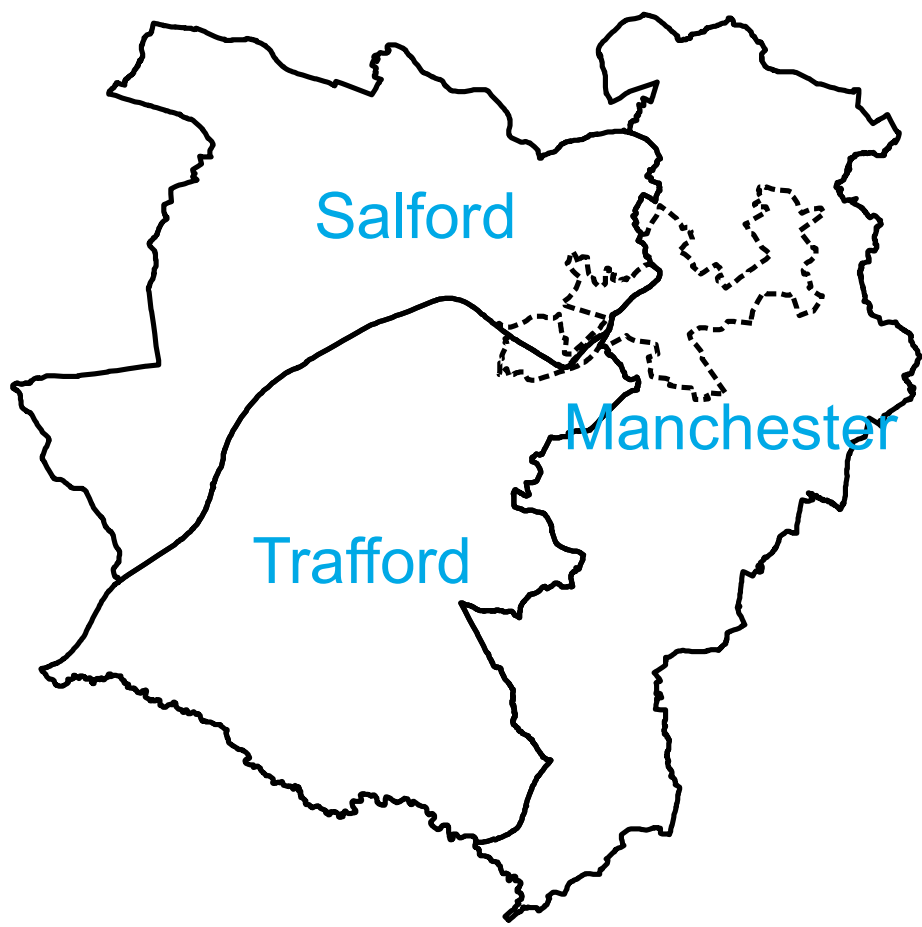
### **Manchester City Council Flood Maps**

- Council Boundary
- Lost Watercourses
- Number Of Properties At Risk**
  - 1 - 5
  - 5 - 20
  - 20 - 50
  - 50 - 100
  - 100 - 154
- Potential Development Sites / Locations**
  - Employment
  - Housing
  - Mixed Use
  - Other
  - Regional Centre Boundary
- Main Rivers (V8.0)**
  - Ashton, Bridgewater and Rochdale Canals
  - Manchester Ship Canal / Grey Inwell
  - Other Waterbodies
- Digitised River Lines**
  - Culverted
  - Open
