Ref: 12-123-L5  
Date: 17<sup>th</sup> December 2020

Kevin Ryan  
**Countryside Properties**  
301 Bridgewater Place  
Birchwood Park  
Birchwood  
Warrington  
WA3 6XG

## **SUPPLEMENTARY GEOENVIRONMENTAL SITE INVESTIGATION BELLE VUE**

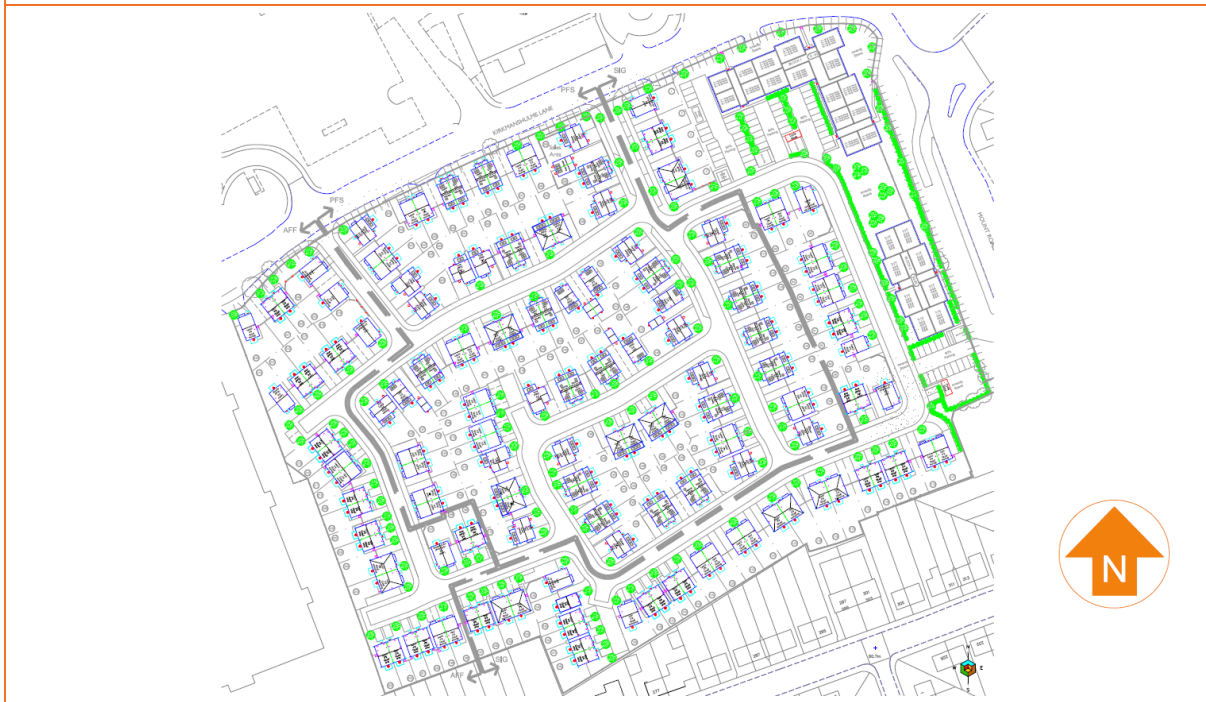
FIGURE 1.1      SNAPSHOT OF PROPOSED DEVELOPMENT

E3P has been provided with a draft planning layout and a snapshot of the proposed development is provided in Figure 1.1 with the full drawing attached to the rear of this letter.

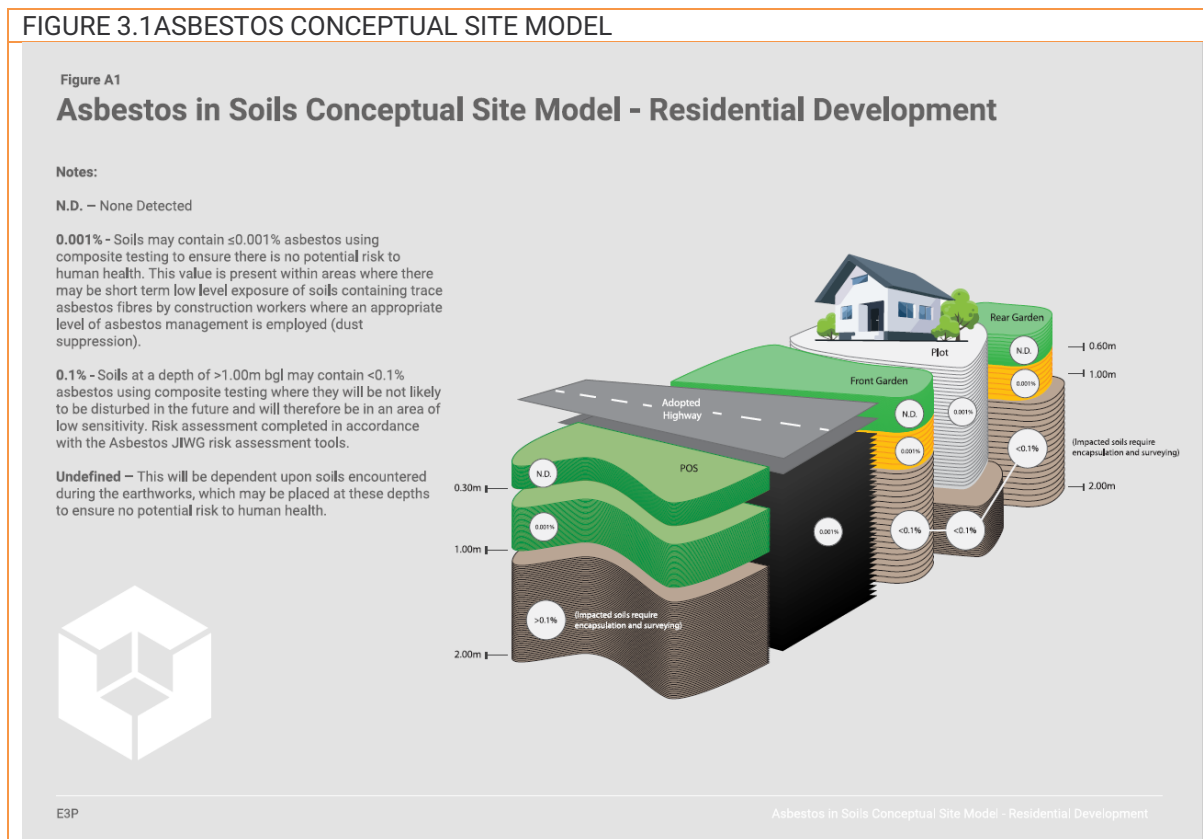
FIGURE 3.1 ASBESTOS CONCEPTUAL SITE MODEL

The assessment has identified several chemical exceedances within soil samples submitted for chemical analysis from within the trial pits. These include heavy metals, asbestos, polycyclic aromatic hydrocarbons (PAHs) and total petroleum hydrocarbons (TPHs). This is in line with the 2019 Phase 2 Ground Investigation which identified several exceedances of these compounds across the site.

The laboratory analysis confirms the assessment within the initial conceptual site model that the main constituents of concern were likely to be asbestos, petroleum-based contamination and heavy metals within Made Ground Deposits. Chemical analysis from the natural deposits across the site have confirmed the absence of any contamination.

All of the identified elevated concentrations have primary exposure pathways related to dermal contact and ingestion of soils, inhalation of vapours and consumption of home-grown vegetables. The chronic risk to human health associated with the elevated concentrations on inorganic heavy metals and non-volatile PAH compounds can be mitigated through the installation of a suitable cover system in all proposed private gardens, landscaping and public open space to remove any potential for direct exposure to impacted soils.

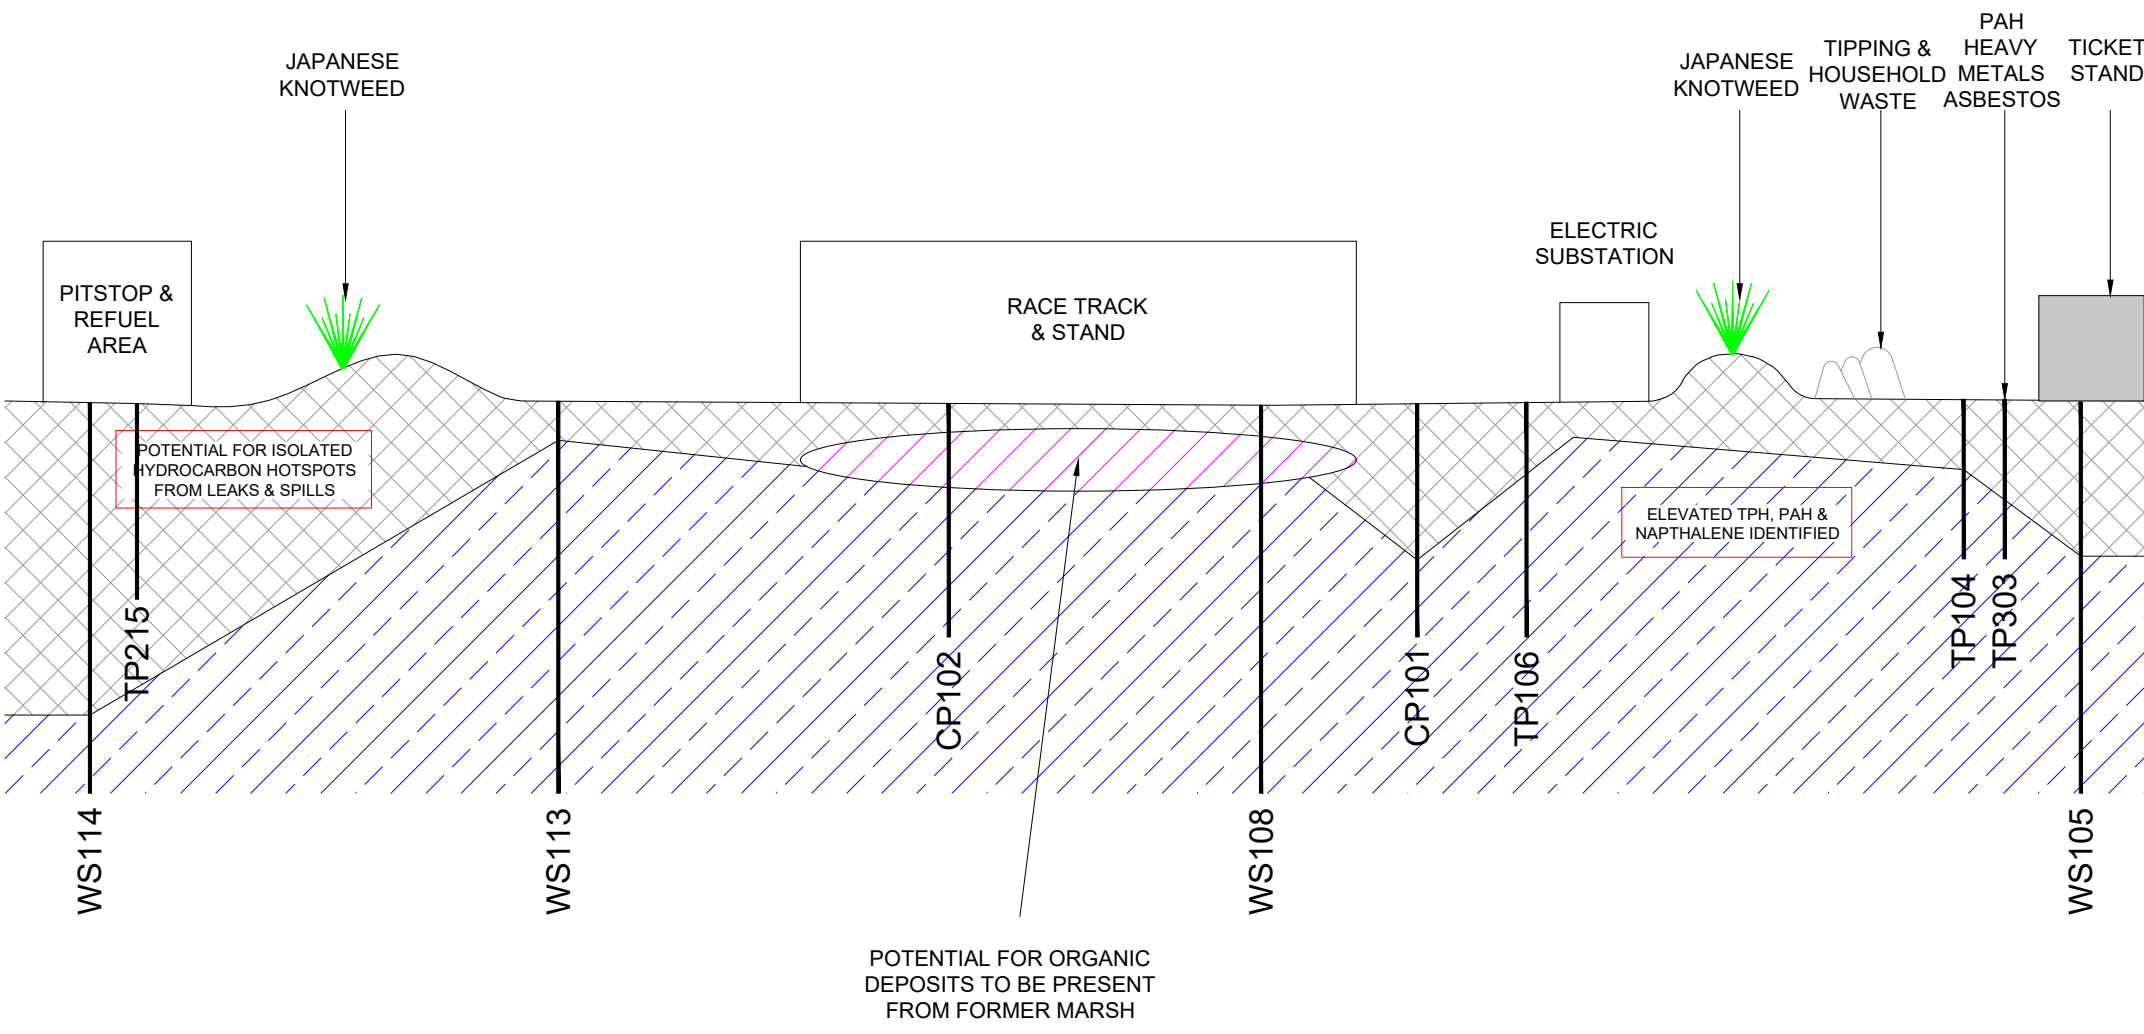
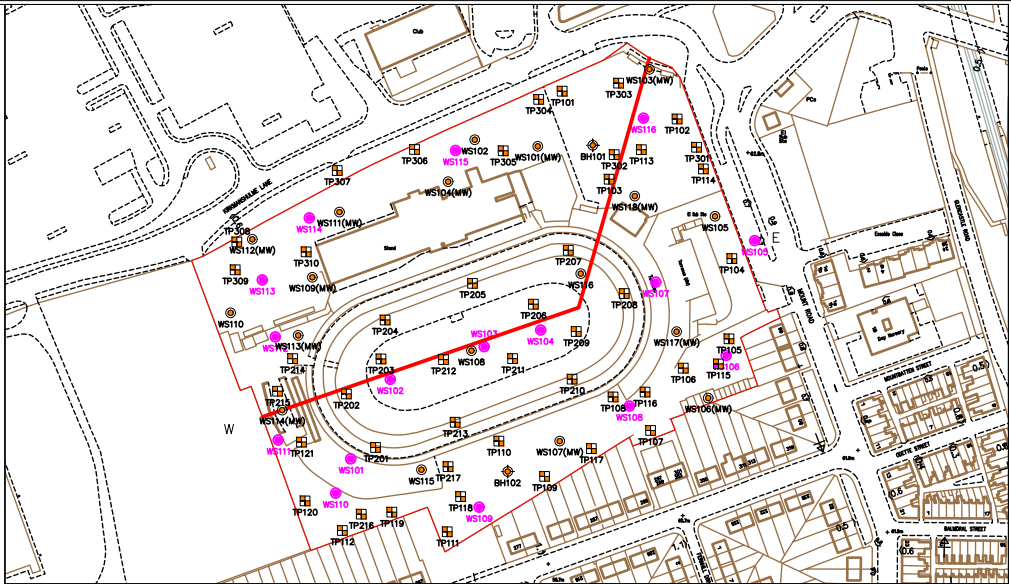
| | | | <div>Job Title:</div> <div>Belle Vue Stadium</div> | | | <div>Drawing Title:</div> <div>Conceptual Site Model</div> | <div>The client must not amend any drawing, design or other intellectual property produced by E3P Ltd without permission in writing from E3P Ltd in advance of any amendments being made. In the event that such written permission is not obtained in advance of the amendments being made, E3P Ltd shall not be liable for any damage and/or losses occurring as a result of the amended drawing, design or intellectual property.</div> |

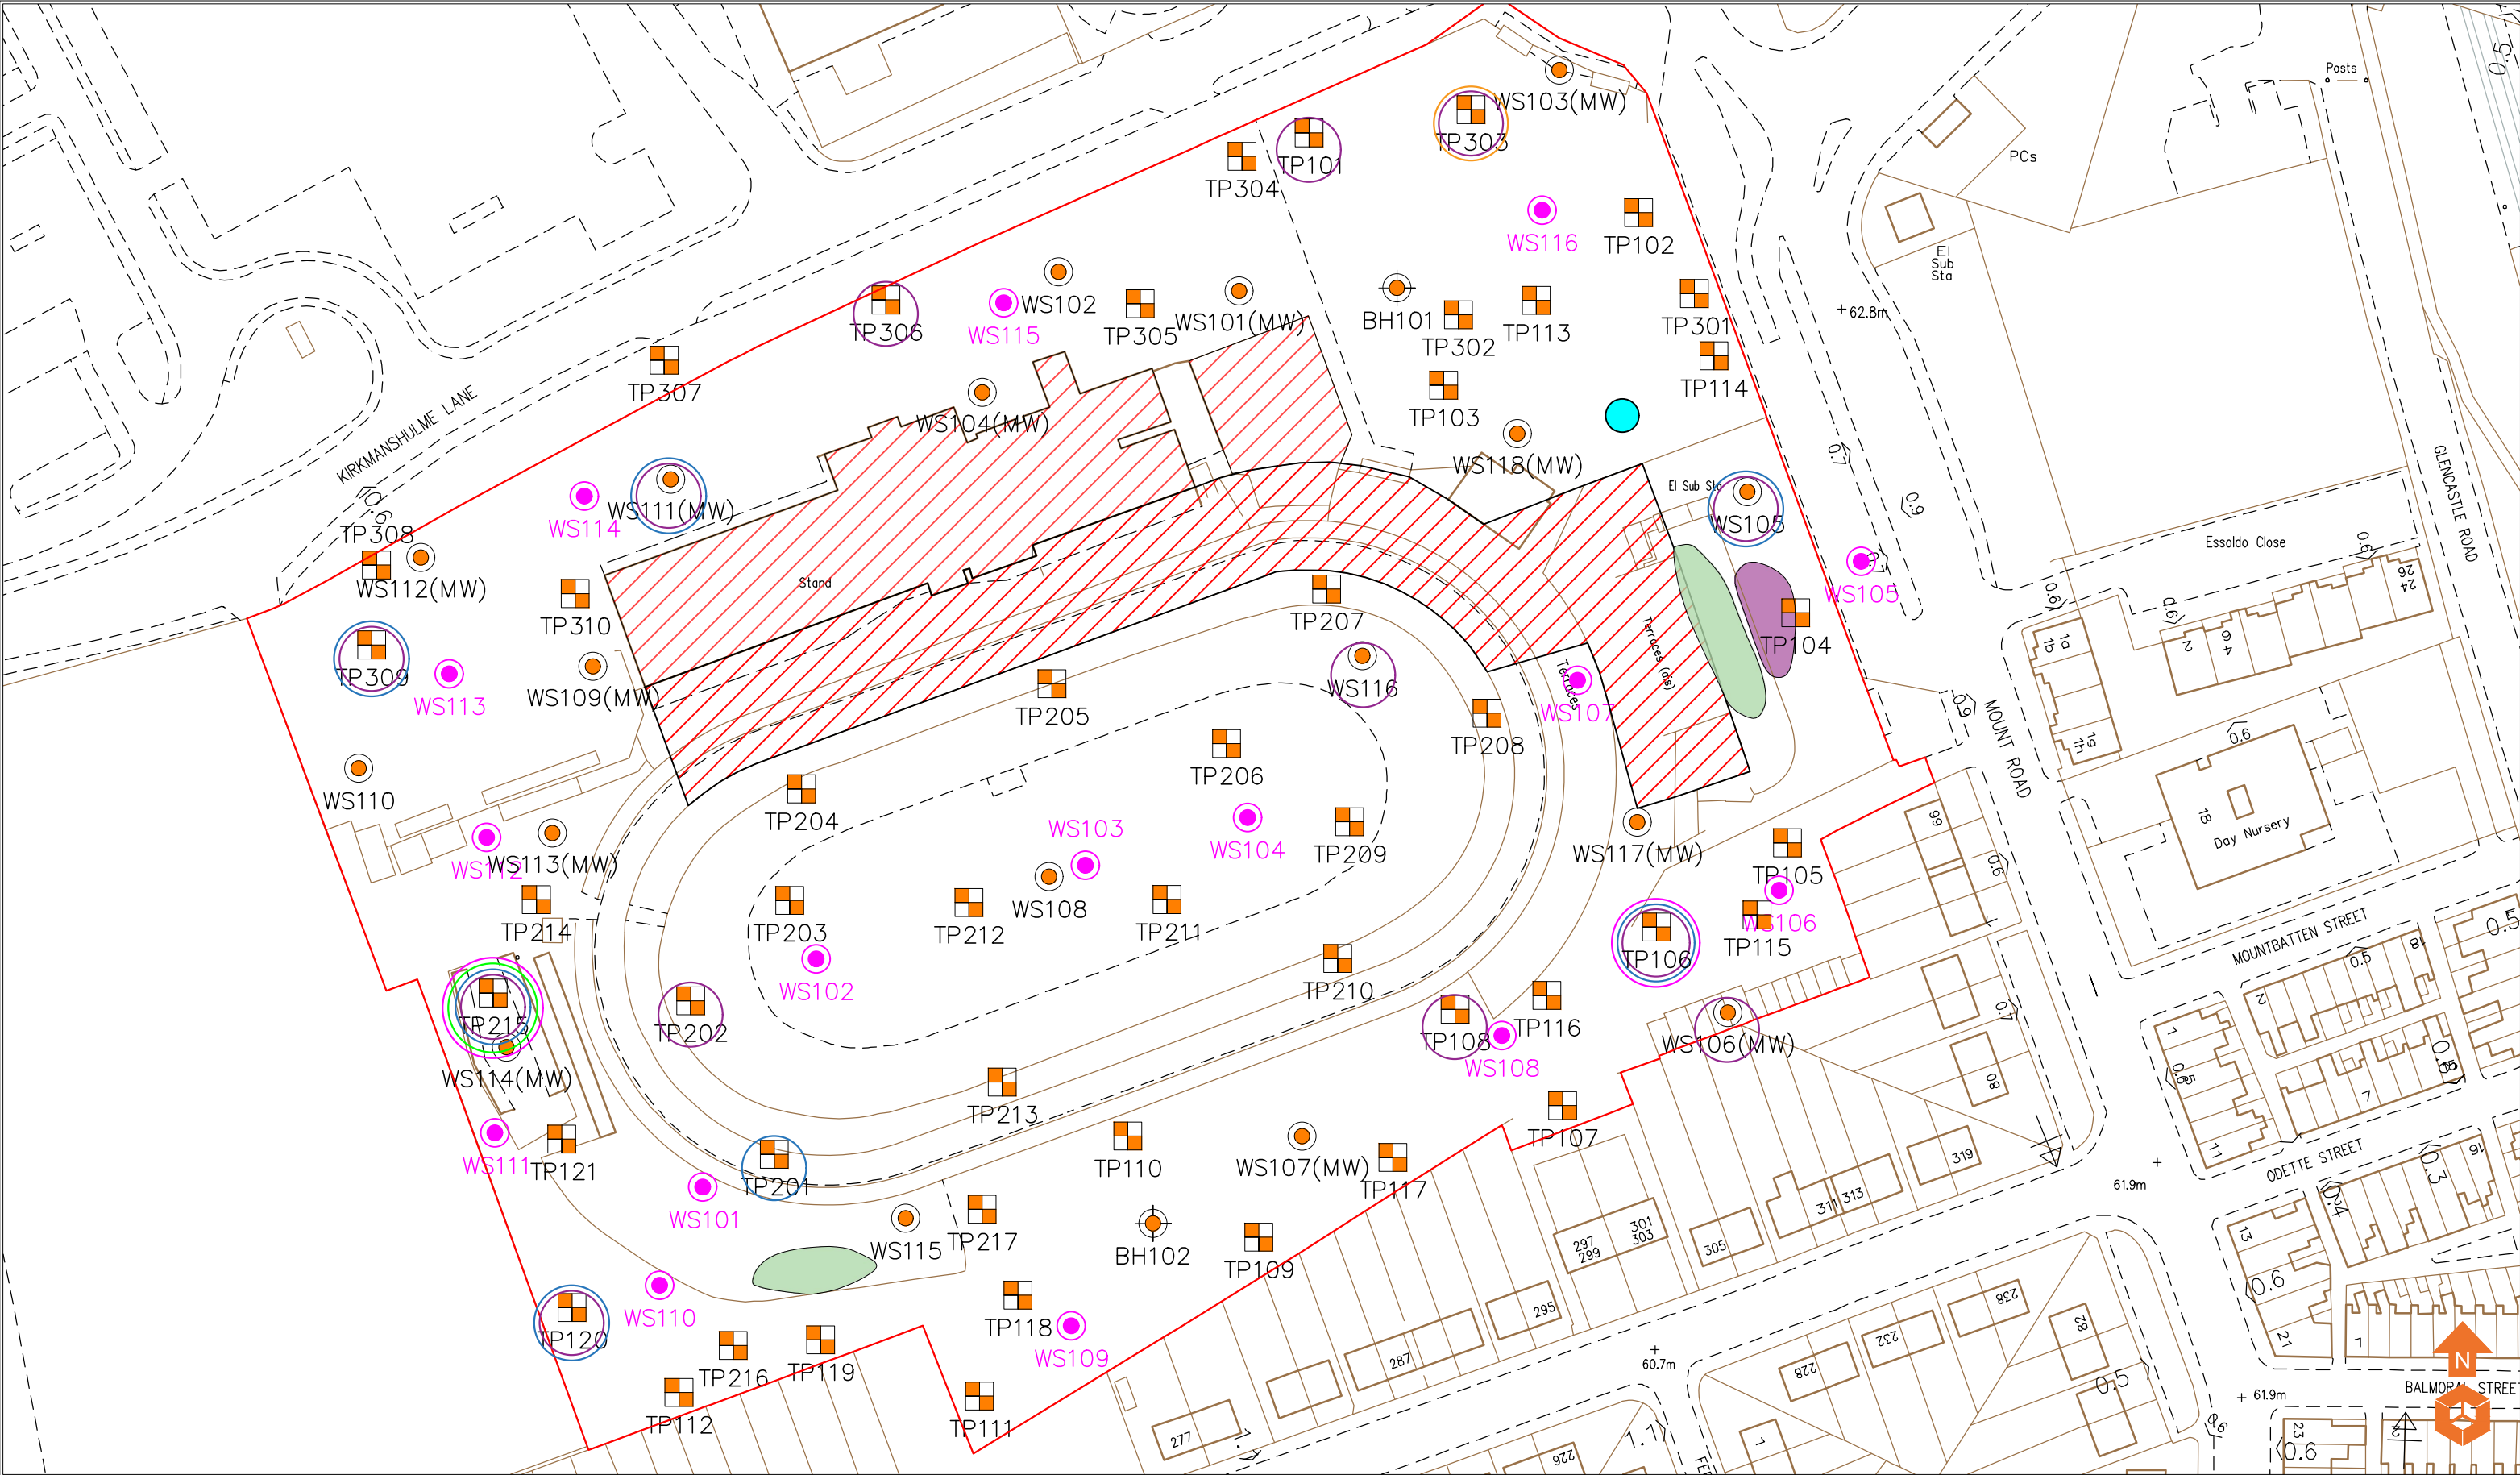
| <b>Location Symbols</b> <div><div><div><div></div></div><div>Approximate Window Sample Probehole Location</div></div><div><div><div></div></div><div>Approximate Window Sample Probehole Location with Install</div></div><div><div><div></div></div><div>Approximate Trial Pit Location</div></div><div><div><div></div></div><div>Approximate Cable Percussive Borehole Location</div></div><div><div><div></div></div><div>Approximate DB Window Sample Probehole Location</div></div></div> <div><b>Exceedances</b><div><div><div></div></div><div>Elevated Heavy Metals and non volatile PAHs identified</div></div><div><div><div></div></div><div>Elevated Mercury Identified</div></div><div><div><div></div></div><div>Asbestos Identified</div></div><div><div><div></div></div><div>TPH C16-C35</div></div><div><div><div></div></div><div>Elevated Volatile organic compounds and TPH C5-C16 Identified</div></div><div><div><div></div></div><div>Area Not Investigated</div></div><div><div><div></div></div><div>Area of Japanese Knotweed</div></div><div><div><div></div></div><div>Area of Fly Tipping</div></div><div><div><div></div></div><div>Abstraction Boreholes</div></div></div> | <b>Notes:</b> <div><div><div>P1</div><div>REV B</div><div>06.01.2021</div><div>LM</div><div>SE</div></div><div><div>P1</div><div>REVA</div><div>04.01.2021</div><div>HM</div><div>SE</div></div><div><div>Phase</div><div>Issue</div><div>Date</div><div>Drawn</div><div>Checked</div></div></div> | <b>Client:</b> <div>Countryside Properties</div> <div><b>Job Title:</b><div>Belle Vue Stadium</div></div> | <div><b>Job No:</b><div>12-123</div></div> <div><b>Drawing No:</b><div>010</div></div> | <div><b>Date:</b><div>06.01.2021</div></div> <div><b>Scale:</b><div>NTS</div></div> | <div><div><div><div></div></div><div>e3p</div></div><div>Environmental Engineering Partnership Ltd<br/>Taylor Road, Trafford Park<br/>Urmston, Manchester, M41 7JQ<br/>Tel: 0161 707 9612<br/>E-mail: info@e3p.co.uk<br/>Website: www.e3p.co.uk</div></div> <div>The client must not amend any drawing, design or other intellectual property produced by E3P Ltd without permission in writing from E3P Ltd in advance of any amendments being made. In the event that such written permission is not obtained in advance of the amendments being made, E3P Ltd shall not be liable for any damage and/or losses occurring as a result of the amended drawing, design or intellectual property.</div> |
