## Historic Building Investigation

Swan House,  
Rochdale Road,  
Manchester

**Report No:**  
SA/2021/11

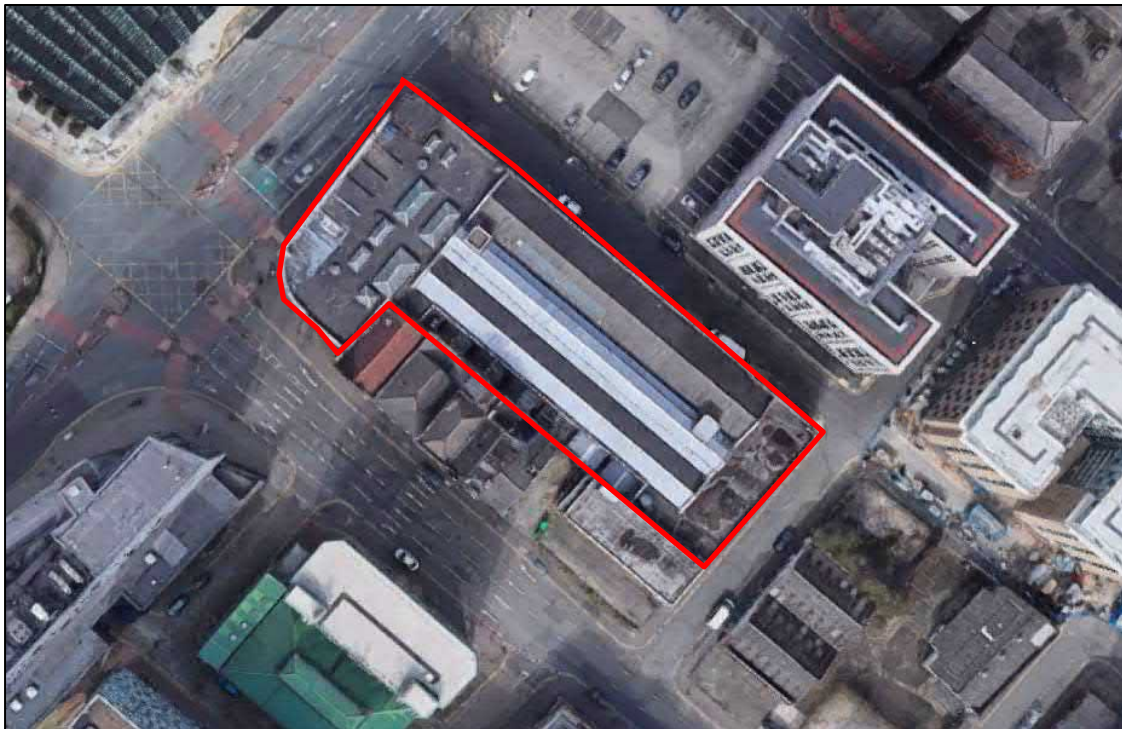
Swan House is located in Manchester City Centre, and is bounded by Swan Street to the south, Mason Street to the east, Rochdale Road to the west, and Cable Street to the north (centred at NGR 384510 398850). The site was comprised two early to mid-twentieth century buildings and a single, mid-century addition, currently split into multiple commercial premises (Plate 1).

*Plate 1: Recent aerial view of Swan House*

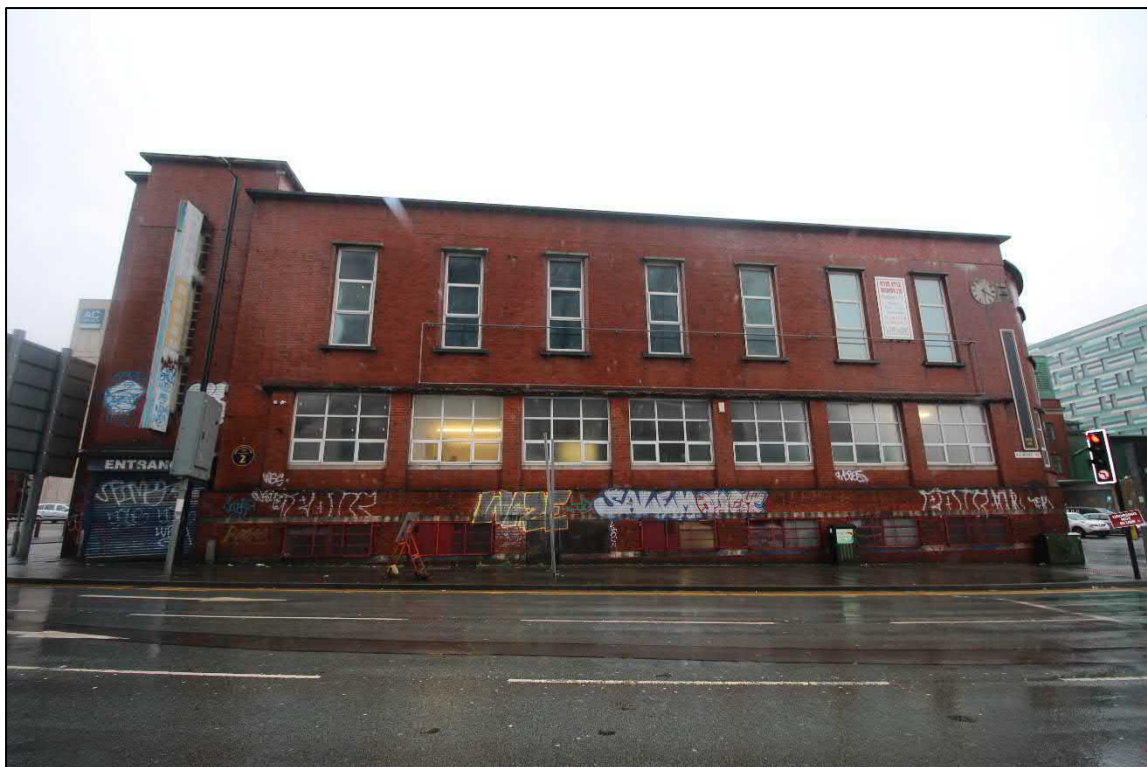
Plate 10: General view of the north-western elevation

**The north-western elevation:** this elevation, which fronted onto Rochdale Road, is built in a Monk bond and was the north-western elevation of the mid-20<sup>th</sup> century office block (Plate 10). The ground-floor comprises seven window apertures with a door at the north-eastern end and set within the stair tower. The window apertures comprised a single continuous protruding concrete lintel and flush concrete sills that were recessed between brick square reveals. The openings housed a nine-light uPVC casement window with clear glazing (Plate 10). The first-floor apertures consisted of protruding chamfered concrete sills and lintels and housed a vertical uPVC three-light casement window (Plate 10). The basement was lit by seven window apertures within this elevation. Each consisted of painted flush concrete sills and lintels and housed a small six-light steel framed window glazed in obscure glass panes (Plate 11).

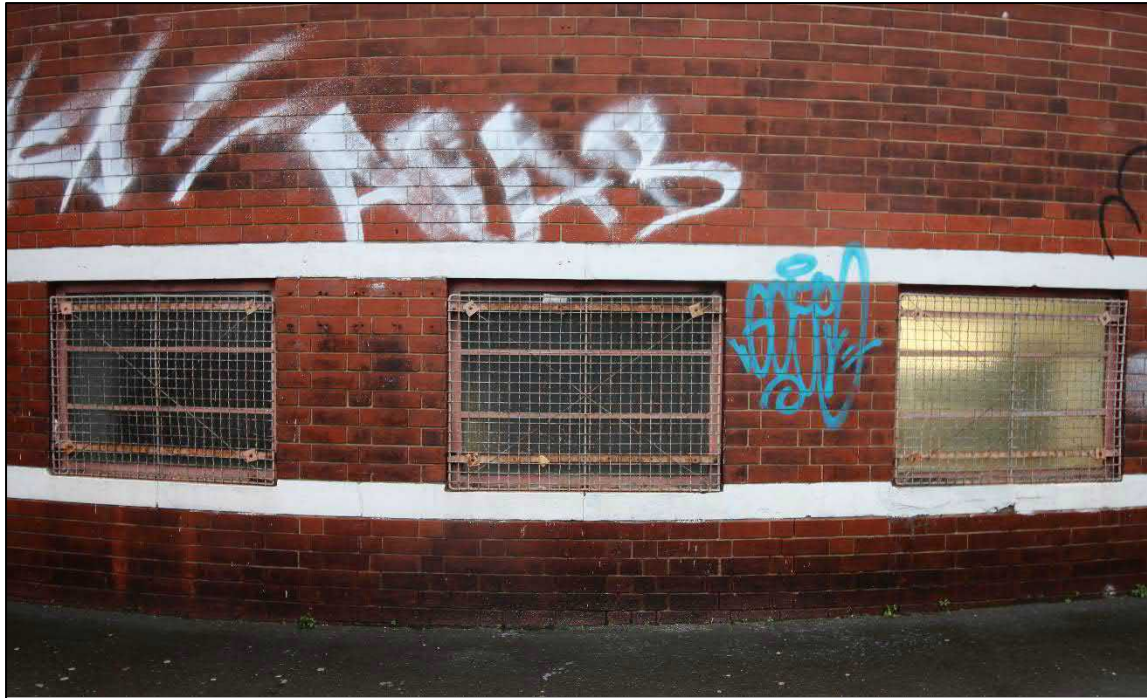
*Plate 11: Detail of the basement windows on the north-eastern elevation*

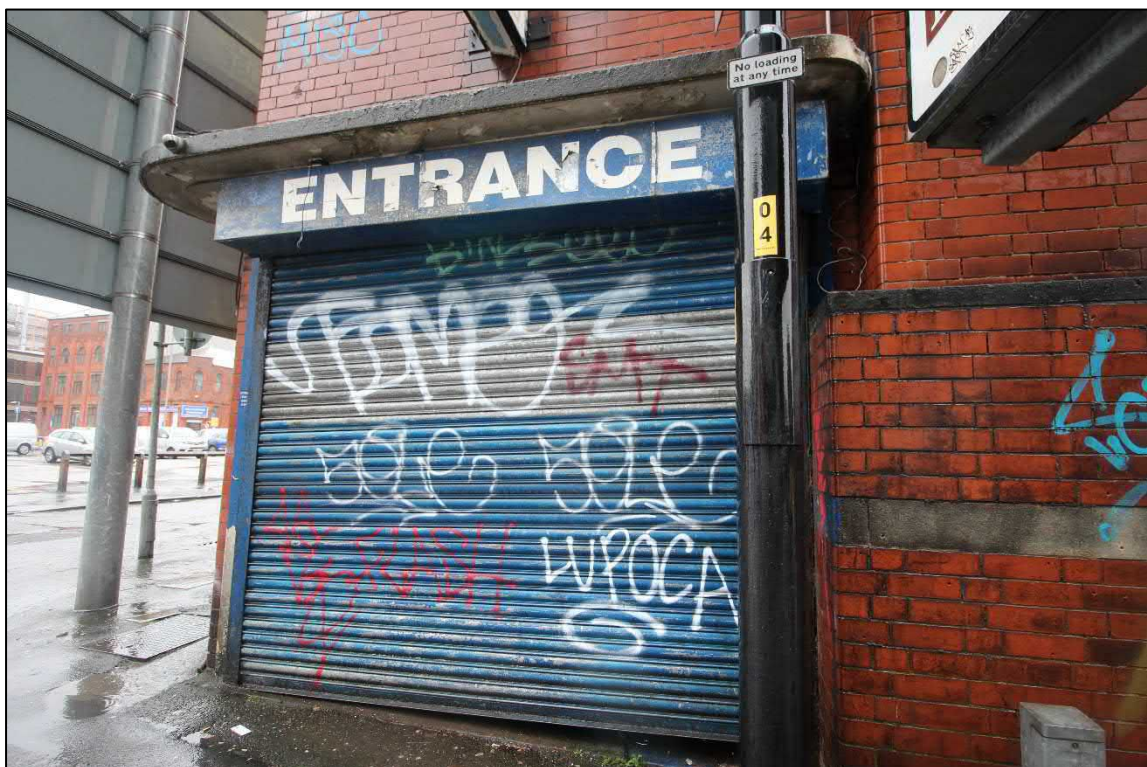
The single doorway at the north-eastern end had a protruding lintel overhanging an entrance sign; the motor and gearing for a modern roller shutter door was attached to the underside of the lintel (Plate 12). Behind this shutter was the original doorway which consisted of a timber doorframe housing two flush timber doors with side lights and a three-light fixed transom window. The doors had a blocked glass panel above the lock rail (Plate 13).

*Plate 12: The roller shutter door at the north-eastern end of the elevation*

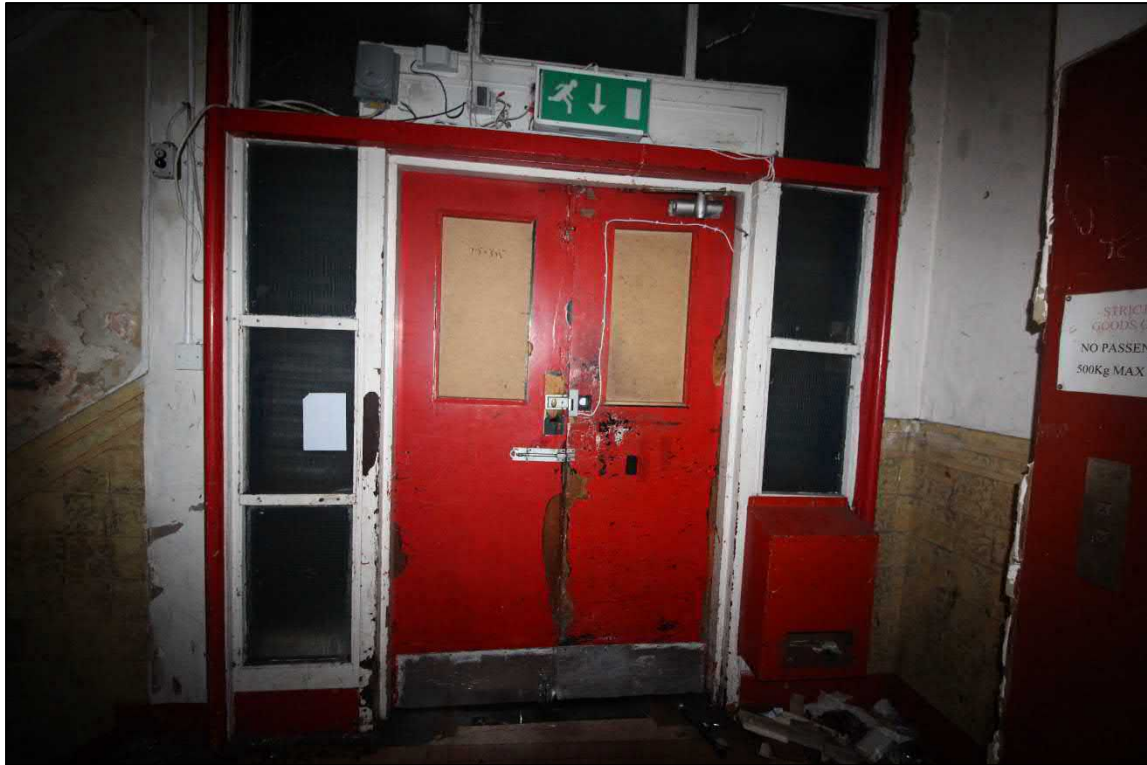
*Plate 13: Detail of the timber doors behind the roller shutter*

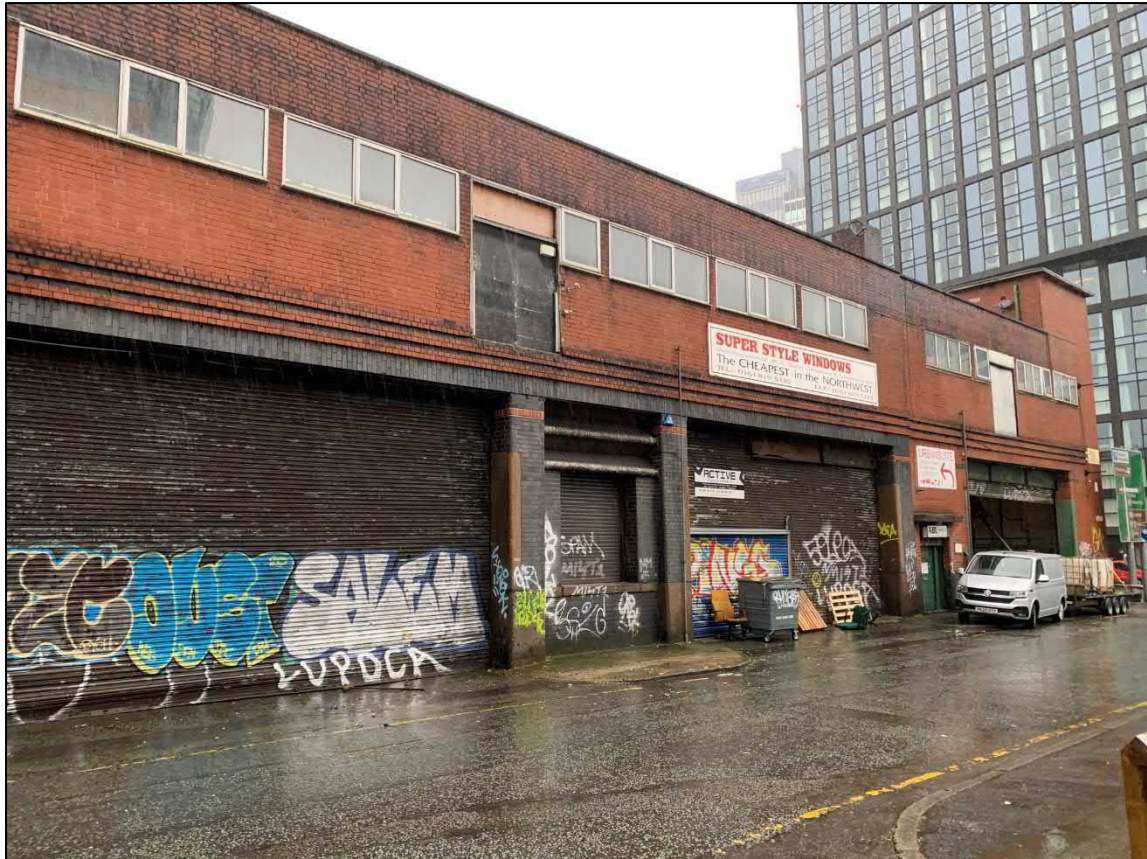
The ground-floor had five large loading-bay doorways and two smaller pedestrian doorways. Each of the openings had grey engineering brick lintels and reveals. The loading-bays had sandstone bumpers. The loading-bays housed a large modern roller shutter door (Plate 14). Two of the bays had the doors removed and the openings blocked up using modern perforated brick, into which three uPVC casement windows had been inserted to let in additional light to the ground-floor (Plate 15).

The first-floor contained a continuous row of horizontal uPVC casement windows with four loading-bay doors. Each of the doorways contained two timber doors set within an opening of brick reveals, lintels, and sills (Plate 14).

Plate 14: The north-western end of the north-eastern elevation

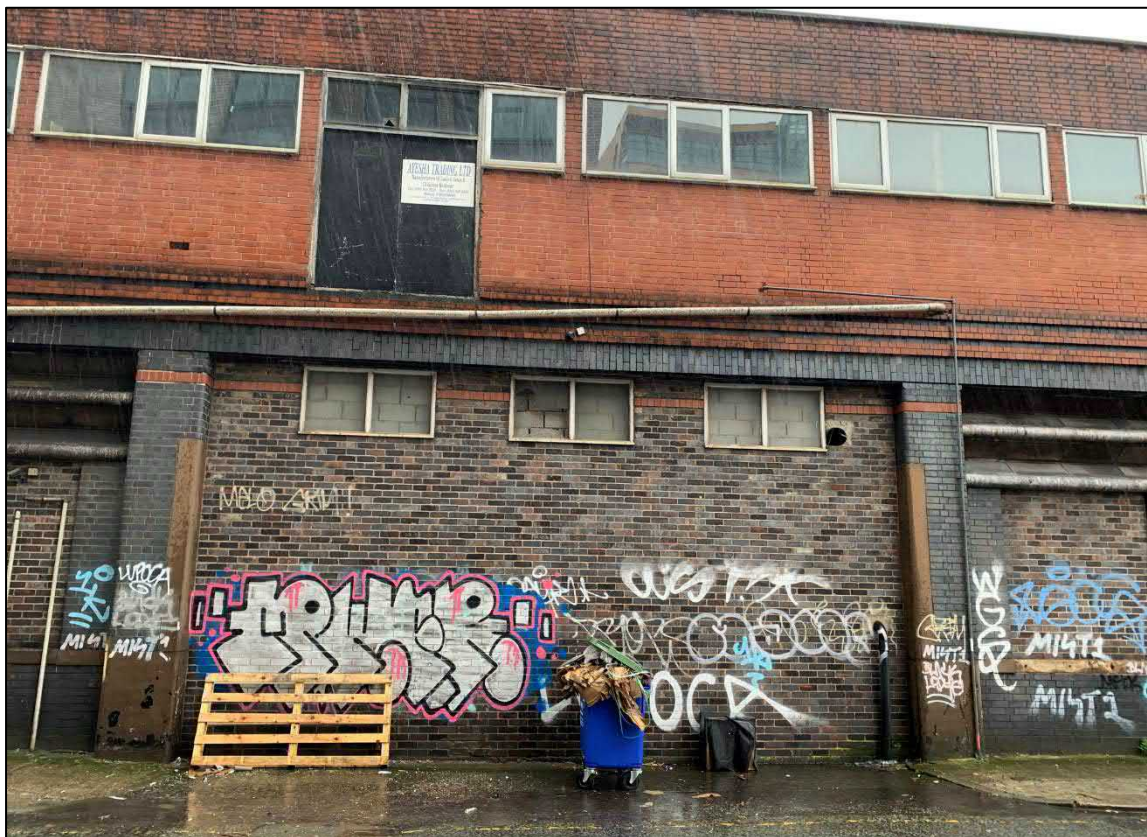
Plate 15: The central doorway within the north-eastern elevation

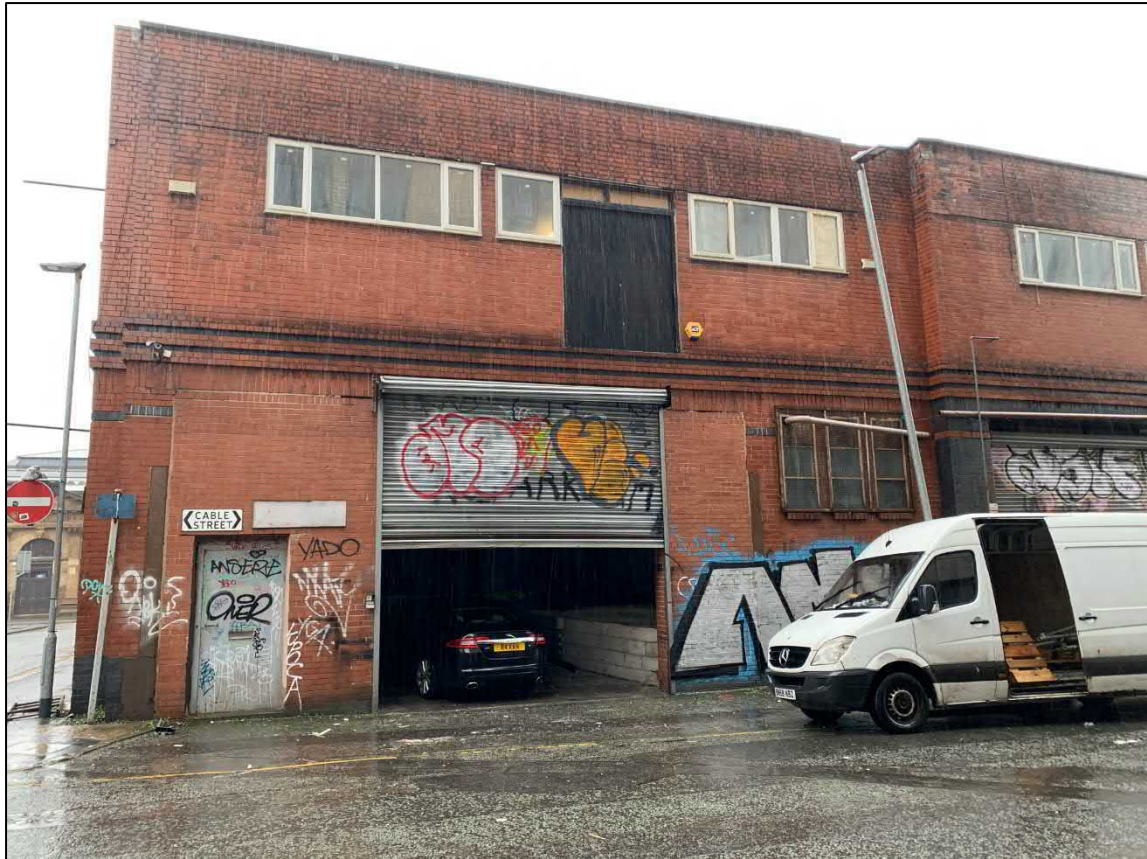
The office/warehouse block had been set back from the warehouse and had been constructed in the same design. The large loading bay-doorway is a recent insertion into an earlier doorway that also had sandstone bumpers. The original opening had been partially blocked using modern aeriated brick with steel framed rolled shutter door situated at the centre (Plate 16).

*Plate 16: The south-eastern end of the north-eastern elevation*

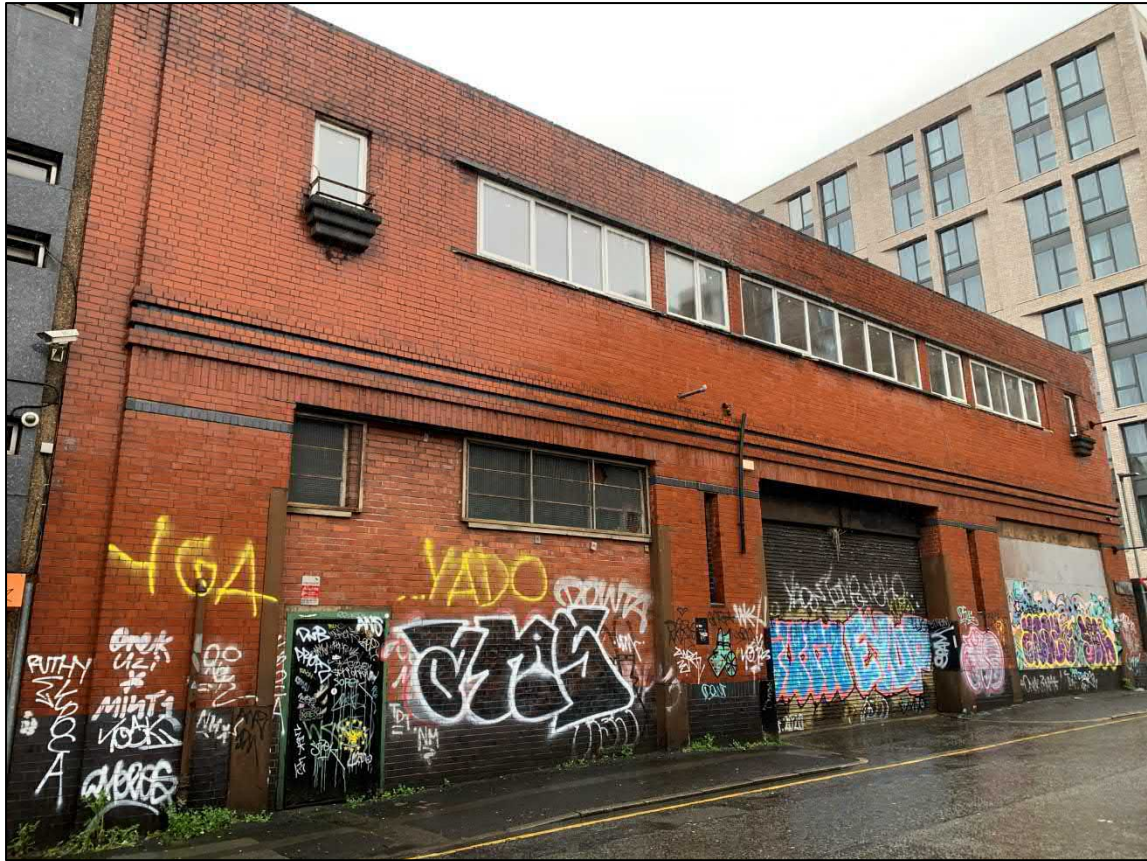
**The south-eastern elevation:** this elevation fronted Mason Street and formed the south-eastern elevation of the early-20<sup>th</sup> century office/warehouse block. It was constructed in a Monk bond with three protruding brick string courses at ceiling height of the ground-floor. A small parapet wall was constructed above the lintels of the first-floor windows which obscured the flat roof (Plate 17).

*Plate 17: General view of the south-eastern elevation*

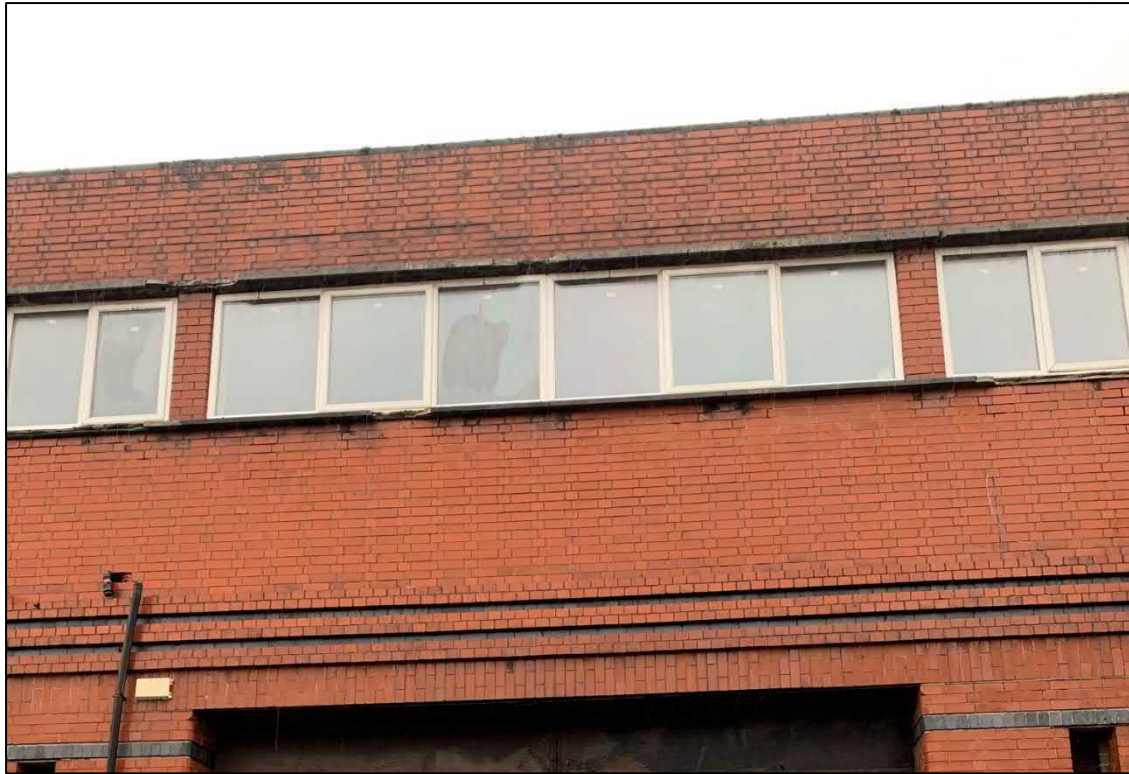
The first-floor was of similar design the north-eastern elevation and had a row of horizontal uPVC casement windows. These were set within an opening that had chamfered protruding concrete sill and lintel (Plate 19). Two small windows with a more decorative stepped sill were situated at either end.

*Plate 19: Detail of the first-floor windows on the south-eastern elevation*

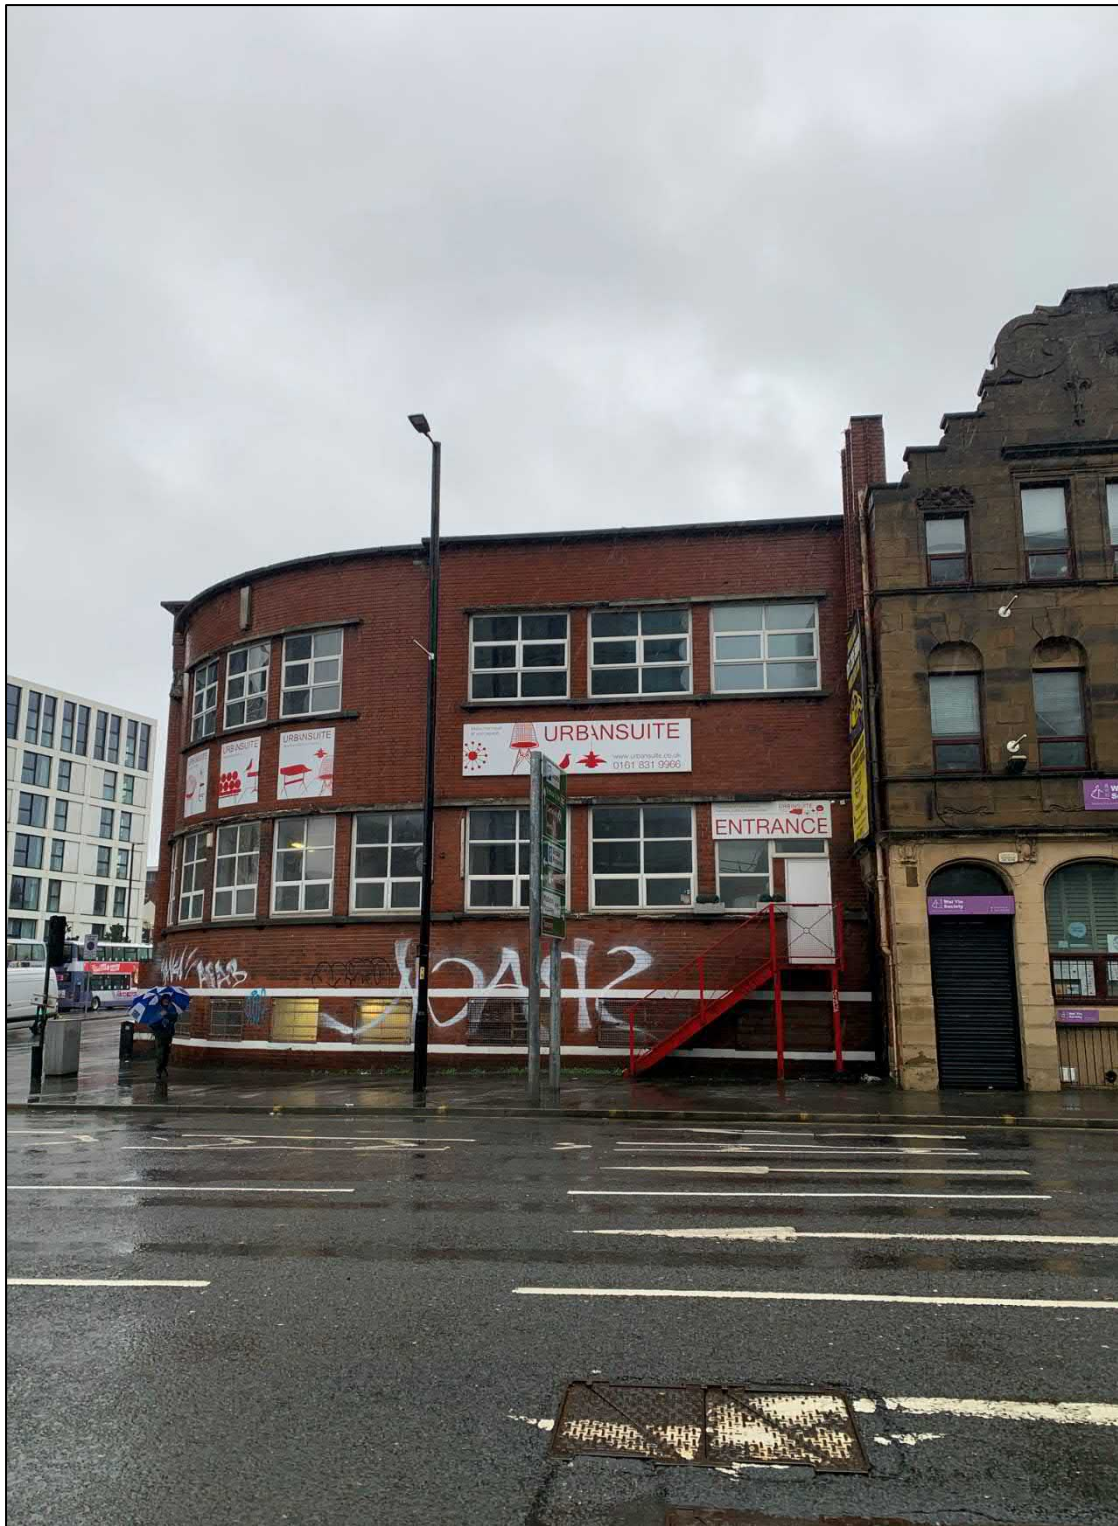
**The south-western elevation:** the south-western elevation fronted Swan Street and was constructed in a Monk bond with three protruding brick string courses at ceiling height of the ground-floor (Plate 20). The north-western corner had been curved corner which follows the junction of Swan Street and Rochdale Road. This was the south-west elevation of the mid-20<sup>th</sup> century office block.

The ground-floor comprised seven window apertures with an inserted door at the south-eastern. The window apertures comprised a single continuous protruding concrete lintel and flush concrete sills that recessed between brick square reveals. The openings housed a nine-light uPVC casement window with clear glazing (Plate 20). The first-floor apertures consisted of protruding chamfered concrete sills and lintels and housed a vertical uPVC three-light casement window (Plate 20). The basement had been light by seven window apertures within this elevation. Each consisted of painted flush concrete sills and lintels and housed a small three-light steel framed window glazed in obscure glass panes (Plate 20).

The doorway had been recently inserted and was accessed by a set of mild-steel steps. A flush timber door with modern door furniture had been housed within the opening along with an off-centre uPVC transom light (Plate 20).

*Plate 20: General view of the south-western elevation*

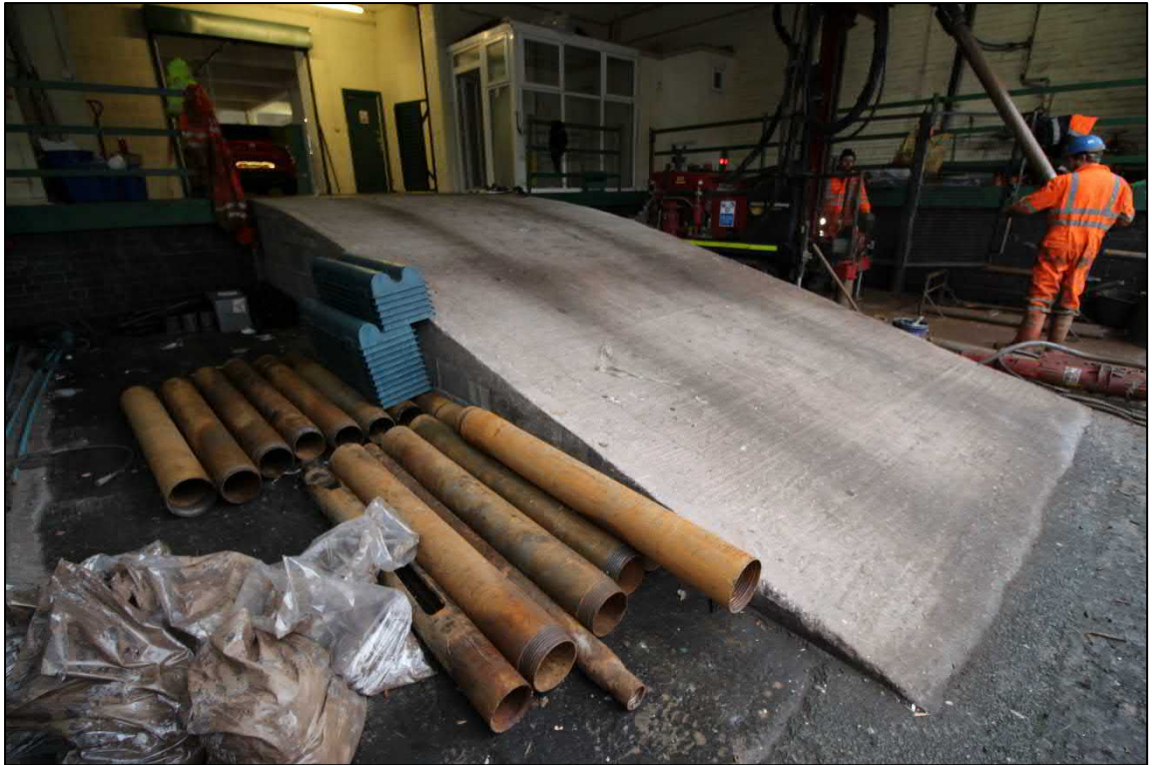
*Plate 22: The concrete ramp at the centre of the north-western loading-bay*

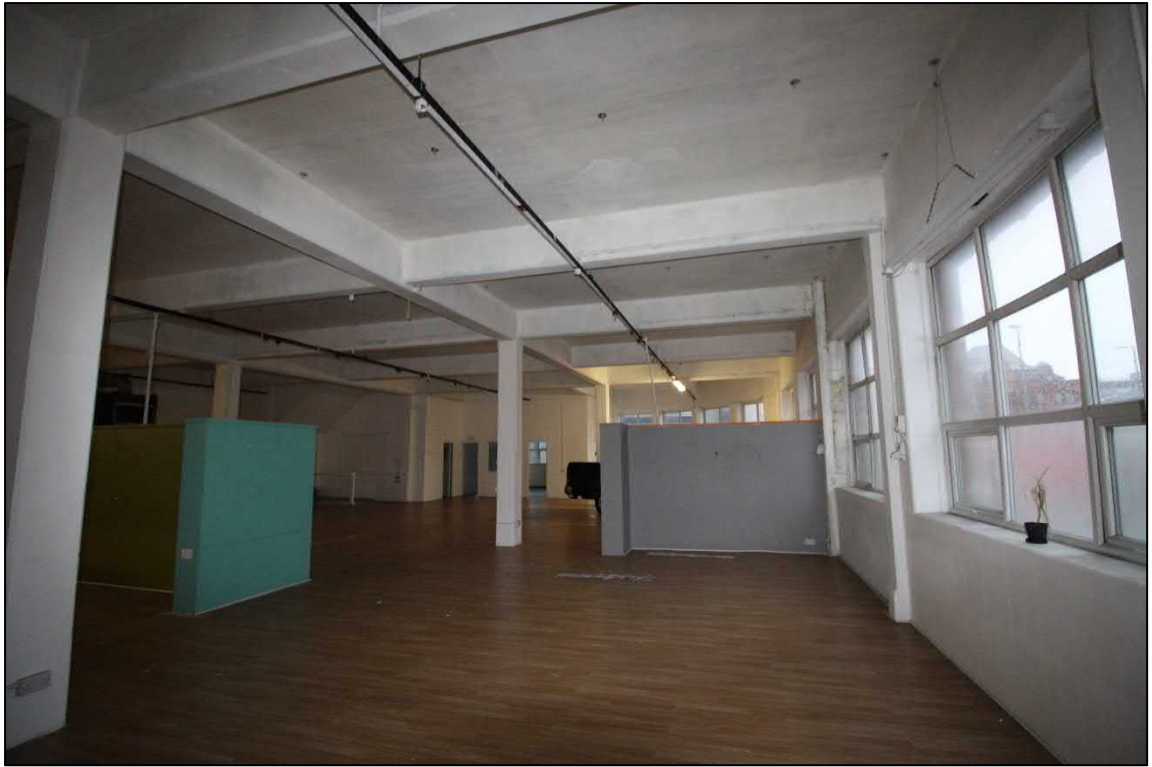
The main central room of this building had been heavily modernised with painted concrete block walls and a laminate timber floor. The room was open plan with two rows of concrete rendered steel columns. These had supported the concrete rendered steel ceiling beams (Plate 23). The render had been removed on one of the beams exposing a rolling stamp: 'Appleby-Frodingham England'. The windows on the north-western and western walls had squared reveals with flush concrete lintels and flat concrete rendered sills. Modern uPVC casement windows had been housed within the openings (Plate 24).

*Plate 23: The central room of the ground-floor*

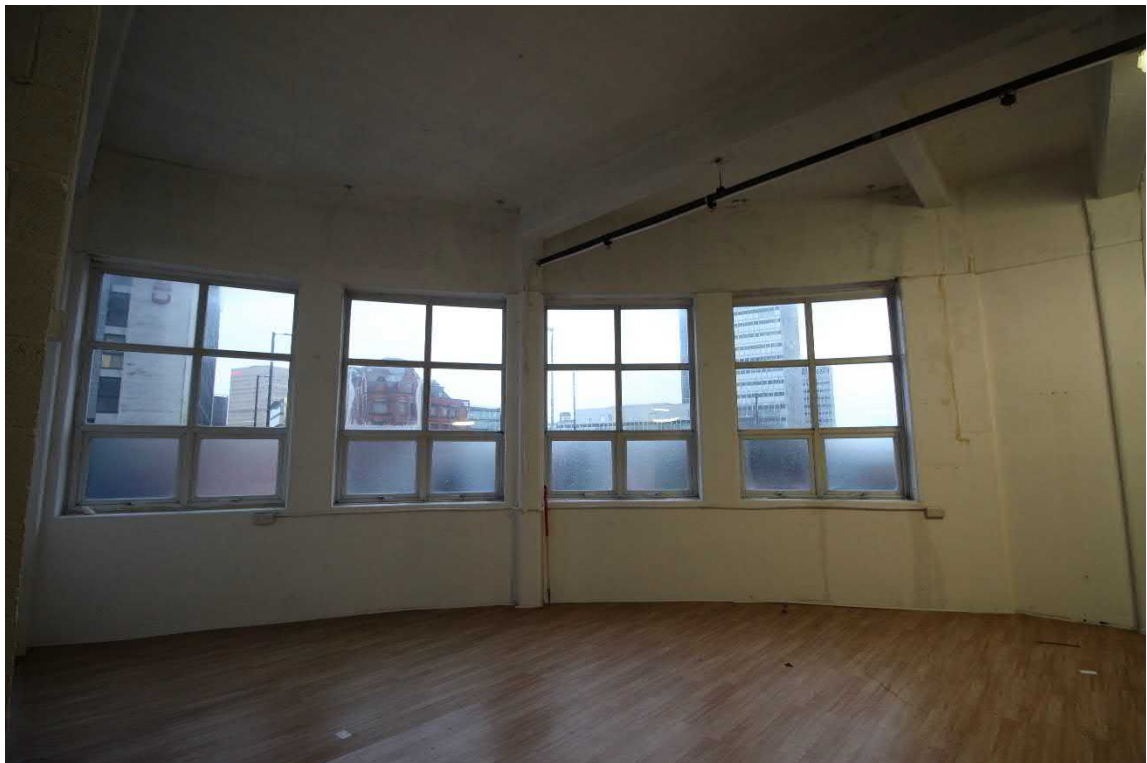
*Plate 24: The windows within the western wall of the ground-floor*

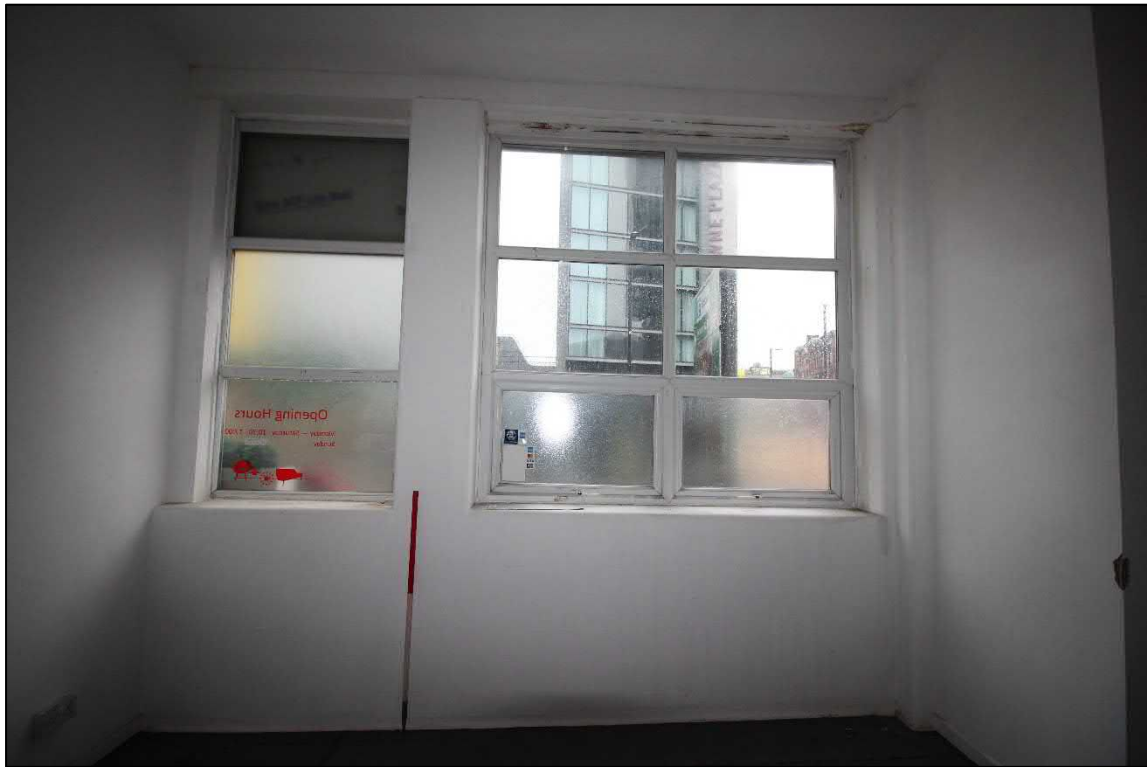
and flat concrete rendered sills. Modern uPVC casement windows had been housed within the openings (Plate 25).

*Plate 25: The windows within the south-western office on the ground floor*

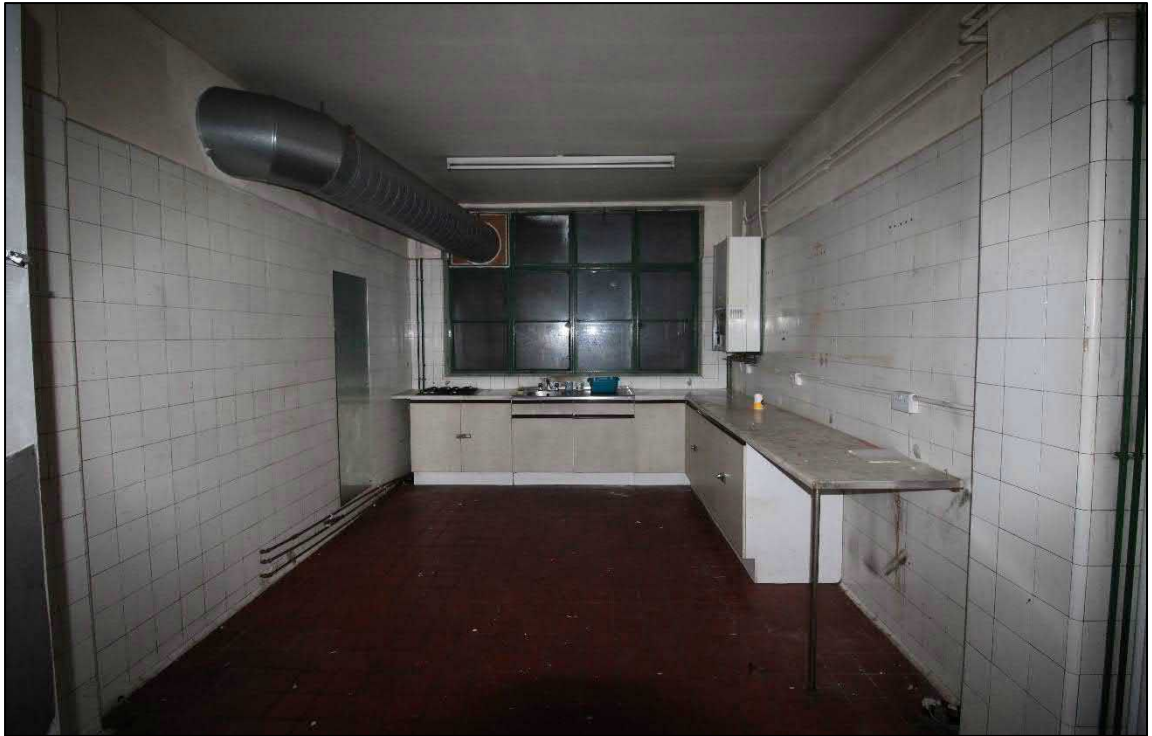
A kitchen had been situated within the south-eastern corner of this later extension (Fig 2). This comprised white tiled walls, brown floor tiles and a painted concrete ceiling (Plate 26). The south-eastern wall had been dominated by a large 12-light steel framed window with clear glass panes with the upper north-eastern pane having been removed for the installation of the modern galvanized ducting (Plate 26).

*Plate 26: The kitchen at the south-easter corner of the ground-floor*

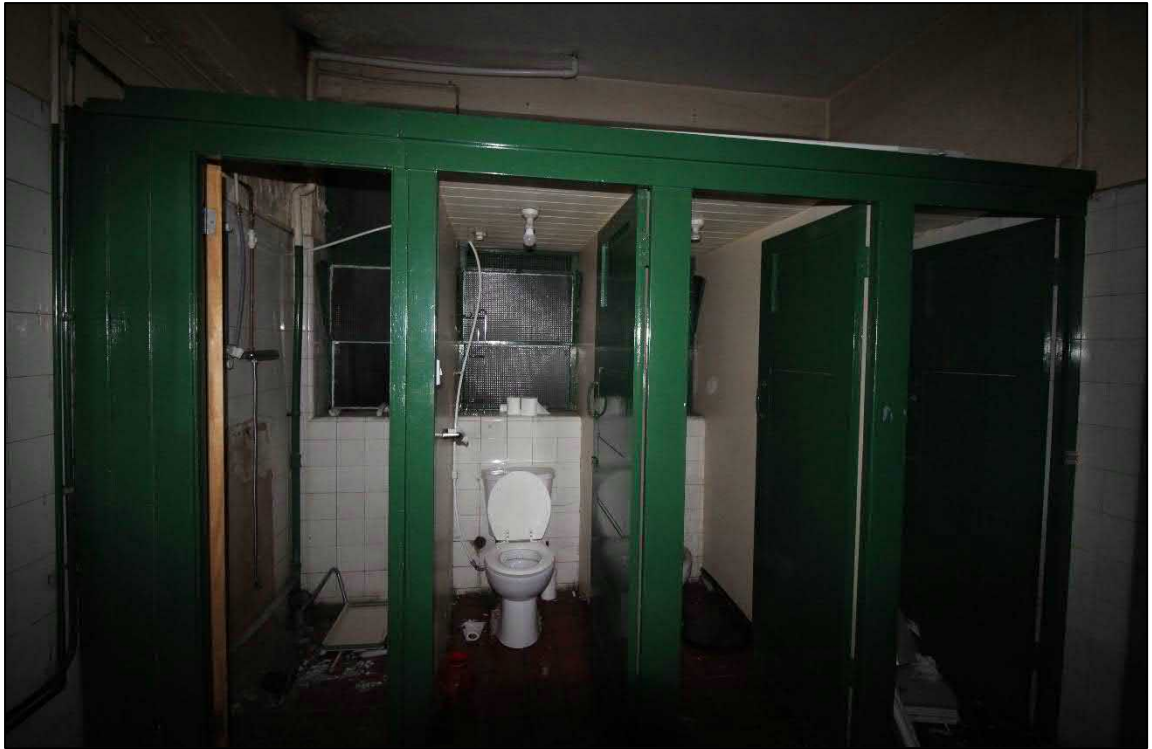
Access into the south-western end of the basement was gained from a set of quarter turn concrete stairs to the south of the kitchen (Plate 27; Fig 2). These stairs gave access into a room that contained four toilet cubicles (Plate 28). The room had consisted of white tiled walls, brown floor tiles and a painted concrete ceiling; each of the stalls had timber doors and partition walls and contained modern sanitaryware (Plate 28).

*Plate 28: Detail of the timber toilet stalls within the basement of the office block*

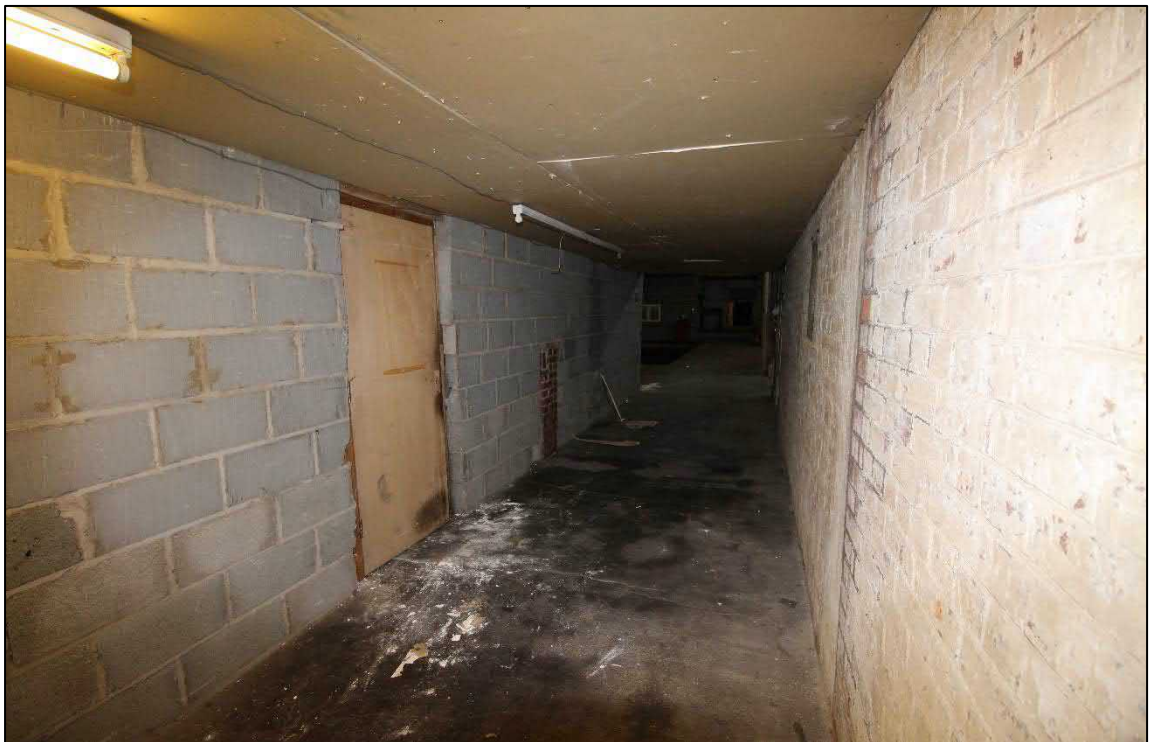
Internal access into the warehouse compartments to the south-eastern end was gained through a modern flush timber door that was inserted into a concrete, block constructed partition wall. A small narrow L-shaped corridor at the north-western end of the large warehouse gave lateral access into the warehouse area (Plate 29).

*Plate 29: The narrow corridor giving internal access between the later office block and the earlier warehouse*

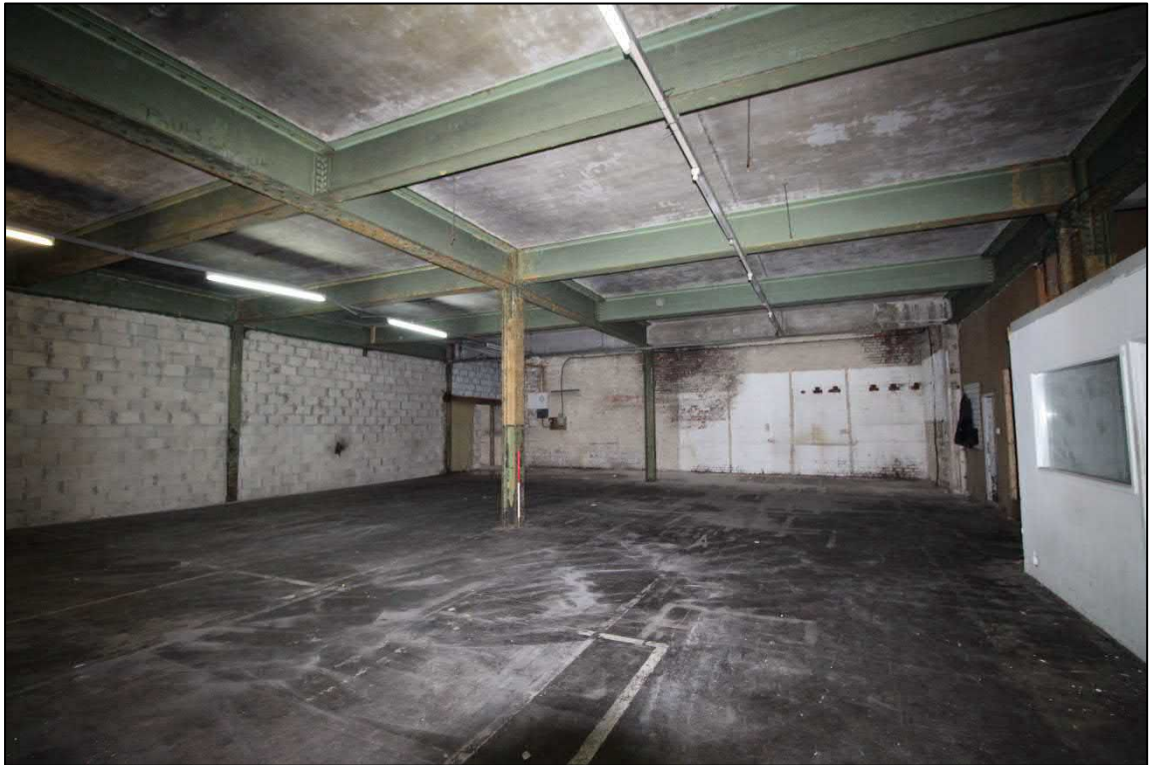
The warehouse had been divided into eight large compartments (Fig 2), with each room consisting of concrete floors, painted brick walls and an open ceiling that exposed the underside of the concrete floor of the first-floor. The steel I-section beams had been supported by H-section columns that were bolted to the concrete floor and to each beam using L-section angle-iron cleats (Plate 30). All the exposed steel beams and columns within this section of the building along with the earlier office/warehouse block had 'Dorman Long & Co Ltd Middlesbrough England' roll stamped; the roll stamps were visible on the webs (Plate 31).

*Plate 30: General view of the north-western end of the warehouse*

The three rooms to the south-west of the warehouse were open plan with concrete floors, painted brick walls, and exposed I-section steel beams. Each of the beams had been supported by a row of H-section columns that were bolted to the concrete floor and to each beam using L-section angle-iron cleats (Plate 30 and 34).

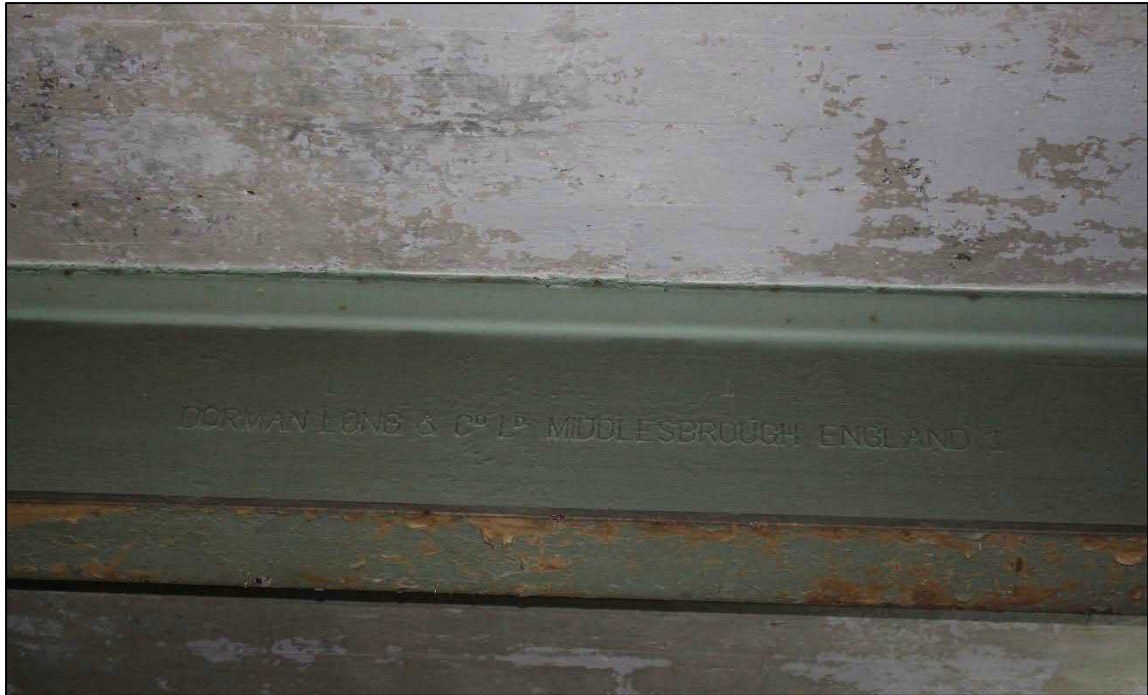
*Plate 31: The rolling stamp of Dorman Long on the steel beams and columns used in the construction of the warehouse and attached office/warehouse block*

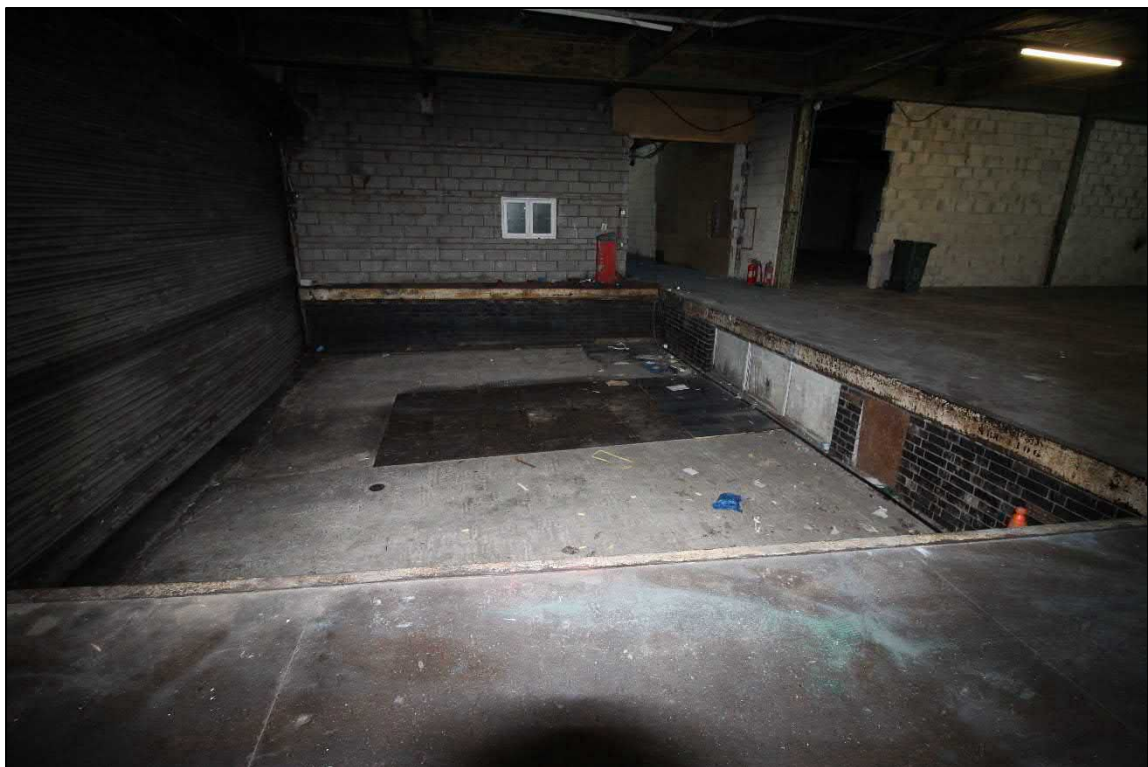
The four compartments on the north-eastern end of the building had all been used as loading-bay docks. Each had a concrete dock pit floor with brick and steel dock walls (Plate 32). The bays had been separated from the room to the south-west by a modern concrete block wall which had been partially been demolished at the north-western end (Plate 33).

*Plate 32: The loading-bay at the north-western end of the warehouse*

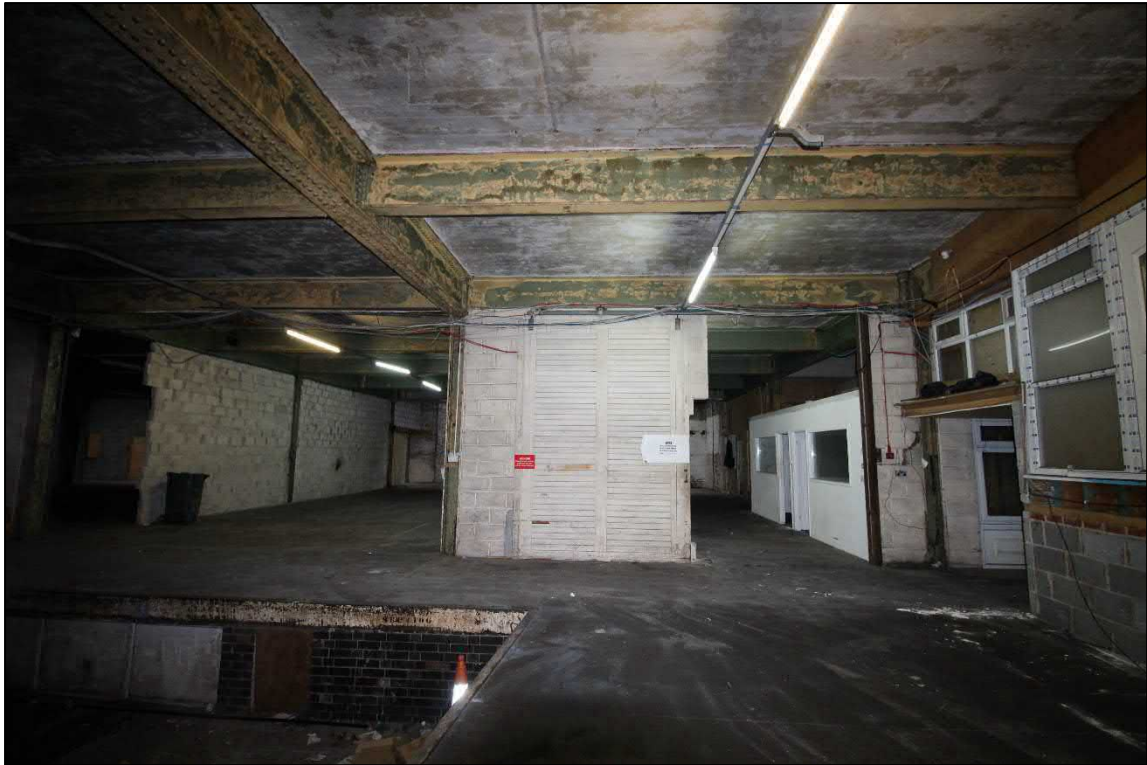
*Plate 33: The partition wall between the loading-bay and the storage area to the south-west*
