## Historic Building Investigation

Swan House,  
Rochdale Road,  
Manchester

**Report No:**  
SA/2021/11

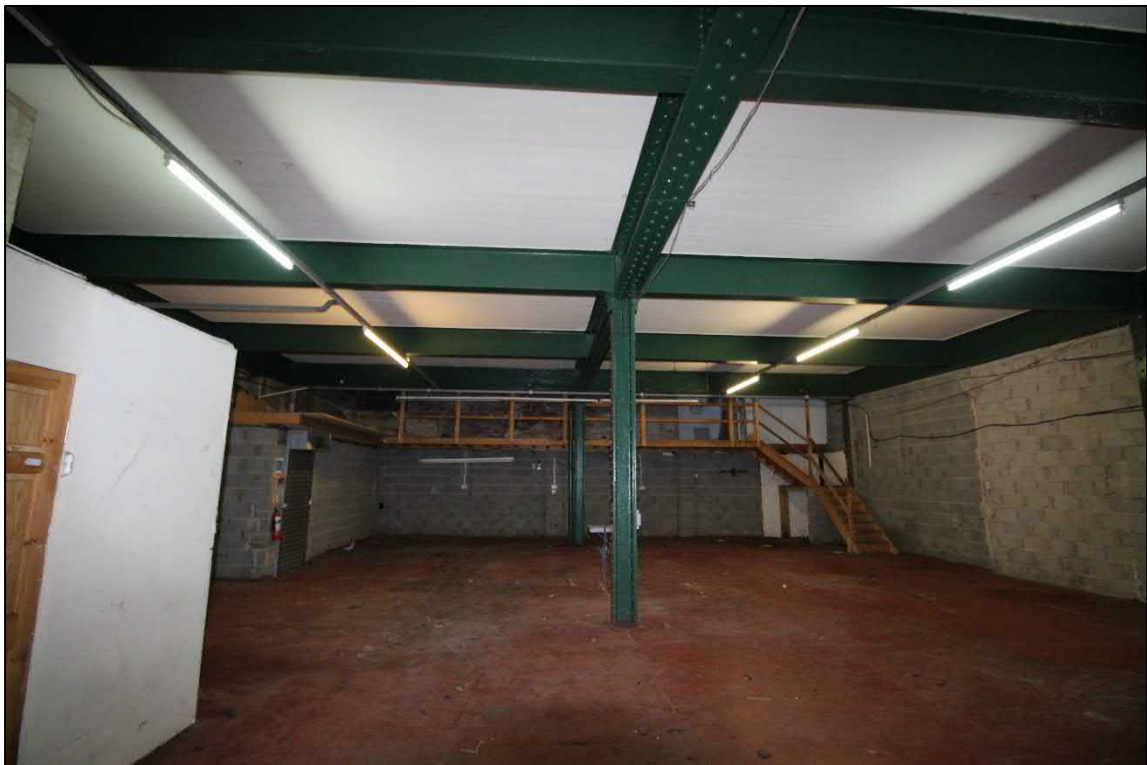
The three rooms to the south-west of the warehouse were open plan with concrete floors, painted brick walls, and exposed I-section steel beams. Each of the beams had been supported by a row of H-section columns that were bolted to the concrete floor and to each beam using L-section angle-iron cleats (Plate 30 and 34).

*Plate 34: General view of the central compartment within the warehouse*

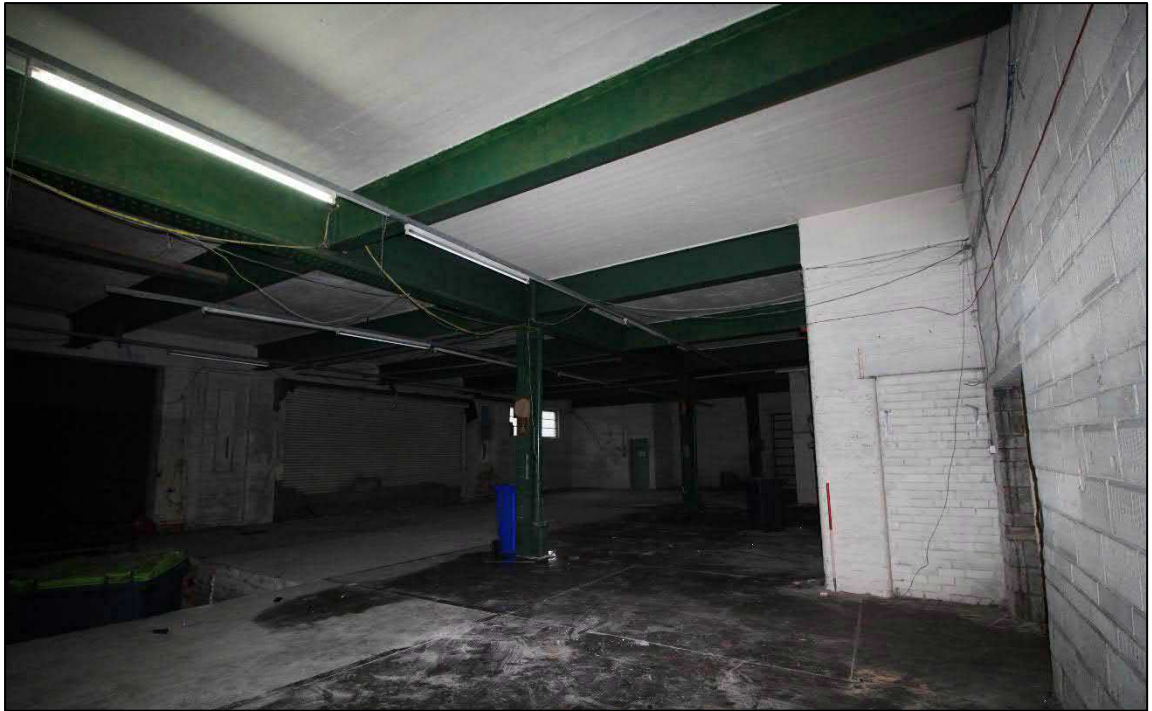
The south-eastern compartment was a large open plan room, with no partition wall between the loading bay and the and the storage area to the south-west (Plate 36; Fig 2). The area comprised a concrete floor, painted brick walls and an open ceiling that exposed the rivetted steel ceiling beams (Plate 36). This section was the ground-floor of the office/warehouse block, and does seem to have originally been intended as storage space with offices on the first-floor.

*Plate 36: General view of the south-east compartment within the warehouse*

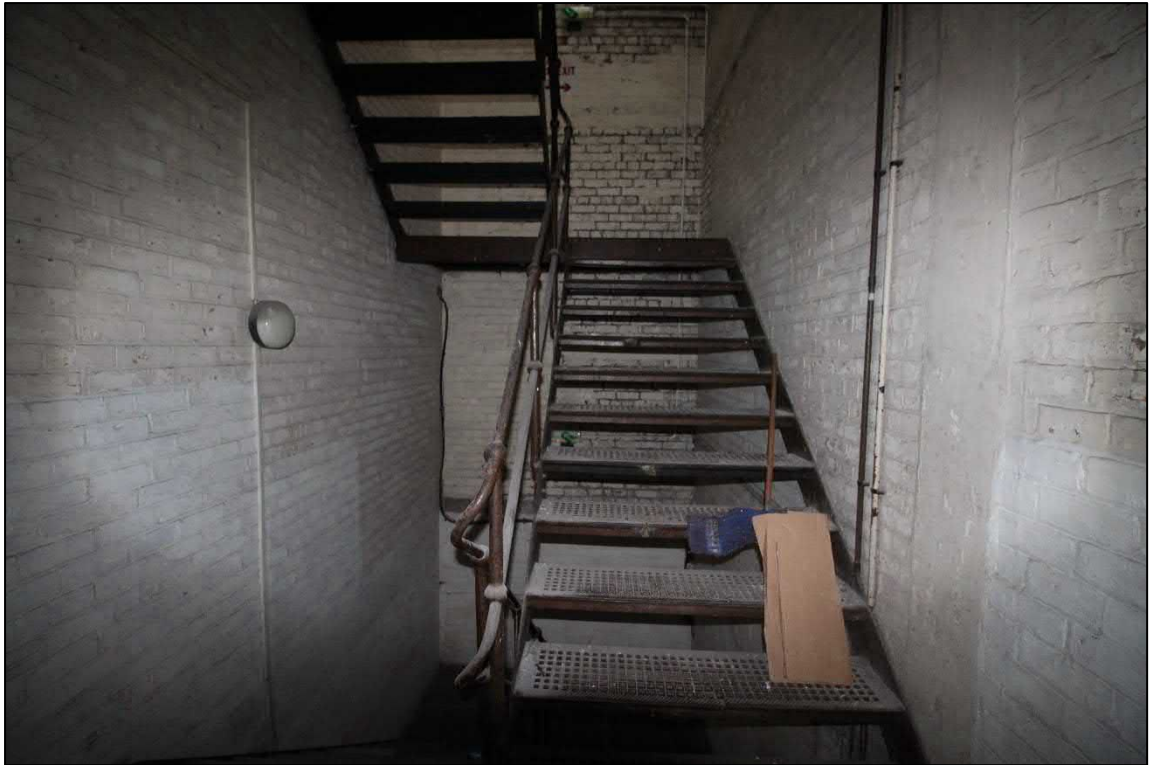
This stairwell was one of three stairwells that gave access to the first-floor and basement (Fig 2). The walls consisted of painted brick with concrete landings to each of the floors. The steel closed stringer staircase had mesh steel treads with open risers and a hollow steel tube handrail that was supported by steel balusters (Plate 39). The stairwell had a single round skylight and a single window aperture within the north-western wall, providing the only means of light into the stairwell. The skylight and the window had been glazed in clear glass panes (Plate 40).

*Plate 39: The southern staircase*

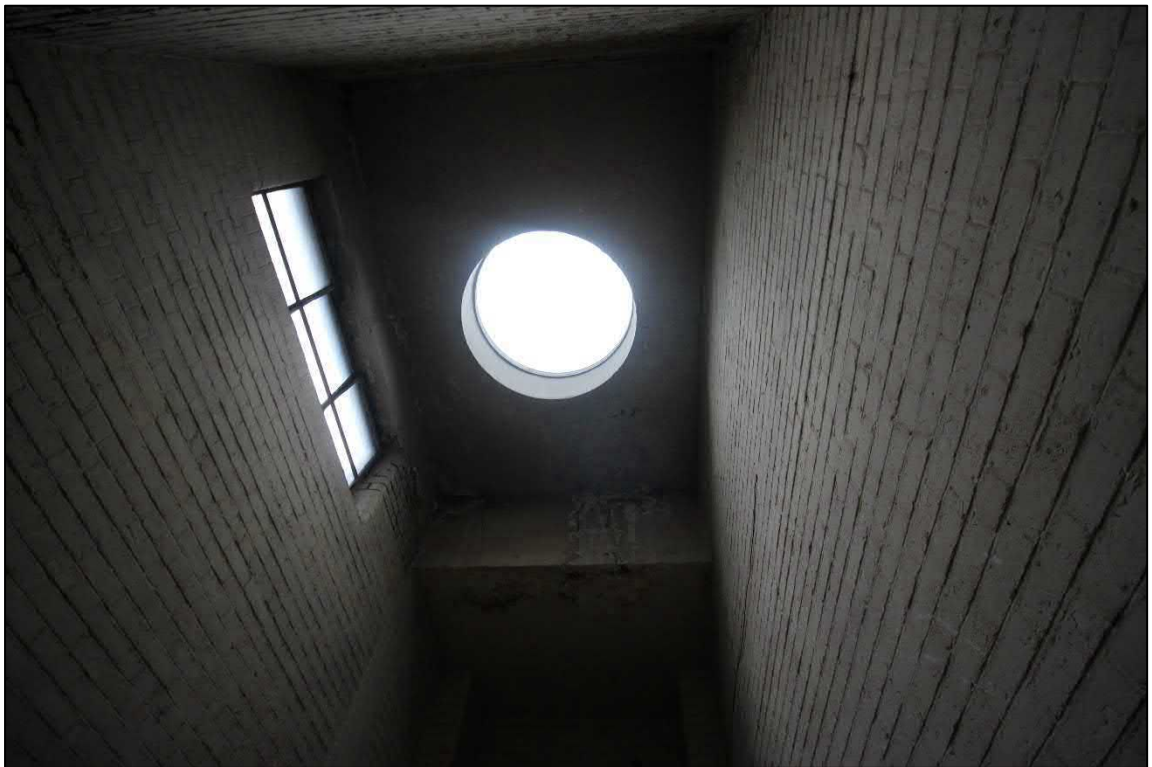
*Plate 40: Detail of the round skylight and the single window within the southern stairwell*

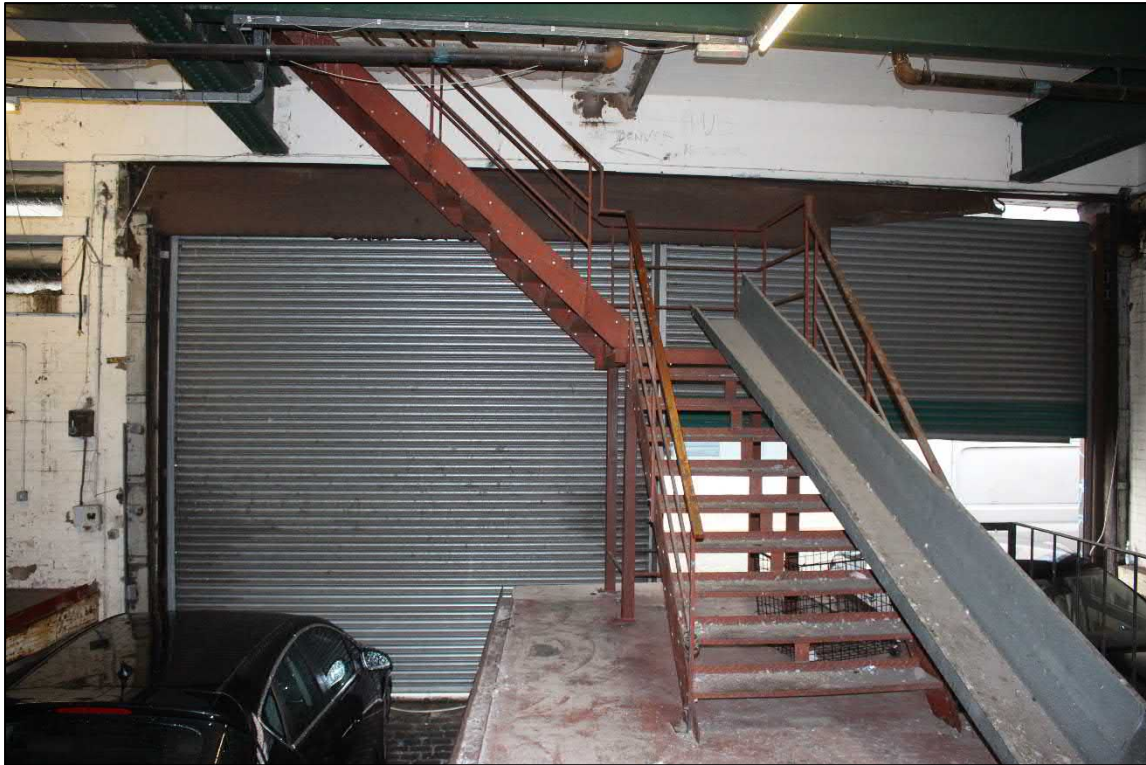
*Plate 41: The central steel staircase*

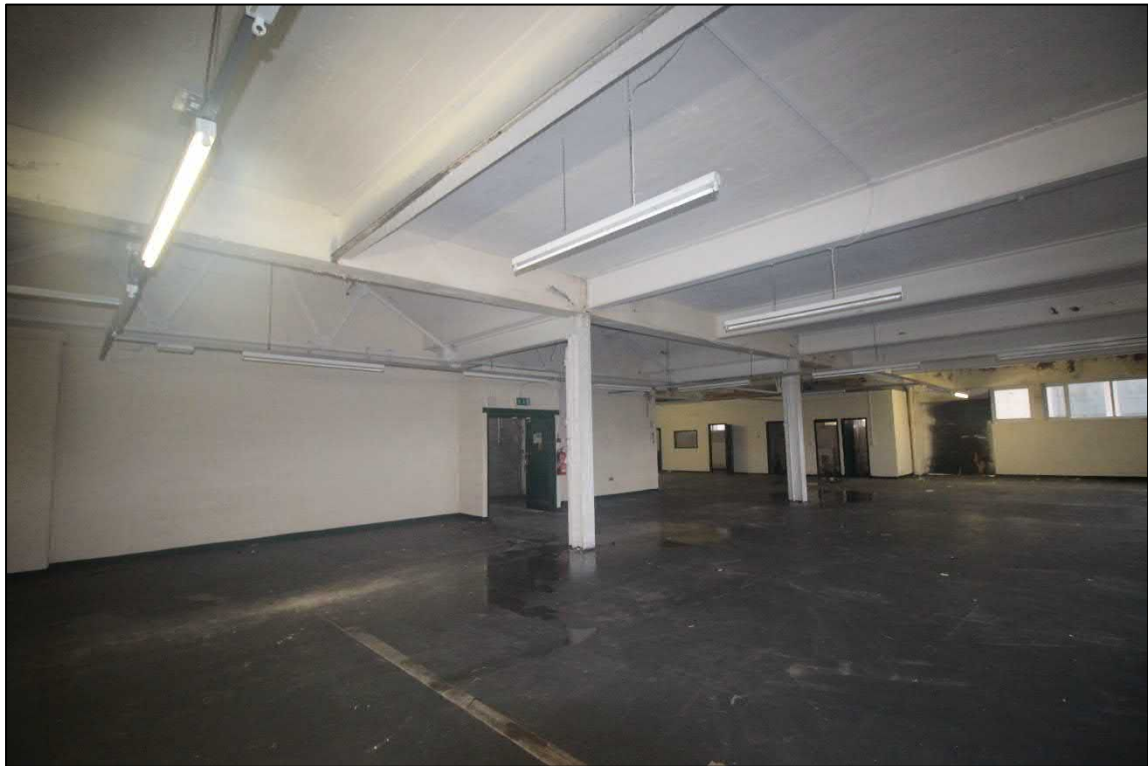
The southern room was a large L-shaped open planned room the with a painted concrete floor, painted brick walls and an open ceiling with exposed concrete rendered steel beams. A row of concrete rendered steel columns supported the beams at the north-western end of the room (Plate 43). The L-section angle-iron fan roof trusses of the warehouse had been seen at the northern end of the room (Plate 44).

*Plate 43: The first-floor of the office/warehouse block*

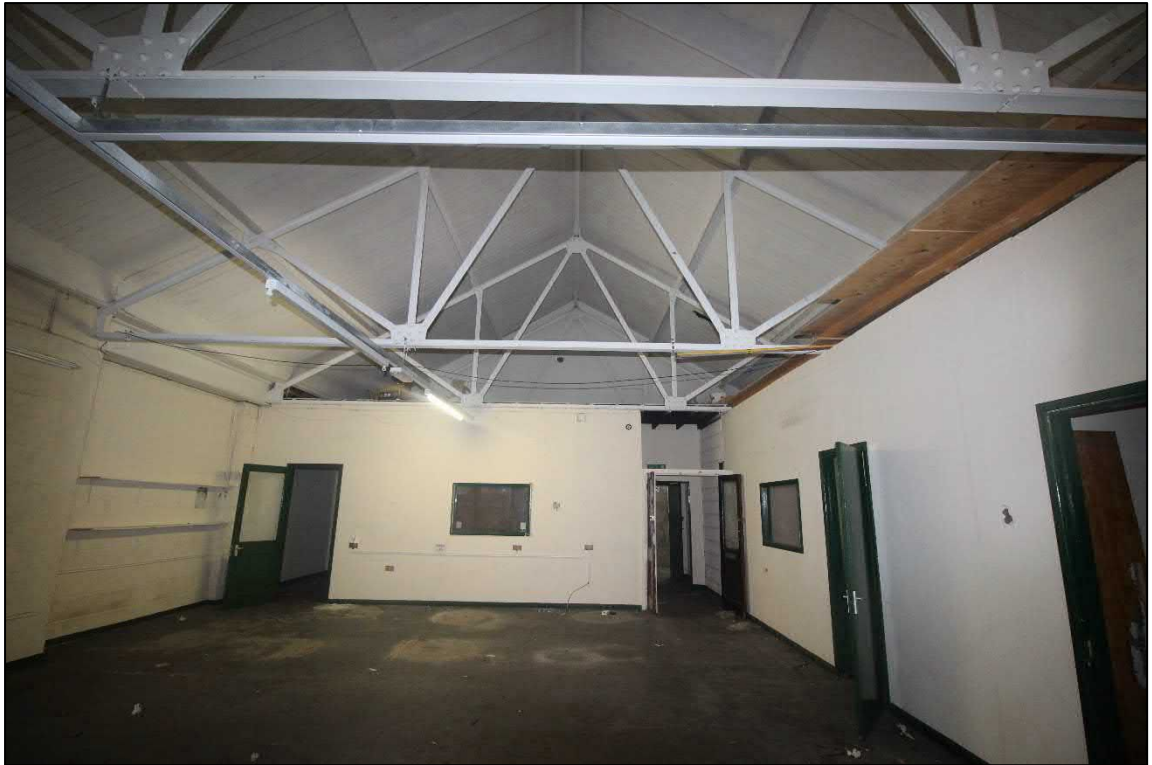
*Plate 44: The northern end of the office showing the exposed fan trusses of the warehouse*

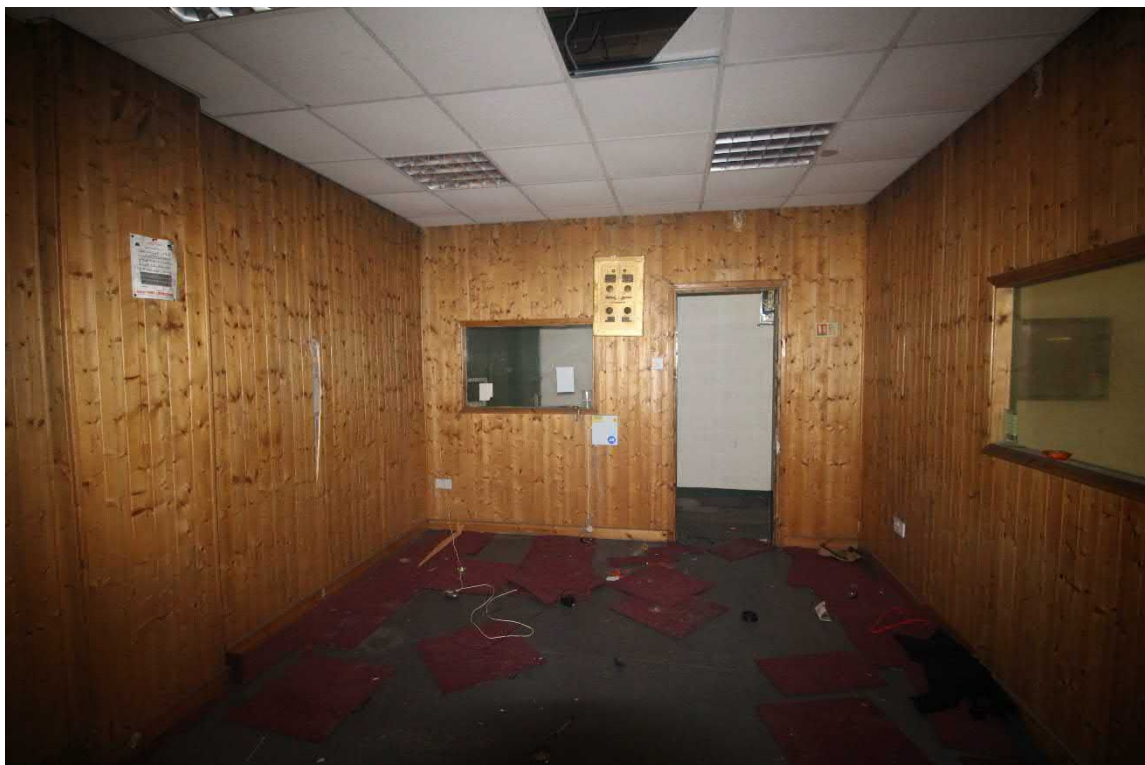
The warehouse had been divided into eight compartments, with six having been constructed during the late-20<sup>th</sup> century. Four compartments comprised timber framed panelled walls with false suspended ceilings and carpeted floors and had been used as offices (Plate 45).

*Plate 45: One of the modern offices created at the south-eastern end of the warehouse*

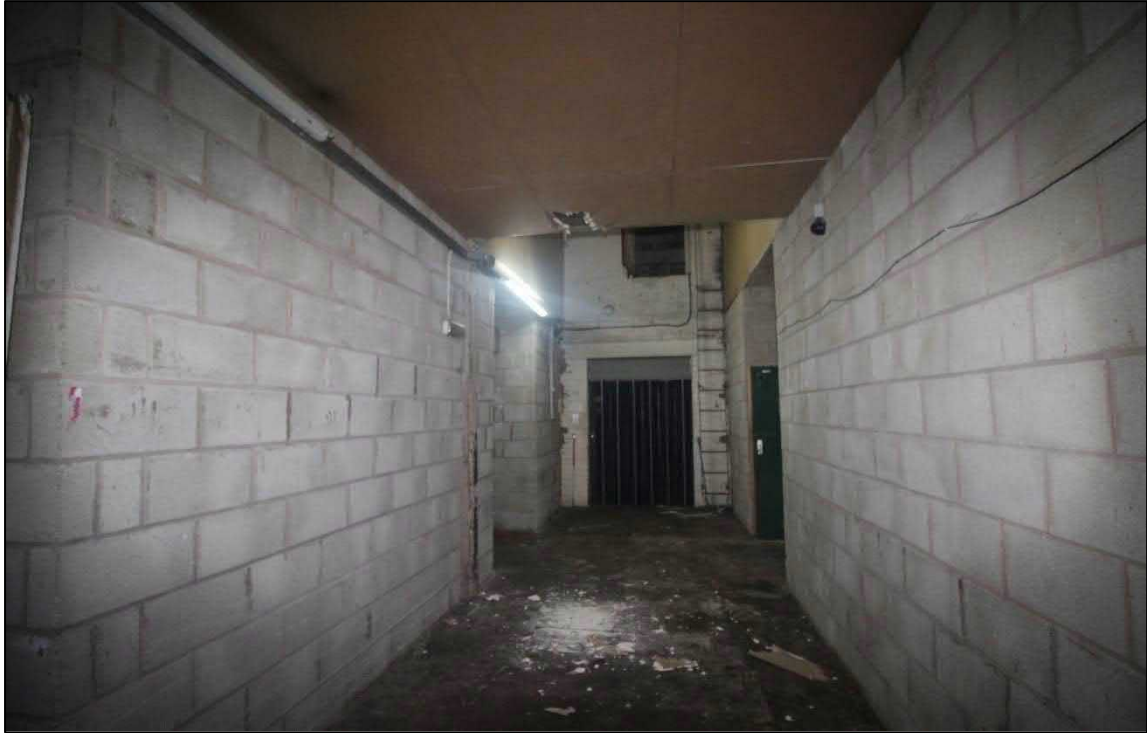
The landing of the southern staircase gave access to a narrow corridor running between the warehouse and office block (Fig 3). This corridor had modern concrete block walls, a concrete floor with a high open ceiling (Plate 46). At the northern end was the original lift tower. This had squared reveals with a concrete lintel and a modern galvanised concertina door occupied the opening (Plate 47).

*Plate 46: The corridor within southern staircase first-floor landing*

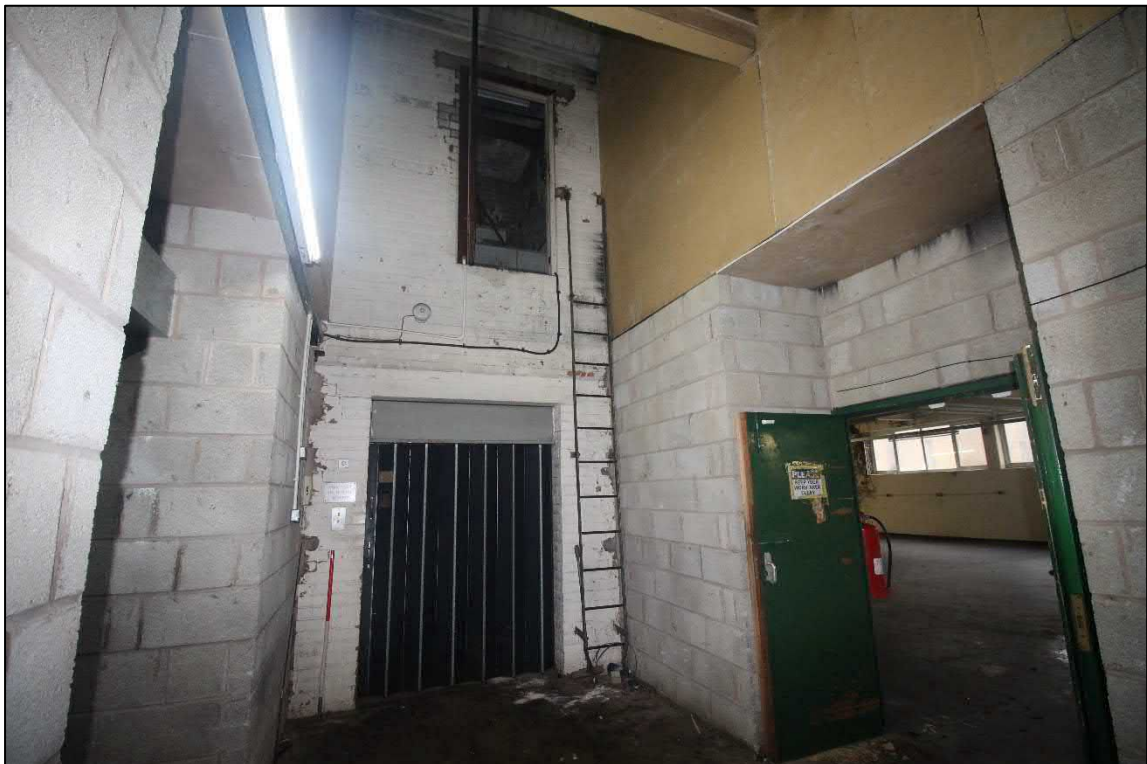
*Plate 47: The lift tower at the northern end of the southern corridor*

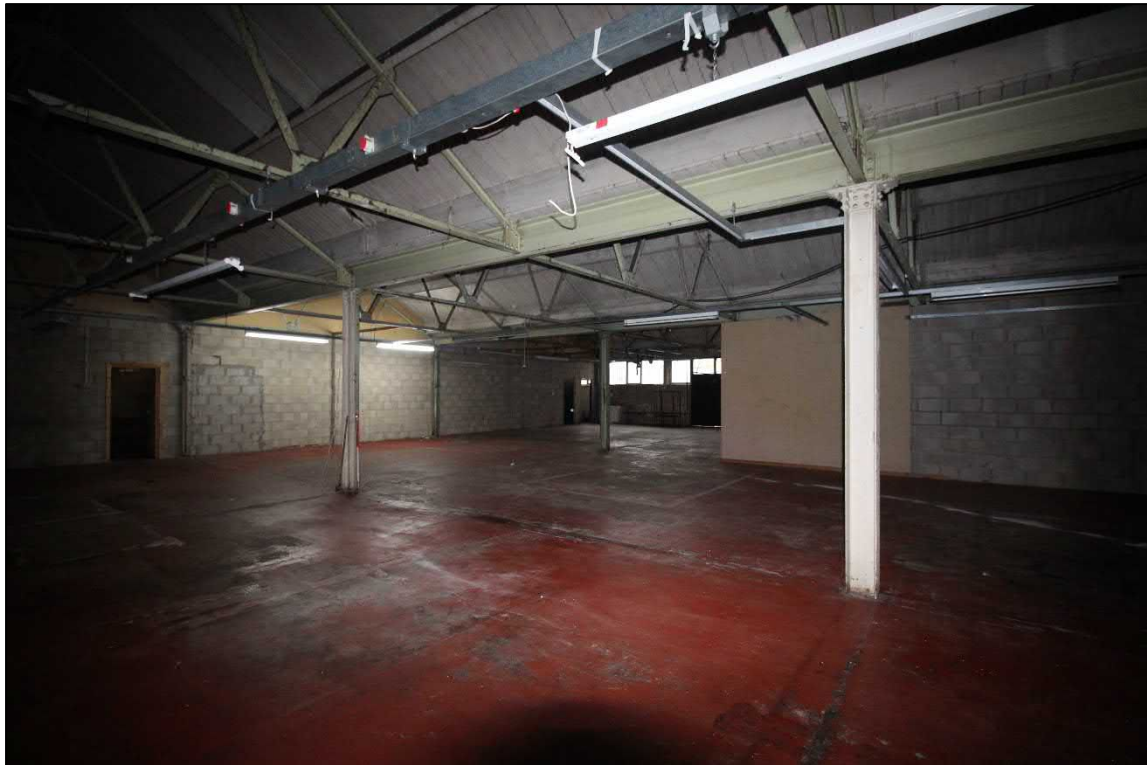
The southern compartment of the warehouse consisted of a painted concrete floor, exposed brick walls and an open ceiling (Plate 48). This exposed the L-section angle-iron fan roof trusses with each truss having been supported by large steel I-section steel beams. Two rows of H-section columns had been bolted to the beams and the floor using L-section angle-iron cleats (Plate 48).

*Plate 48: General view of the southern compartment on the first-floor of the warehouse*

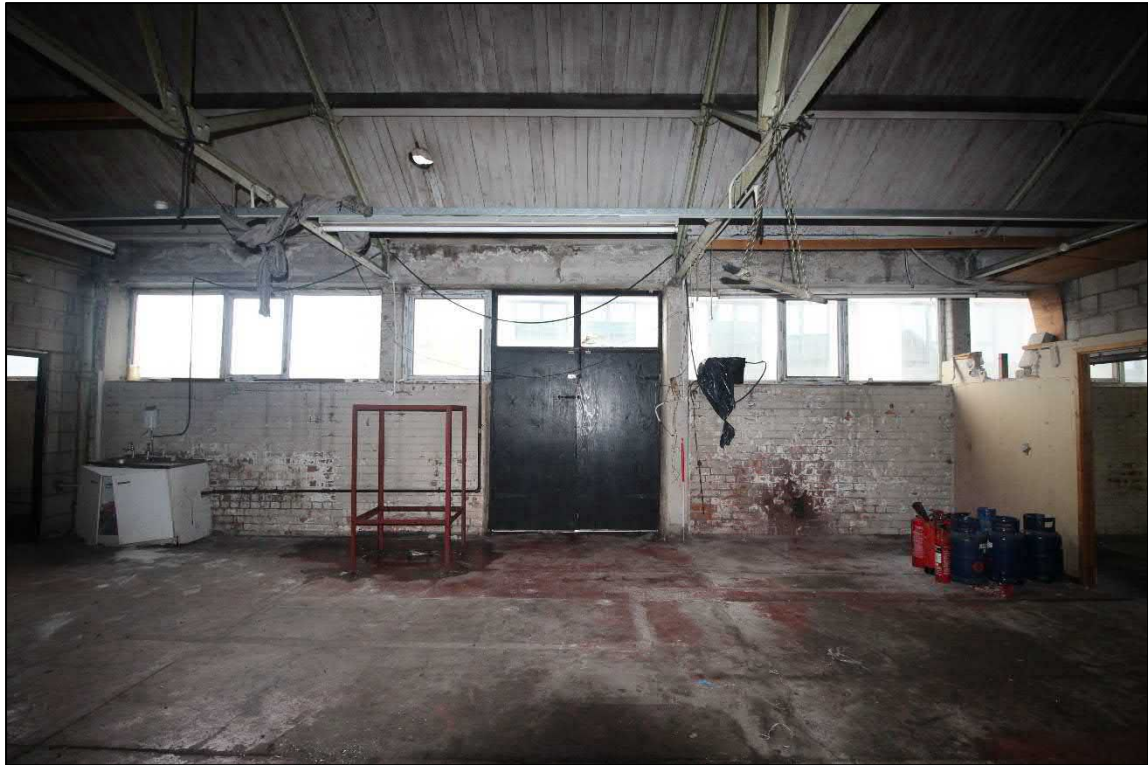
At the centre of the north-eastern wall was a loading-bay door that had been flanked by a bank of horizontal window apertures. The doorway had bullnose brick reveals with a flush concrete lintel. Two replacement plywood doors with modern door furniture had been hung within the opening (Plate 49). Two fixed light timber framed transom windows had been fitted directly above the top rail of the doorframe (Plate 49).

The windows that flanked the loading-bay had flush concrete lintels, flat brick sills with bullnose reveals. These housed modern uPVC casement windows that had been glazed in clear glass panes (Plate 49).

*Plate 49: The north-eastern wall of the warehouse*

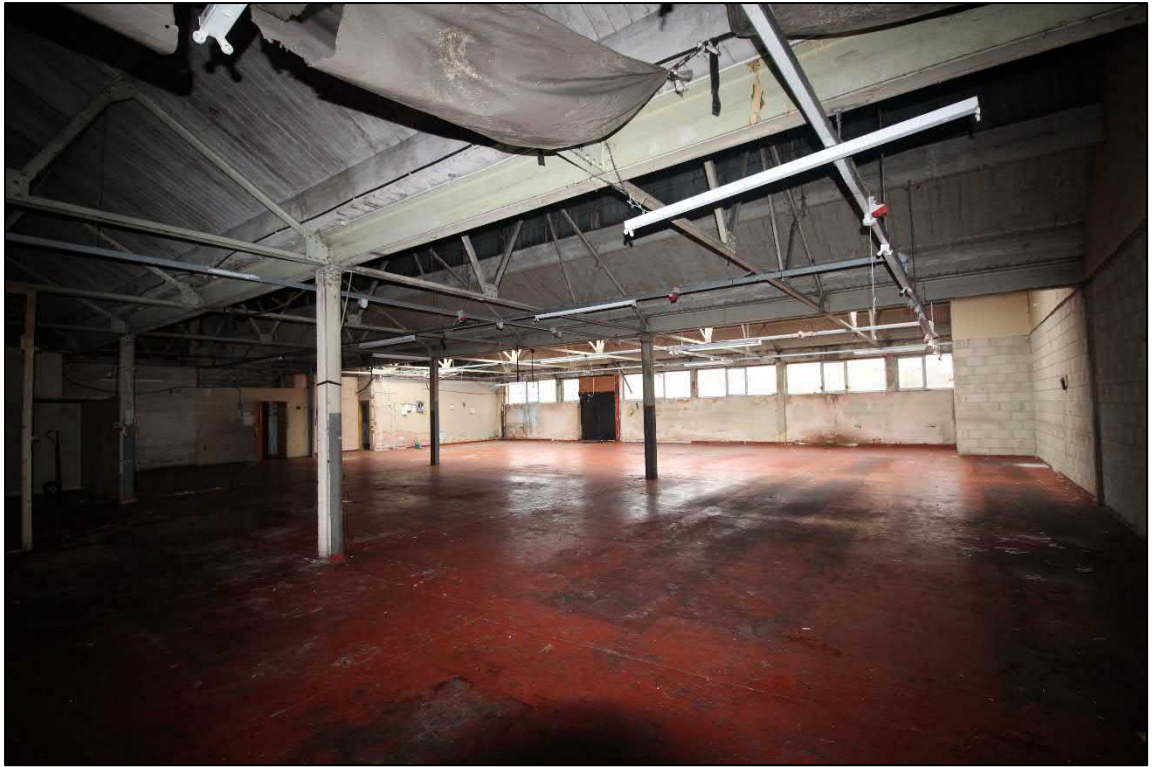
The northern room was of a similar layout to that of the central compartment. This consisted of a largely open plan rooms of three-bays wide, with a painted concrete floor, painted brick walls and an open ceiling (Plate 50). This exposed the L-section angle-iron fan roof trusses with each truss having been supported by large steel I-section steel beams. Two rows of H-section columns had been bolted to the beams and the floor using L-section angle-iron cleats (Plate 50). The dividing wall between the two large compartments was of modern concrete blocks.

*Plate 50: General view of the northern compartment on the first-floor of the warehouse*

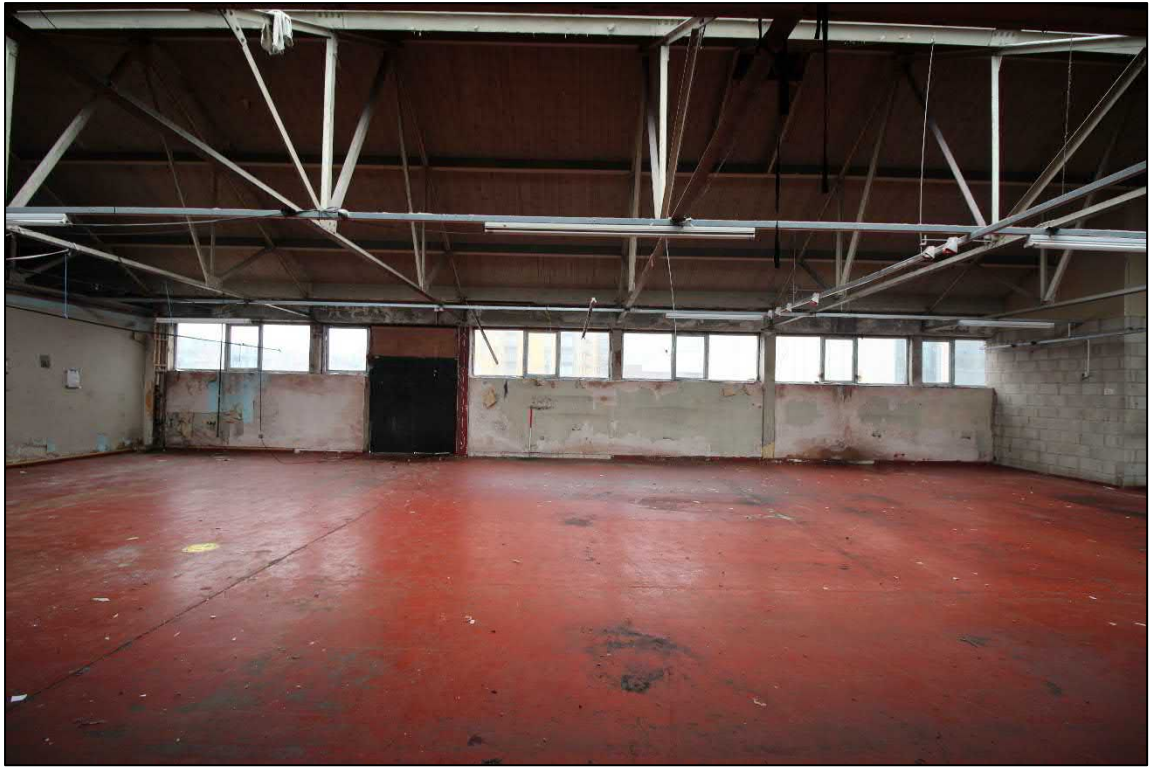
The north-eastern wall contained a loading-bay door to the north-western end that had been flanked by a bank of horizontal window apertures. The doorway had bullnose brick reveals with a flush concrete lintel. Two replaced plywood doors with modern door furniture had been situated within the opening (Plate 51). The transom light above the doorway was blocked using plywood (Plate 51). The windows that flanked the loading-bay had flush concrete lintels, flat brick sills with bullnose reveals. These housed modern uPVC casement windows that had been glazed in clear glass panes (Plate 51).

*Plate 51: The north-eastern wall of the warehouse*

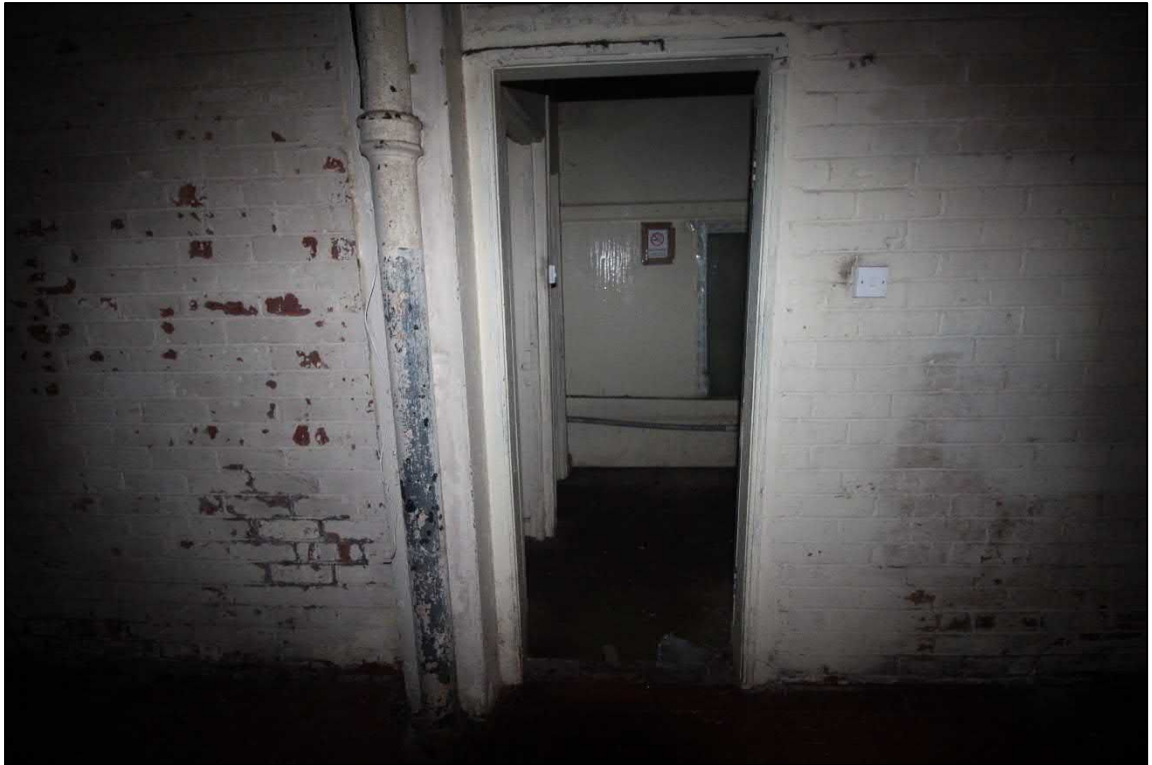
The north-western wall contained three doorways leading to leading to a set of toilets at the south-western end, a lobby area for the central lift and a set of modern constructed offices at the north-eastern end (Fig 3). The doorway leading into the toilets and the offices had simple rectangular architraves with brick lintels, while the central doorway had been inserted into a modern timber partition wall (Plate 52 and 53).

*Plate 52: The doorway leading into the toilets within the north-western wall*

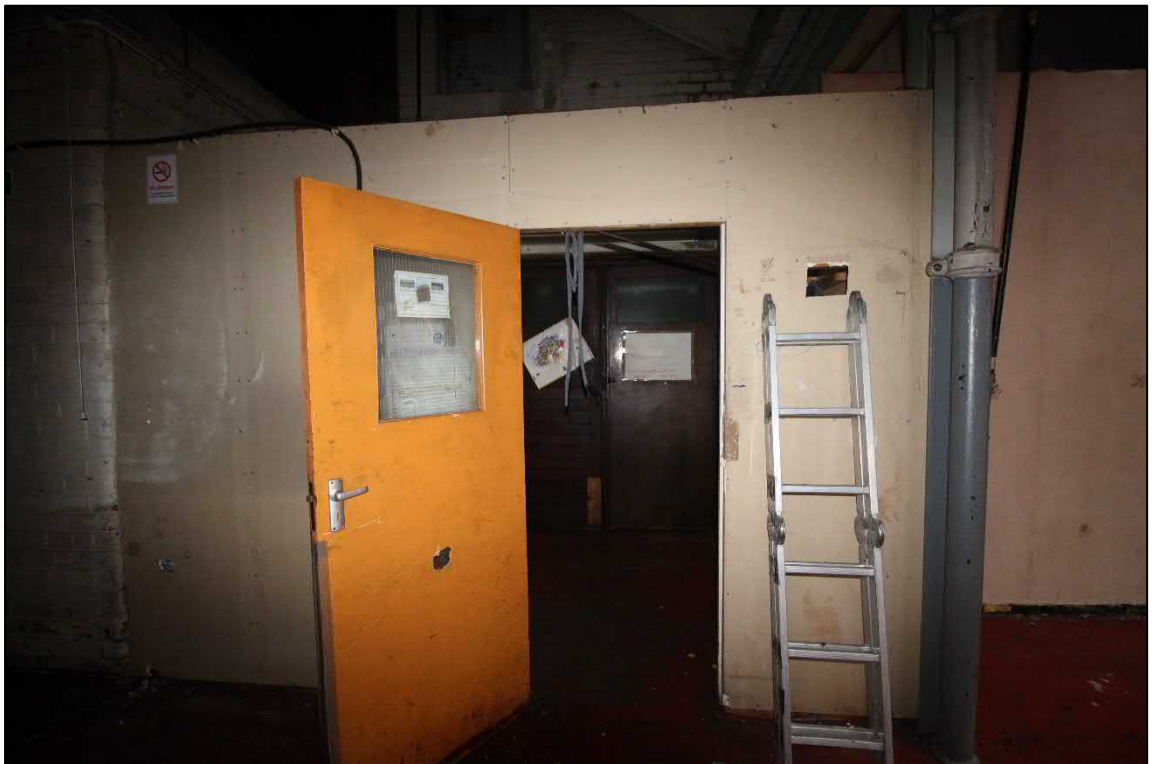
*Plate 53: The doorway and partition wall of the northern lift lobby*

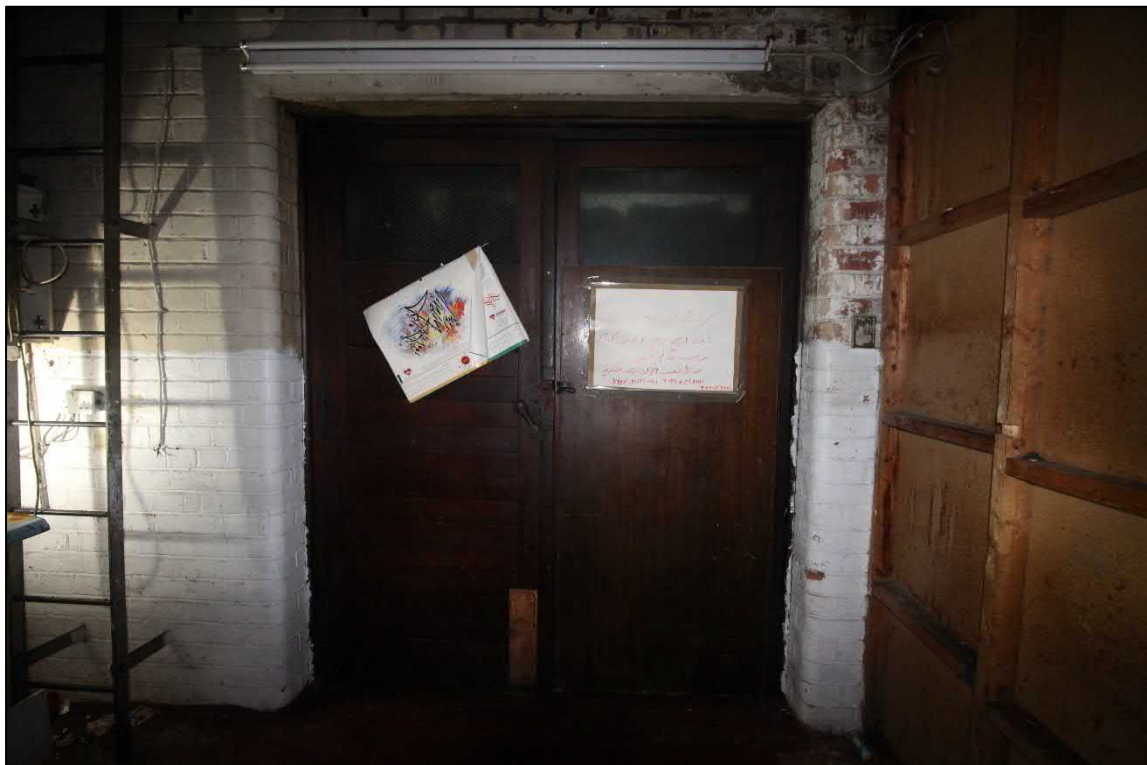
The lobby had been formed using plywood and timber framing, but originally had been unrestricted. The lift shaft was constructed in brick with the doorway situated at the centre of the south-eastern wall. This consisted of bullnose brick reveals with a concrete lintel and had retained the original timber door (Plate 54). No access was gained into the lift. A small doorway was situated at ceiling height within the south-western end of the shaft. This gave access into a small room that had contained the lift winding gear. The doorway had bullnose brick reveals, a flush concrete lintel and threshold. A timber ledge and braced door was housed within the opening (Plate 55).

*Plate 54: The lift doorway on the south-eastern wall of the lift shaft*

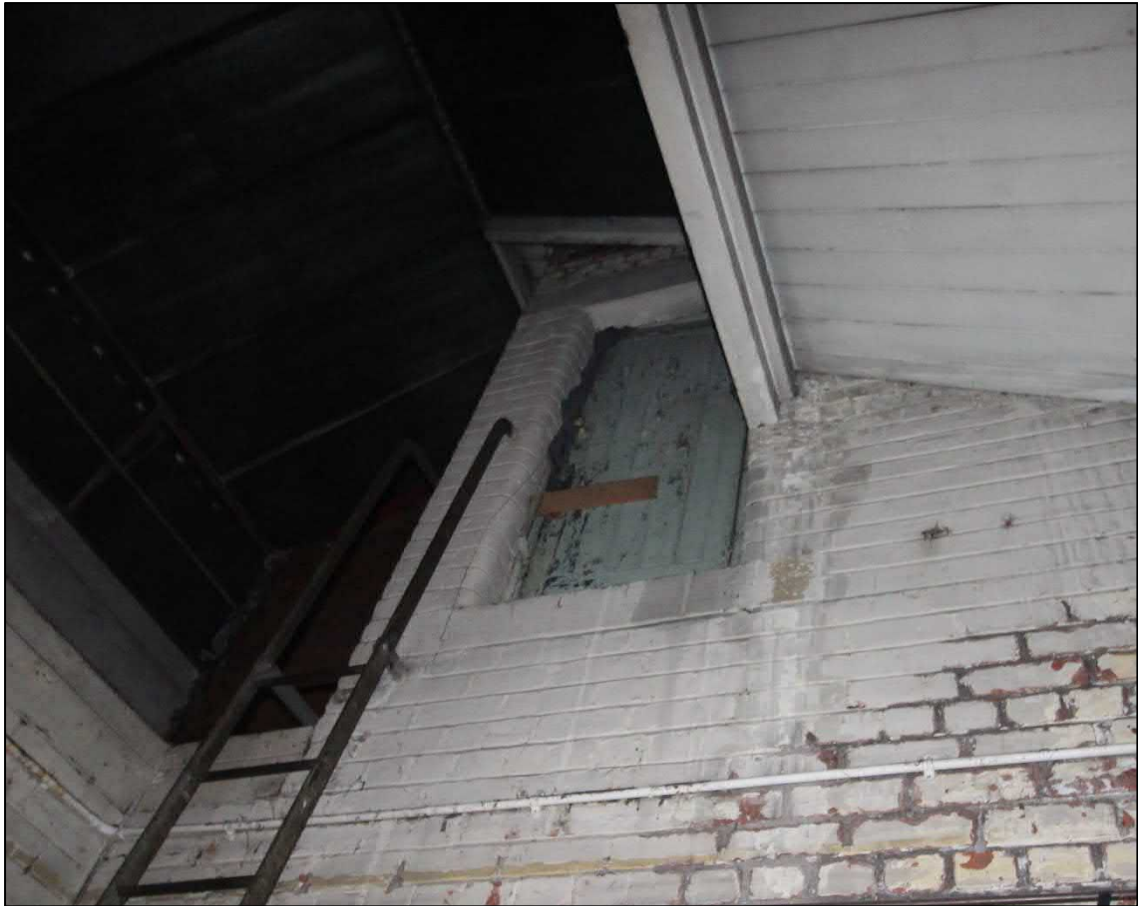
*Plate 55: The doorway leading to the small room containing the lift winding gear*

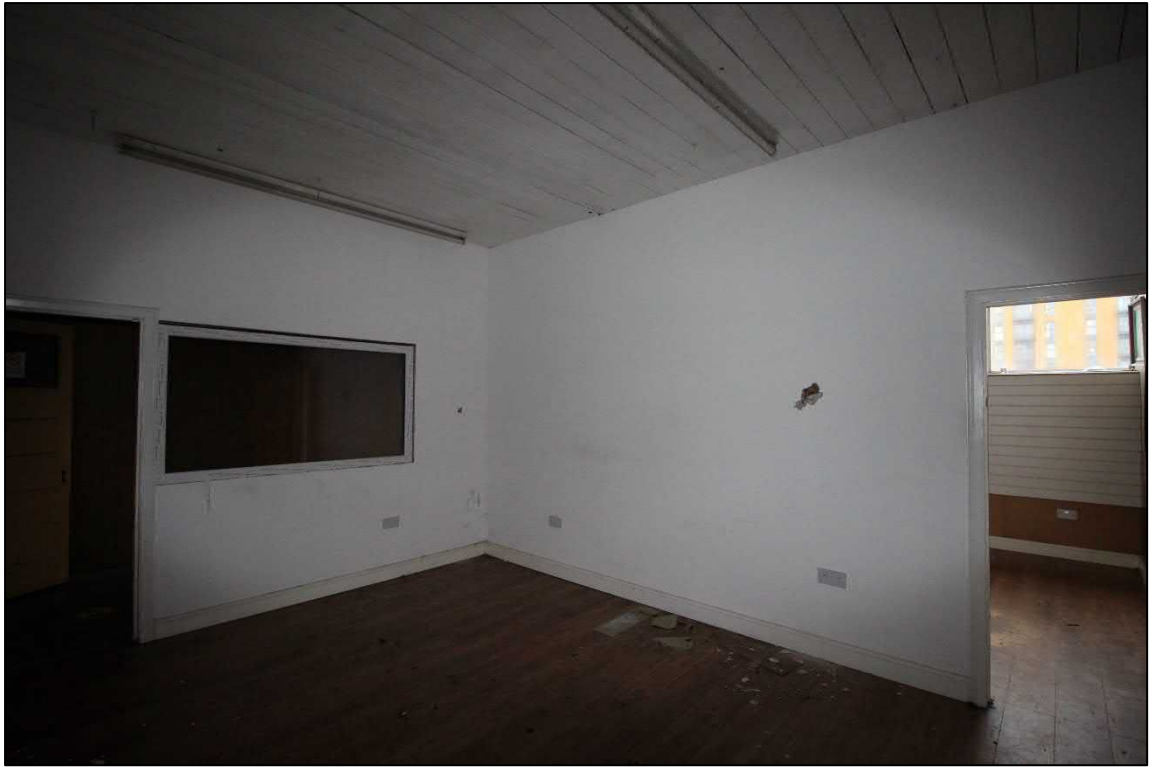
The modern constructed offices at the north-eastern end consisted of timber framed partition walls, a concrete floor that had been covered in modern timber laminate flooring and a false suspended ceiling (Plate 56). The north-eastern wall of the north-eastern office had contained a bank of four-horizontal uPVC casement windows. These had been housed in aperture that consisted of a concrete lintel and brick sill that had been obscured by tongue and groove timber boards that had recently been attached to the brick wall (Plate 57).

*Plate 56: The central office at the north-western end of the warehouse*

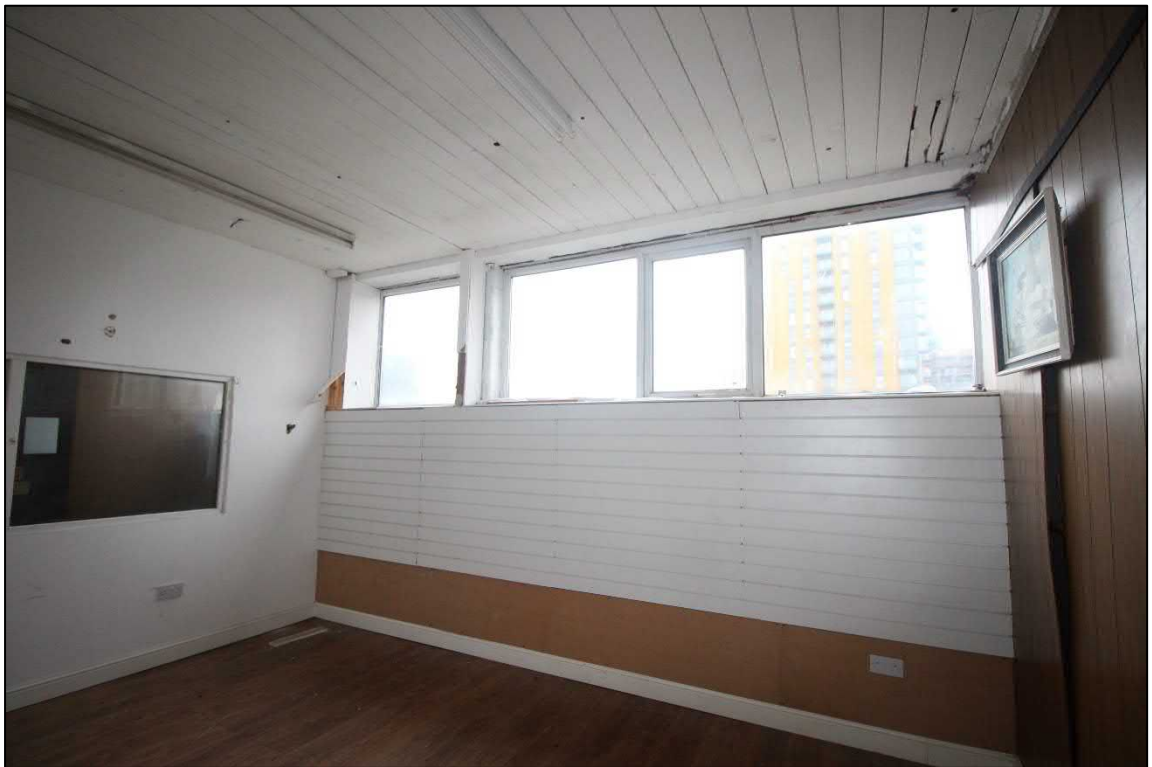
*Plate 57: The north-eastern wall of the warehouse, detailing the altered windows*

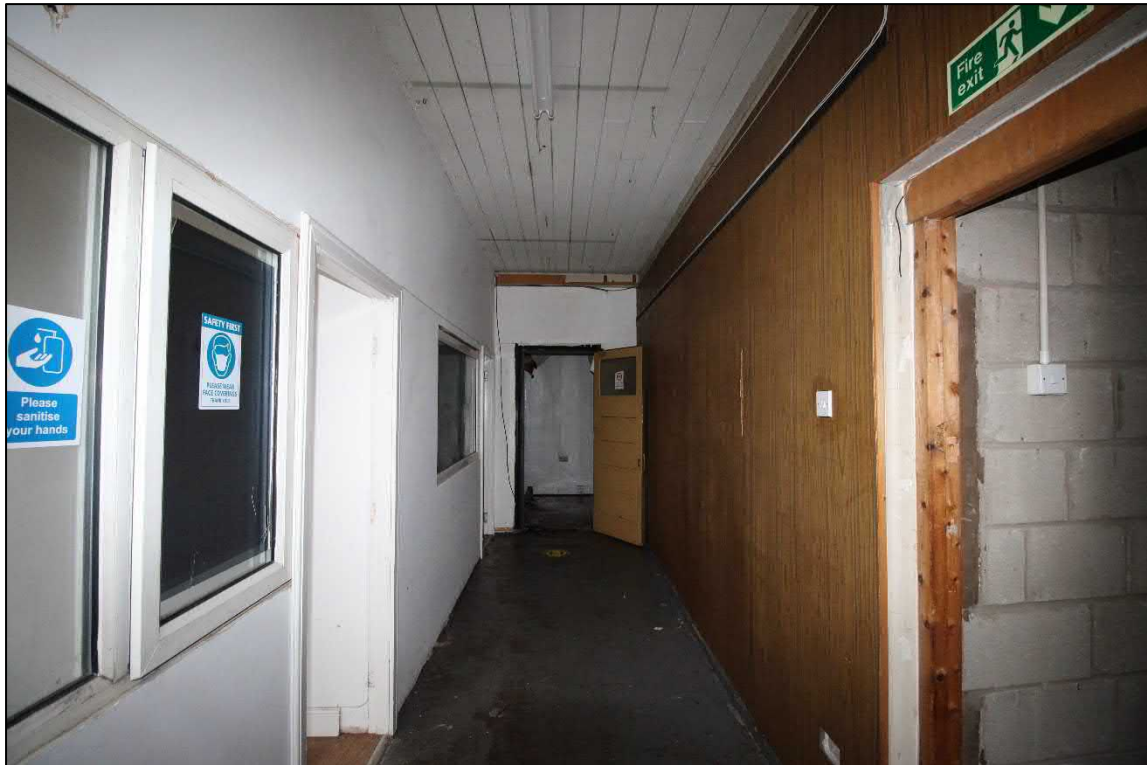
The north-western wall to each office gave access into a small narrow corridor that had been built after the front office block had been constructed (Fig 3). This had a timber panelled suspended ceiling, plywood clad walls and a painted concrete floor. The north-western wall of was the original gable of the warehouse which had been obscured by the cladding on the wall (Plate 58).

*Plate 58: The northern corridor at the north-western end of the warehouse*

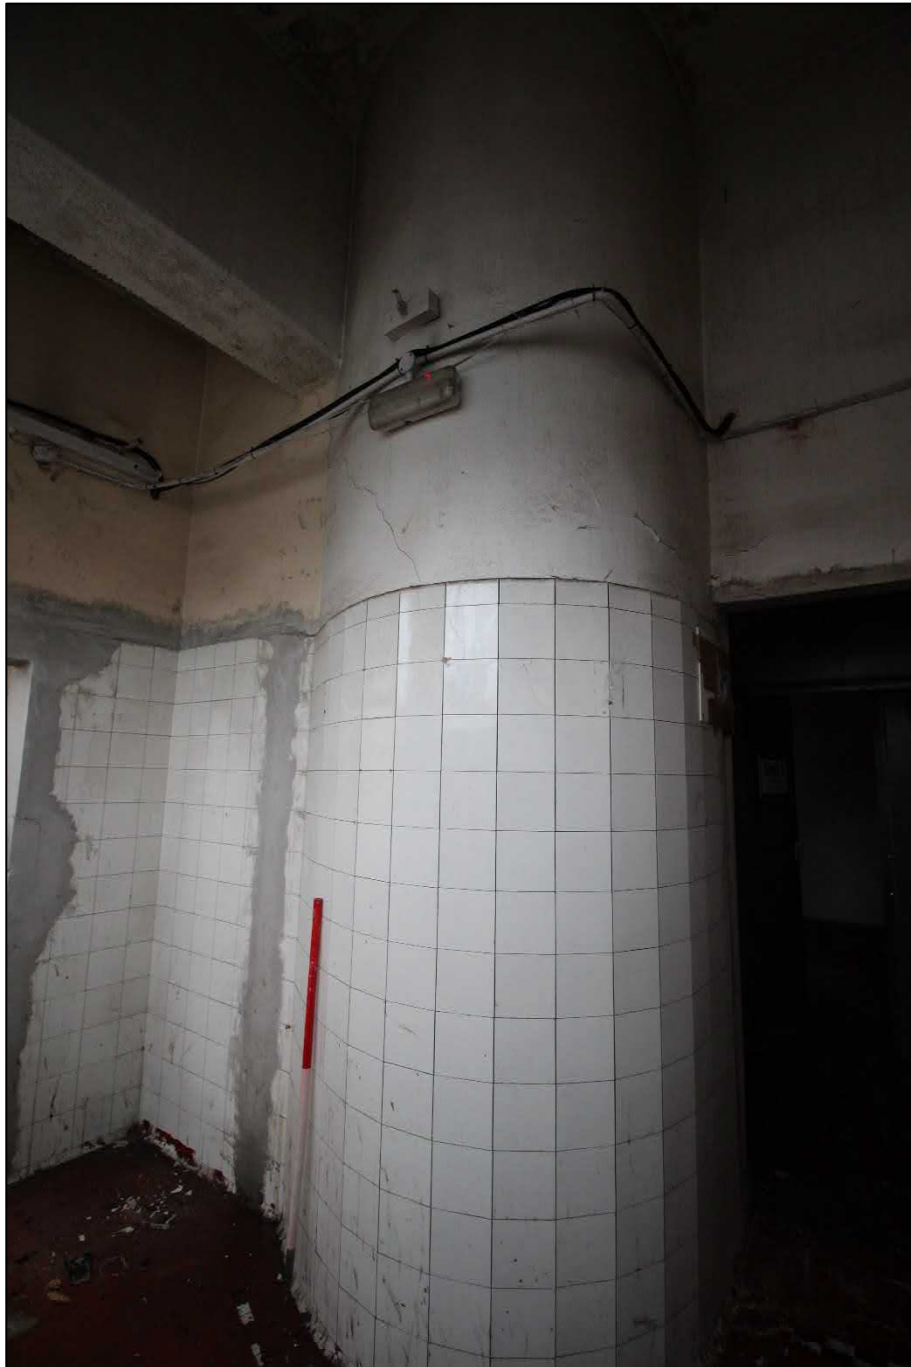
At the northern end of the corridor was a circular stairwell which gave access into a small attic space. The stairwell had concrete rendered walls with white tiles on the external face (Plate 60). Internally, a small cast-iron spiral staircase with mesh treads and open risers had been situated at the centre of the stairwell (Plate 61). At the top of the stairs were two rooms containing the lift winding gear (Plate 62). Each room had painted brick walls, concrete floors and suspended concrete ceilings (Plate 62).

*Plate 60: The round stair tower at the northern end of the corridor*
