## Historic Building Investigation

Swan House,  
Rochdale Road,  
Manchester

**Report No:**  
SA/2021/11

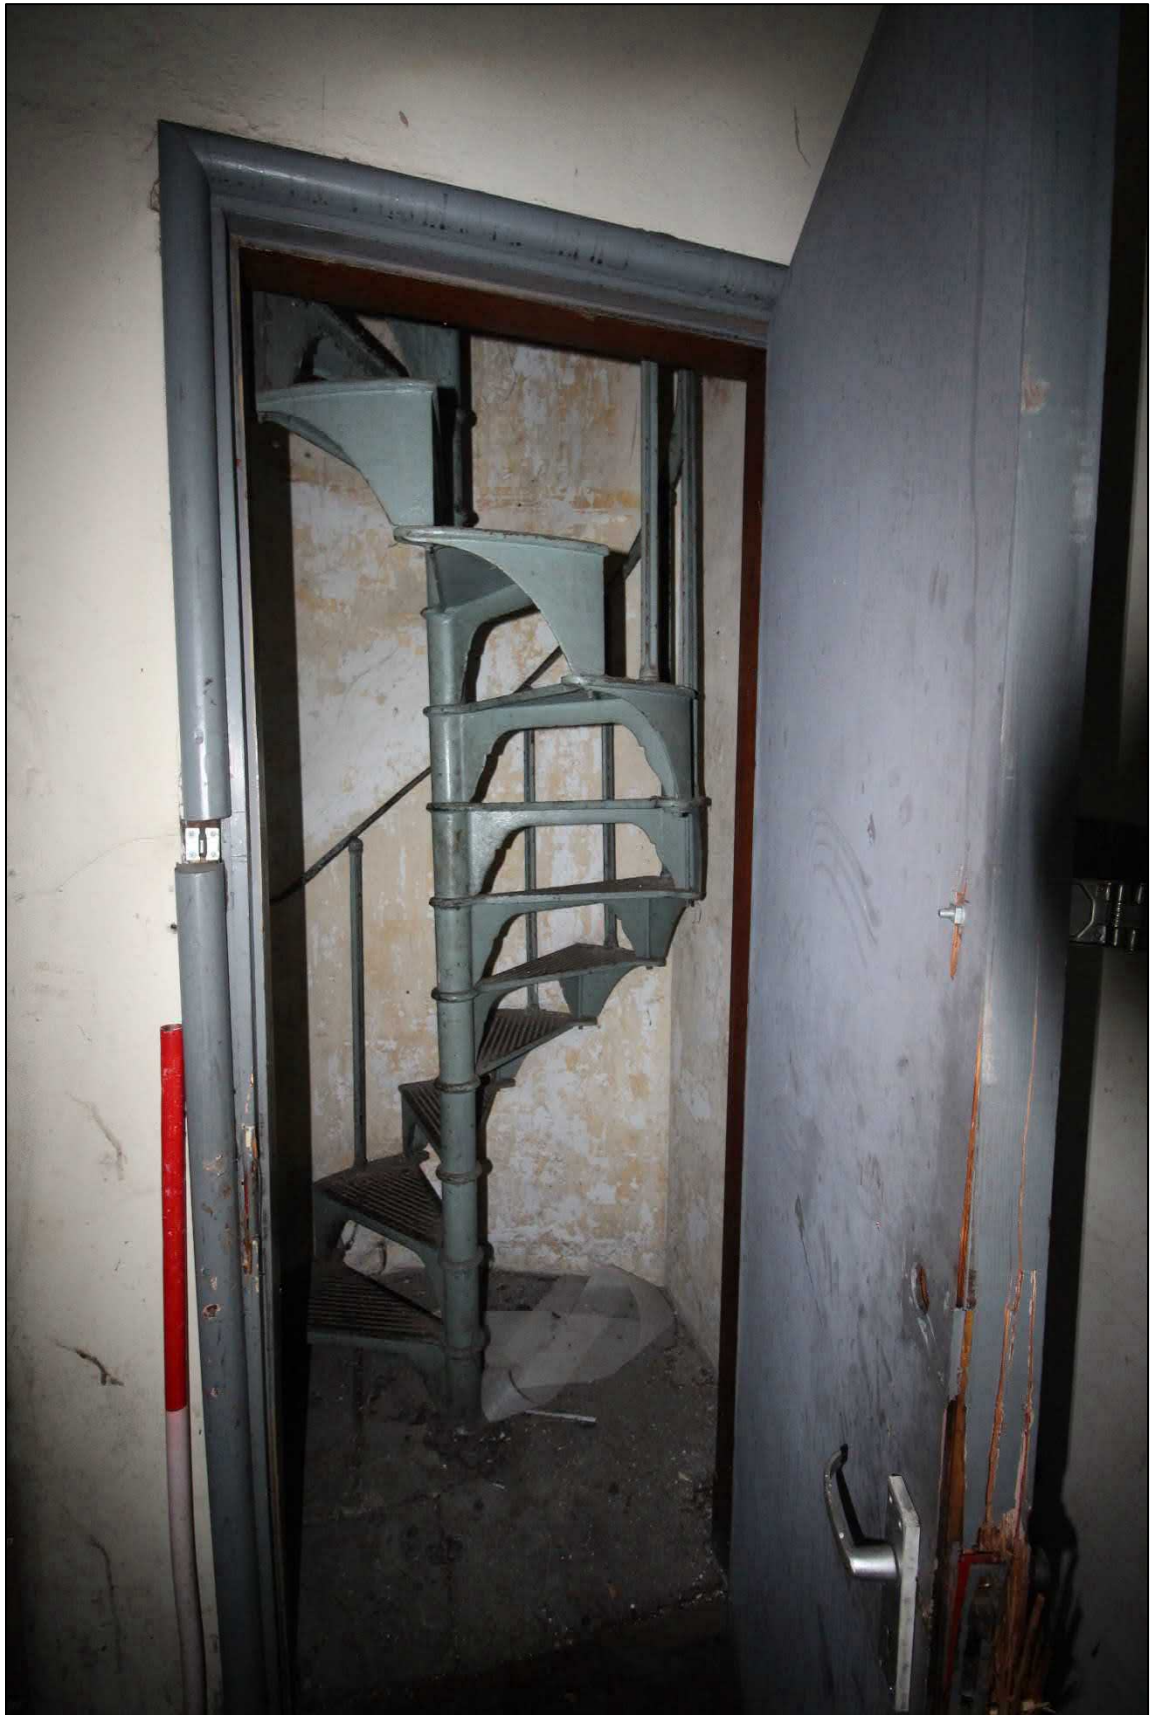
At the northern end of the corridor was a circular stairwell which gave access into a small attic space. The stairwell had concrete rendered walls with white tiles on the external face (Plate 60). Internally, a small cast-iron spiral staircase with mesh treads and open risers had been situated at the centre of the stairwell (Plate 61). At the top of the stairs were two rooms containing the lift winding gear (Plate 62). Each room had painted brick walls, concrete floors and suspended concrete ceilings (Plate 62).

*Plate 61: The spiral staircase leading to the roof space of the later office block*

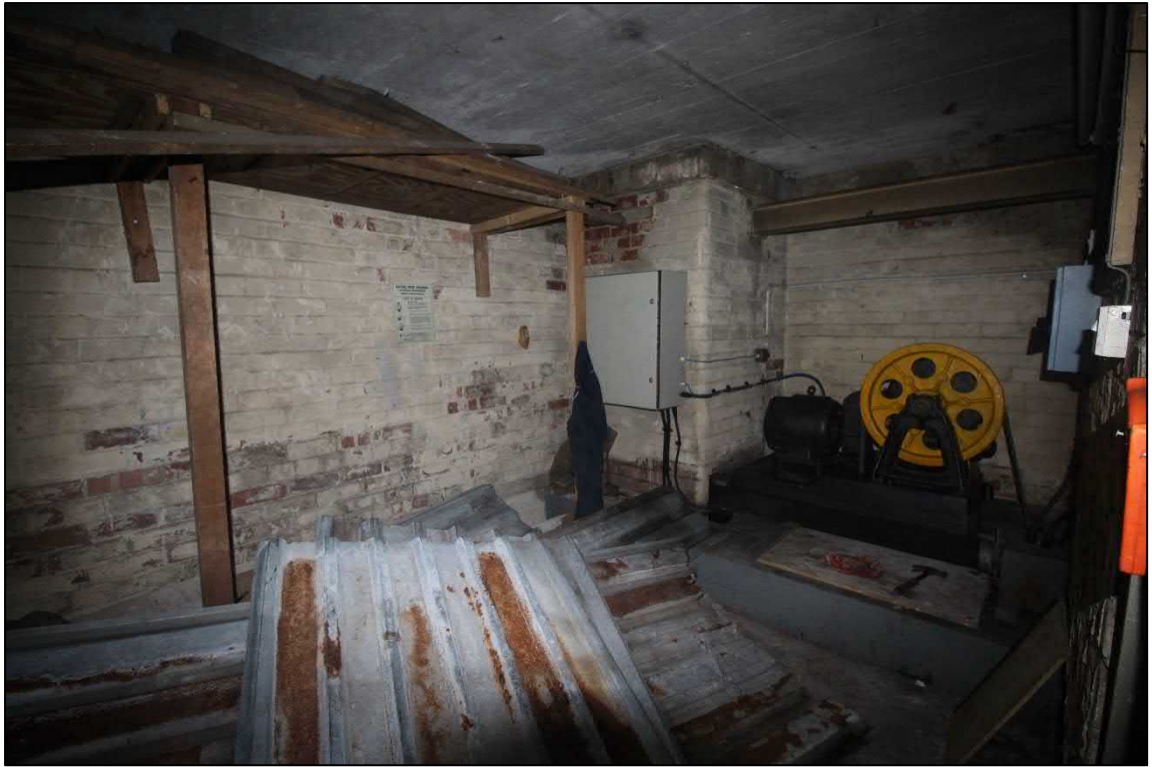
*Plate 62: The lift winding gear room*

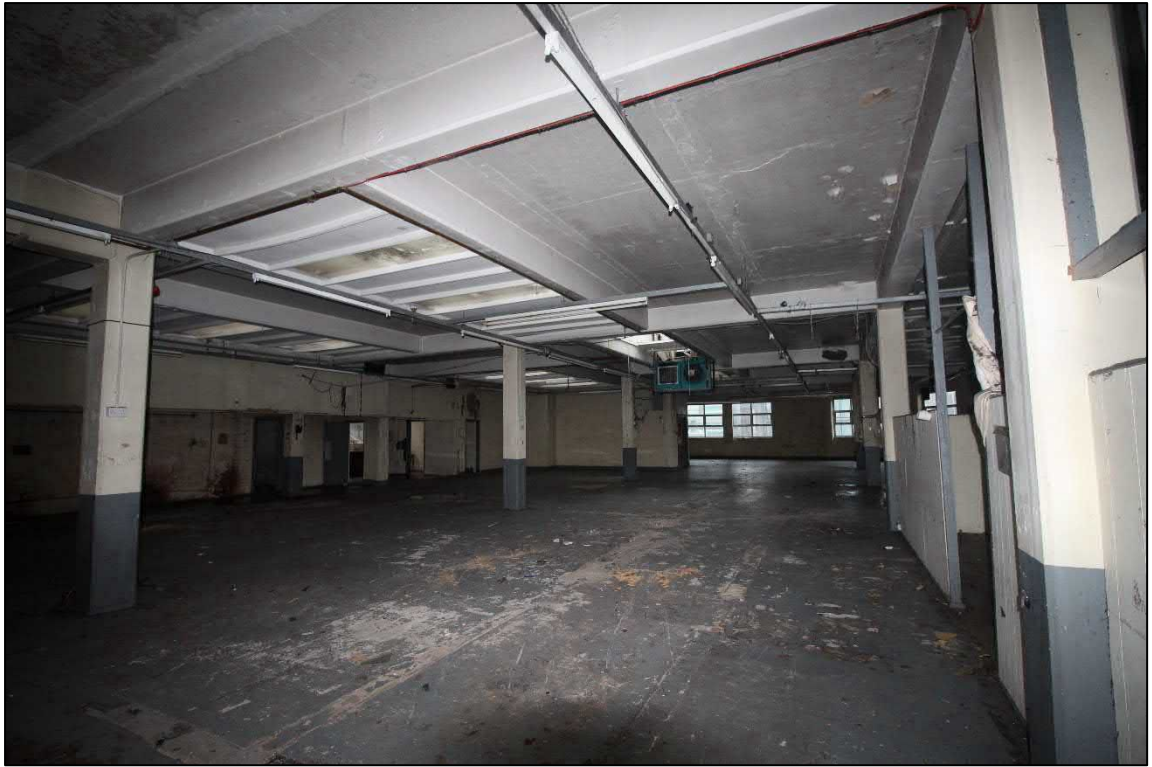
The office block had been divided into nine compartments with six of the rooms having been built using timber framed and concrete block walls. The main central room of this level was open plan, consisting of a painted concrete floor, painted brick walls and a suspended ceiling. The ceiling had been supported by concrete rendered beams and a single row concrete rendered columns (Plate 63). The tall vertical windows on the north-western and western walls had bullnose reveals with a three-light uPVC window housed within the openings (Plate 64).

*Plate 63: General view of the central room of the later office block*

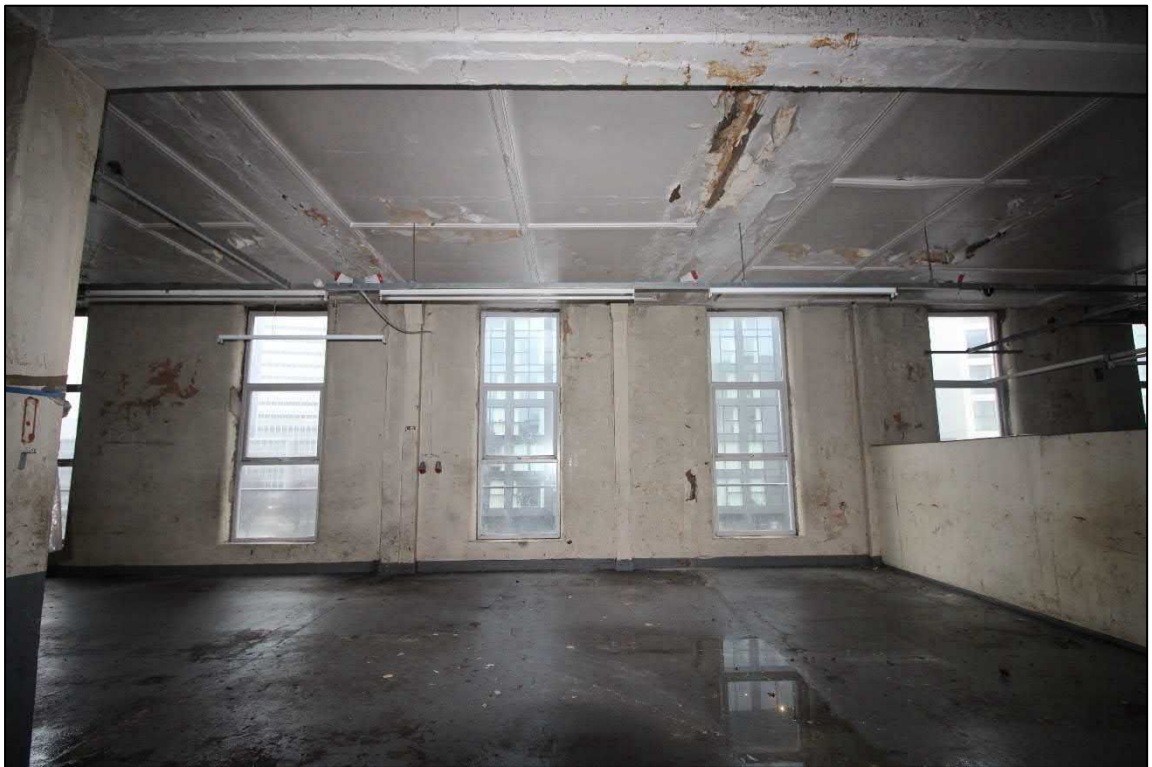
*Plate 64: The north-western wall of the later office block*

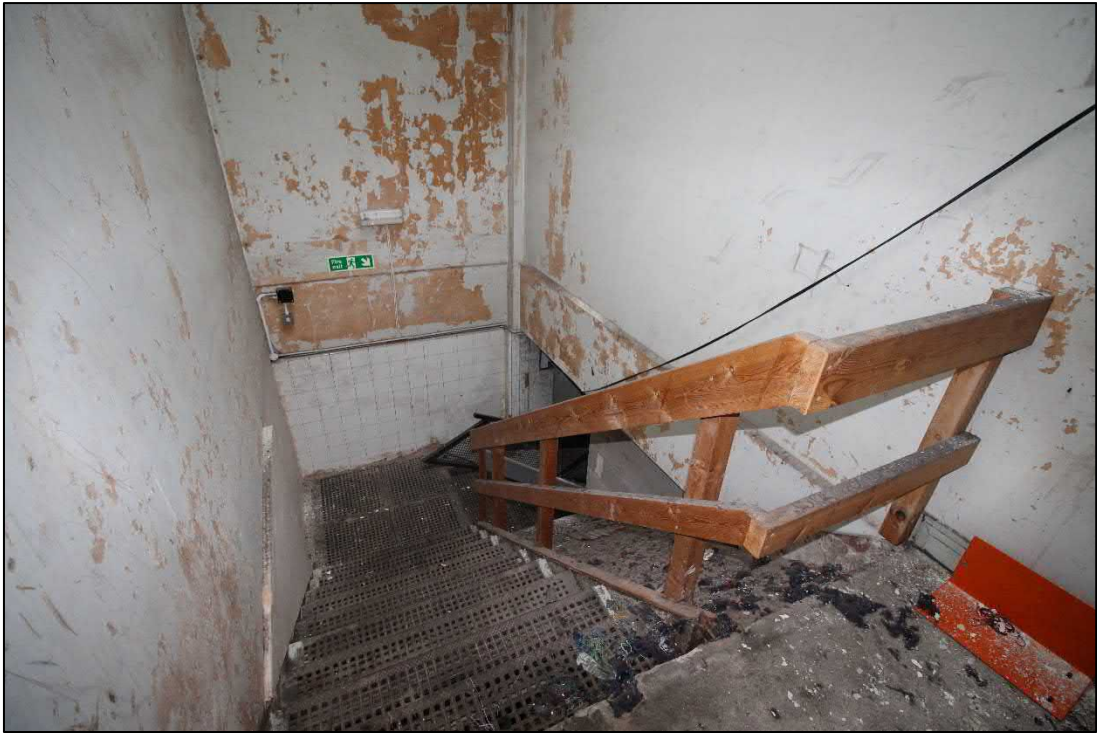
The main room had been accessed vertically by two stairwells situated to at the southern end of the level. Each had mesh steel treads with open riser stairs that had been built into the stairwell walls (Plate 65). The first-floor landing of the central of the two had also contained a blocked doorway that had originally given access into the northern end of the warehouse. This had bullnose brick reveals, a flush chamfered-edge concrete lintel and had been blocked using modern concrete blocks (Plate 66).

*Plate 65: The southern stairwell of the later office block*

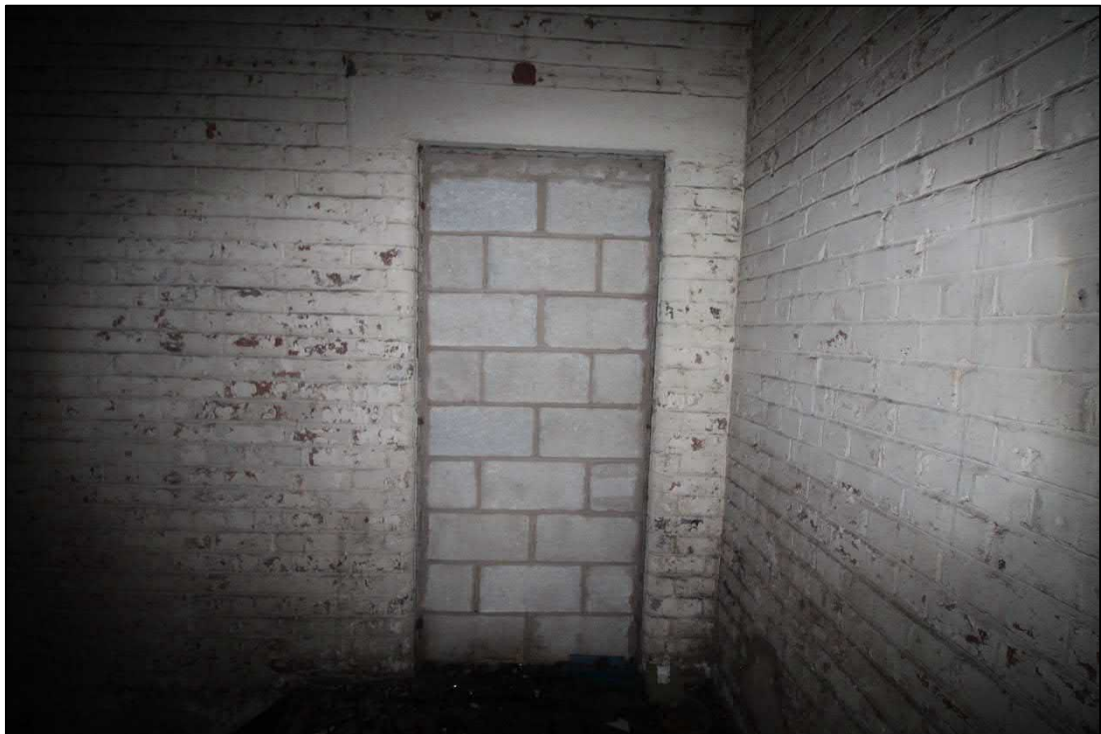
*Plate 66: The doorway within the central stairwell originally giving access into the first-floor of the warehouse*

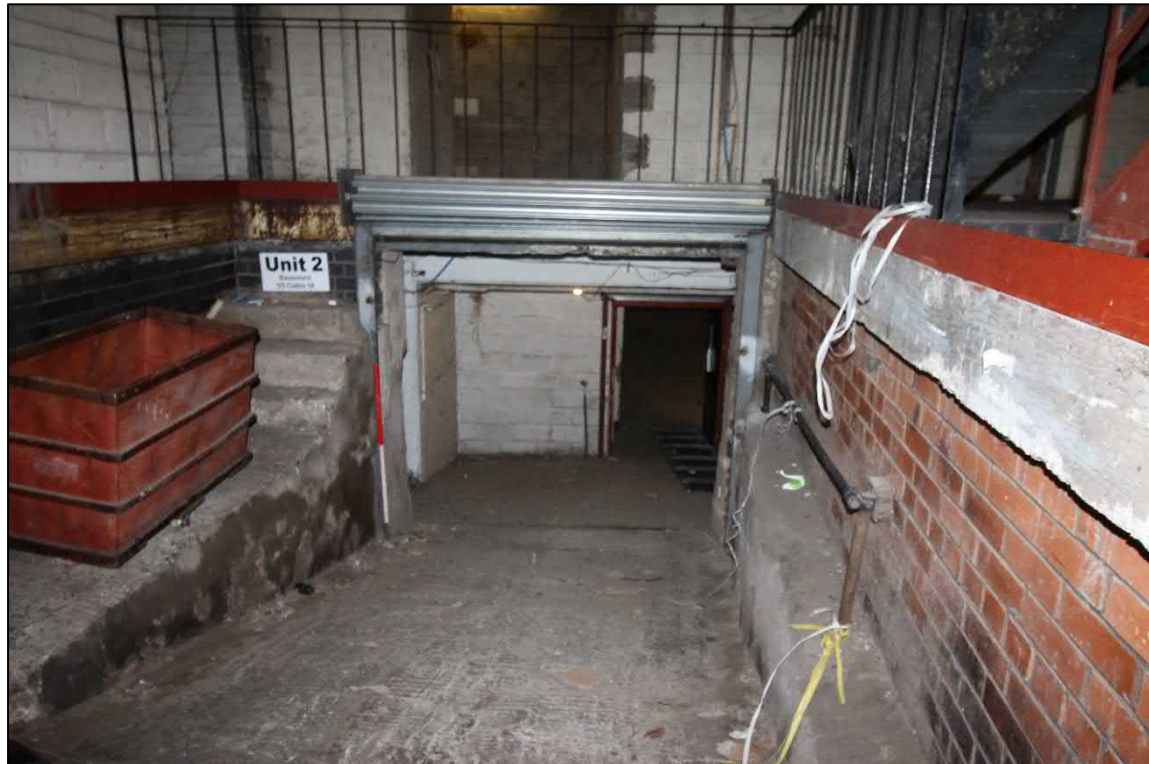
*Plate 67: The doorway leading into the warehouse basement*

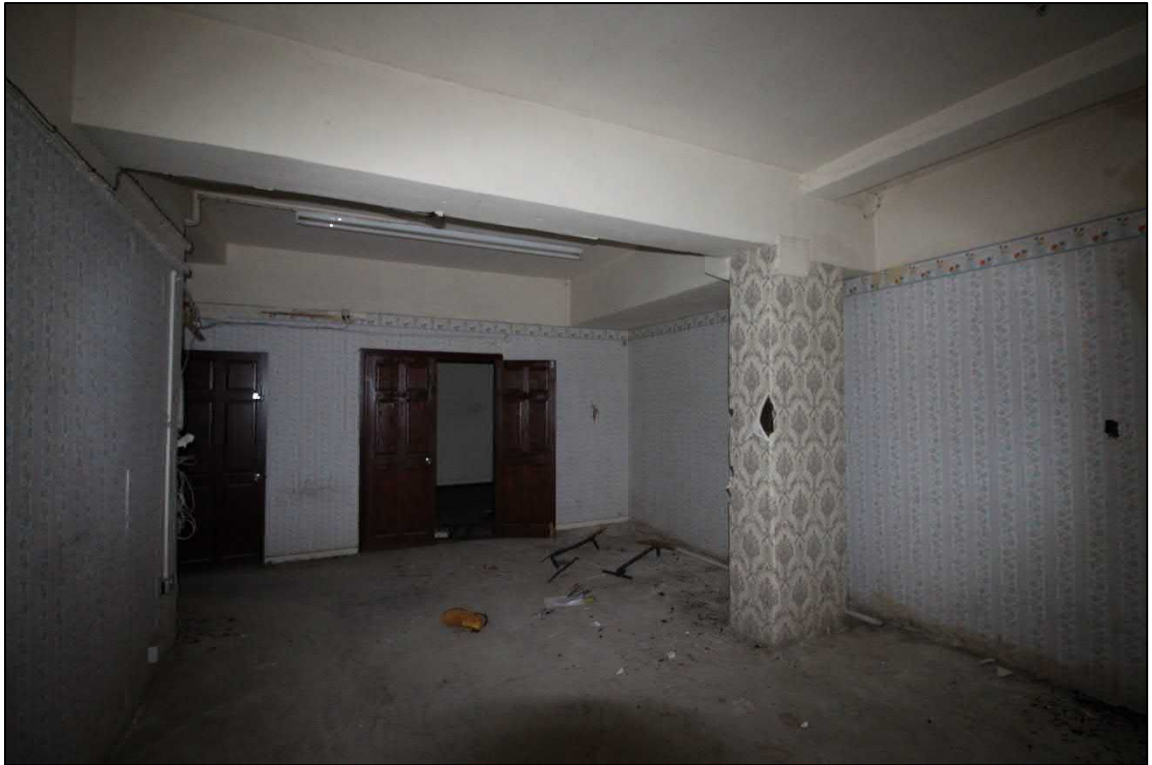
Each of the small rooms had recently been used as offices, comprised of timber-framed partition walls, concrete floors, and suspended ceilings, with the northern room having a false suspended ceiling (Plate 68). The original ceiling had been supported by steel beams and columns that had recently been boxed in using plasterboard (Plate 68). The north-eastern wall was built using concrete blocks and had served as the dividing wall between the room and a narrow corridor, which provided access into the large north-western room of the basement.

*Plate 68: One of the northern offices within the basement of the office/warehouse block*

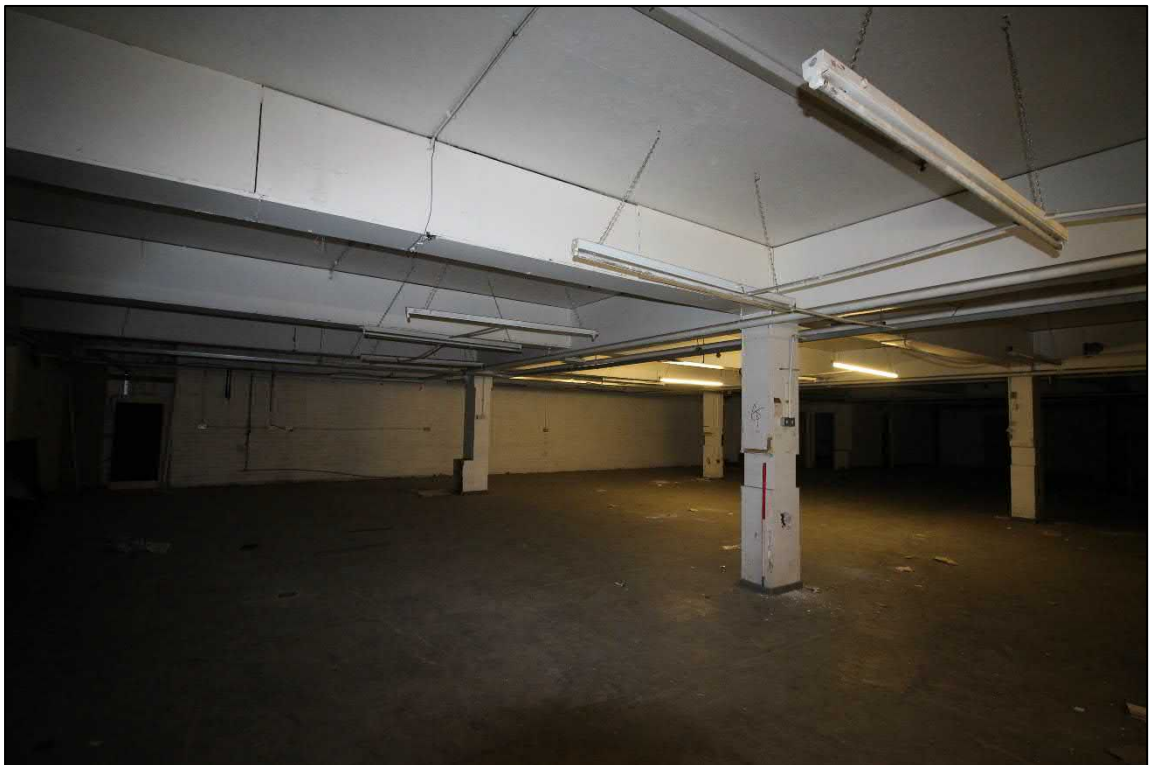
The large south-eastern room was open plan, comprising four-bays north-east/south-west by three-bays north-west/south-east. It had a concrete floor, painted brick walls and an open ceiling, revealing the underside of the ground-floor floor. This steel I-section beams and columns had been boxed in using plasterboard (Plate 69).

*Plate 69: General view of the south-eastern room*

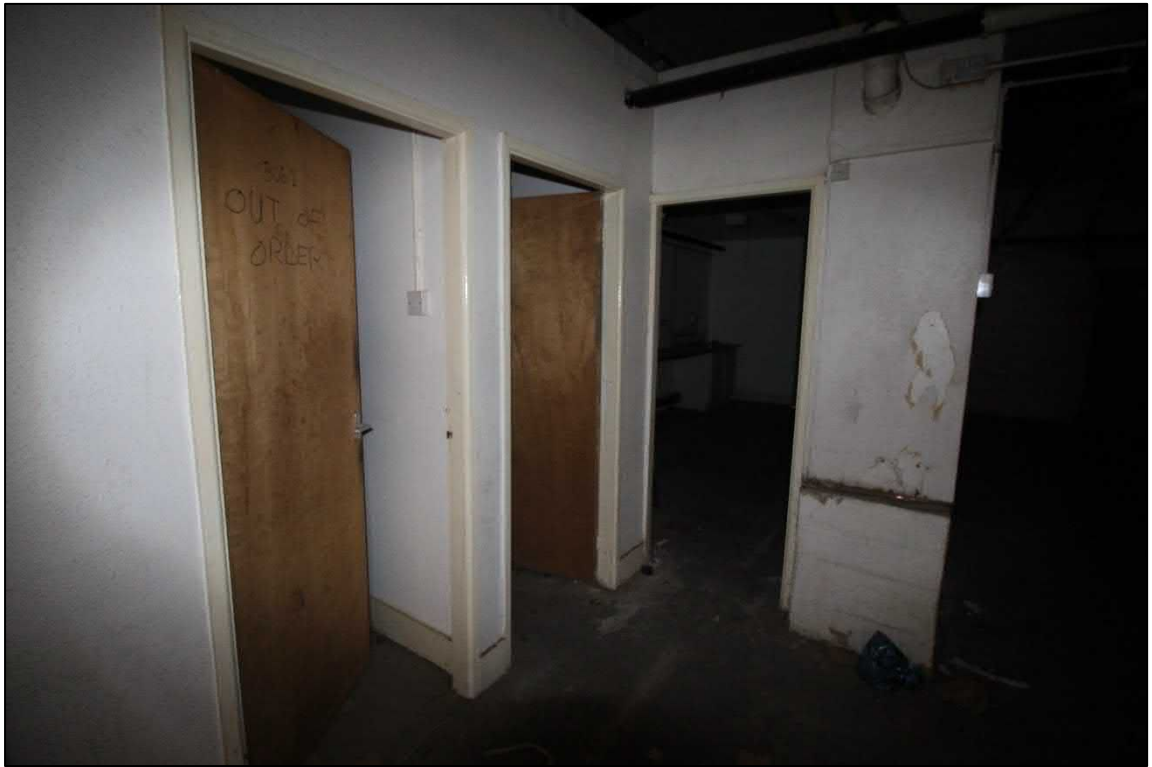
*Plate 70: The doorways of the kitchen and toilets*

At the north-western end of the room were two rooms that had latterly been in use as a kitchen and a set of toilets. Entry into each room was gained through doorways that consisted of simple rectangular architraves with flush timber doors within the openings (Plate 70). The toilets had timber framed partition walls with false suspended ceilings and contained modern sanitaryware. The kitchen consisted of a suspended plasterboard ceiling, painted brick walls and a painted concrete floor. The room had retained some of the modern kitchen units and sink at the eastern corner (Plate 71).

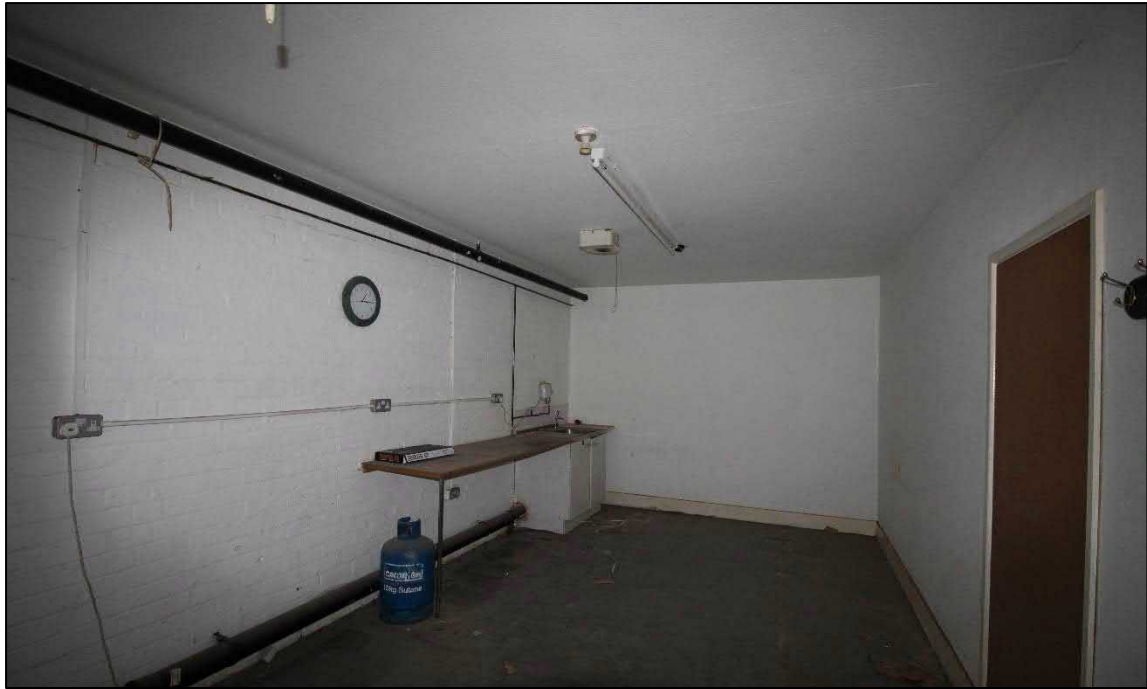
*Plate 71: The kitchen at the north-west end of the south-eastern compartment of the basement*

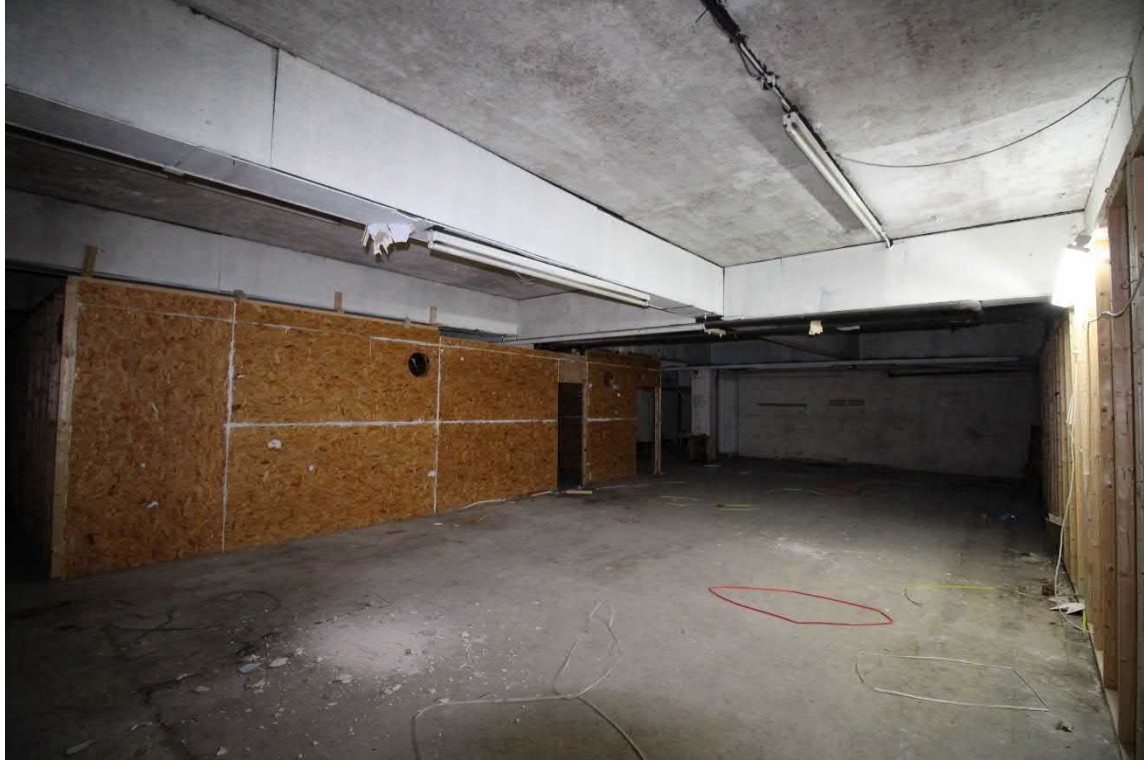
This room had until recently been open plan. A modern (MDF) timber-walled division had been built at the western corner of the room. Excepting this modern addition, the room was of three-bays north-east/south-west by three-bays north-west/south-east. It had a concrete floor, painted brick walls and an open ceiling, exposing the underside of the ground-floor floor. The steel I-section beams and columns were boxed in with plasterboard (Plate 73).

*Plate 73: General view of the north-western room*

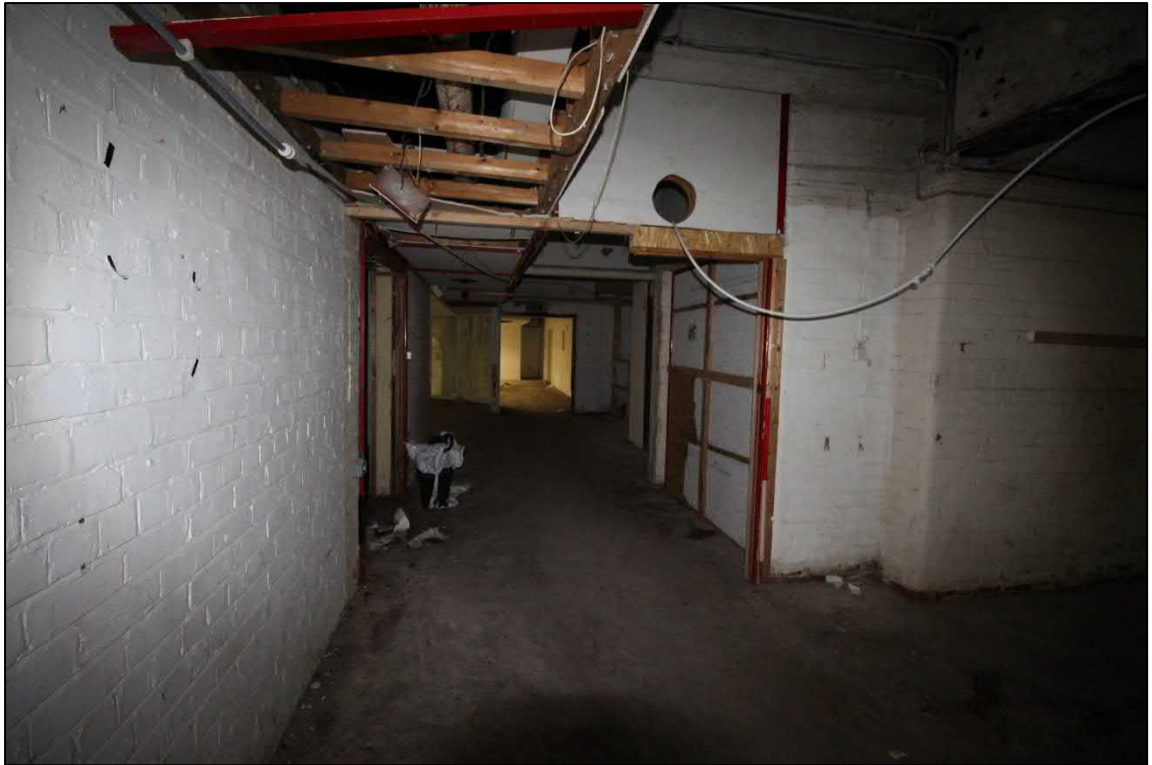
The north-western wall of the room contained a single doorway that gave entry into a small corridor providing internal access between the warehouse and office block basements (Fig 4; Plate 74). This corridor had a single room situated to the south-west, which had been converted into a modern privy. The room had painted plasterboard walls, a false suspended ceiling, and a tile floor (Plate 75). Three small windows had been inserted into the south-western wall with the central window containing a galvanised steel air duct (Plate 75).

*Plate 74: The doorway leading to the linking corridor between the buildings*

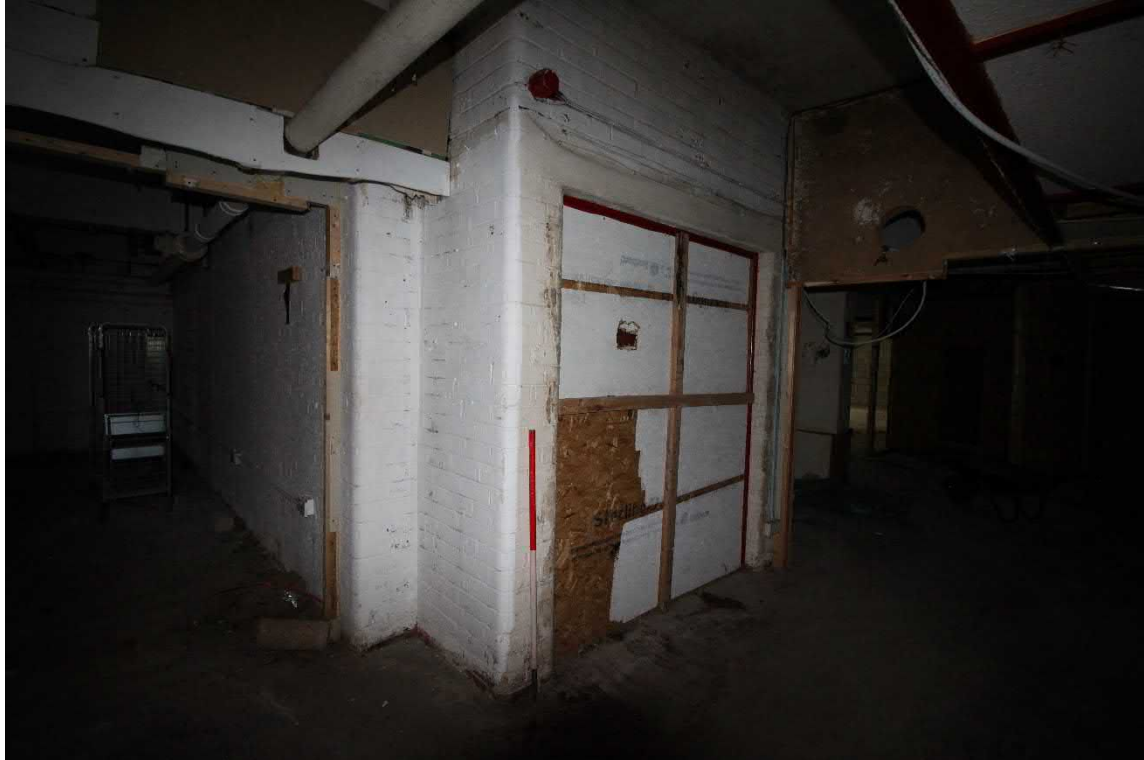
Entry into the stairwell at the north-eastern end of the corridor was gained doorway with bullnose brick reveals and a flush concrete lintel. The opening had recently been blocked. The closed stringer staircase (with mesh steel treads and open risers) was however visible through an aperture in the blocking. As described above, a hollow steel tube handrail that was supported but steel balusters had been bolted to the stringers (Plate 76).

*Plate 76: The blocked entrance into the north-eastern staircase*

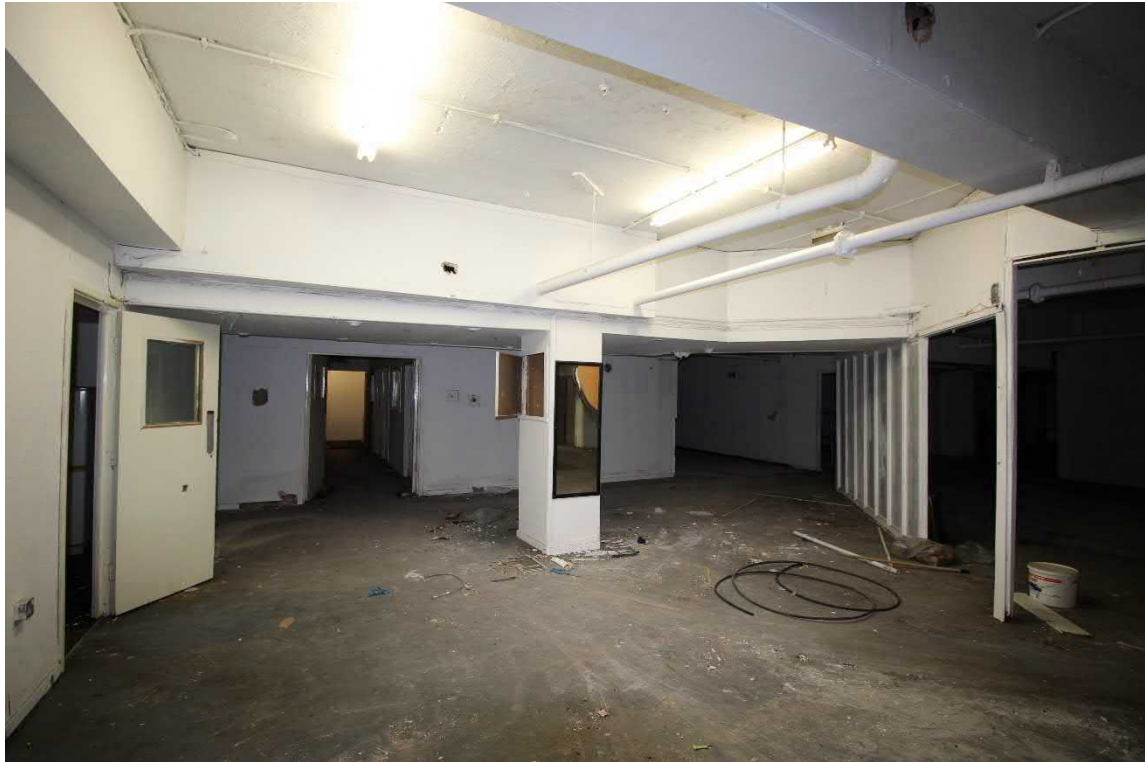
The building had been divided into 15 compartments, with eight compartments having been created recently using timber framed partition walls (Fig 4). Each of the rooms consisted of concrete floors, painted brick walls and open ceilings. The steel ceiling beams, and columns had been boxed in using plasterboard (Plate 77). The windows within the south-west and western walls comprised bullnose brick reveals, and sills with flush concrete lintels. These housed a small six-light, steel-framed window, glazed with 'obscure' – offering reduced visibility – glass panes (Plate 79).

*Plate 77: General view of the central room of the office block basement*

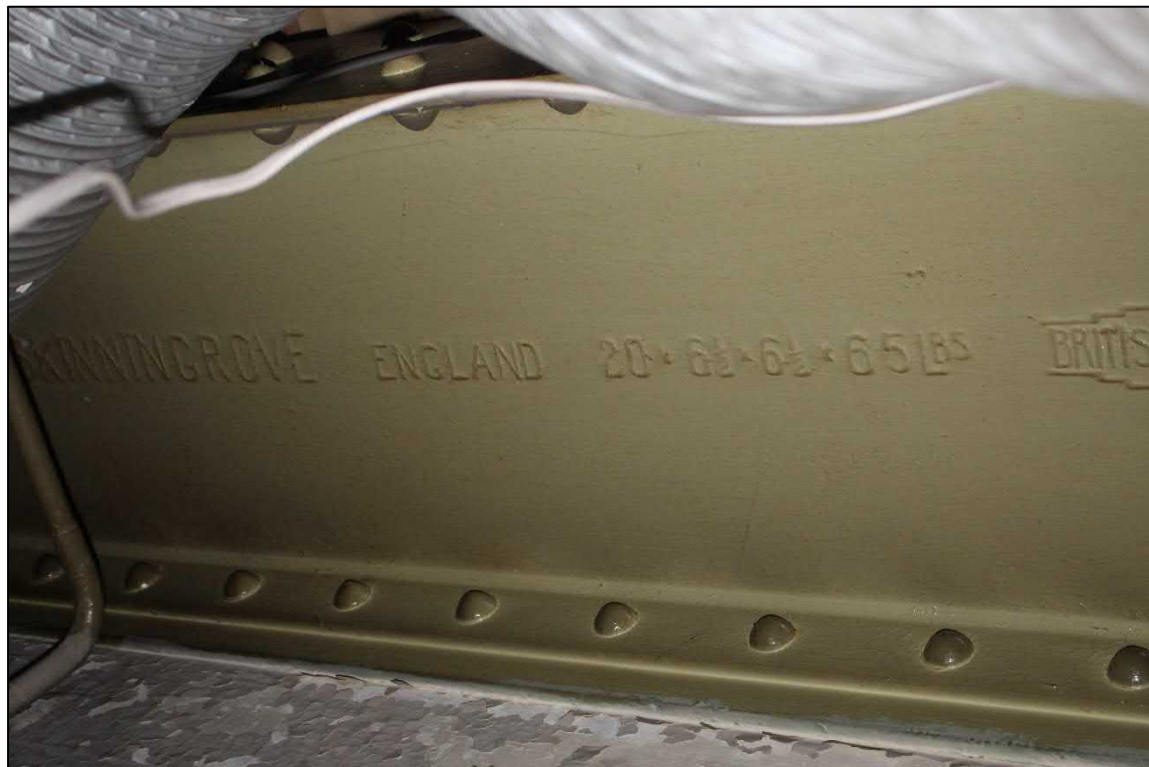
The basement of the office block had been constructed using Appleby-Frodingham Steel, which is consistent with the upper-floors. During the late-20<sup>th</sup> century some of the ceiling beams had been replaced with Skinningrove Steel (Plate 78).

*Plate 78: The rolling stamp of Skinningrove on the steel beams used in the later office block*

Several ceiling beams within the basement of this later building had been replaced using Skinninggrove Steel, which had a 'British Steel' rolling stamp. The Skinninggrove Iron Co was nationalised in 1951. This reinforces the notion that the building was established some time before 1948, as the structure underwent this alteration or repair. Based on the understanding that Skinninggrove ceased to be an independent company in 1951, the steel was probably produced before nationalisation and whilst it may be anticipated that existing stock bearing the stamp will have been in circulation post-1951, this nevertheless suggests that the extension was completed beforehand.

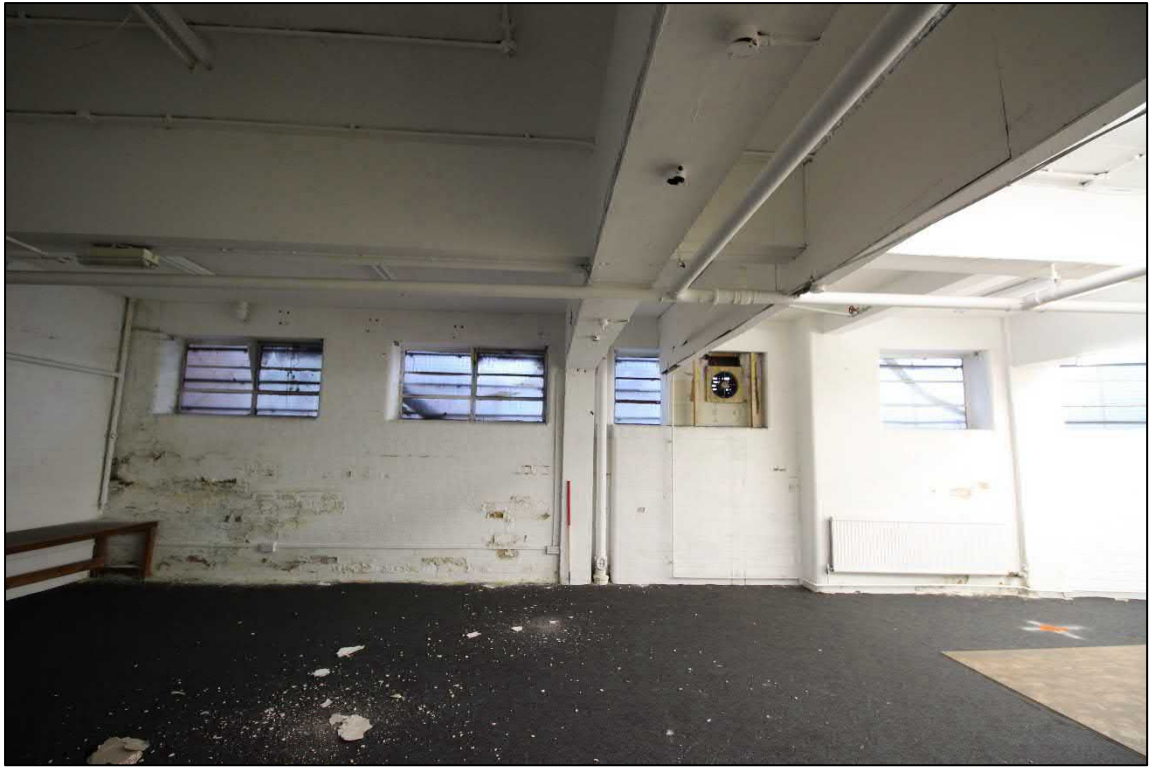
*Plate 79: The windows within the south-west wall*

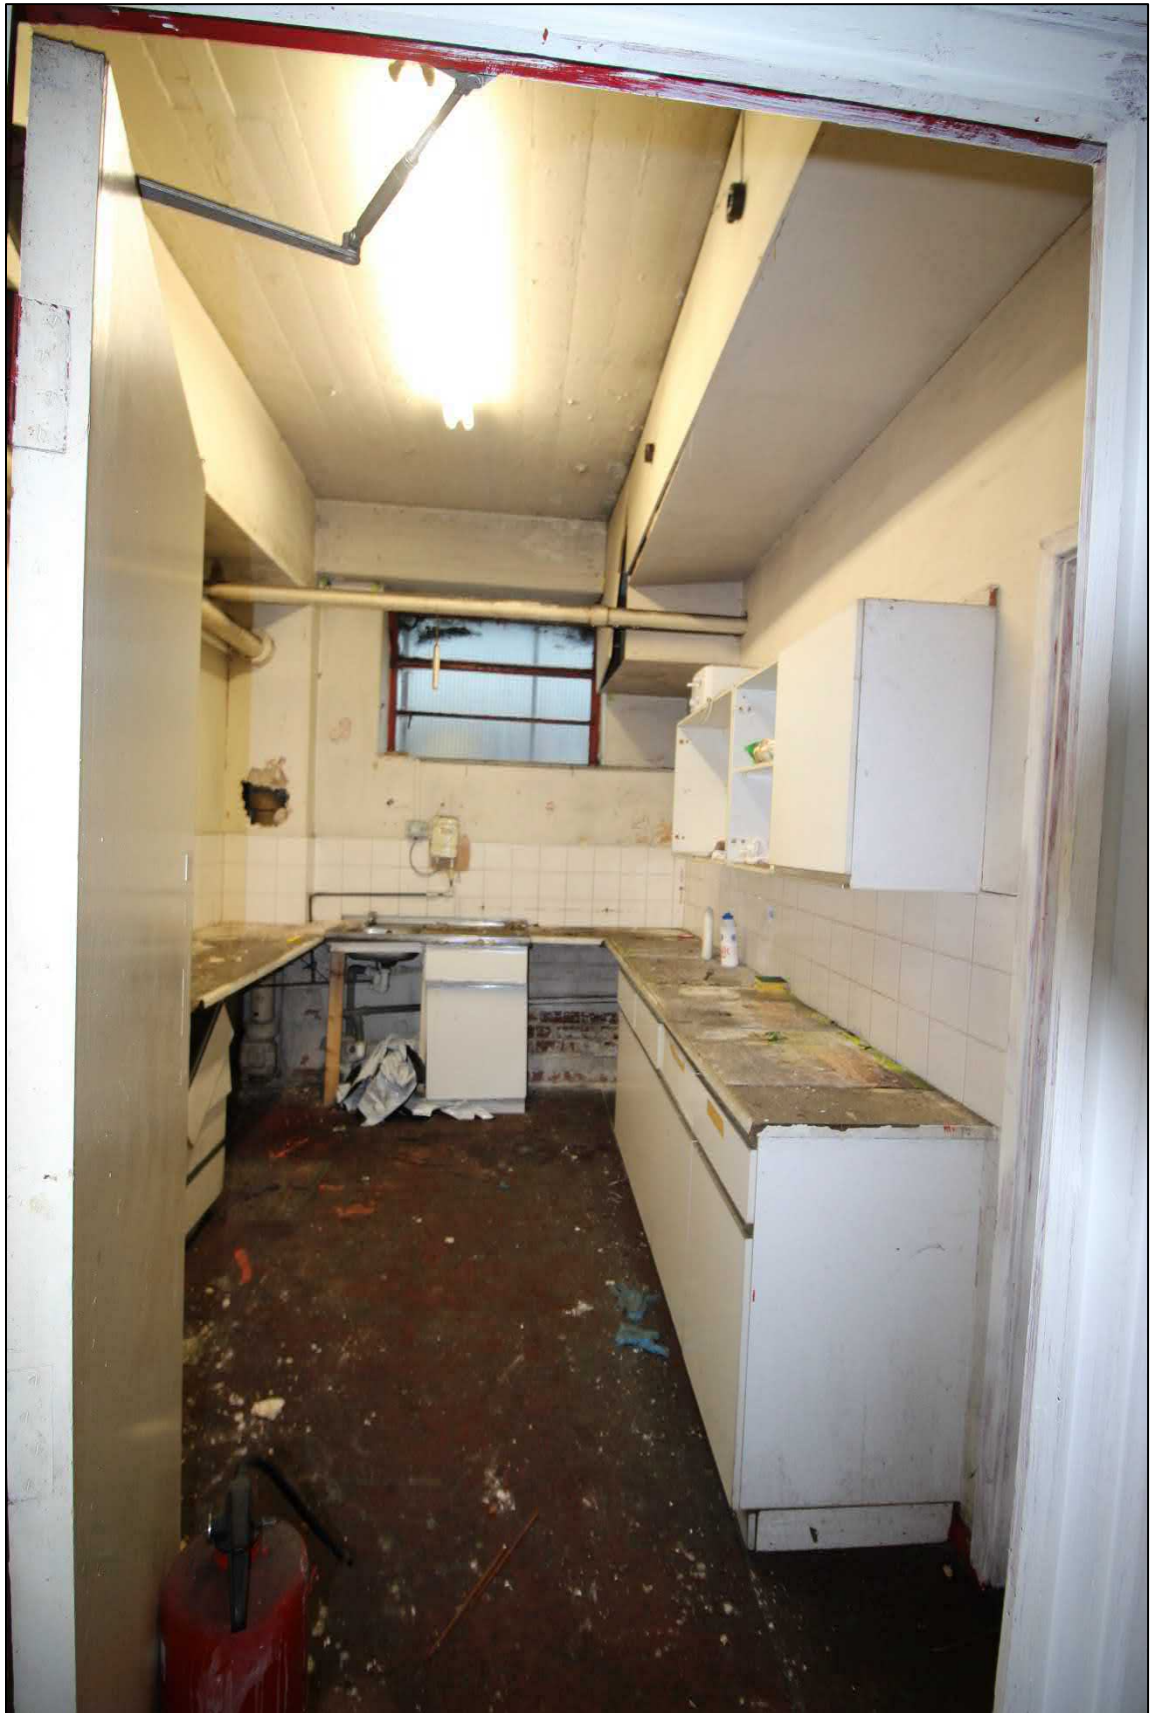
At the northern end of the basement was a small kitchen with a detached toilet to the north. The kitchen consisted of white tiled walls, a concrete floor, and a suspended ceiling. The kitchen units and sink are of late-20<sup>th</sup> century (Plate 80). A single window with bullnose brick reveals, and sill and a flush concrete lintel had been situated within the western wall. A six-light steel framed window glazed in obscure glass panes had been housed within the opening (Plate 80).

*Plate 80: The kitchen at the northern end of the basement*

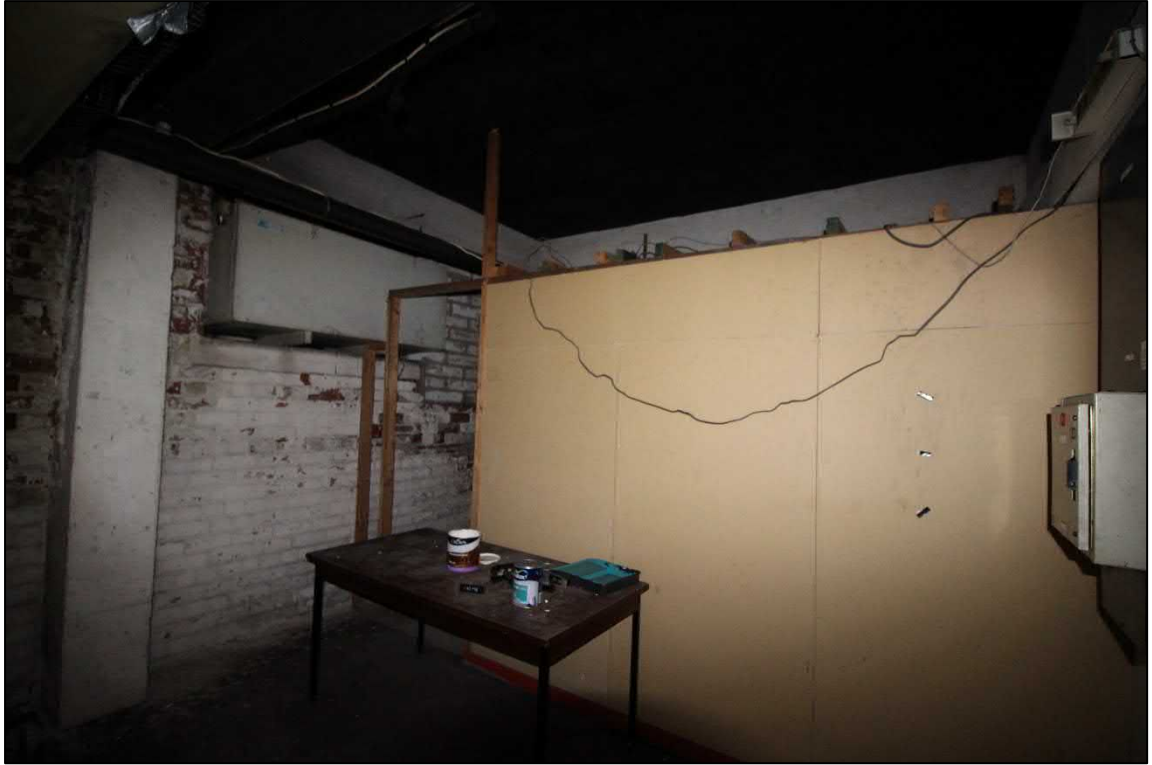
The toilet had painted brick walls, a concrete floor and an open ceiling that exposed the boxed in steel beams. Two cubicles with modern sanitaryware had been built at the northern end of the room (Plate 81).

*Plate 81: The toilet at the northern end of the basement*

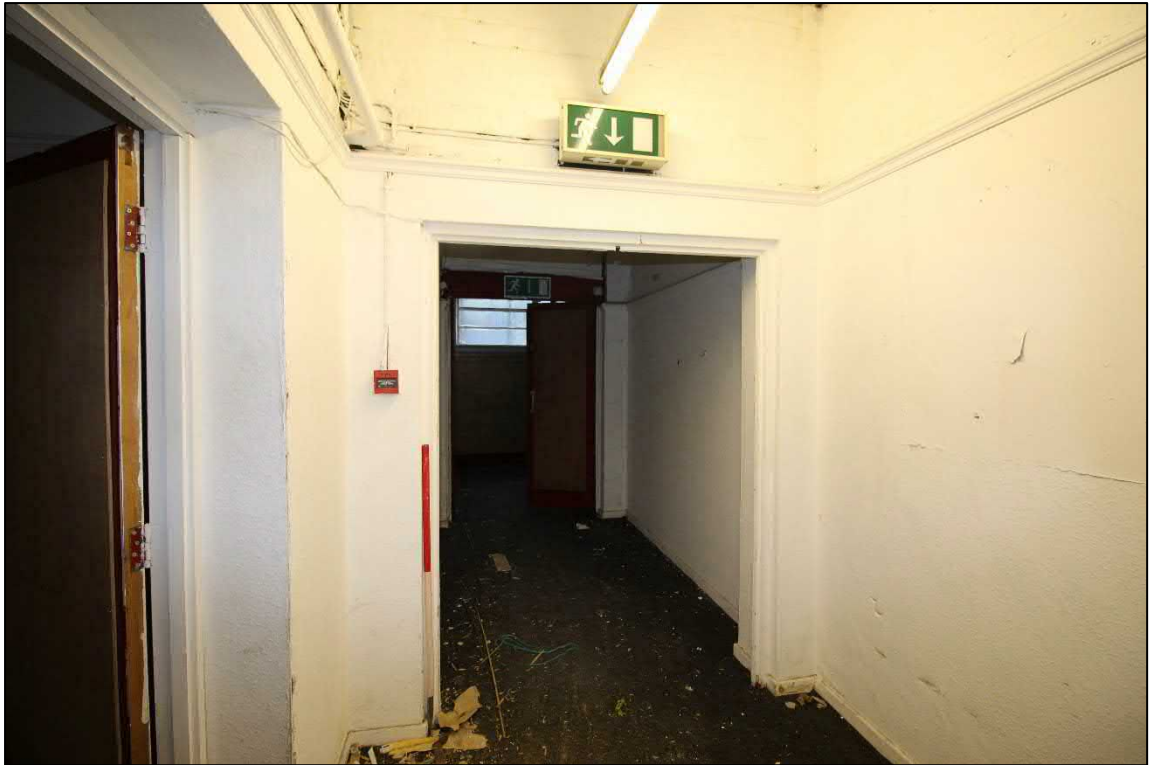
At the north-eastern end of the basement was a narrow corridor which gave access into two further toilets and the basement landing of the northern staircase (Fig 4). The corridor had a concrete floor, an open ceiling and plaster rendered walls (Plate 82). Two central doorways with squared reveals and flush lintels had been situated within the corridor. The doors on the southern doorway had been removed, whilst northern doorway contained two timber doors; each leaf was fitted with modern door furniture (Plate 82 and 83).

*Plate 80: The north-east corridor of the basement*

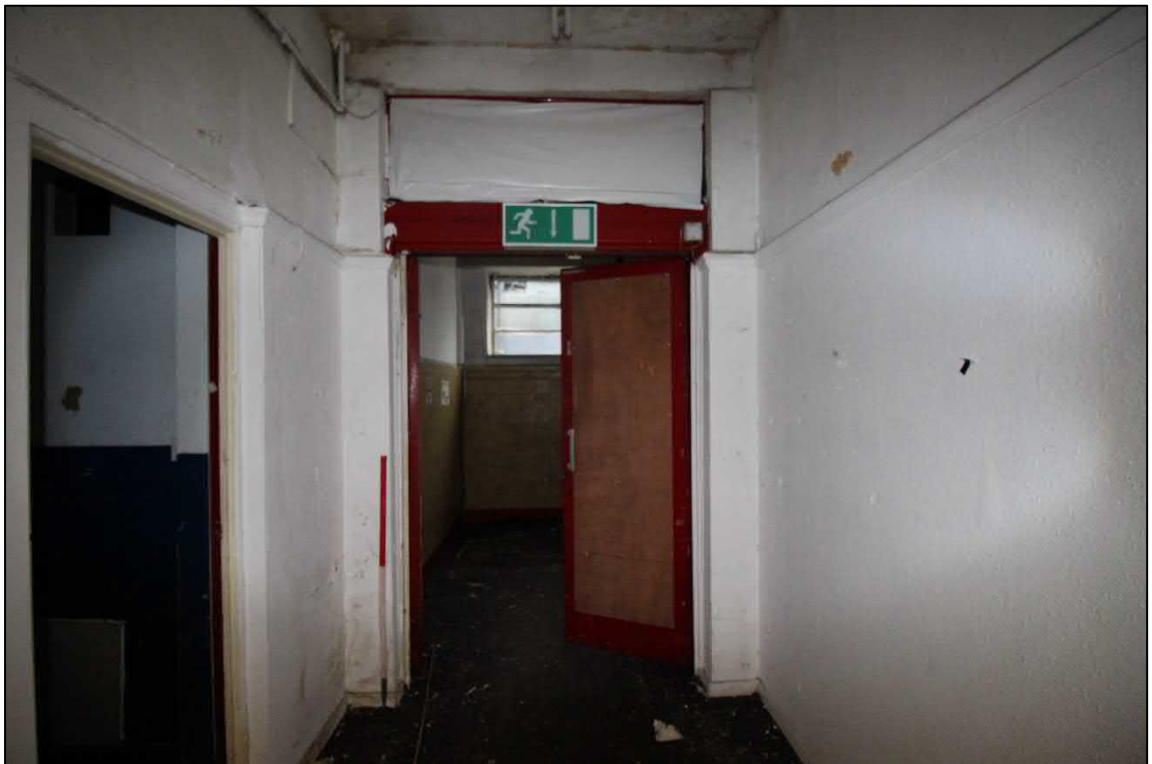
*Plate 83: The north-west doorway of the corridor*
