## Historic Building Investigation

Swan House,  
Rochdale Road,  
Manchester

**Report No:**  
SA/2021/11

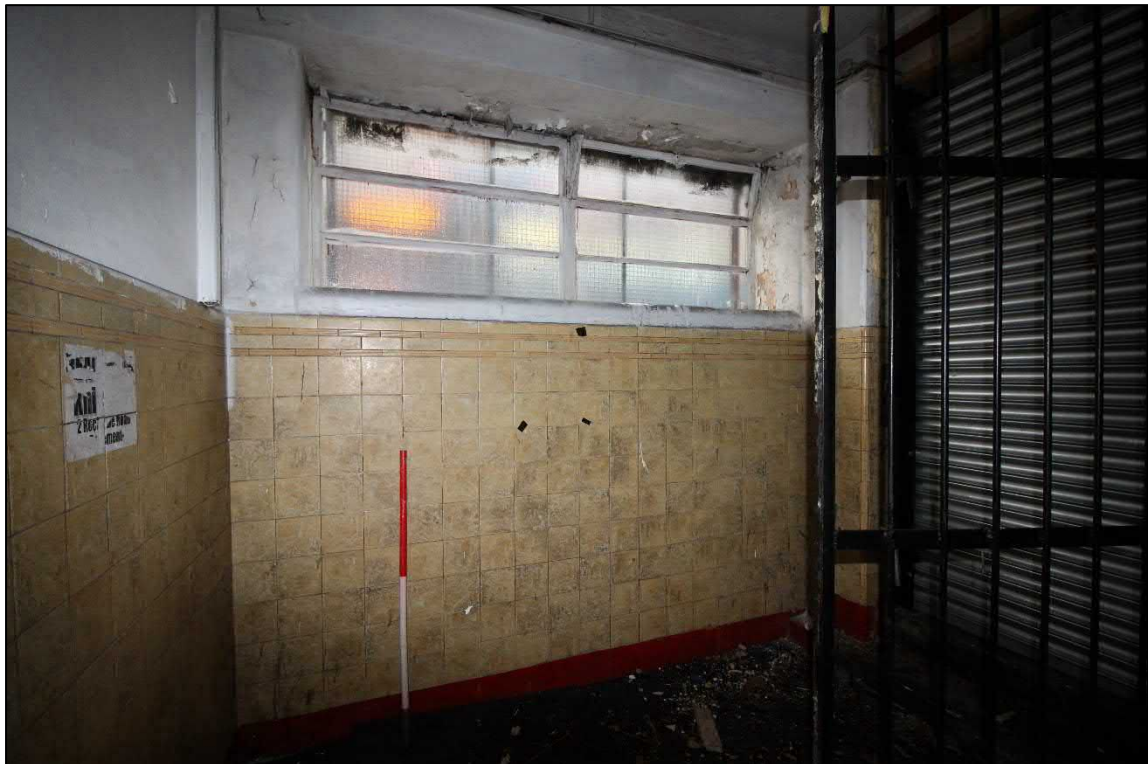
The walls of the basement landing within the northern stairwell had a double, cream-coloured tiled dado; the lower fill contained cream-coloured square tiles, whilst the upper fill was of plaster (Plate 84). As with the landings on the upper floors, this landing had orange-coloured square tiles with a border of black tiles. The concrete risers and treads of the stairs had been built into the walls of the stairwell with a simple half-round steel handrail and round steel balusters.

*Plate 84: The basement landing of the northern stairwell*

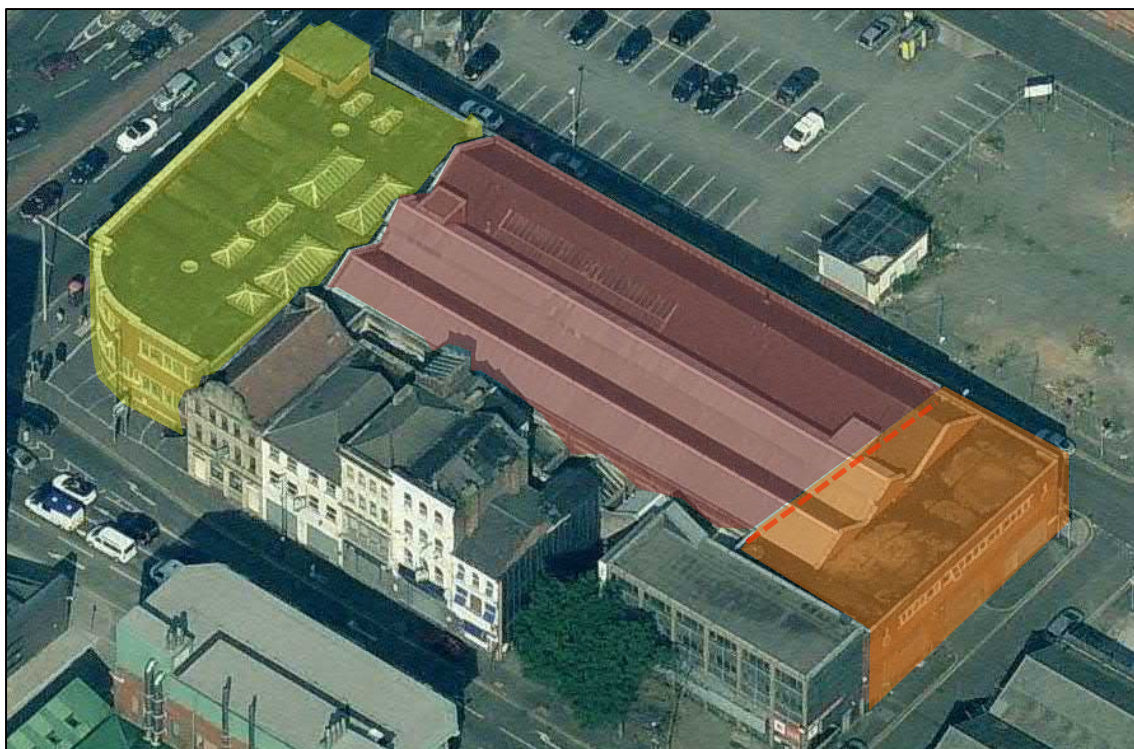
*Plate 85: Recent aerial photograph of the site showing the three components of the building, looking north*

Three elements to the warehouse complex were discernible during the survey (Plate 85). The main building had been constructed between 1932 and 1948 and had two parts, mainly containing open plan warehouse space. It was of red brick construction, utilising steelwork from Dorman Long & Co Ltd. Where the steelwork had been exposed, the roll stamp 'Dorman Long & Co Ltd Middlesbrough England' was visible on the web (Plate 86). Dorman Long was founded in 1875 in Middlesbrough and had a long and prestigious history. Expansion of the company throughout the 1920s saw it produce steelwork for several iconic landmarks, not least of all Sydney Harbour Bridge, which was completed in 1932. It operated under the name 'Dorman Long & Co Ltd' until 1951, when it was nationalised under the Iron and Steel Act, becoming part of the Iron and Steel Corporation of Great Britain. As such the beams could have been produced up to 1951, which neatly coincides with the first suspected phase of the construction c. 1932 – 1948.

A later extension to the north-west (Plate 85) was built as an office block and was extant before 1948. It was largely built in red brick with concrete floors and used Appleby-Frodingham steel. The beams had 'Appelby-Frodingham Iron & Steel Co. Ltd, England' rolling stamps on the web. The Appleby-Frodingham Steel Co came into existence in 1912 with the takeover of Appelby Iron Co by the Frodingham Iron Co. This joint venture lasted six years until in 1918 the company was amalgamated with the United Steel Companies. As a branch company, however, it continued to produce steelwork under its own name. By 1961, the Appleby-Frodingham Steel Co was one of nine listed companies that made up the United Steel Companies Group. By 1967 this group had been nationalised as part of British Steel. It is therefore only possible to assign a broad date range for the production beams used in the northern extension, 1912-1967, although it seems likely they were installed in either the 1930s or '40s.

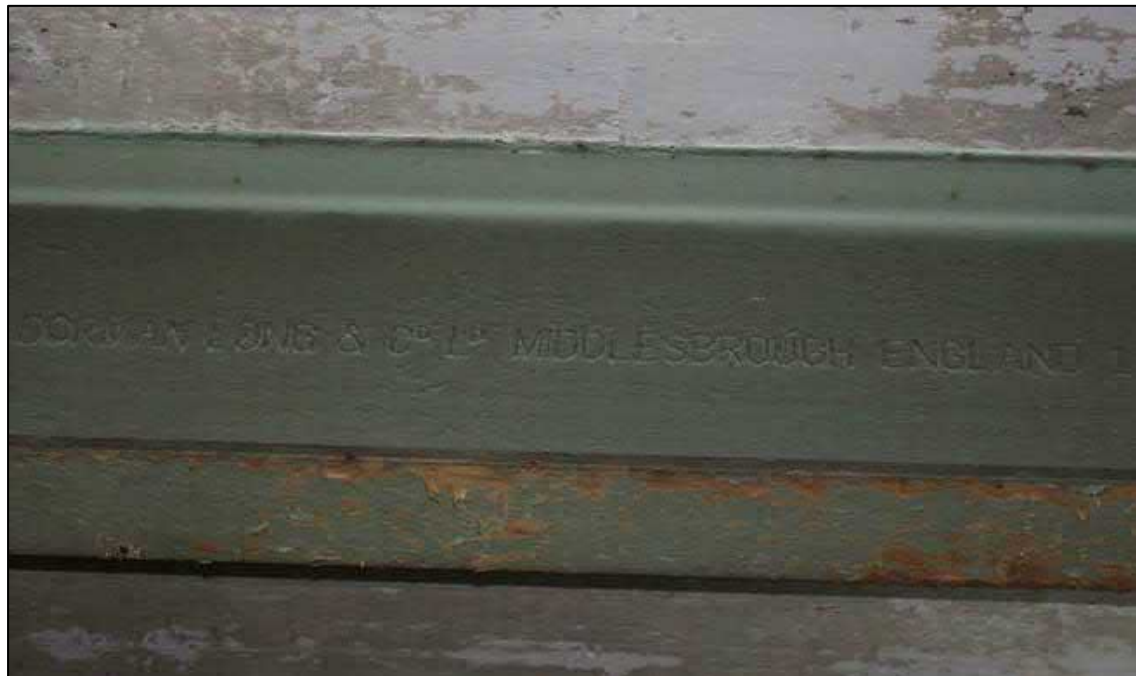
*Plate 86: Detail of the roll stamp 'Dorman Long & Co Ltd Middlesbrough England'*

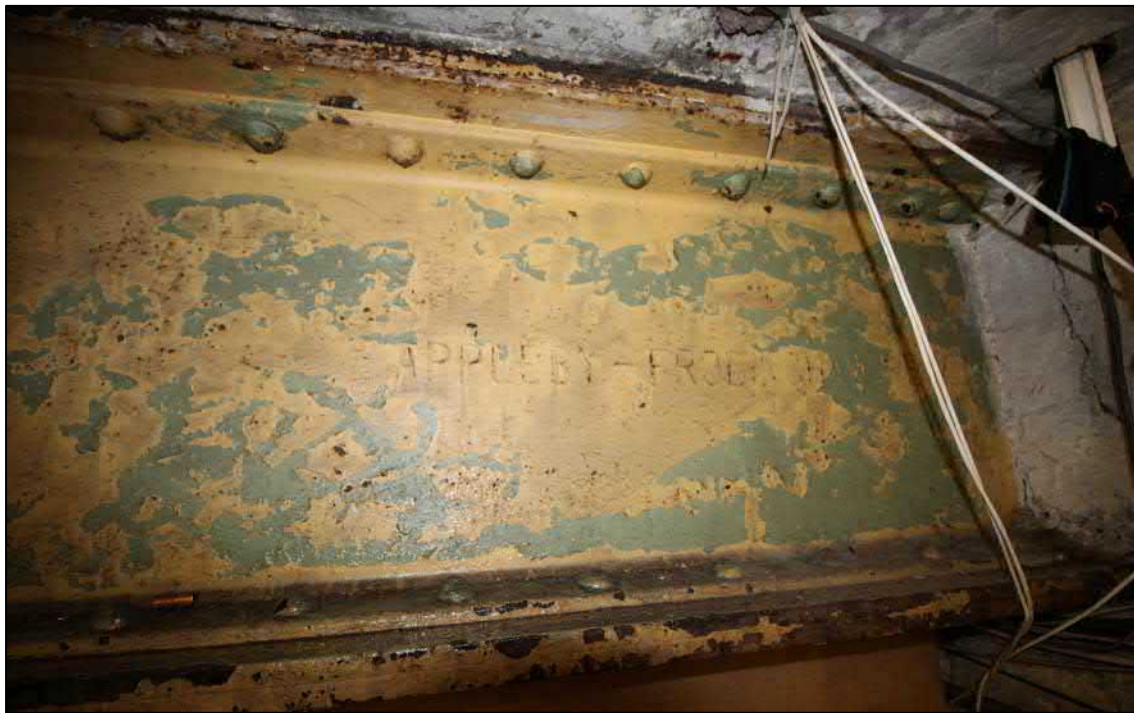
*Plate 87: Detail of the roll stamp 'Appelby-Frodingham Iron & Steel Co. Ltd, England'*
