**DESK STUDY REPORT  
FOR  
VINE STREET,  
GORTON**

| <b>Report Title:</b> | Desk Study Report for Vine Street, Gorton |
| <b>Report Number:</b> | AG3211-20-AL43 |

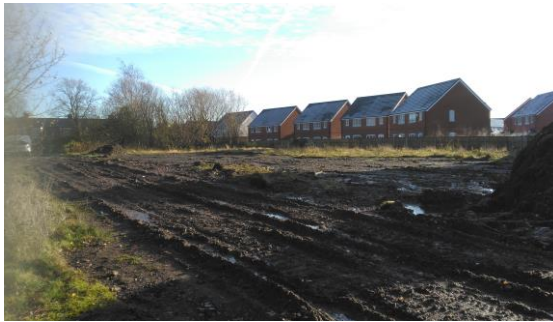
The northern boundary comprises a steep (roughly 60-70 degree) slope lined with semi-mature beech trees, with 2m high palisade fencing at the base, beyond which is a railway. At two main points on the slope, generally to the northwest, it was noted that significant fly tipping had occurred here too, including but not limited to: a large quantity of tyres, plastics, metals, fabrics, black bags of unknown household wastes, traffic cones, shopping trolleys, wood/pallets and a motorcycle.

View across the northern central portion

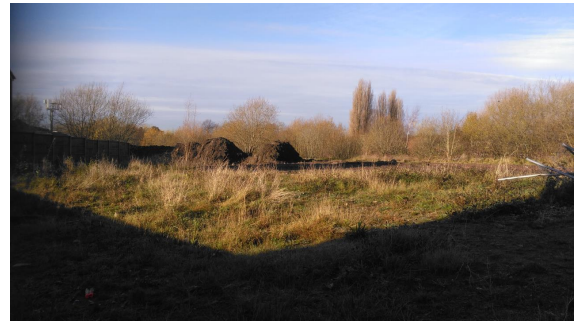
View across the southern central portion

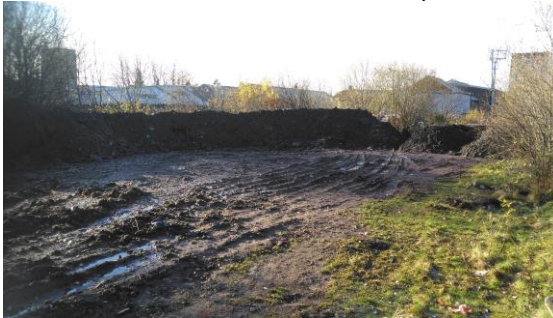
Across the western tip of the site, beyond the mounded material, semi-mature beech trees and fly tipping (e.g., unlabelled clear plastic drums, plastic car parts, tyres, mattress and unknown bagged waste) were present at the surface. This area leads down a steep slope towards the adjacent railway line. Two raised manhole covers were present within the west, one of which had a broken cover with a metal access ladder – the base of which could not be seen and was estimated to be at least 5m in depth. No sound of running water was noted.

View towards the mounded material in the west

It is assumed that the fly tipping would be dealt with during site enablement and clearance works. Although the site now has security guards, the site is still accessible by the public. Further security measures such as fencing/hoarding should be considered to reduce the risk of further incidents and possible sources of further contamination from being brought onto site. The contaminated excavation to the west should be dealt with as soon as practicable and backfilled and the broken manhole cover should be replaced, both for security and potential health and safety risks to members of the public.

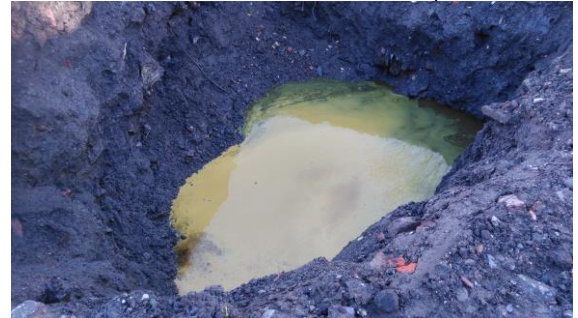
Alongside the mounded material was a roughly 6.5m by 4m excavation, approximately 3m in depth to the top of the water level, with an unknown depth below this. On the surface of the water a yellowish-brown oil was present and at ground level around the excavation. Following discussions with the on-site security, it is understood that an excavator breakdown had recently occurred (relating to the aforementioned unauthorised access). Therefore, it is possible that the substance observed is hydraulic oil from the excavated break down. It was noted that the quantity of mounded material does not appear to equal the amount of material removed from the excavation, therefore, it's not known where the excess material originated. Aerial imagery from 2020 shows mounded stockpiles within the south-central portion of the site, along with some fly tipping and patches of yellowish green-brown (potential oil contamination) colouration at the site surface.

View of the oil contaminated excavation

The desk study has indicated the potential for soil contamination and ground gas to be present at the site, generally associated with the historical site usage and infilling of railway cutting and other earthworks and historical land use in the immediate vicinity (i.e., wider landfill area, including former brick works). Although the risk is largely characterised by historic investigations, more recent stockpiling of material (as noted in 2018 from aerial images) and more recent tipping of waste on the site (as noted during the site walkover) should be investigated. The shallow Made Ground soils should also be investigated for the recent oil contamination observed.

Groundwater samples should be obtained (both from shallow soils for the recent oil contamination and deeper if present within response zone of standpipes) and tested for potential contaminants (or leachate testing of Made Ground soils if no groundwater). Additional specific investigation may be warranted based on visual and olfactory evidence during fieldwork. It is likely that a remediation strategy will be required to comply with likely future Planning Conditions.
