CIS Tower,  
Miller Street,  
Manchester.  
M60 0AL.

## CIS Tower Refurbishment.

### Recording Strategy and Photographic Audit of internal & external features, 2020.

Planning Permission ref: 126118/FO/2020. Condition 29.  
&  
LBC ref: 126119/LO/2020. Condition 10.

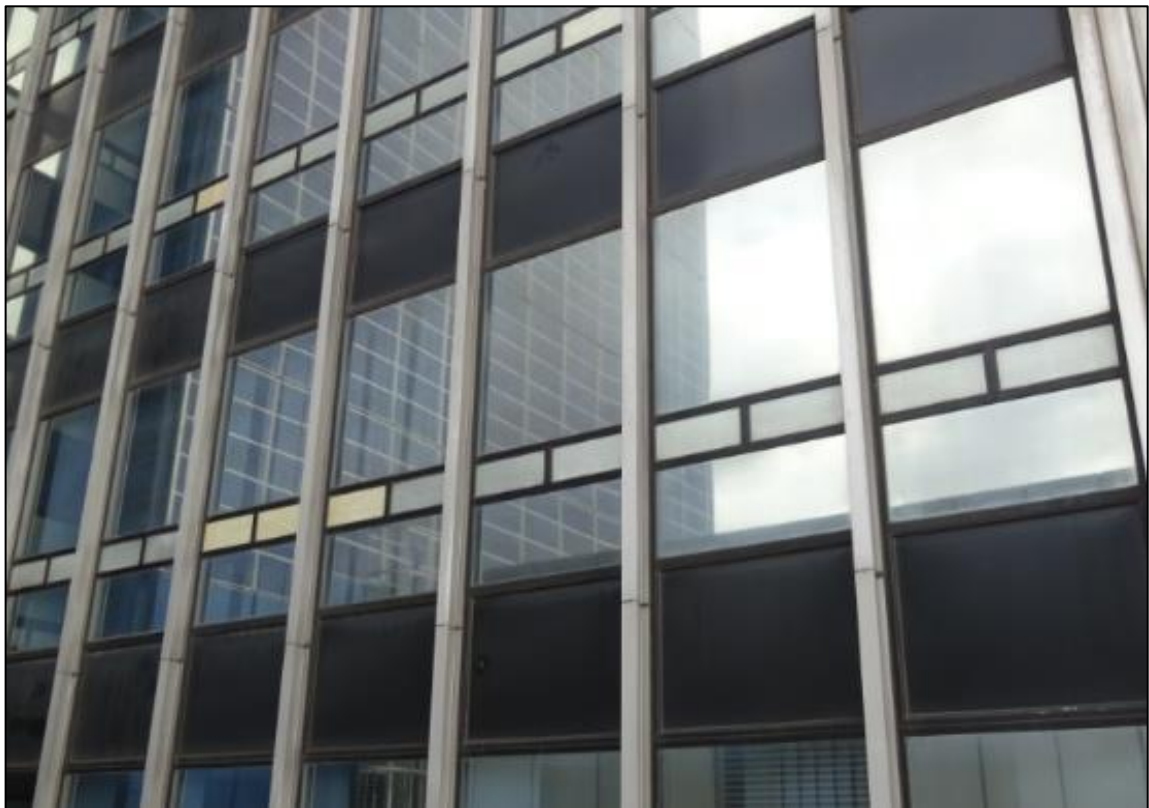
**Figure 3.** View of Miller Street frontage comprising black vitreous enamelled steel spandrel panels supported by the hiduminium mullions. The glazing panels are fitted internally and are supported by a mixture of timber and some replacement aluminium beads. The opaque horizontal glazing is formed of a encased asbestos/glass fibre sheet.

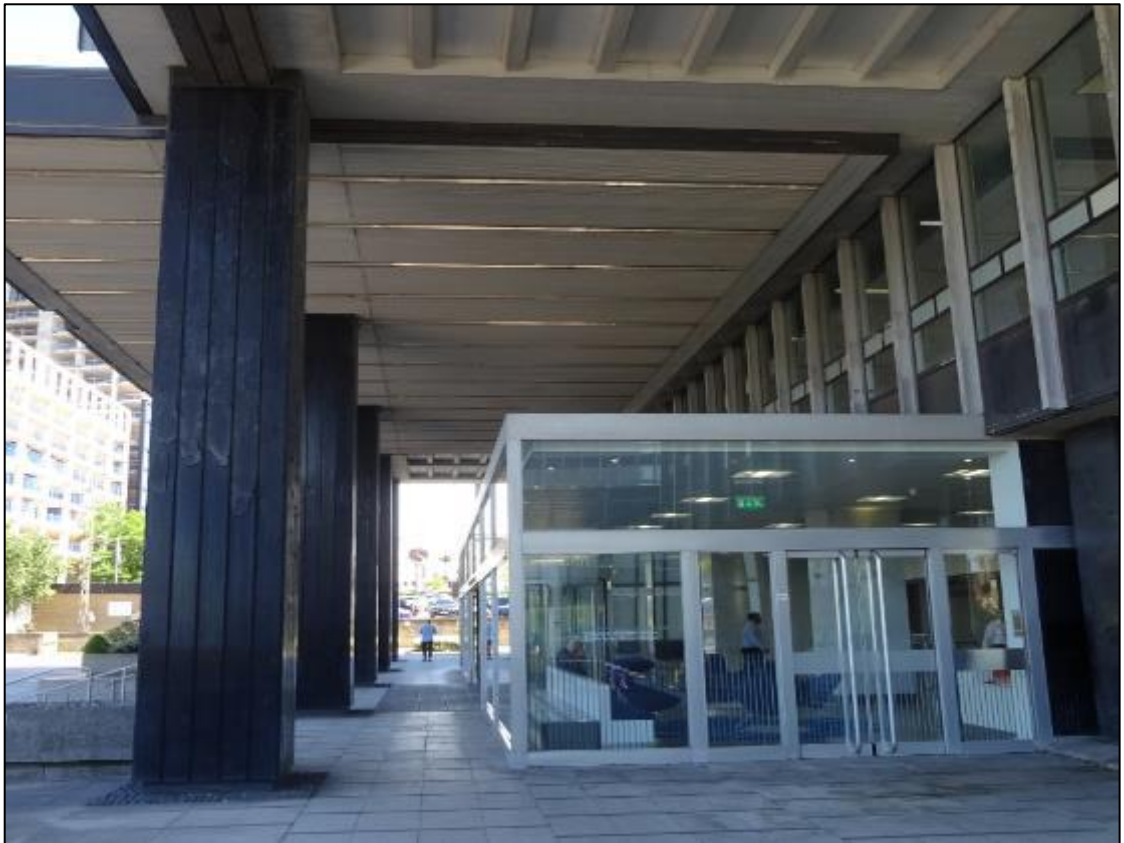
**Figure 4.** View of the main entrance onto Miller Street frontage (January 2020), showing the main soffit clad in metallic ceiling panels.

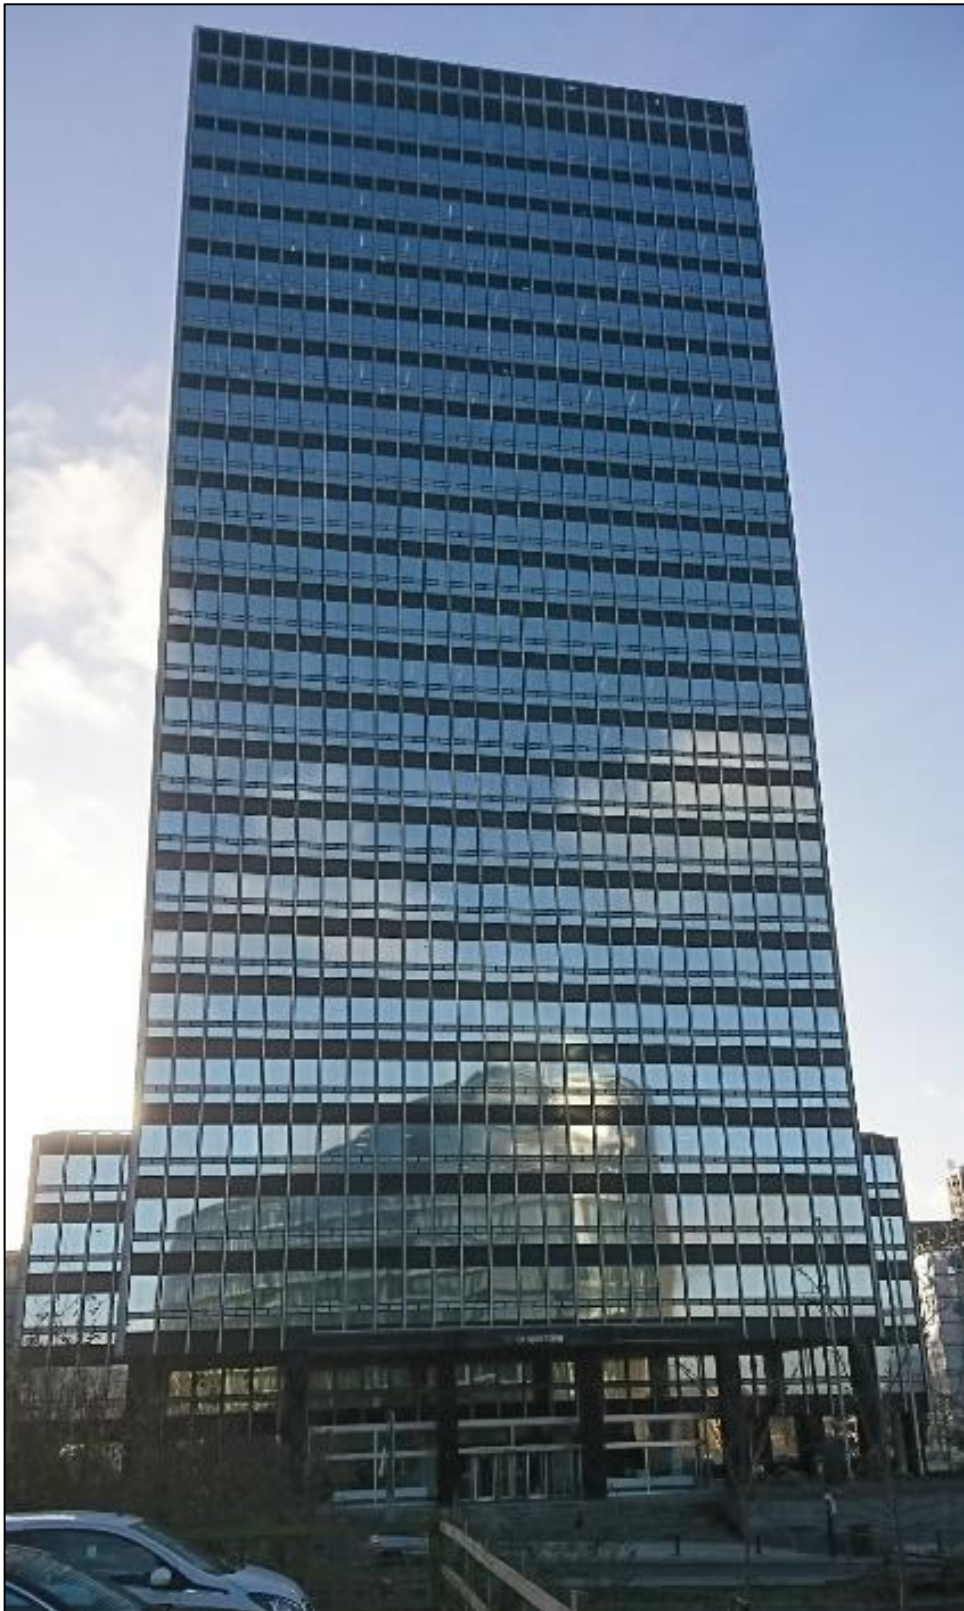
**Figure 6.** Miller Street elevation (Jan 2020), showing the result of the application of the reflective film on the glazing.

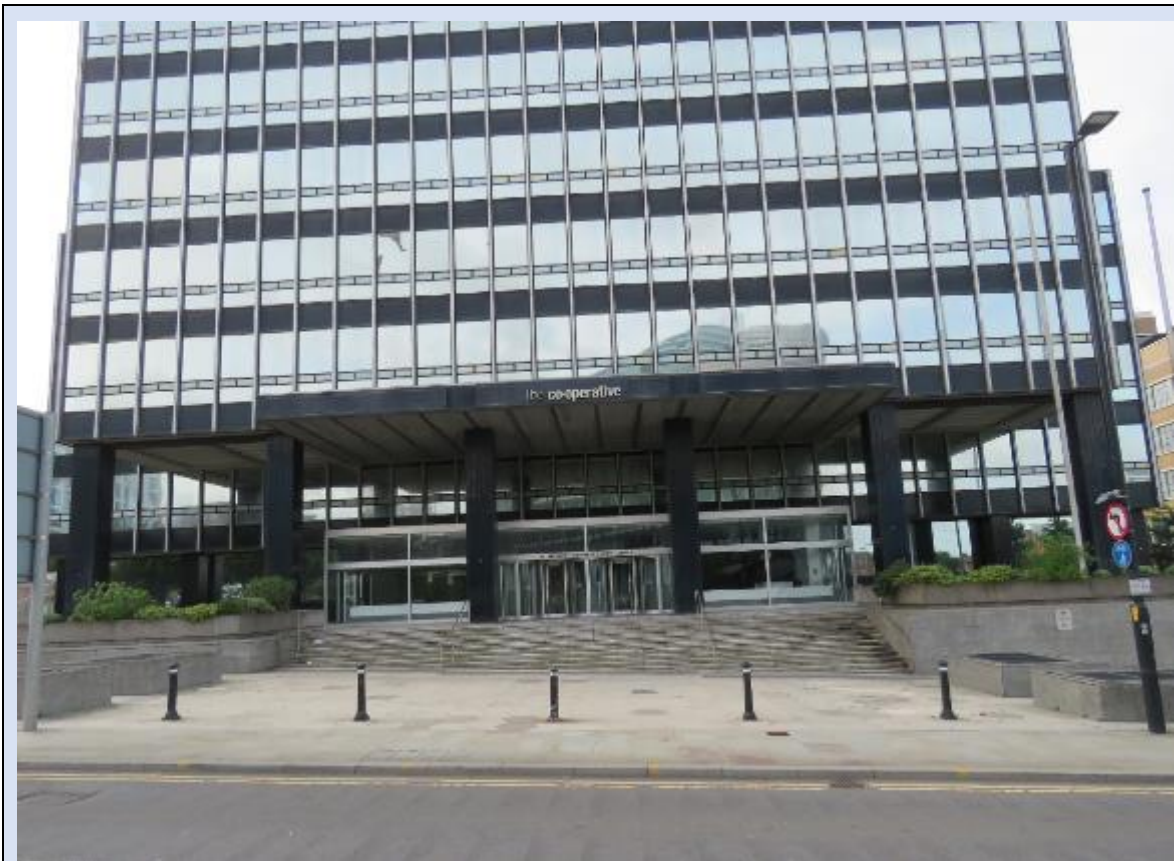
**MS-03** Details of the Miller Street entrance, showing steps and flanking planters

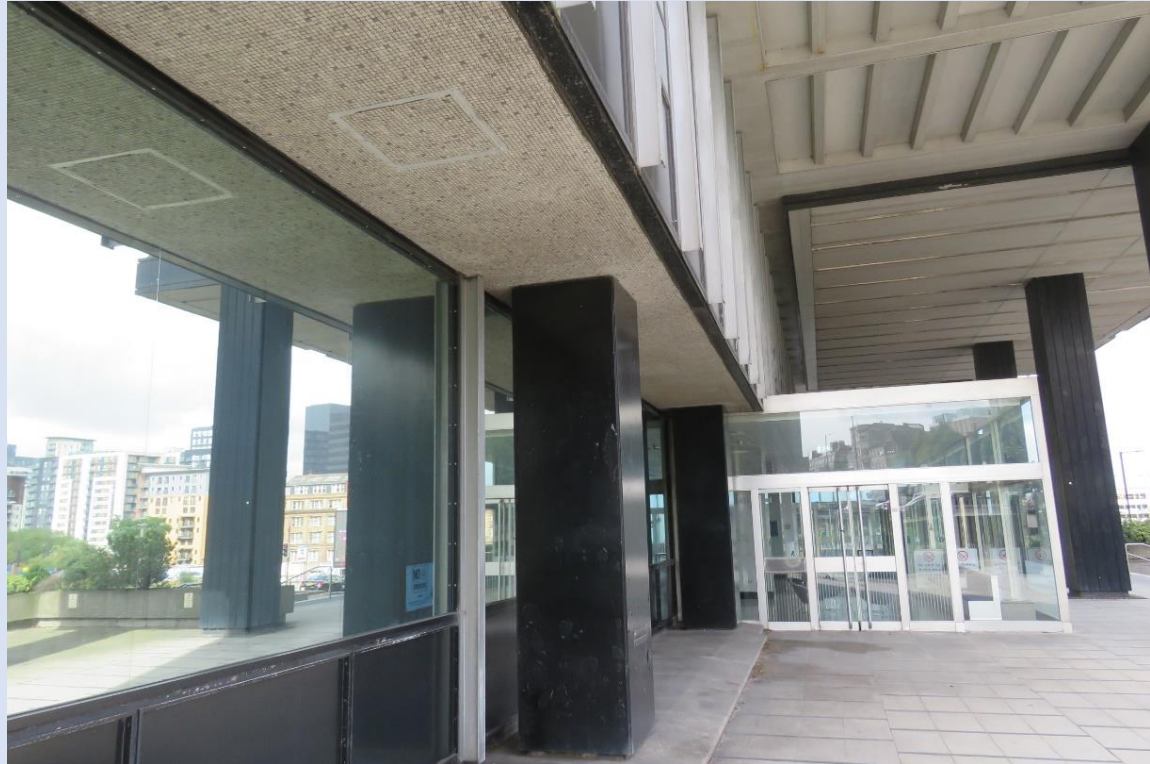
**MS-05** View looking west into the entrance canopy and porch, showing the use of concrete, metal panels and tiling to the soffit.

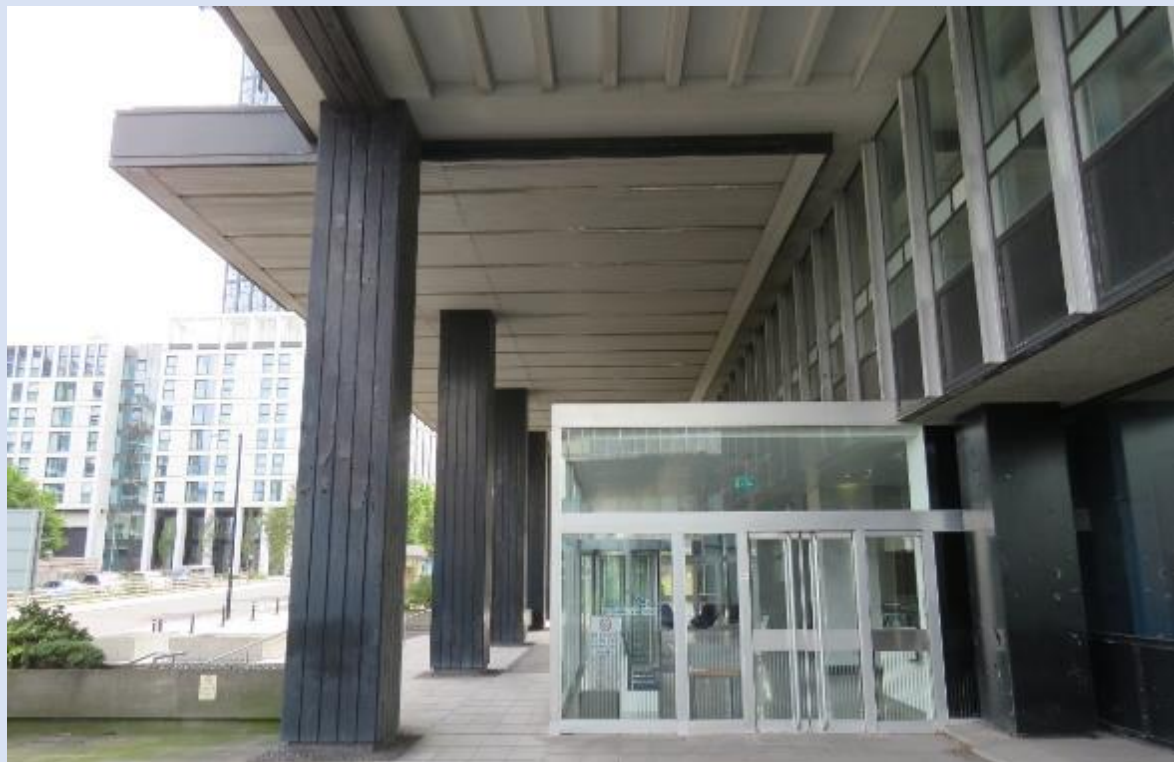
**MS-06** View looking east into the entrance canopy and porch showing the concrete and metal panels and tiling to the main soffit of the porch.

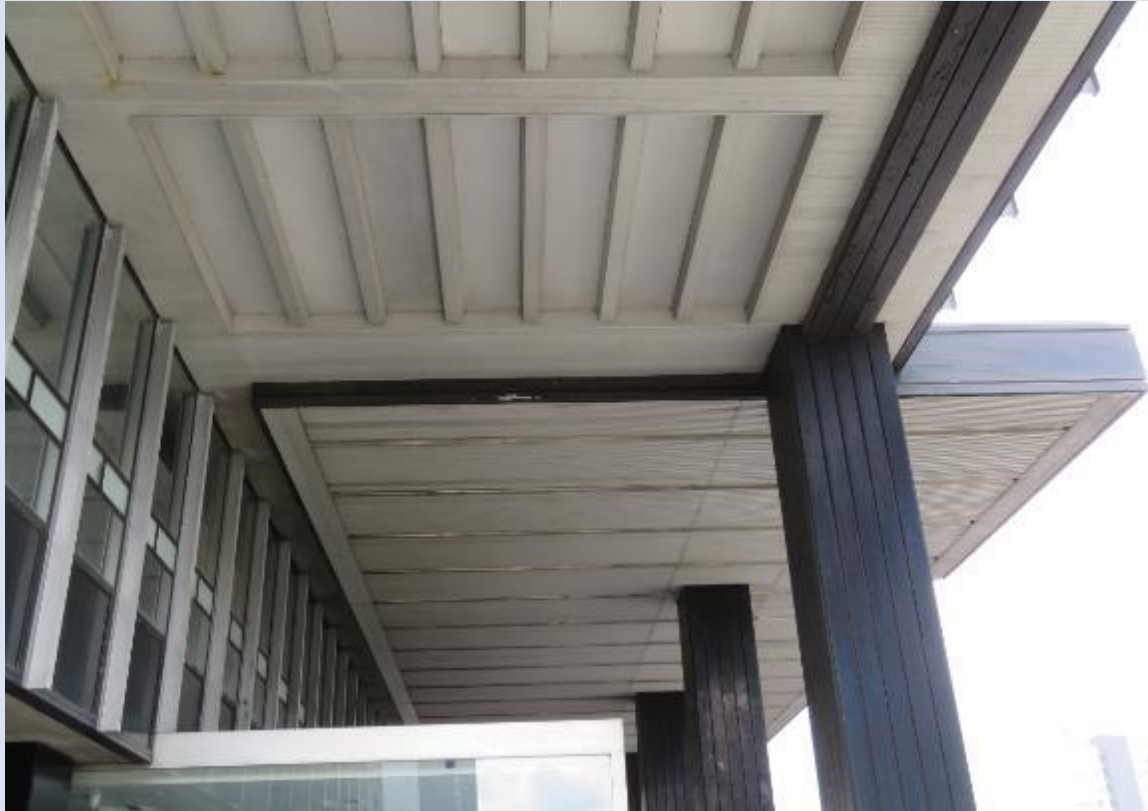
**MS-07** Detail of the soffit to the entrance canopy showing the glazing to the mezzanine floor and columns.

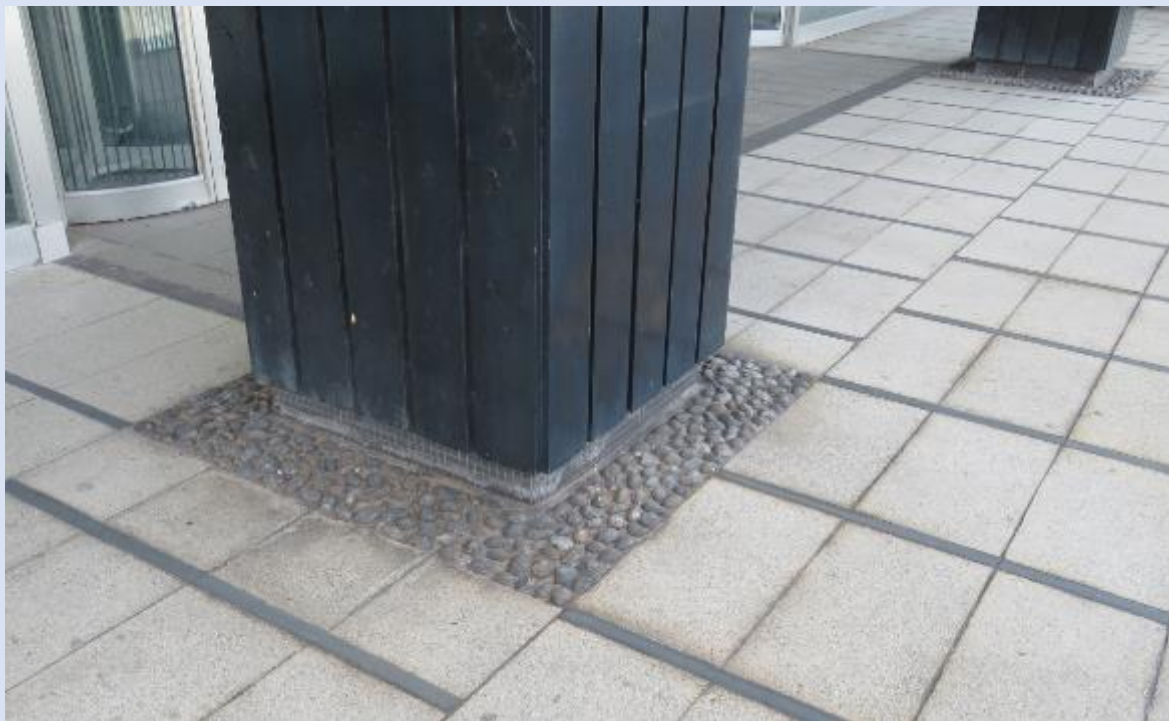
**MS-08** Column cladding details and entrance paving .

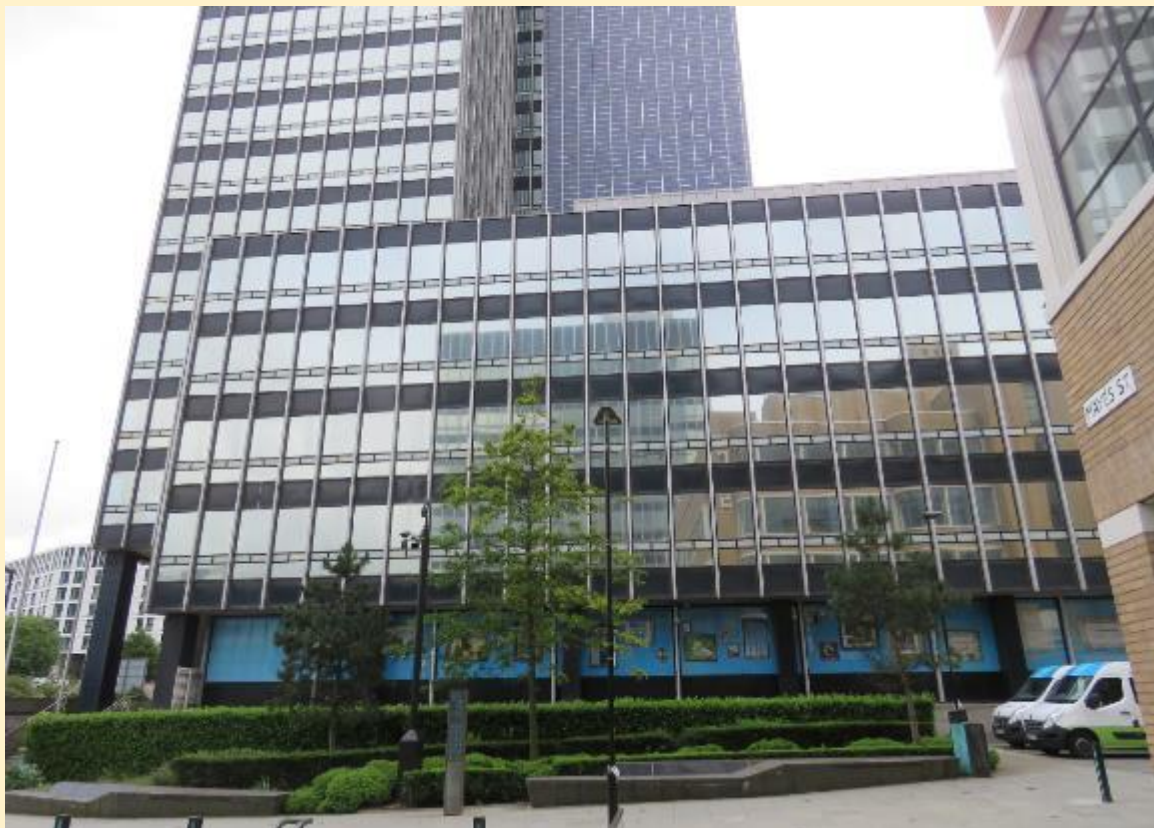
**DS-02** Partial elevation from the steps to Sadlers Yard, showing the former ground-floor Postal Department rooms and the reflective nature of the applied glazing film. The hedge screens the north-west fire escape and gas-plant room.

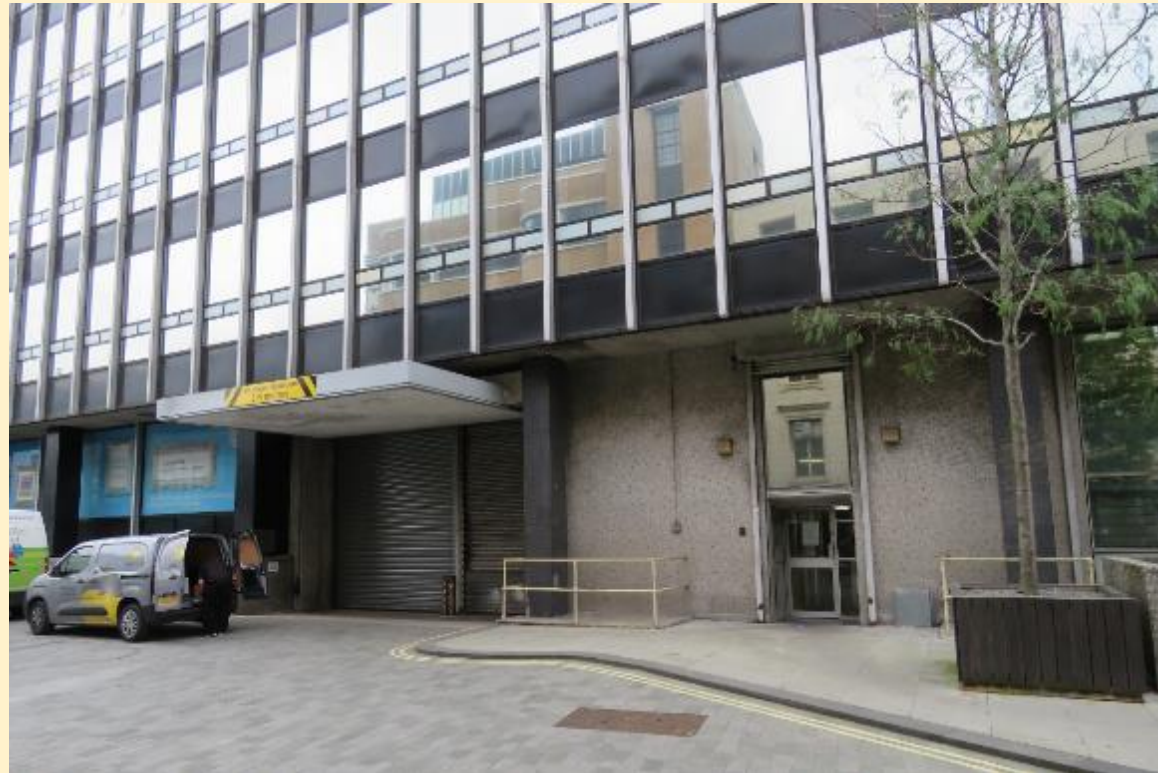
**DS-03** Detail of the Dabtzc Street service entrances, showing the tiled elevations below the soffit and the reflective film to the glazing.

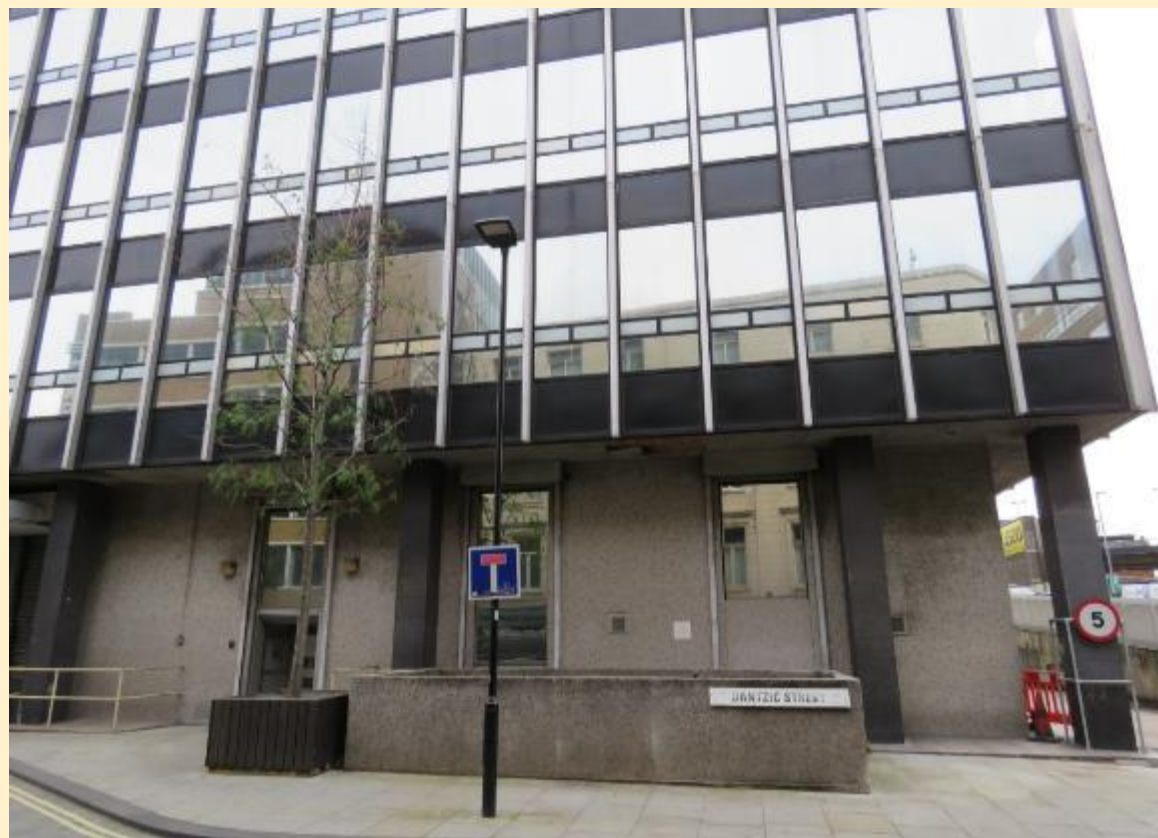
**DS-04** Detail of the Dantzc Street elevation showing foreground south-west fire escape exit.

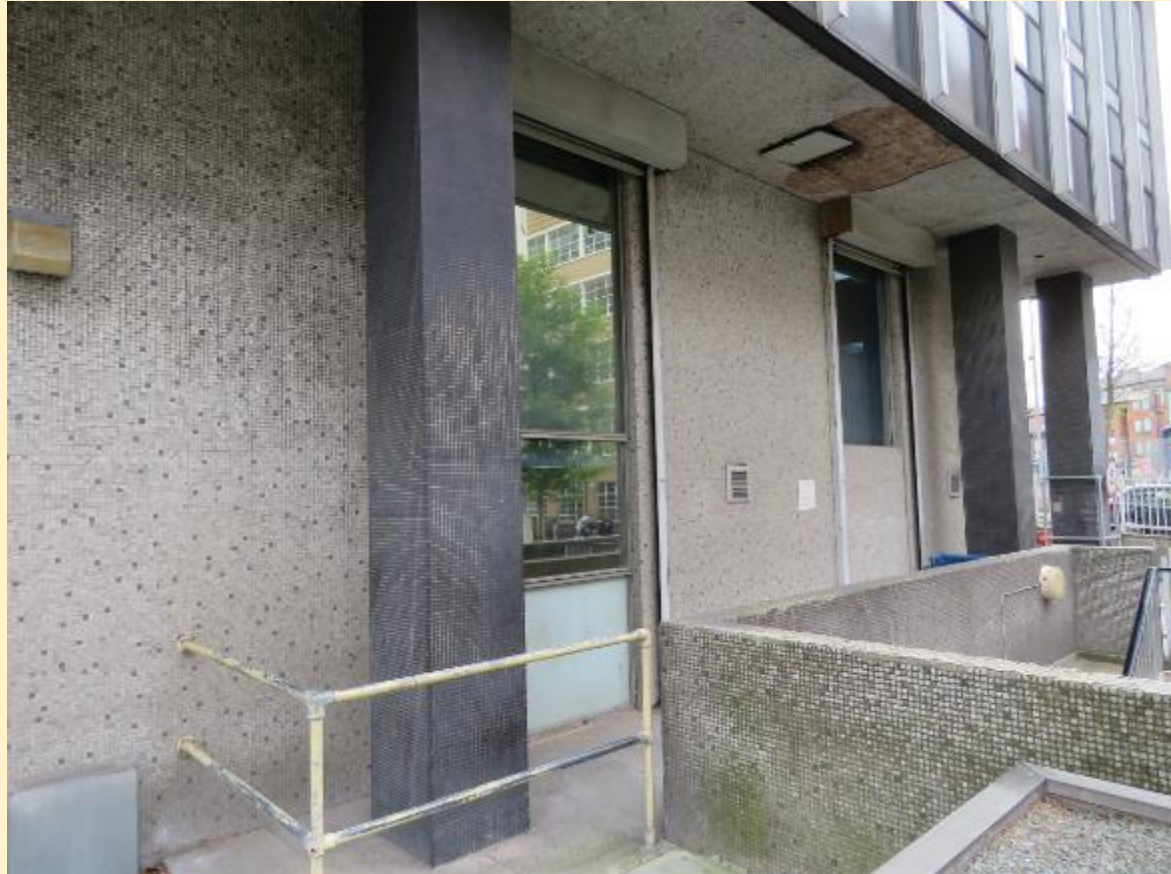
**DS-05** Detail of the elevation and soffit materials, showing the south-west fire escape.

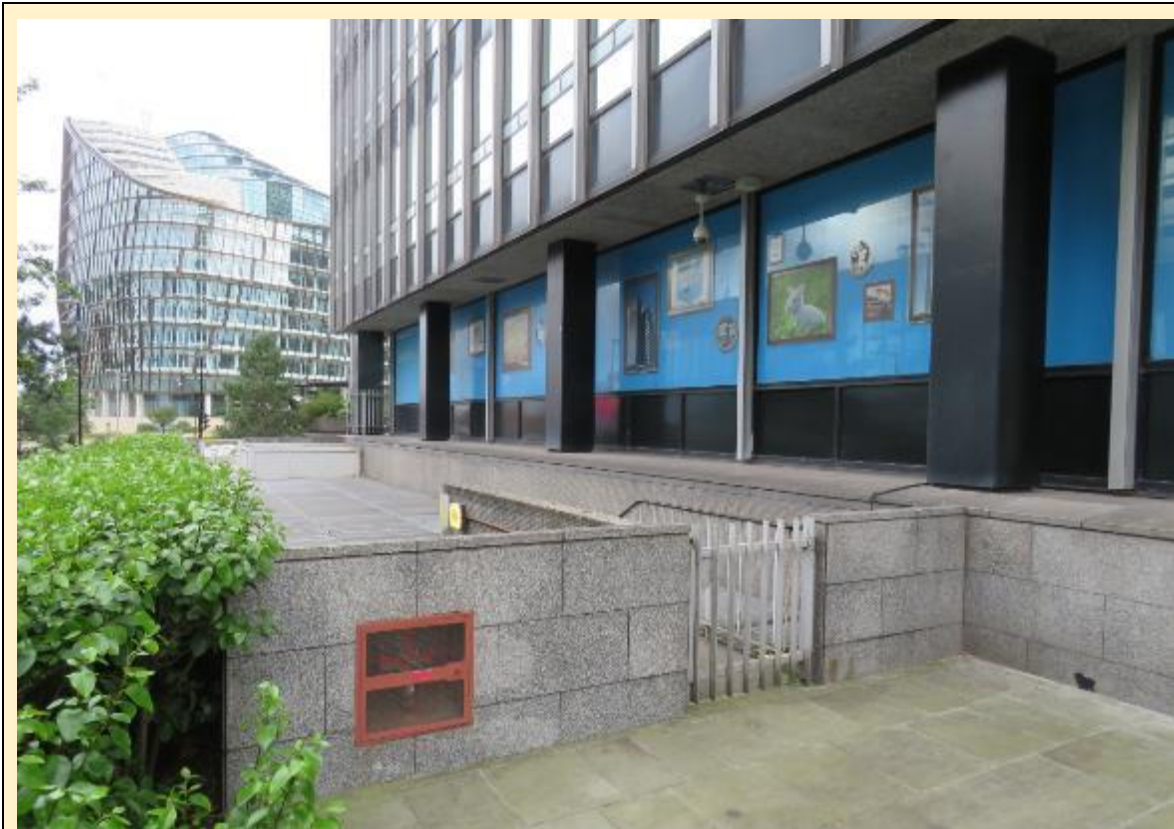
**DS-07** Detail of the former Postal Dept elevation and north fire escape exit and plant room.

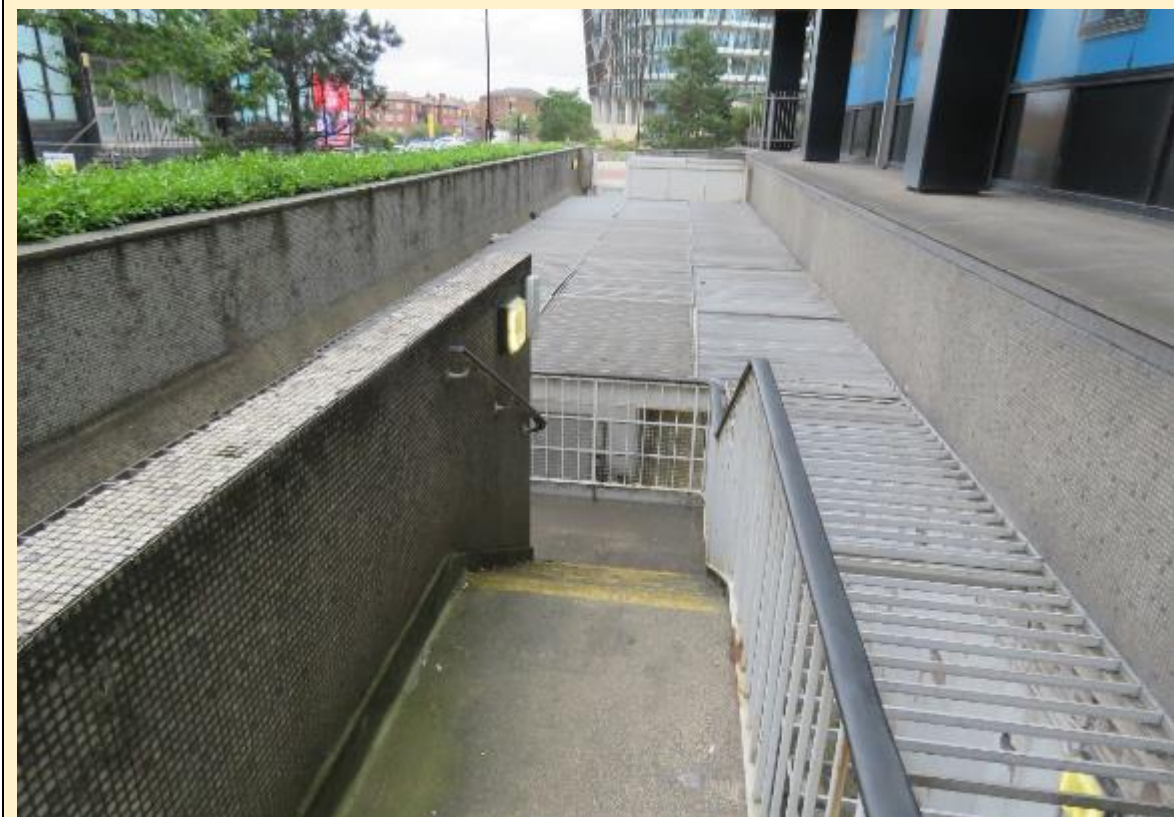
**DS-08** Detail of the Dantzic Street north-west fire escape entrance and gas plant ventilation..

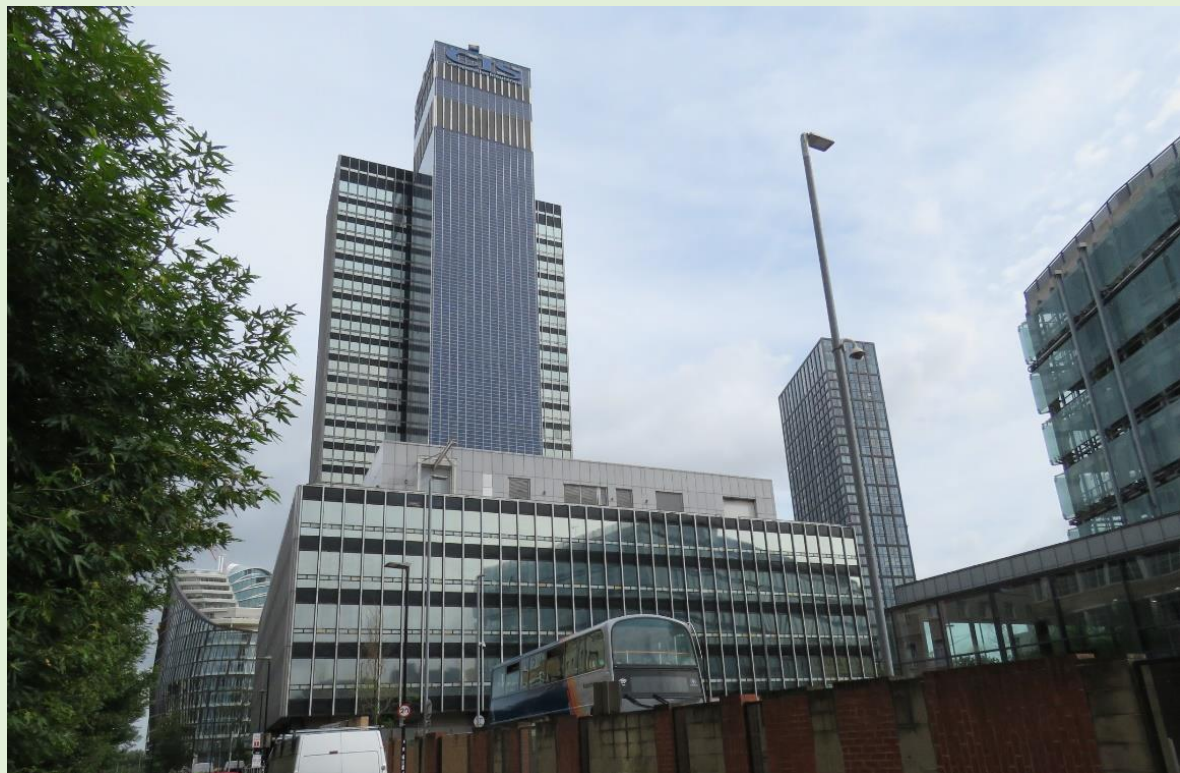
**HS-01** Looking north along Dantzic Street across the bus station to the Hanover Street frontage showing the exposed form of the podium block and plant room and the service tower clad in photovoltaic cells

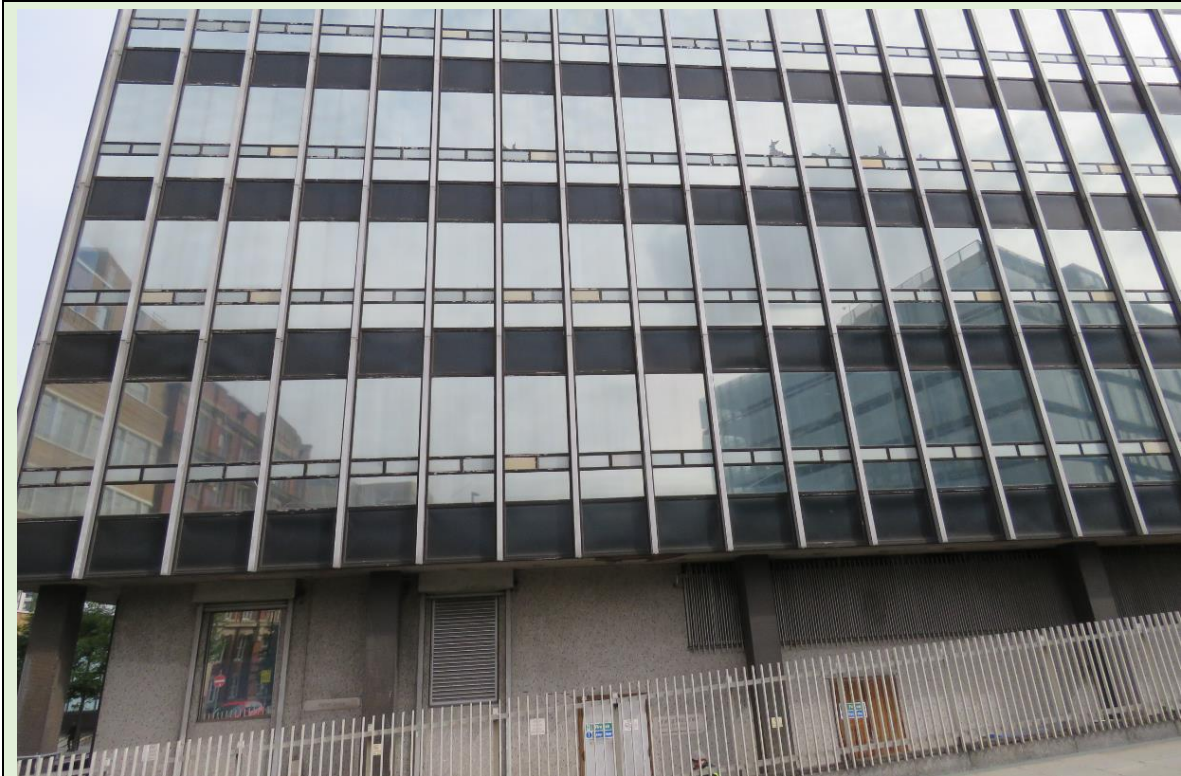
**HS-03** Details showing the over-hang, service area, railings and the eastward rise of Hanover Street.

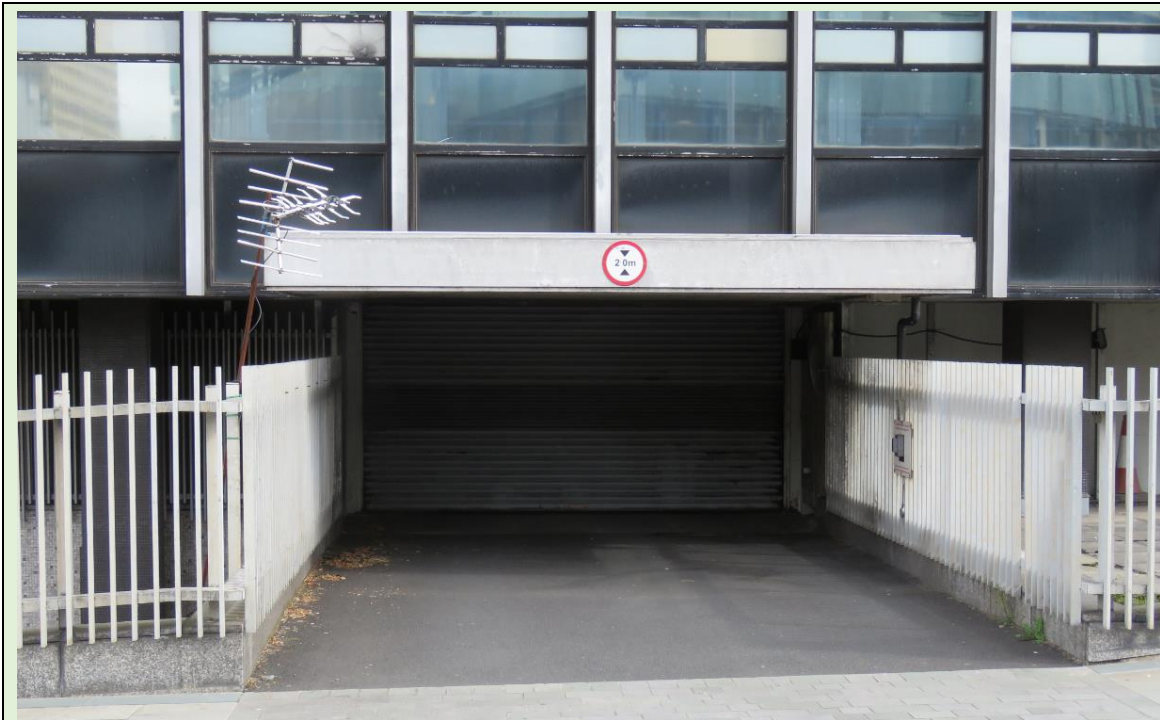
**HS-05** Detail of the bridge and car-park entrance, showing the railings, canopy and roller-shutter door.

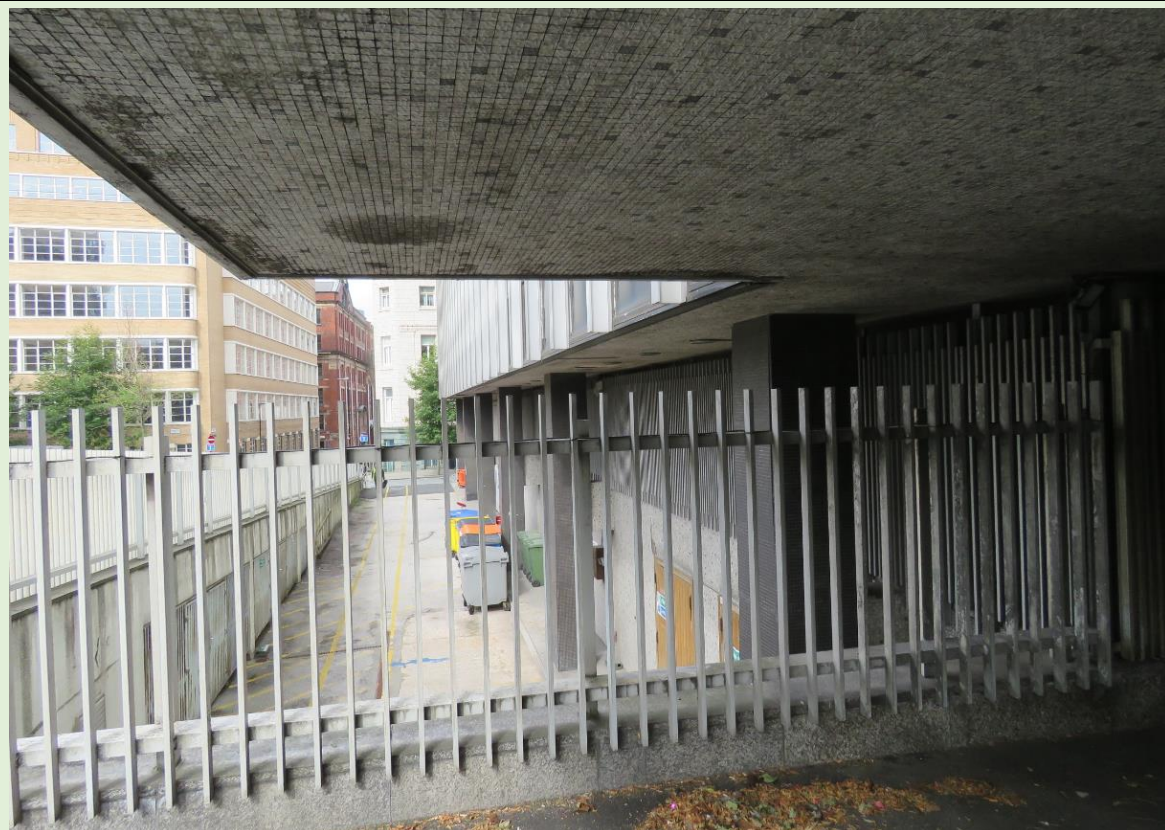
**HS-06** Looking west from the car-park access bridge along the service yard, showing the tiled soffit of the canopy and detail of the square-section, grey painted railings.

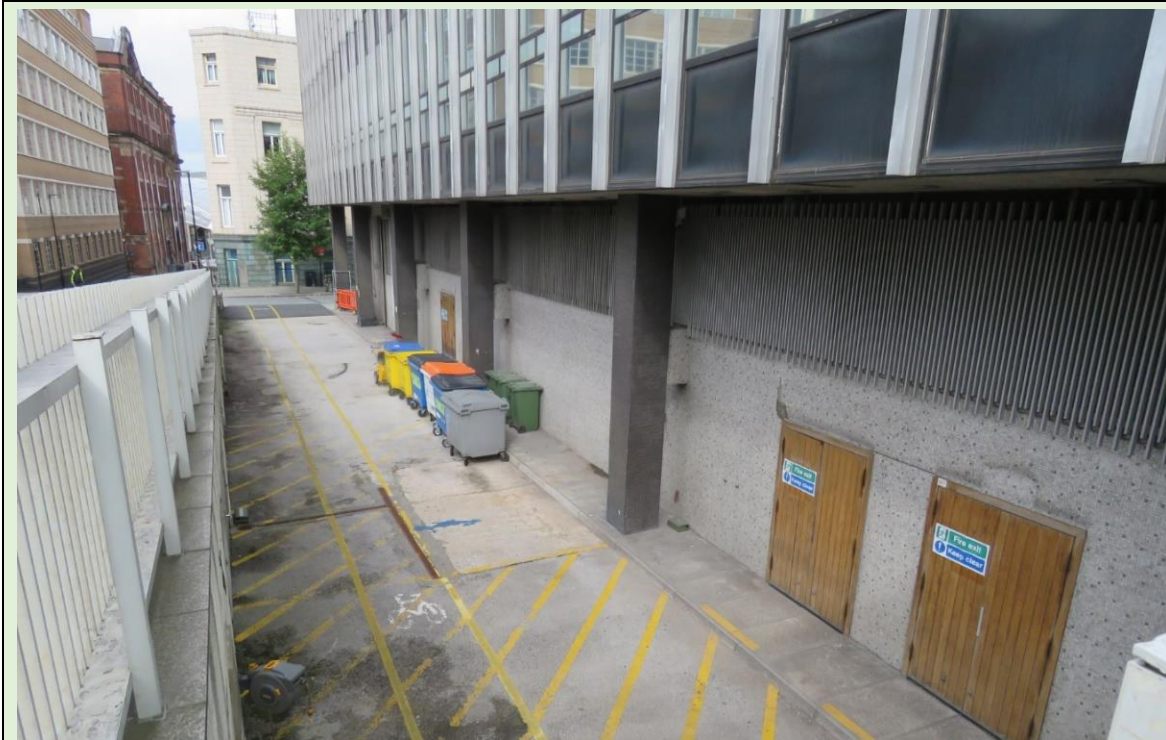
**HS-07** Looking west along the Hanover Street service yard, showing the tile-clad elevations and columns.

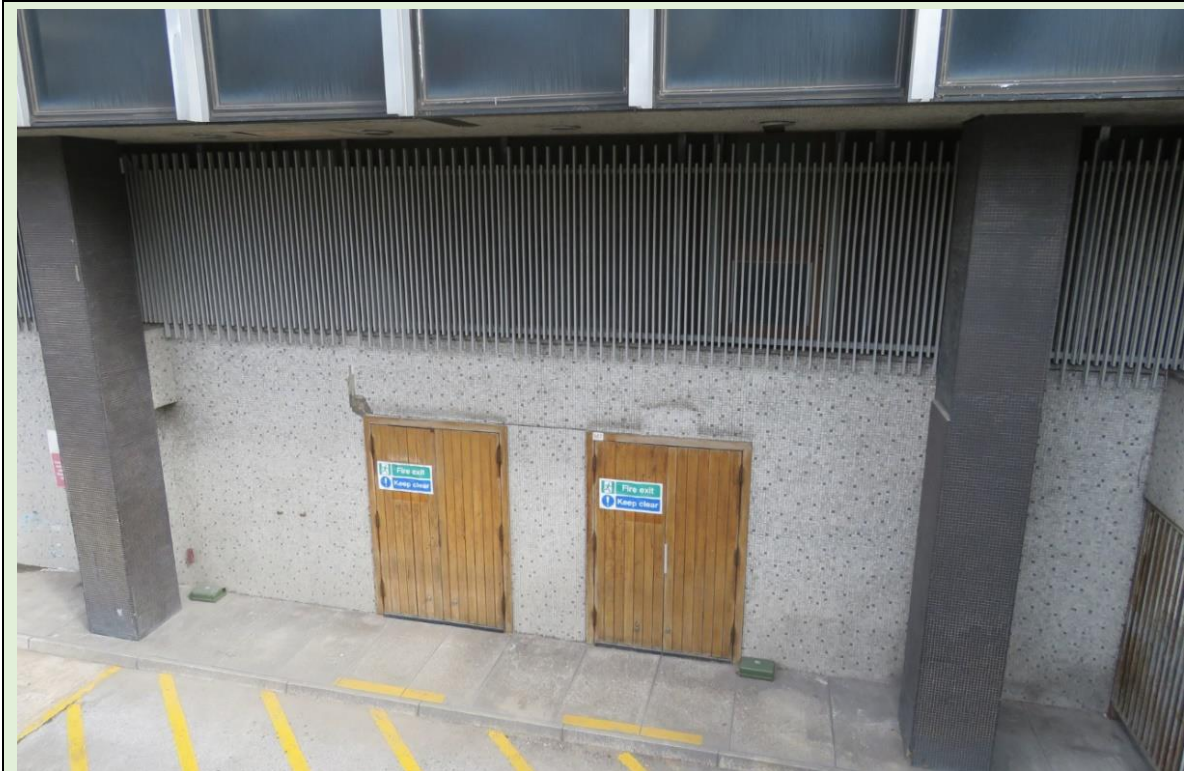
**HS-09** Detail of the Hanover Street service yard elevation and fire-escape doors. The railings to the elevation screen the executive garage. Showing the tile-clad elevations, soffit and columns.

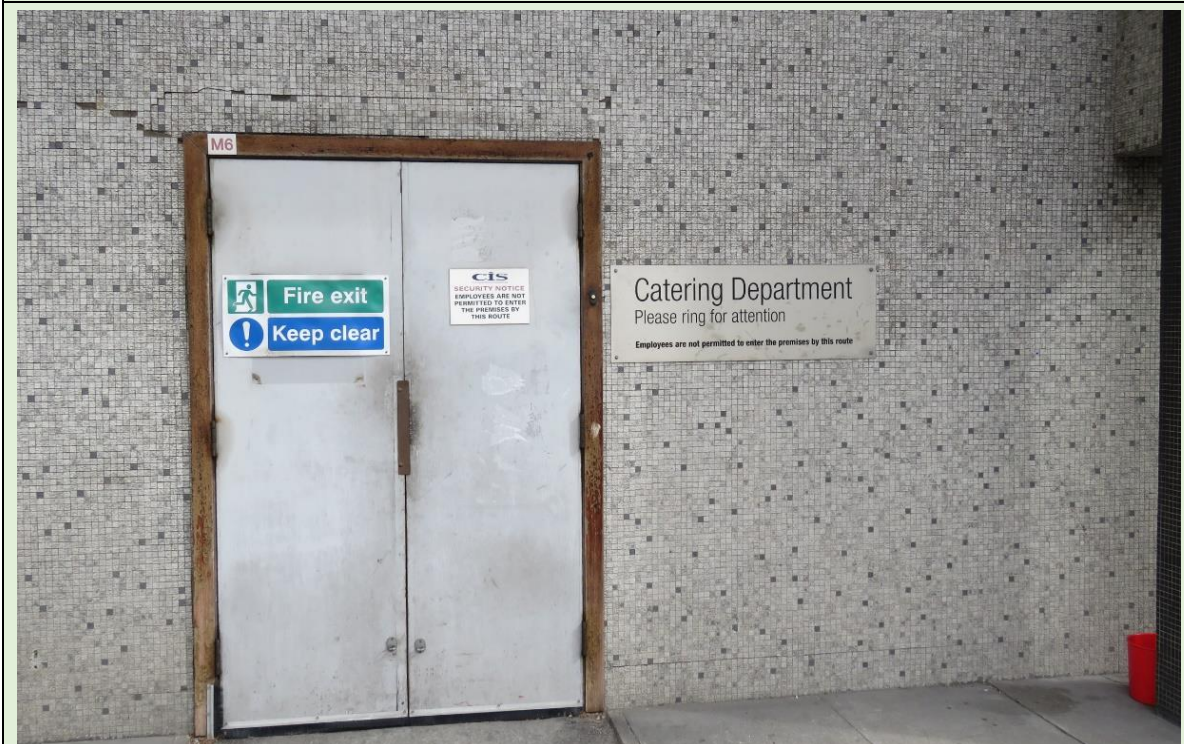
**HS-10** Details of the tiling to the Hanover Street service yard and the kitchen delivery entrance.

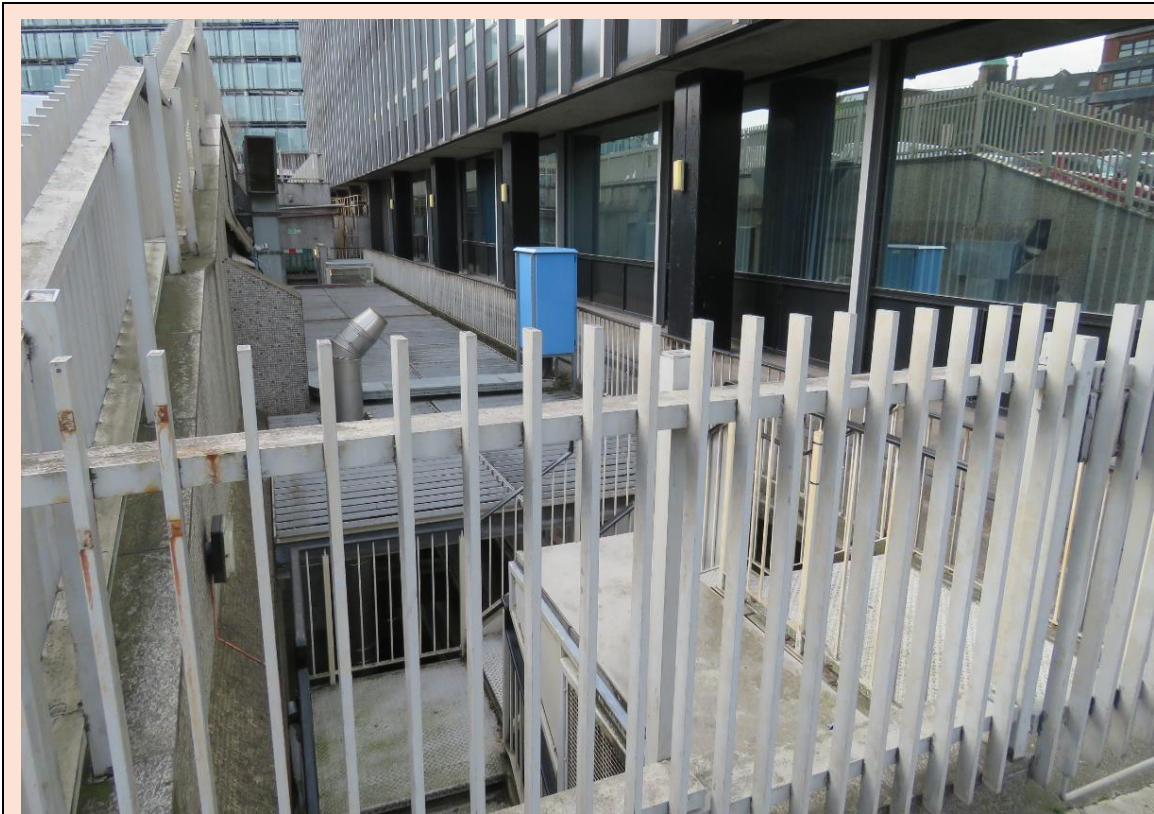
**RS-03** Looking south into the plant basement, showing the square-section railings and retaining walls.

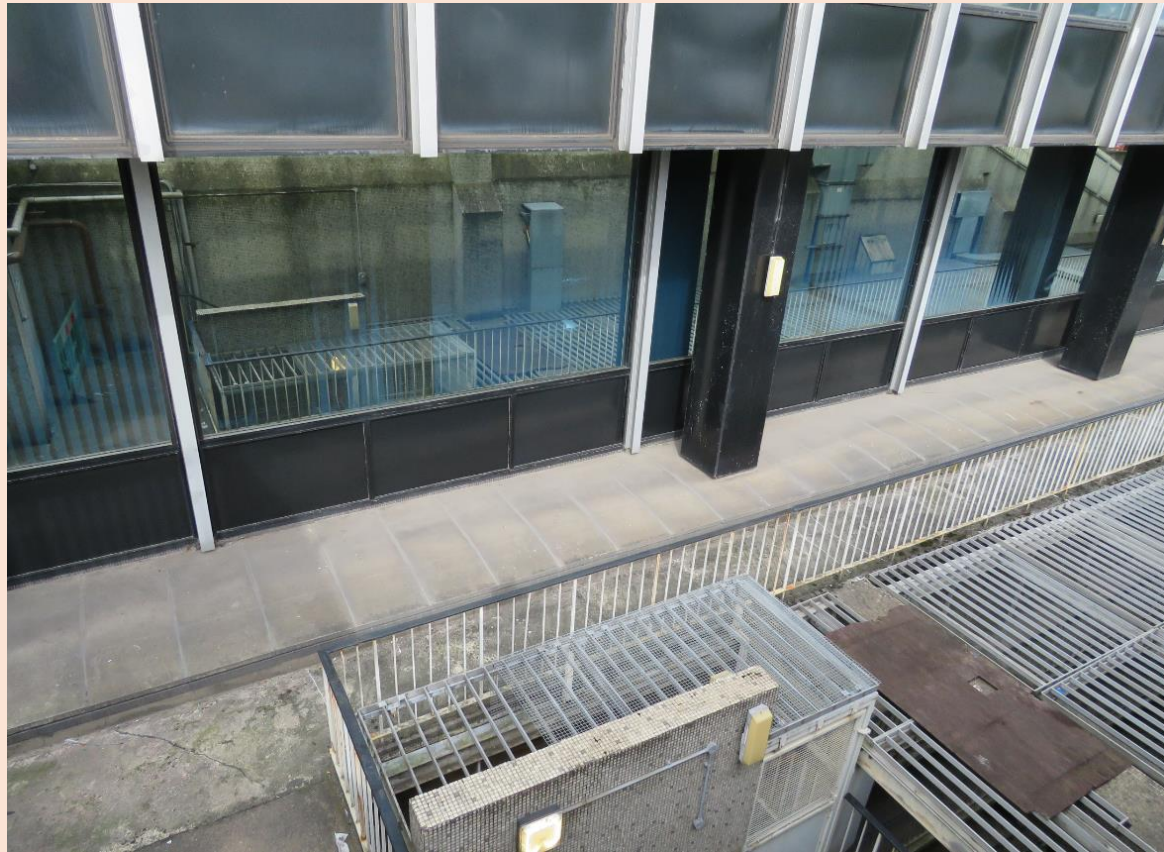
**RS-05** Detail of the central section of the Riga Street ground floor elevation and plant basement, showing the reflective nature of the film applied to the glazing.
