CIS Tower,  
Miller Street,  
Manchester.  
M60 0AL.

## CIS Tower Refurbishment.

### Recording Strategy and Photographic Audit of internal & external features, 2020.

Planning Permission ref: 126118/FO/2020. Condition 29.  
&  
LBC ref: 126119/LO/2020. Condition 10.

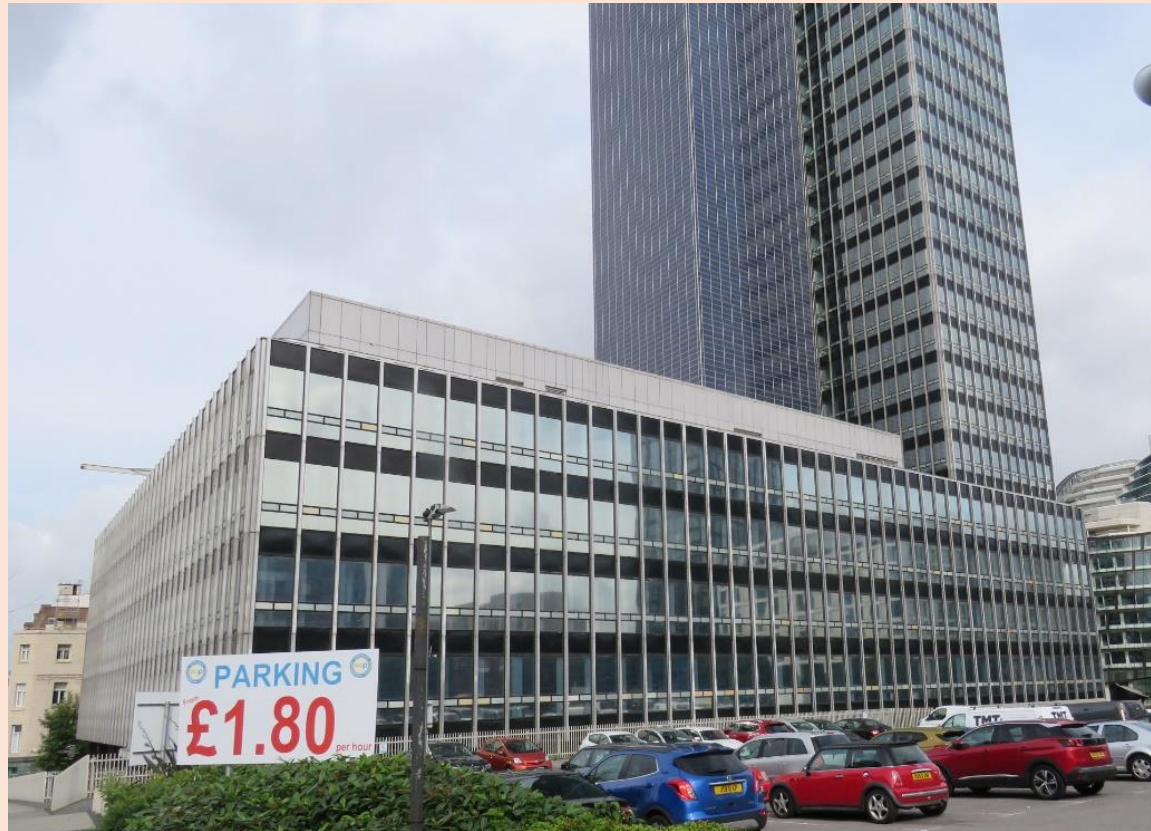
**RS-09** Detail of the Riga Street podium elevation, looking north-west, showing the plant room and expressing the four main blocks to the building.

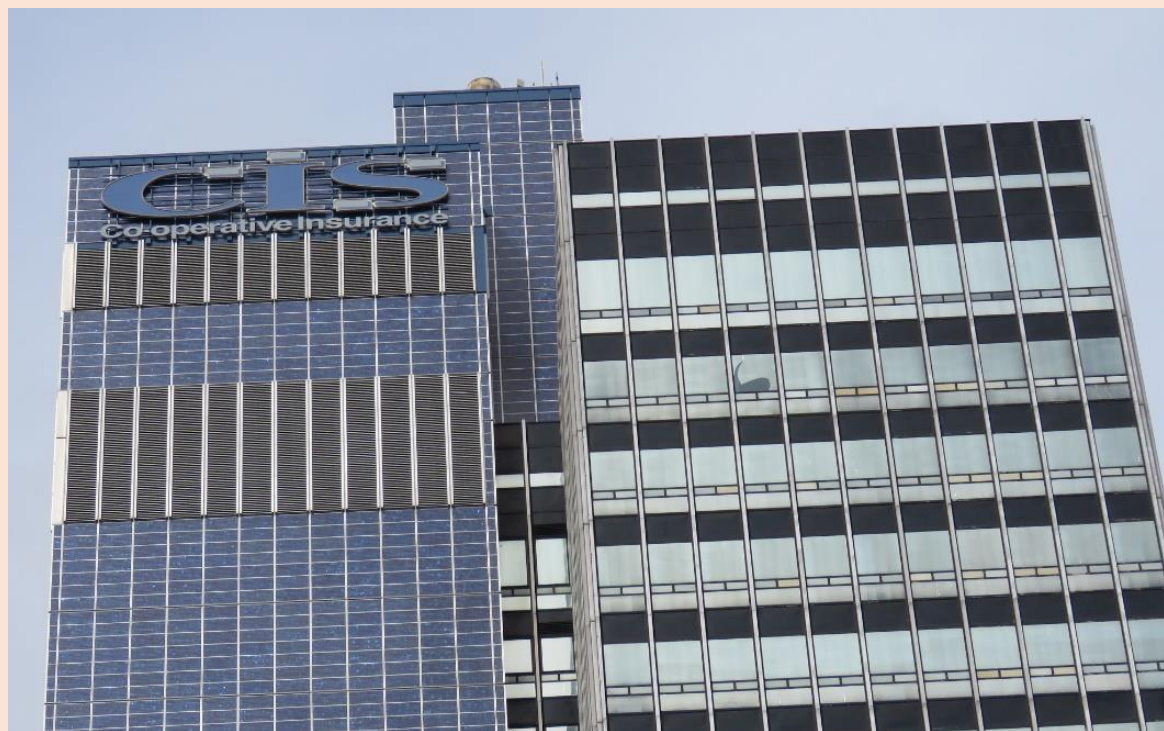
**RS-10** Details of the top of the service and office towers from the Riga Street car-park, showing the non-original signage, photovoltaic panels and failing film applied to the glazing.

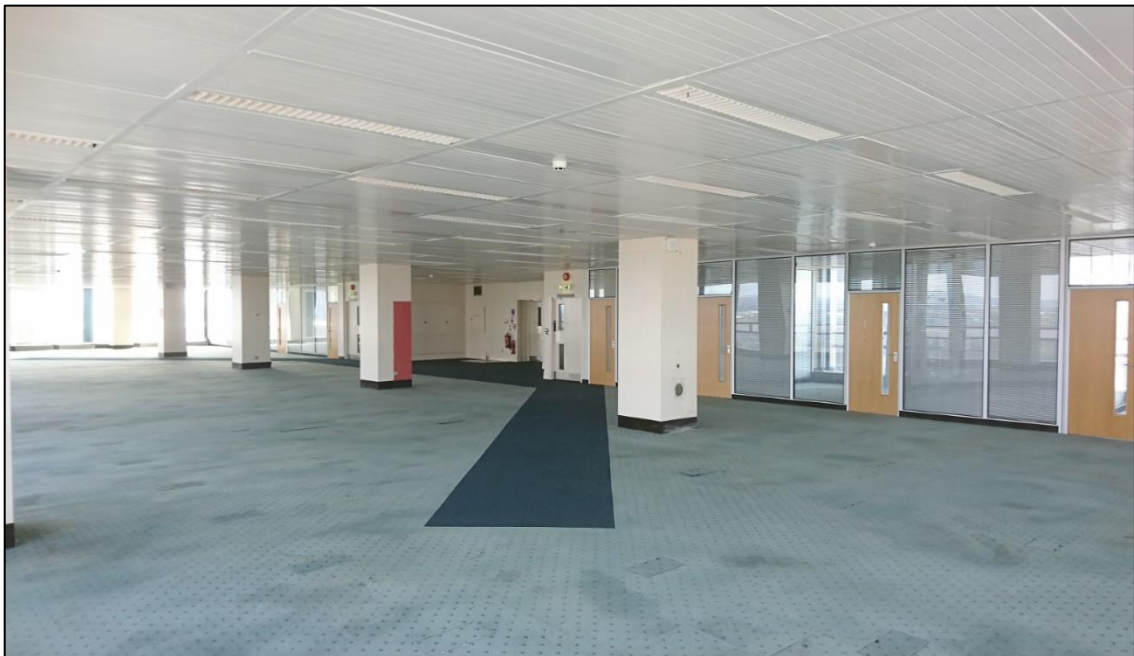
**Figure 19.** Typical office floor (August 2020), Level 16 (see **Appendix 22**). The partitioned offices are non-original, as is the floor covering, ceilings and decorative finish.

- ii) The majority of the fabric items across the building, including the ceilings, fixed and loose furniture and security controls and lifts are non-original replacements from the 1980s refurbishment. Ceilings consist of a mixed collection of suspended metal ceilings and painted ceiling directly to concrete or plaster. Although similar to the original ceiling pattern, the majority of the suspended metal ceilings are not original. The interior wall partitions are largely of negligible architectural or design interest.

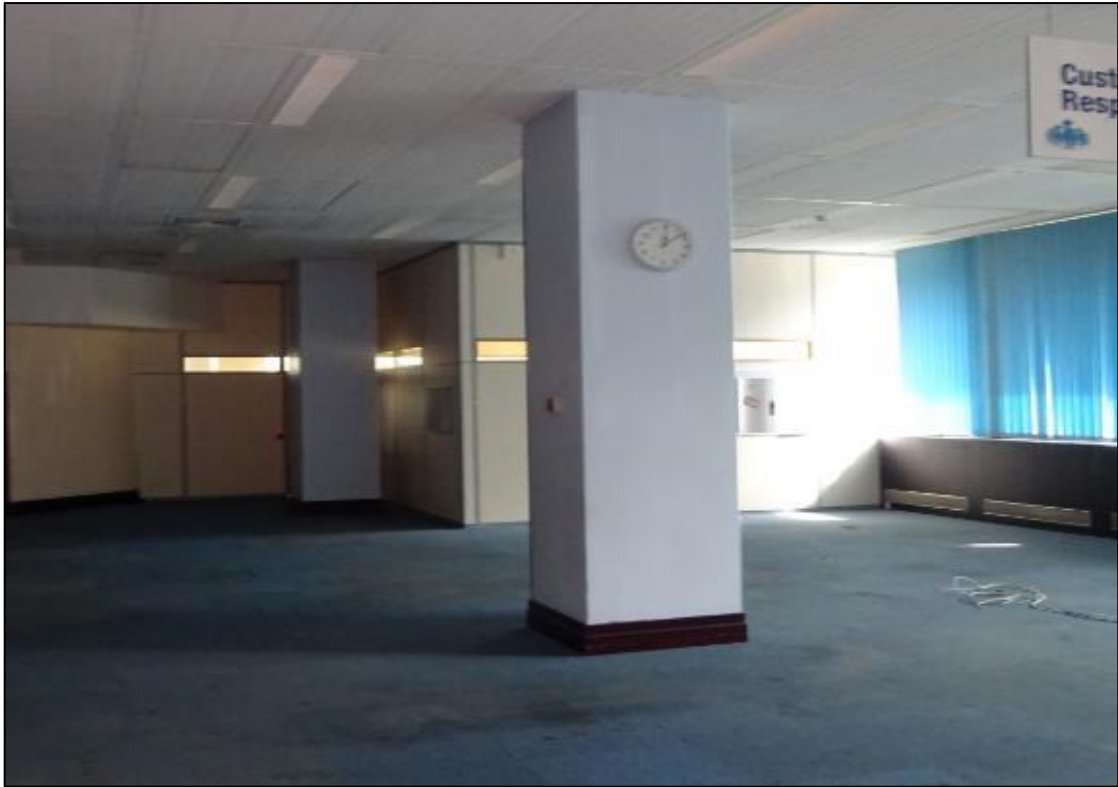
**Figure 20.** Typical Podium floor office space (Level 04 – **Appendix 10**) all fabric components shown (ceilings, floors, cladding to columns) are non-original.

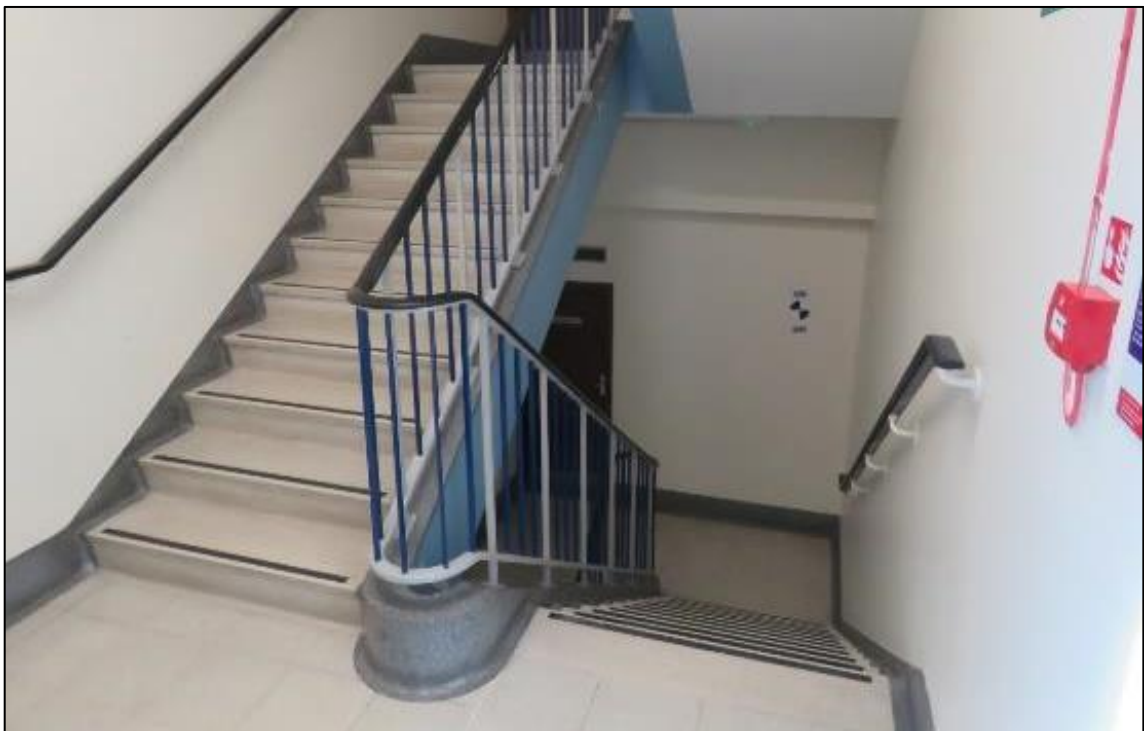
**Figure 23.** Typical stair core on the tower office floors and podium, with functional terrazzo tiled floors and painted steel balustrades and vinyl handrails.

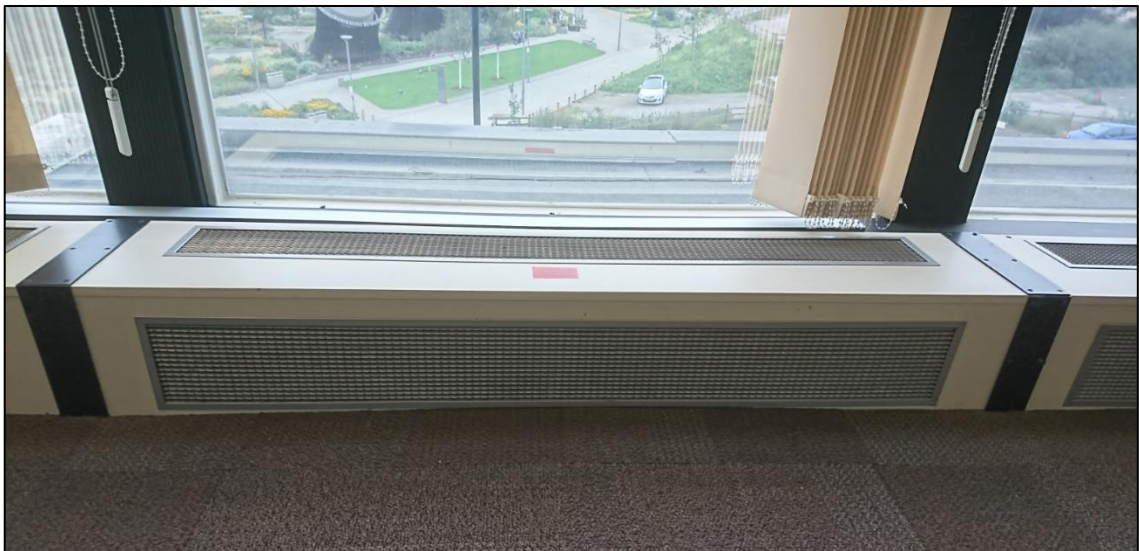
**Figure 26.** Example detail of the encasement of the Weathermaster system.

- viii) Consequently, the 'Weathermaster' perimeter air conditioning system is a component which is not considered to be a significant feature of the building. Removal of the redundant system is also required to meet the fire separation requirements, in line with the proposed fire strategy for the building. Following careful removal of the perimeter system and its safe disposal, the floor gaps will be sealed, and the walls will be made good as necessary required.

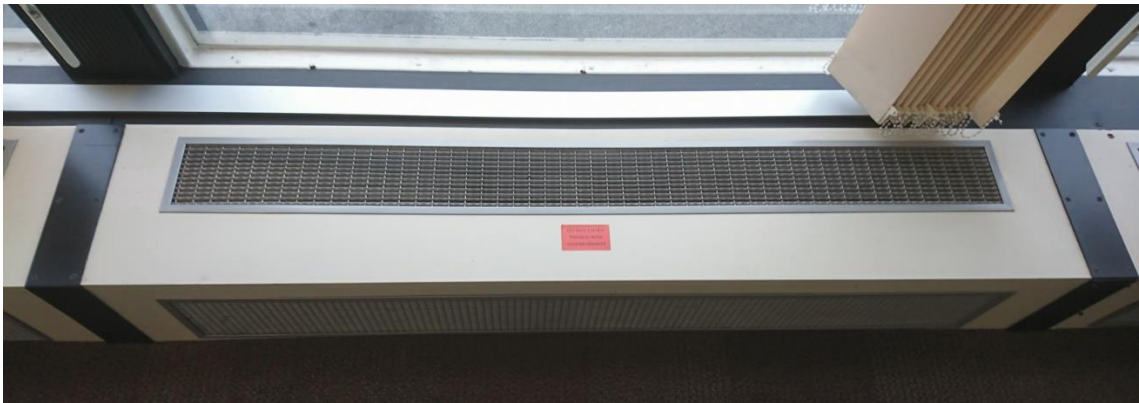
**Figure 29** Details of the top of the perimeter air-conditioning system.

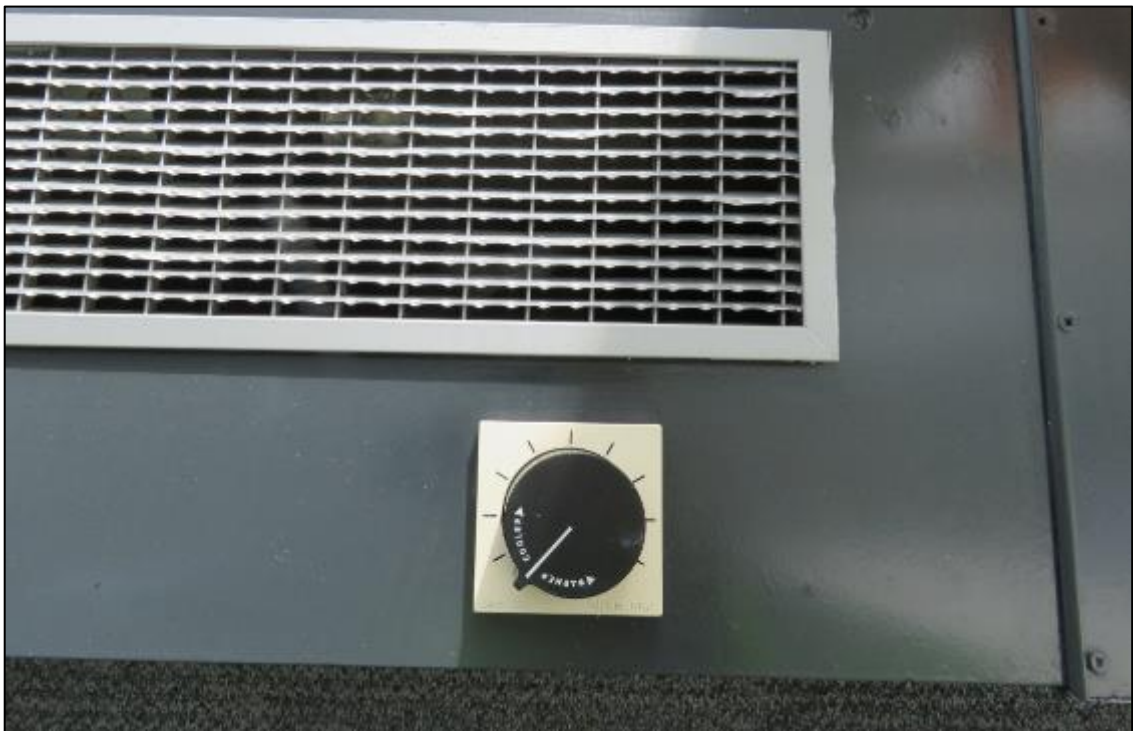
**Figure 30** Detail of the simple adjustment control for each floor level. The main system controls were in the basement.

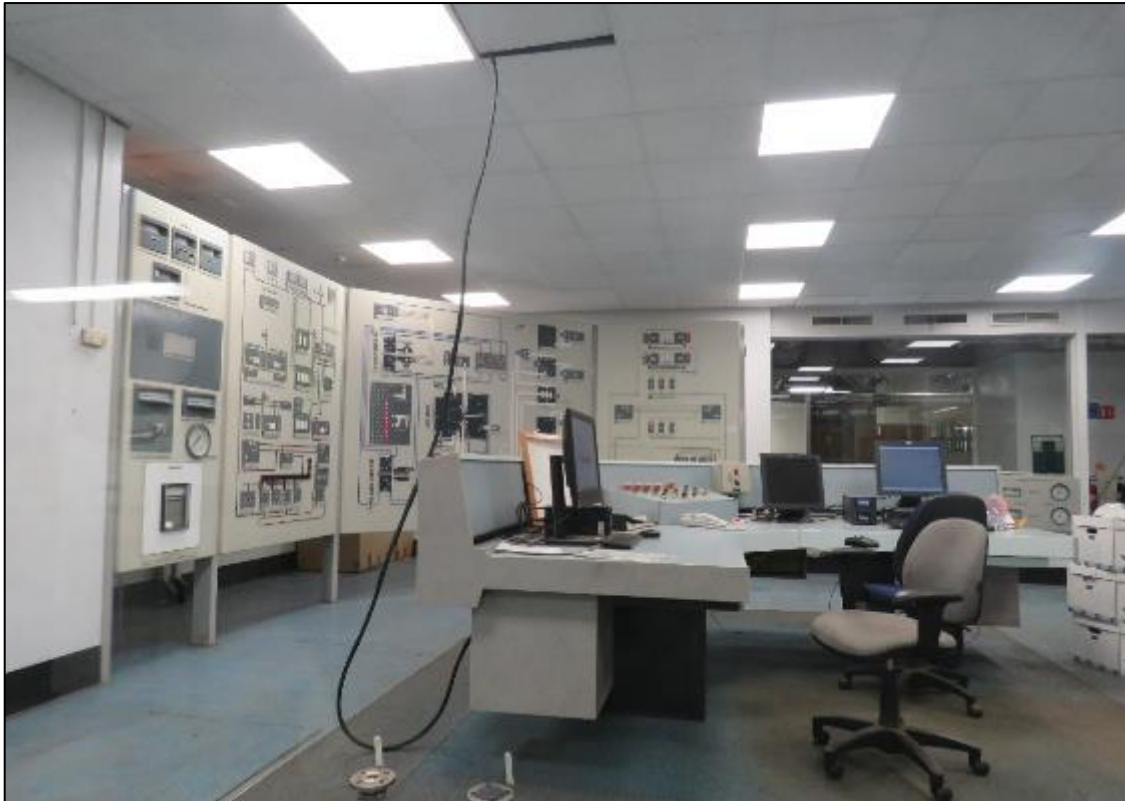
**Figure 31** View of the basement control room (level B2). Note the original control equipment has been removed and replaced.

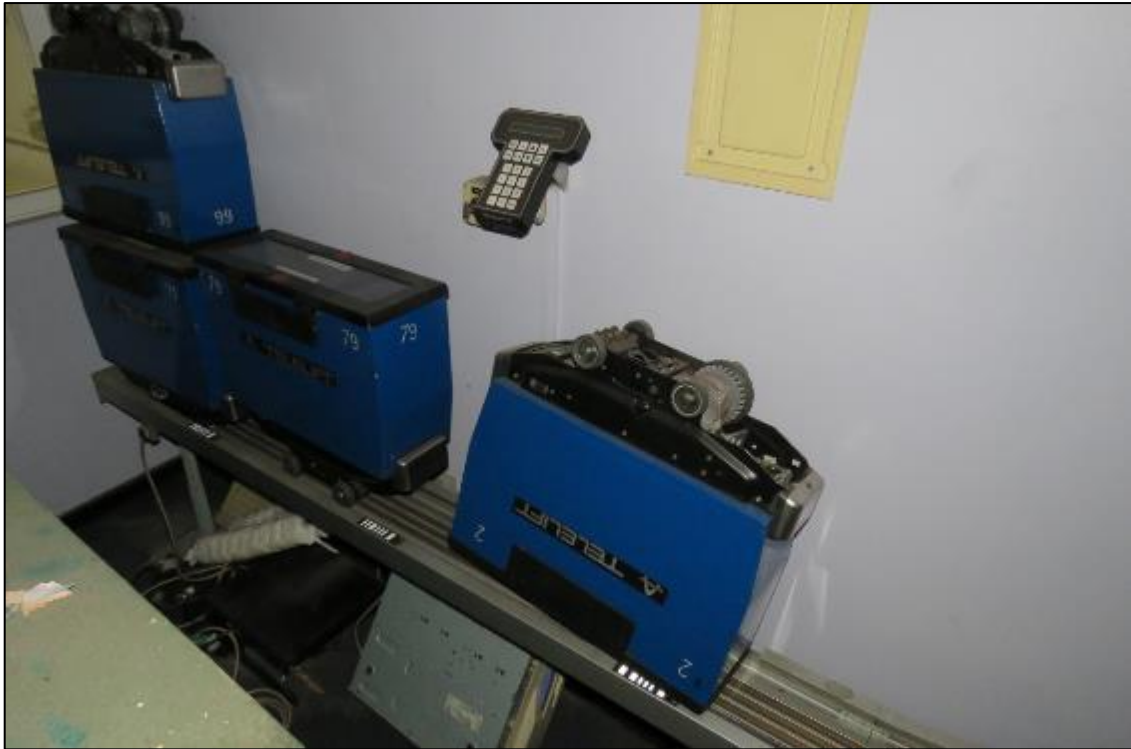
**Figure 34.** The document transportation units (Ground-floor post-room) showing the drive mechanism.

- i) The consented refurbishment and development scheme includes the removal of the redundant document conveyor and distribution system installed by Thyssen Telelift (see **Figures 34 to 40** below). Each office floor had originally been provided with an American 'Westinghouse' document conveyor system located in an open-area adjacent to the entrance to each office floor. The system fed into the extant vertical shaft to distribute documents and post around the building. The system was replaced by the German manufactured Telelift system (enclosed by newly installed screens) in the later 1980s.

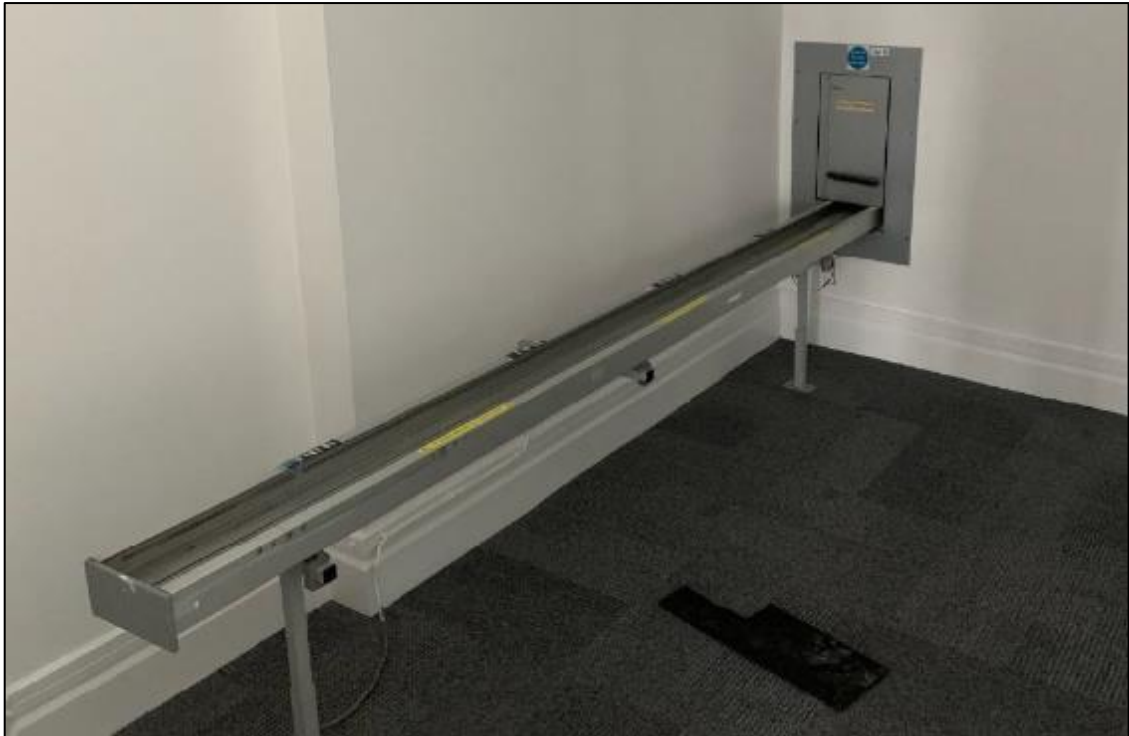
**Figure 36.** An example of the office-side single track system on the 15<sup>th</sup> tower floor, showing the entrance to the riser and vertical distribution.

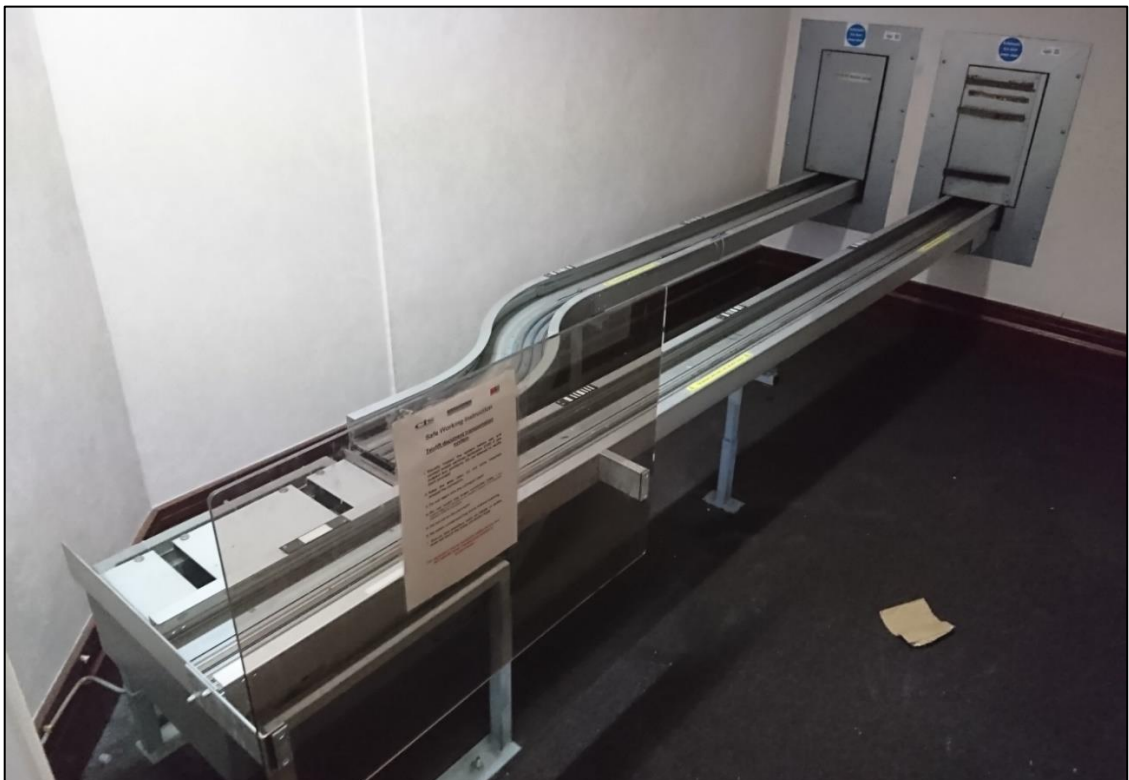
**Figure 37.** An example of the office-side dual track system on the 2<sup>nd</sup> tower and podium floor, showing the entrance to the riser and vertical distribution.

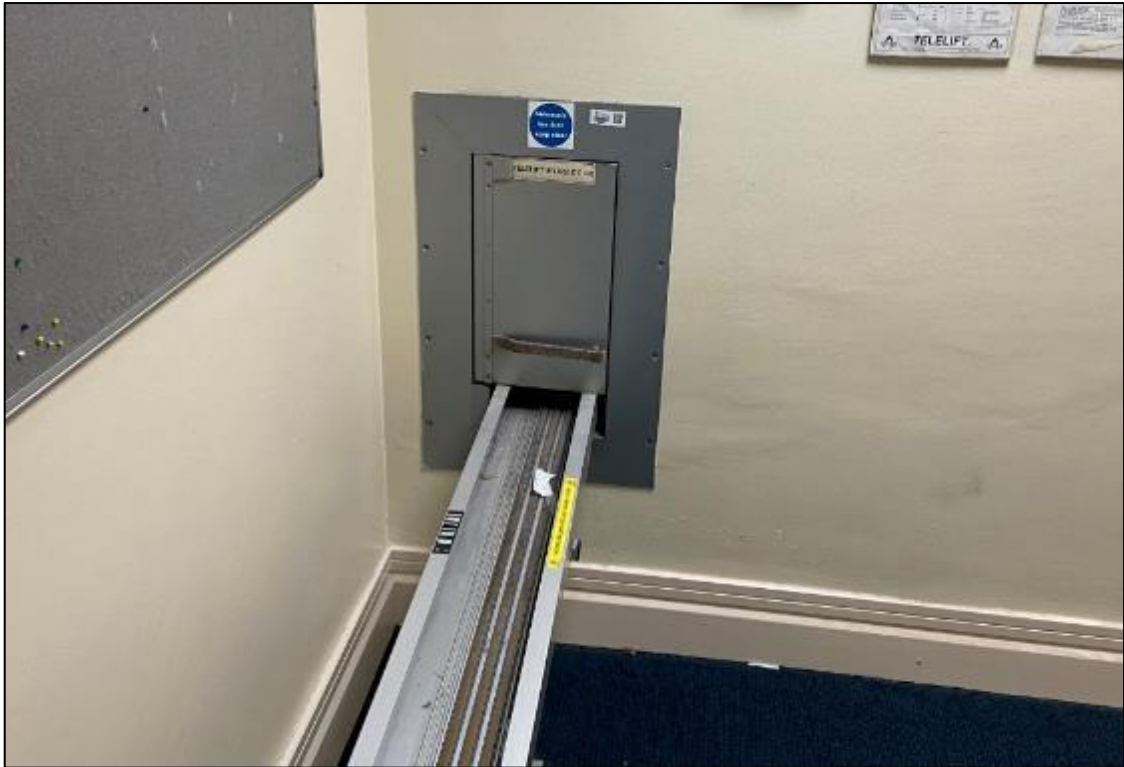
**Figure 38.** Example detail of the door to vertical riser and track bed.

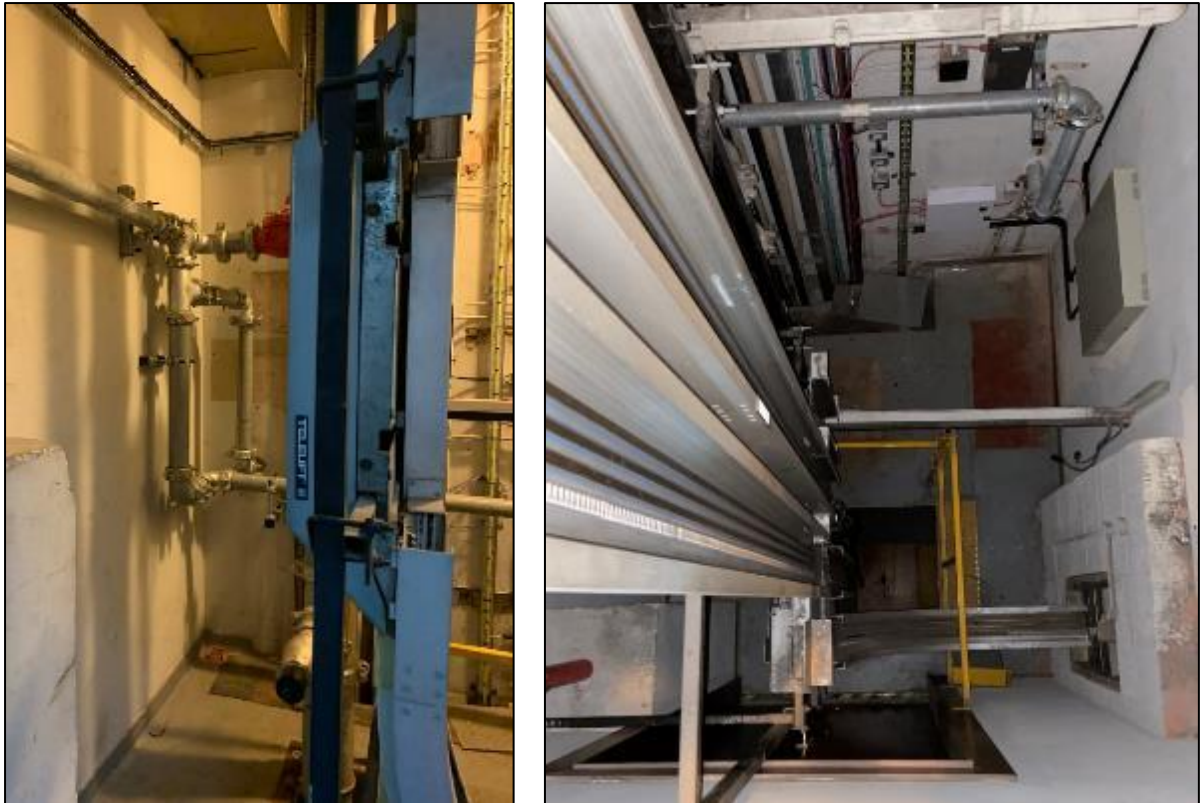
**Figure 40.** Views within the vertical riser showing the Telelift mechanism (left side) and the route of the document movement system which connected each office floor in the tower offices (right hand side).
