Preliminary Roost Assessment and Bat Survey Report  
Laystall street, Manchester

Reference:80-399-R1-1  
Date: October 2020

Laystall Street  
Manchester

**Report Ref: 80-399-R1-1**  
**Date Issued: 01/10/2020**

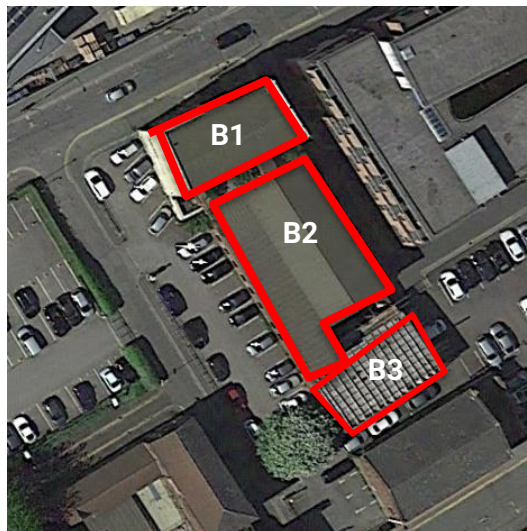
FIGURE 3.1 BUILDING REFERENCES

The buildings could be separated into three distinct sections. The building which fronts onto Laystall Street, Building 1 (B1), the central warehouse building, Building 2 (B2) and the southern section, Building 3 (B3). All of the buildings are adjoined. Please see figure 3.1 for the building references.

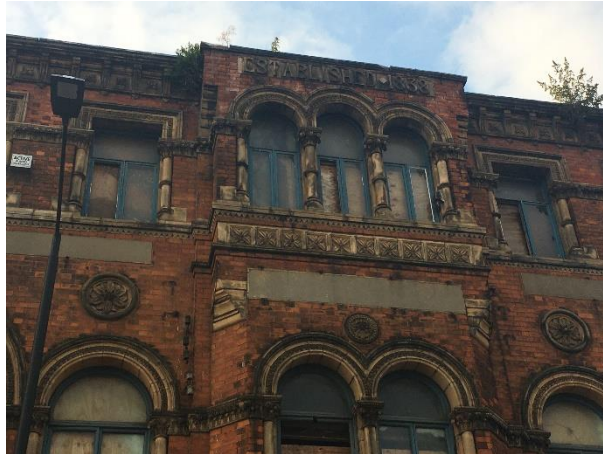
PLATE 1      SHOWING NORTHERN ASPECT OF B1

B1 fronted onto Laystall street, was red brick built and comprised decorative stone masonry. The western aspect of the building was clad with corrugated metal sheeting.

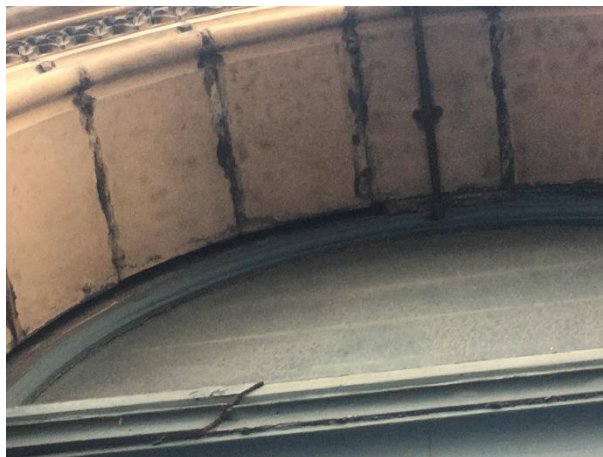
PLATE 2      SHOWING POTENTIAL ROOST FEATURE ON NORTHERN ASPECT OF B1

A number of potential roosting features were identified on the northern aspect of the building. Crevices were identified underneath the stone arches which would have potential to support roosting bats on a regular basis, however, would not be suitable for maternity or hibernation roosting.

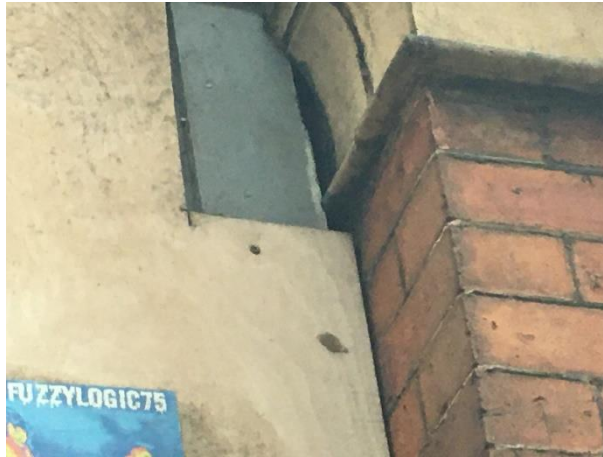
**PLATE 3**                      **SHOWING POTENTIAL ROOST FEATURE ON EAST ASPECT OF B1**

Additional potential roosting features were identified where the building's windows had been boarded up. These cavities would provide potential roost features for use by bats on a regular basis.

A number of windows were open and/or smashed on the northern aspect of the building. These areas provide access for bats into the internal of the building where maternity bat roosts could be supported.

B1 was assessed as having High potential to support roosting bats.

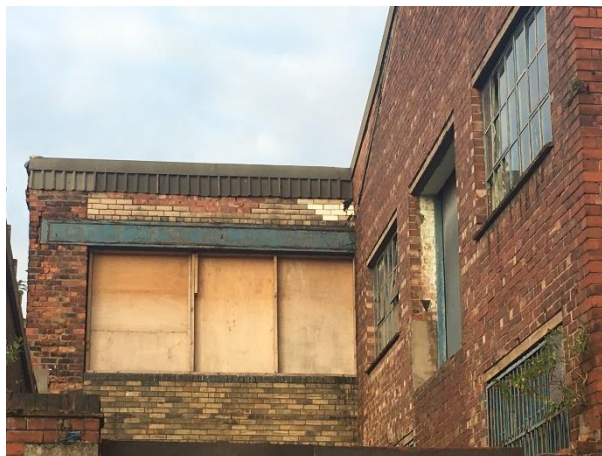
**PLATE 4**                      **SHOWING HANGING TILES AND FACIAS**

B2 comprised a red brick-built structure with a corrugated metal pitched roof, with a flat roofed section. The brickwork was generally well sealed with no substantial crevices which would be utilised by roosting bats.

An area of hanging tiles was located on the eastern aspect of B2. The hanging tiles were well sealed. A number of crevices were located underneath the corrugated metal facias which could provide occasional opportunities for crevice dwelling bat species.

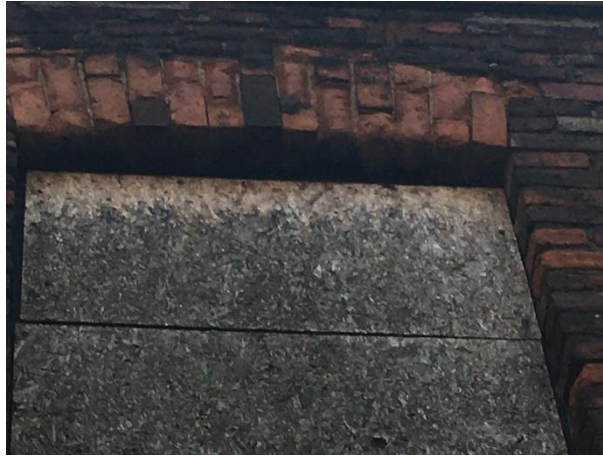
PLATE 5      SHOWING CREVICES LOCATED WITHIN BOARDED WINDOWS

A number of windows were open and/or smashed on the western and southern aspect of the building. These areas provide access for bats into the internal of the building where maternity bat roosts could be supported. Additional crevices above boarded up windows were identified which could provide roosting opportunities for bats on a regular basis.

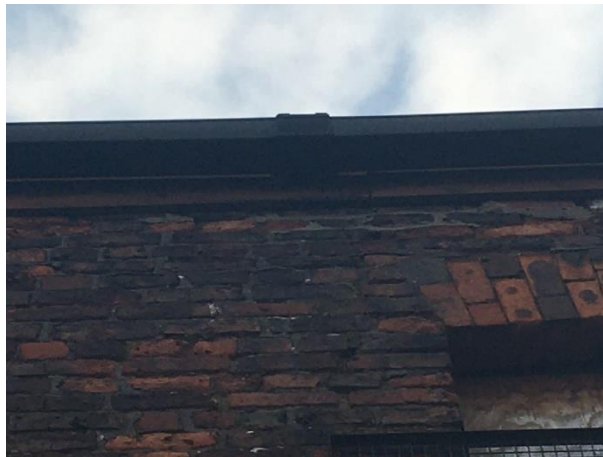
PLATE 6      SHOWING WOODEN FACIA BOARDS

Wooden fascia boards were located on the western aspect of B2. Crevices were present which would provide suitable roosting features for bats on an occasional basis.

B2 was assessed as having High potential to support roosting bats.

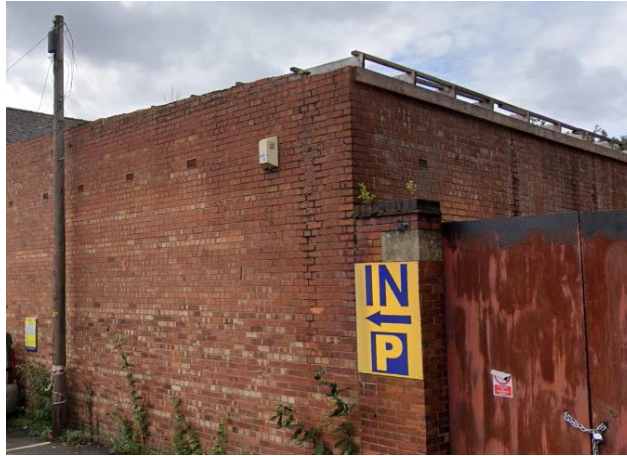
PLATE 7      SHOWING BUILDING 3

B3 was a single story flat roofed building, the brickwork was well sealed with no obvious crevices bats could access. Some crevices were identified on the western aspect of the building at the top of the wall plate and below the flat roof structure. Due to the minimal number of roost features, the building was assessed as having Low potential to support roosting bats.

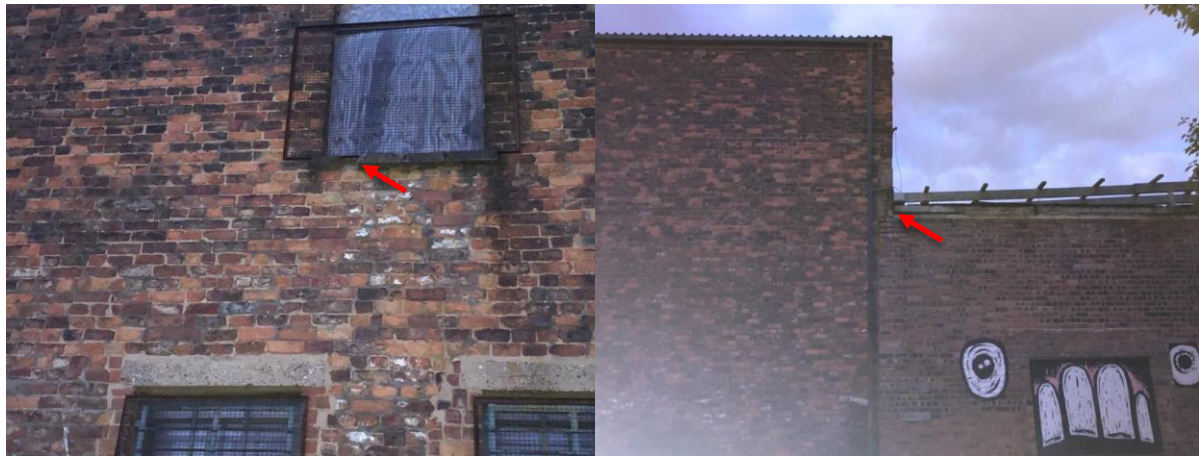
FIGURE 4.1. POTENTIAL ROOST LOCATIONS

During the dusk survey a common pipistrelle was recorded emerging from the building at 19:25, approximately 23 minutes after sunset. The exact location of the roost is unknown, however the emergence was recorded on the western aspect of buildings B2/ B3. The two potential locations of the roost are detailed within Figure 4.1.

| TIME | SPECIES | ACTIVITY |
|---|---|---|
| 19:25 | Common pipistrelle | Emergence from building. Emergence location from crevice below window, or where the roof level changes between B2 and B3. See photos. |

The initial stages of the works will occur under the supervision of the project ecologist. Sensitive areas of the buildings are to be demolished by hand under the direct supervision of the ecologist. This will include areas such as fascia boards, roof tiles, lead flashing and the identified roost locations within the buildings (as detailed within Figure 4.1).
