Our Ref: 11323-L03 (00)

11 December 2020

## **COVER SYSTEM VALIDATION REPORT – CORNBROOK HUB**

This document presents information obtained as part of the remedial actions carried out in accordance with the approved Remediation Strategy (RS) for the Cornbrook Hub development site located off Chester Road, Manchester, M15 4LZ .

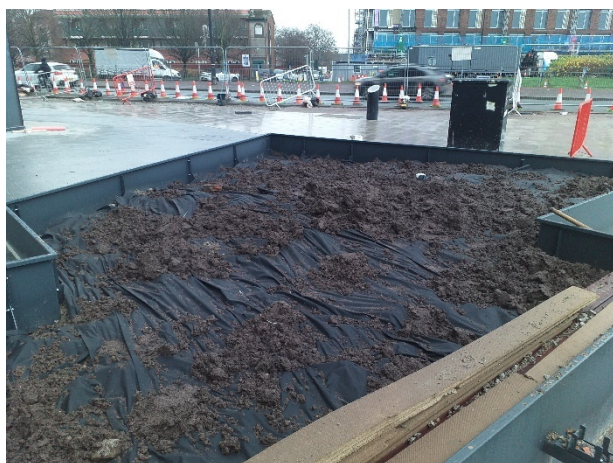
| PHOTOGRAPHIC LOG | | |
|---|---|---|
| Soft landscaping area | Date:<br>07/12/2020 | |

| PHOTOGRAPHIC LOG | | |
|---|---|---|
| Black geotextile layer placed prior to topsoil covering the area | | |

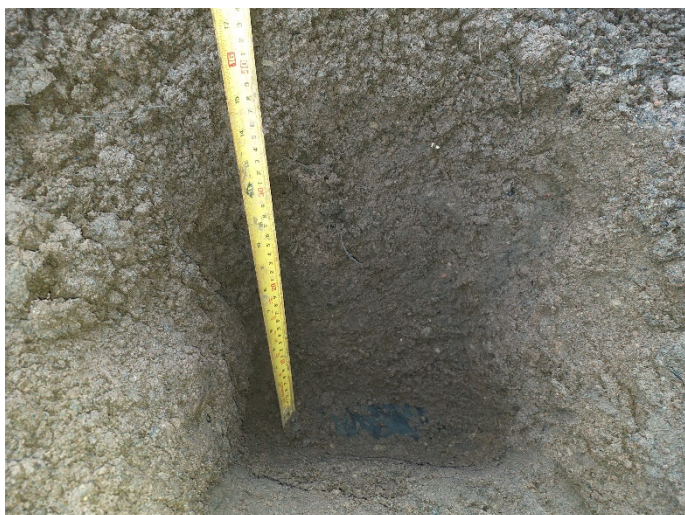
| <b>Trial Hole:</b><br><b>IP101</b> | <b>Date:</b><br>10/12/2020 | |

3No. inspection pits (reference IP101 to IP103, inclusive) were hand-excavated by RSK at a general spread of locations across the soft landscaping area in the south western corner of the site. The inspection pits confirmed that imported cover soils placed within soft landscaped areas were of sufficient thickness, composition and construction to meet the requirements of the RS. As required by the RS, the presence of a geotextile break layer was recorded at the base of each inspection pit.

| <b>Topsoil thickness: 0.47m</b><br><br><b>Total cover thickness:</b><br><b>0.47m</b> | | |

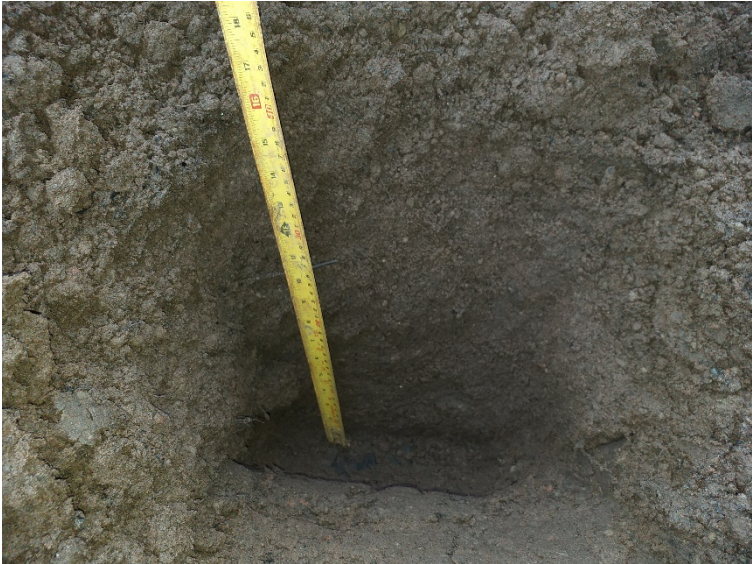
| <b>Trial Hole:</b><br>IP102 | <b>Date:</b><br>10/12/2020 | |

| <b>Topsoil thickness: 0.46m</b><br><br><b>Total cover thickness: 0.46m</b> | | |

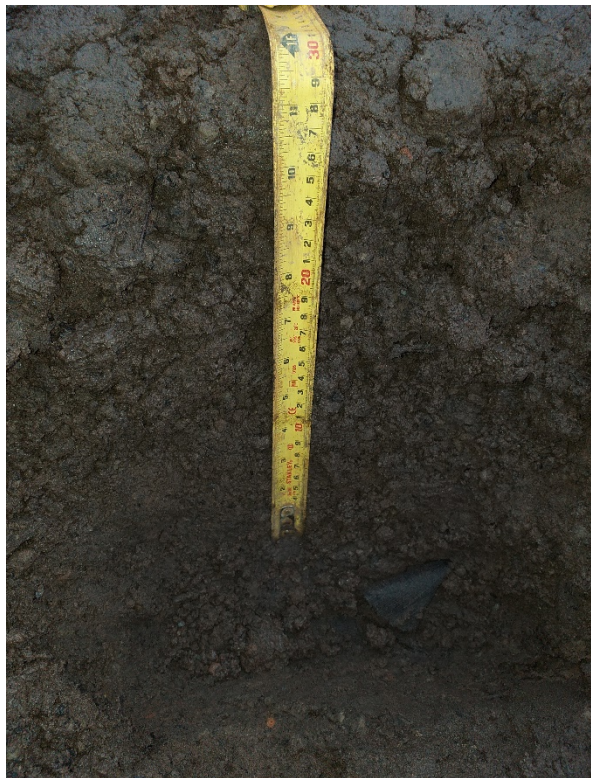
| <b>Trial Hole:</b><br>IP103 | <b>Date:</b><br>10/12/2020 | |

| <b>Topsoil thickness: 0.30m</b><br><br><b>Total cover thickness:</b><br><b>0.30m</b> | | |
