# EXTENDED PHASE 1 HABITAT SURVEY & DAYTIME BAT SURVEY AT PHOENIX WORKS, ELLESMERE STREET, MANCHESTER

2020

**RACHEL  
HACKING  
ECOLOGY**

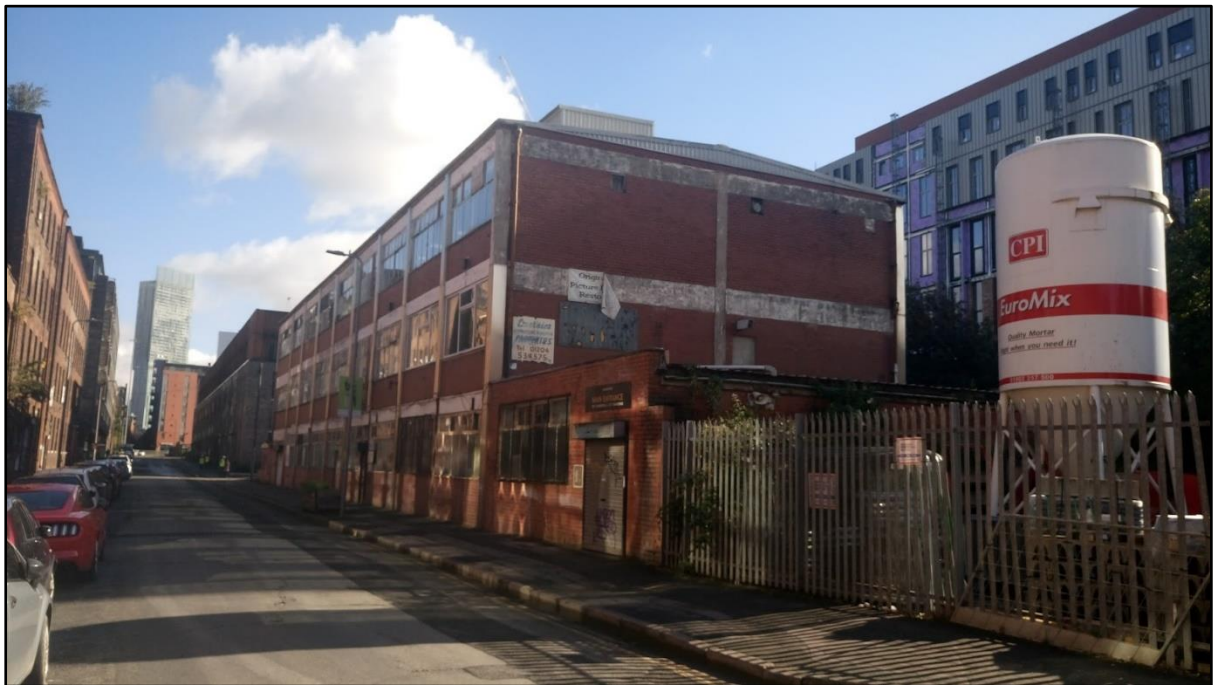
- 3.13 The three-storey building onsite is constructed from brick (see cover page above). The brickwork and associated mortar are in good condition with no holes, gaps or missing sections present (see Photograph 8). The wood window frames across the building are showing signs of aesthetic degradation. However, the wood and uPVC window and door frames and are well-sealed to the surrounding masonry with no gaps or crevices bats may exploit (see Photograph 9).

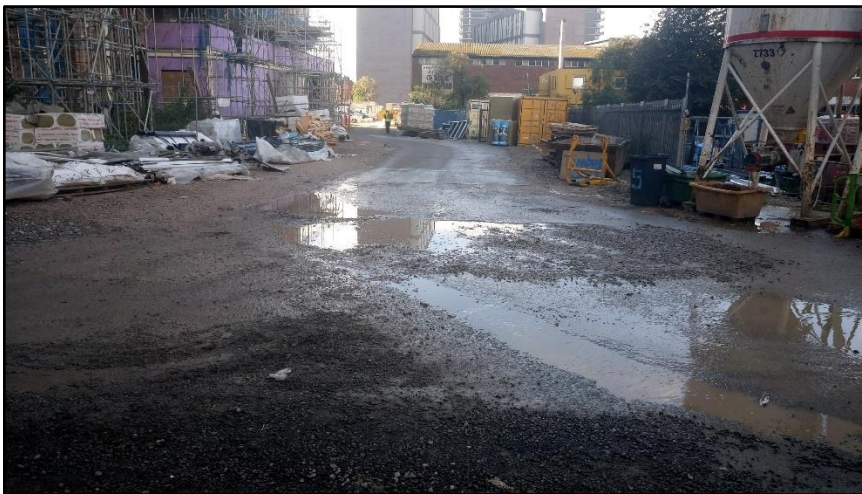
**Photograph 1 showing an area of bare ground on site**

- 3.2 This habitat is the most abundant on site and consists of tarmac and compact crush-and-run (see Photograph 1). These areas are used for vehicular access and footpaths. Ephemeral/short perennial species have established in a few small areas between cracks and at the peripheries of the bare ground habitats. These areas are minor and consist Mugwort *Artemisia vulgaris*, Dandelion *Taraxacum officinale* agg., Horsetail species *Equisetum* sp., Annual Meadow-grass *Poa annua*, Common Mouse-ear *Cerastium fontanum* and Smoot Sow-thistle *Sonchus oleraceus*.

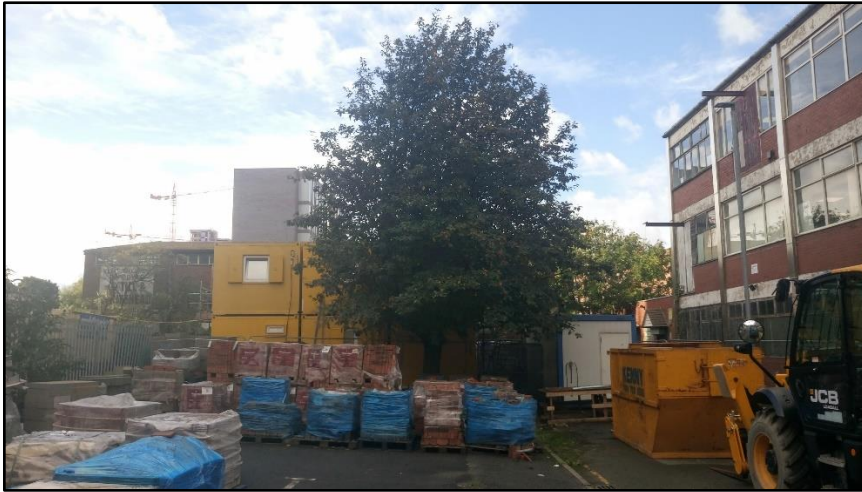
**Photograph 2 showing the Swedish Whitebeam on site**

- 3.3 Three scattered trees are located on site (see Photograph 2). Tree species present are Rowan *Sorbus aucuparia*, Ash *Fraxinus excelsior* and Swedish Whitebeam *Sorbus intermedia* agg. These trees are young to semi-mature in age.

- **Nesting Birds** – It is recommended the removal of the trees on site is carried out outside the nesting bird season (generally March – August). If clearance work needs to be carried out within the bird nesting season, then a nesting bird survey will be required immediately prior to work commencing.

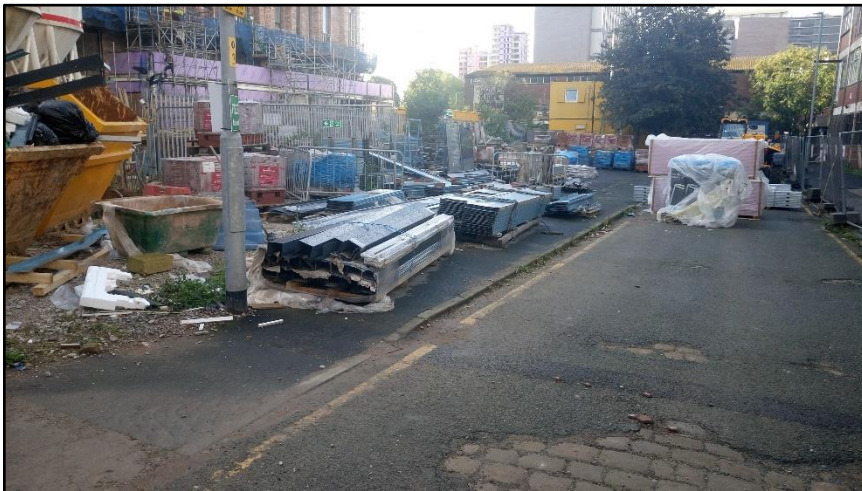
**Photograph 3 showing an area of bare ground/building materials and equipment**

- 3.4 This habitat has been assigned separately to bare ground due to the amount and density of building materials and equipment present (see Photograph 1 above and Photograph 3 below).

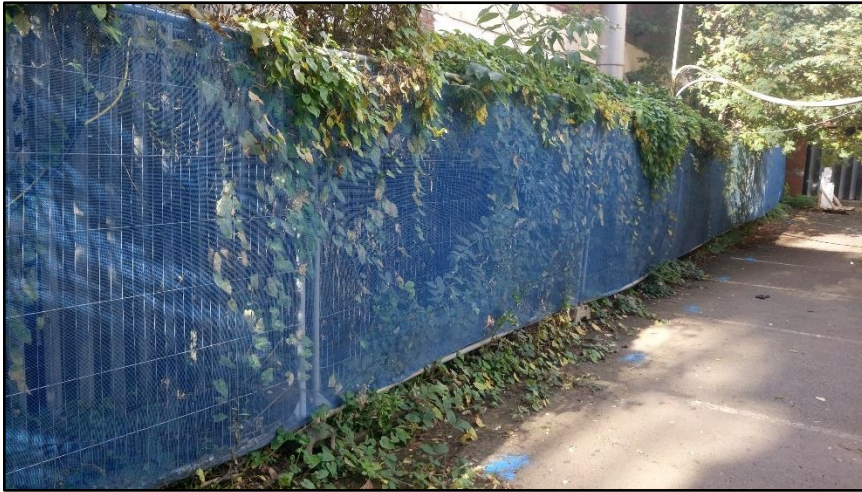
**Photograph 4 showing the tall, ruderal herb between the boundary fence and the heras fencing**

- 3.5 A narrow strip of tall, ruderal vegetation exists along the western boundary of the site, between the boundary fencing and a stretch of netted heras fencing that runs parallel (see Photograph 4). Dominant species include Stinging Nettle *Urtica dioica*, Bramble *Rubus fruticosus* agg. and Hedge Bindweed *Calystegia sepium*.

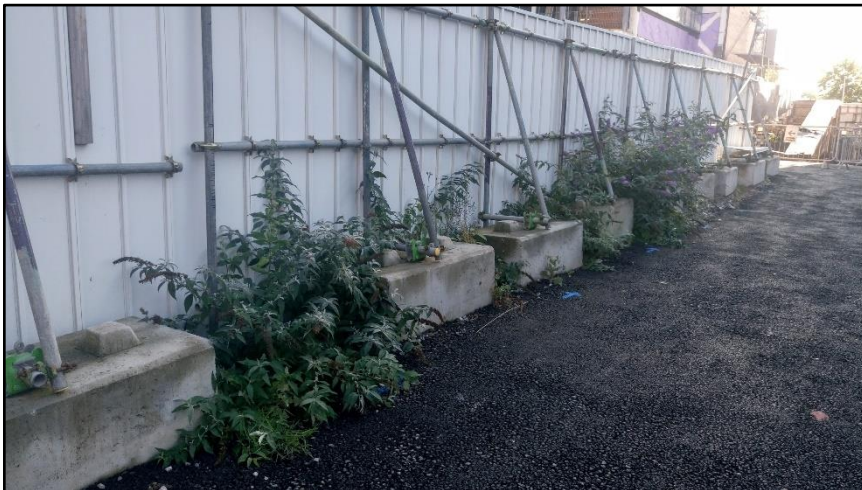
**Photograph 5 showing some of the scattered scrub on site**

- 3.6 This habitat is located across the site along fencing and the peripheries of the site (see Photograph 5). Species present are Butterfly Bush *Buddleja davidii*, Sycamore *Acer pseudoplatanus* and Ash *Fraxinus excelsior*.

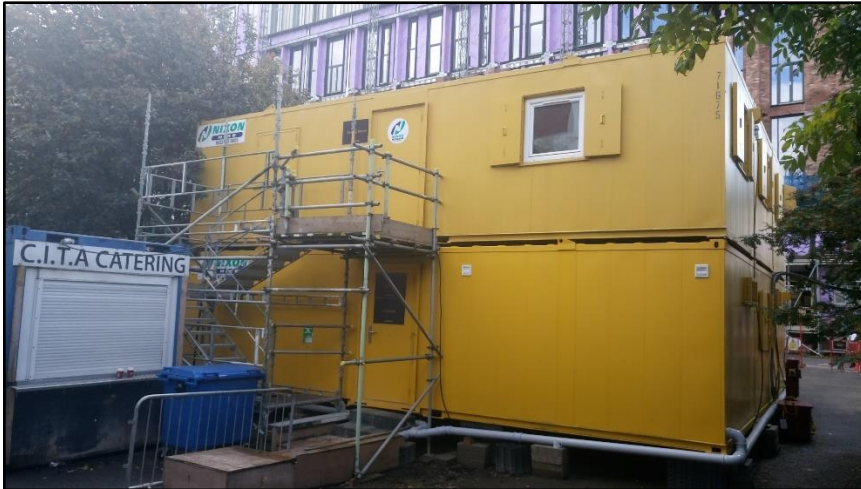
**Photograph 6 showing some of the portable cabins on site**

- 3.7 A large three storey, brick-built building is located along the northern boundary of the site. Numerous portable cabin type structures and two silos are also present on site (see Photographs 6 and 7).

- 3.22 Numerous portable cabins and two silos are located on site (see Photographs 6 and 7 above). All these structures are well-sealed, are heavily disturbed and offer no suitable roosting habitat for bats. Therefore, these structures are considered to offer **negligible bat roost suitability** and are discounted.
- 3.23 The trees on site were surveyed from the ground for potential bat roosting features, such as cavities, knot holes or peeling bark. No suitable features were found. Therefore, it is considered the trees on site offer **negligible bat roost suitability**.

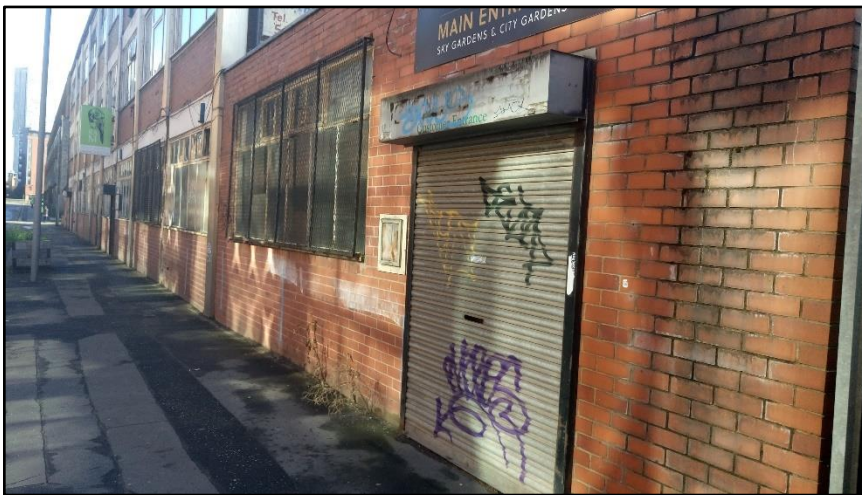
**Photograph 8 showing the exterior of the building**

- 3.14 Some of the windows have been smashed and subsequently boarded up. The boards are fixed flush to the frames with no gaps or holes present. Metal roller-shutter doors are also located across the ground floor of the building (see Photograph 8 above). The metal frames are in excellent condition and well-sealed to the surrounding brickwork.

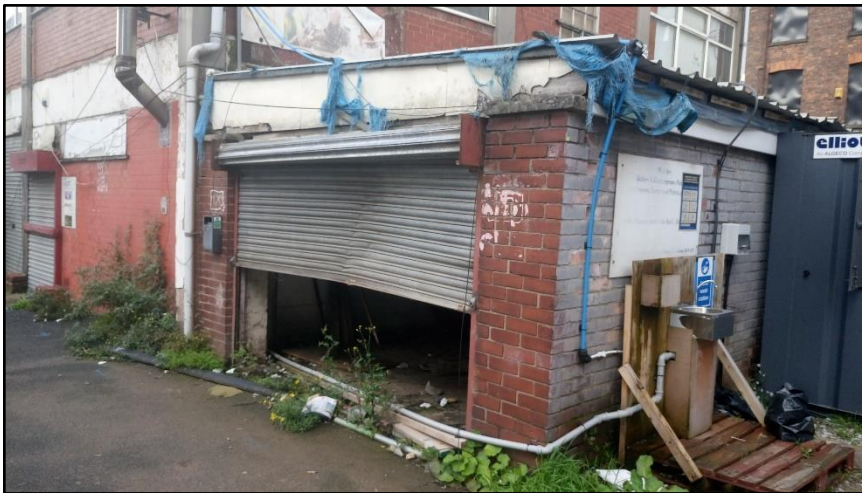
**Photograph 10 showing the eastern extension on the three-storey building**

- 3.15 The shallow pitched roof is covered with metal corrugated roofing sheets. The sheets appear to be in good condition as there are no signs of water ingress internally. The roofs edges are finished with metal roof capping providing no internal access points.
- 3.16 Small ground floor extensions are located on the eastern and western elevations of the three-storey building. The extension located on the eastern elevation is in poor condition with a damaged roller-shutter door offering open access into the internal space (see Photograph 10).

- 4.5 The ground floor extension located on the eastern elevation of the building is poor condition with open access into the internal space via the damaged roller-shutter door. The internal space is in good condition with no void spaces present.

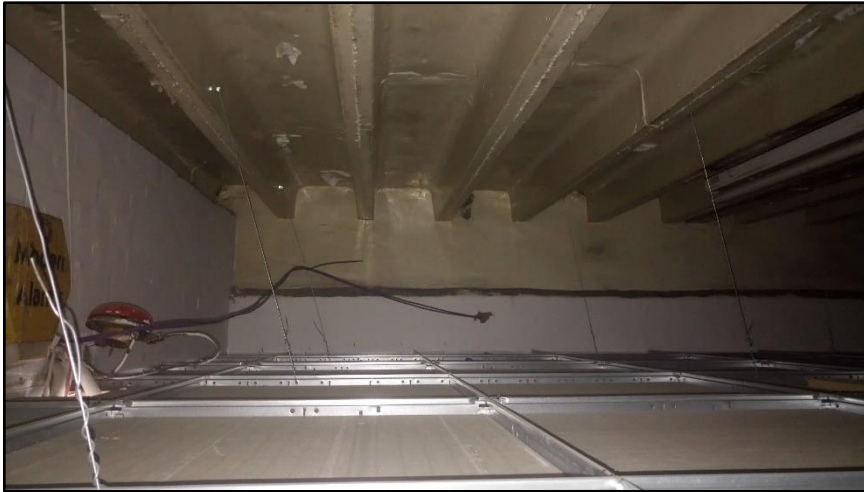
**Photograph 13 showing one of the small void spaces between the suspended ceiling and the underside of the roof**

3.19 A few of the rooms on the top floor have suspended ceilings with a small void space located between the suspended ceiling and the underside of the roof above (see Photograph 13). These were easily accessed by moving one of the ceiling tiles. The voids consist small amounts of wiring and other services. The voids are well-sealed with no daylight seen at any point.

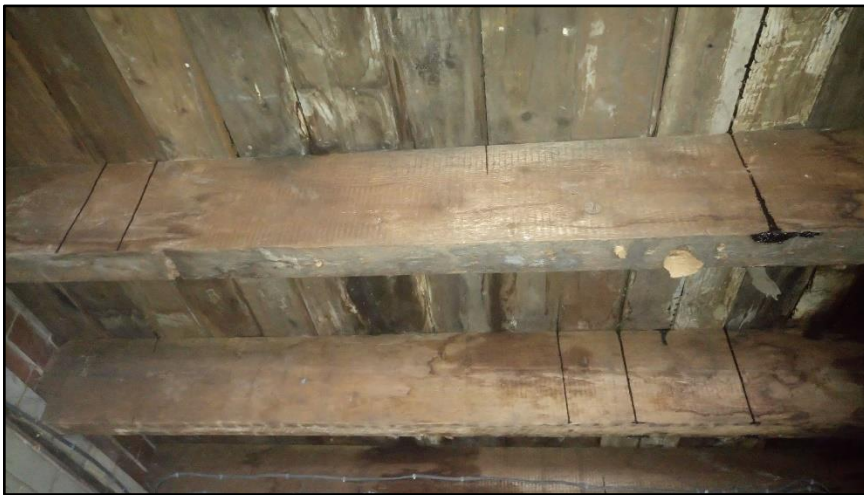
**Photograph 14 showing the underside of the roof**

- 3.20 The interior of the eastern, ground floor extension is damp. The brick internal walls are painted white. The walls are in good condition and well-sealed with mortar. No roof void spaces are present as the space is open to the underside of the roof (see Photograph 14). The roof timbers are in good condition with no cracks or gaps bats may exploit.
